ORNL/TM-6067

HTGR Fuel Development: Investigations of Breakages of Uranium-Loaded Weak Acid Resin Microspheres

METALS AND CERAMICS DIVISION

HTGR FUEL DEVELOPMENT: INVESTIGATIONS OF BREAKAGES OF
URANIUM-LOADED WEAK ACID RESIN MICROSPHERES

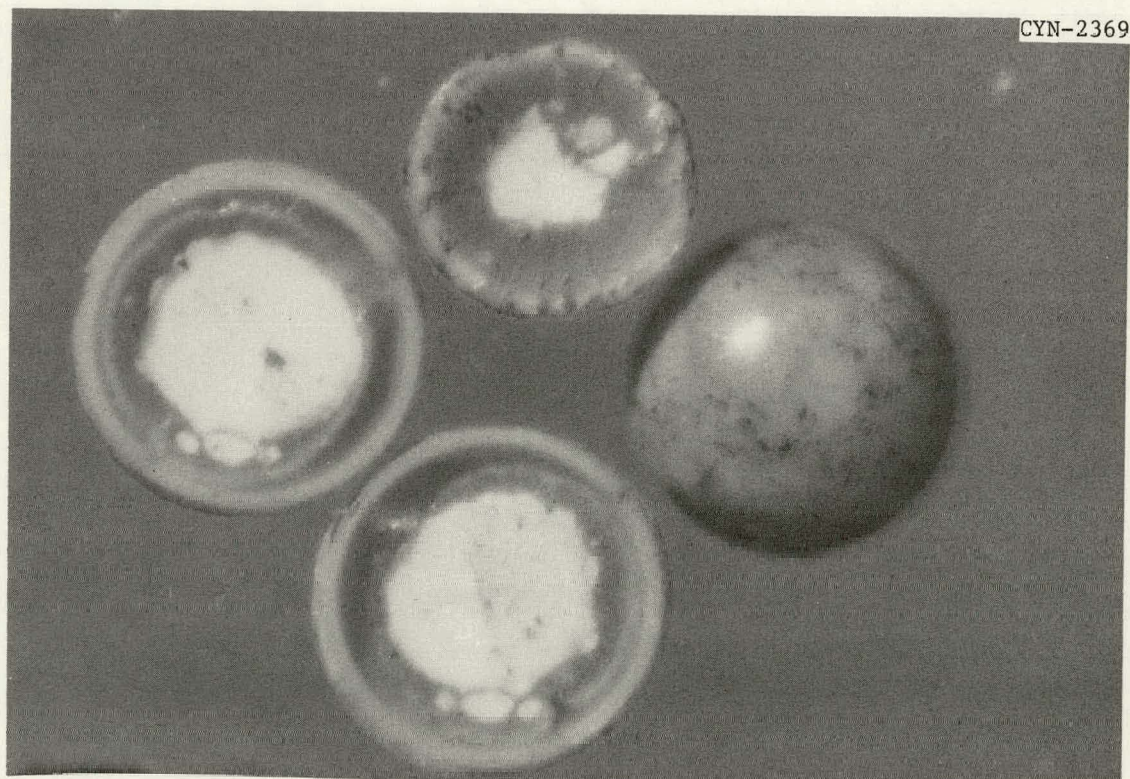
Examples of resin particles that cracked during the pneumatic transfer tests are shown in Fig. 1. The unusual inner structures of the particles were obvious when compared with particles examined later. The irregularly shaped white central area is surrounded by a yellowish glassy material, which in turn is surrounded by a pale yellow-green translucent shell. The

Fig. 1. Uranium-Loaded Amberlite IRC-72 Weak Acid Resin Microsphere Pieces Cracked During Pneumatic Transfer. 60 \times . Reduced 14.5%.

whole is enclosed by a thin glassy rim. (Color versions of these figures are available upon request.) The white color of the central areas is reminiscent of the resin before loading. The black specks on the surfaces of the particles in this and the other figures is flake graphite blended with these particles to reduce static charges.

Breakage of the microspheres during pneumatic transfer probably resulted from the presence of significant quantities of the glassy material. This is clear from Fig. 1, which shows no pieces from normal microspheres (such as seen in Figs. 15 and 16), which contain little of the glassy material except for the thin outer layer. Evidently, the substantial quantities of the glassy material reduced the resilience of the microspheres and made them brittle, so they split.

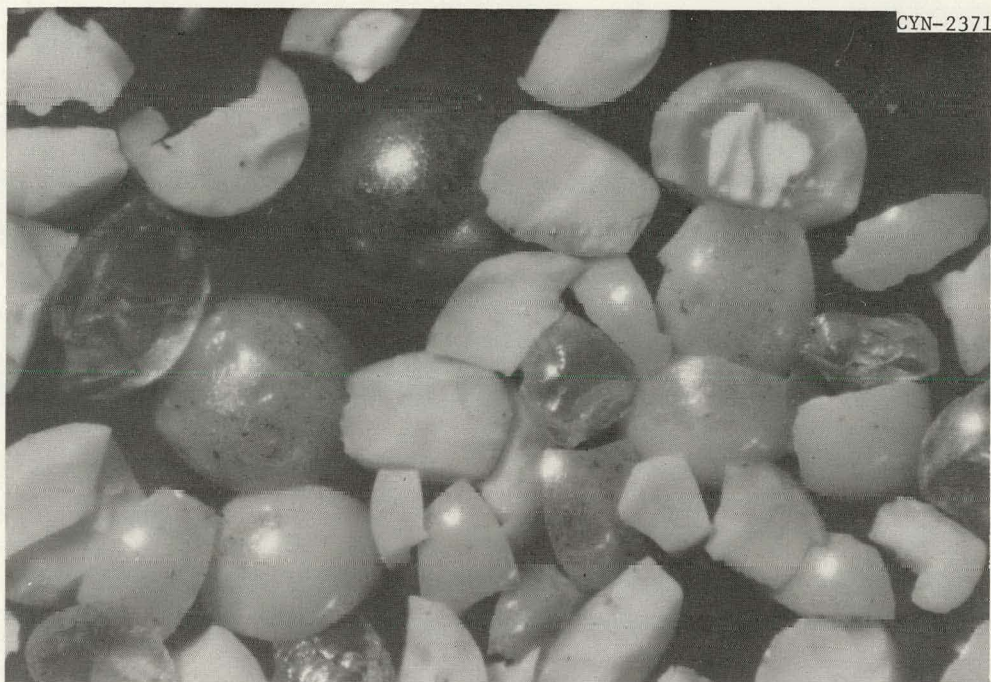
To ascertain the extent of this unusual inner structure throughout the batch, other particles were selected at random from the batch and cracked open by crushing between the anvil and spindle of a hand-held micrometer caliper. The bits and pieces so produced are shown in Fig. 2. Clearly, the unusual inner structure was not typical of the majority of the particles. Note the apparently clean breaks of some of the glassy material away from the translucent material.

Fig. 2. Bits and Pieces of Uranium-Loaded Amberlite IRC-72 Weak Acid Resin Microspheres Selected at Random from the Same Batch as the Broken Pieces Shown in Fig. 1. These are fragments of deliberately crushed whole microspheres. 60 \times . Reduced 24%.

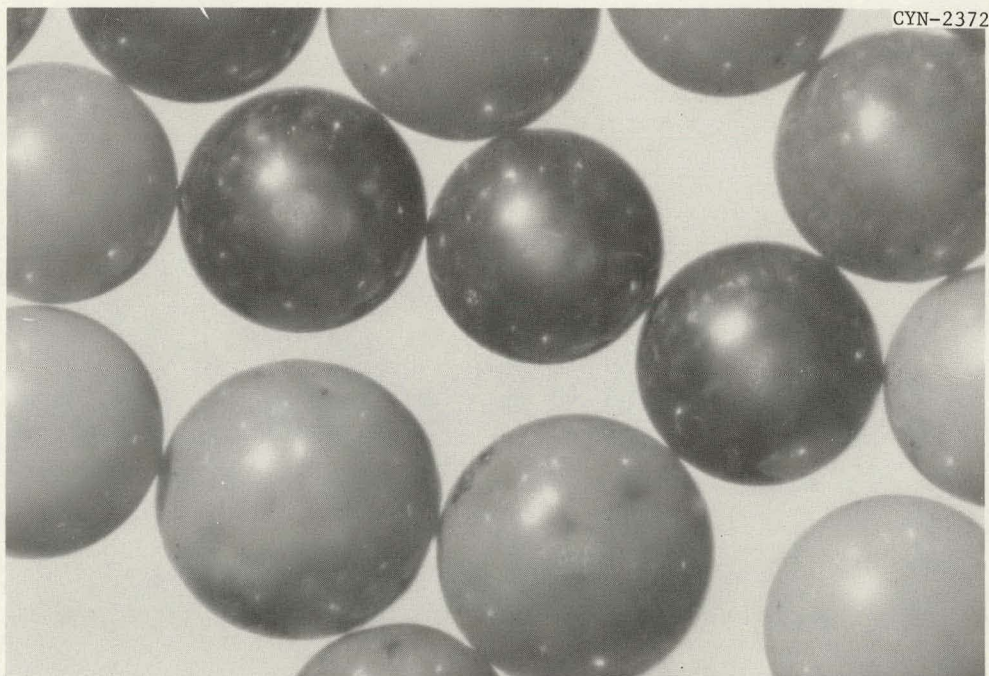
Whole uncrushed microspheres are shown in Fig. 3. Note the darker color of the three slightly smaller microspheres that are aligned horizontally just above center.

Fig. 3. Whole Uranium-Loaded Amberlite IRC-72 Weak Acid Resin Microspheres Selected at Random from the Same Batch as Those Shown in Figs. 1 and 2. 60 \times . Reduced 24%.

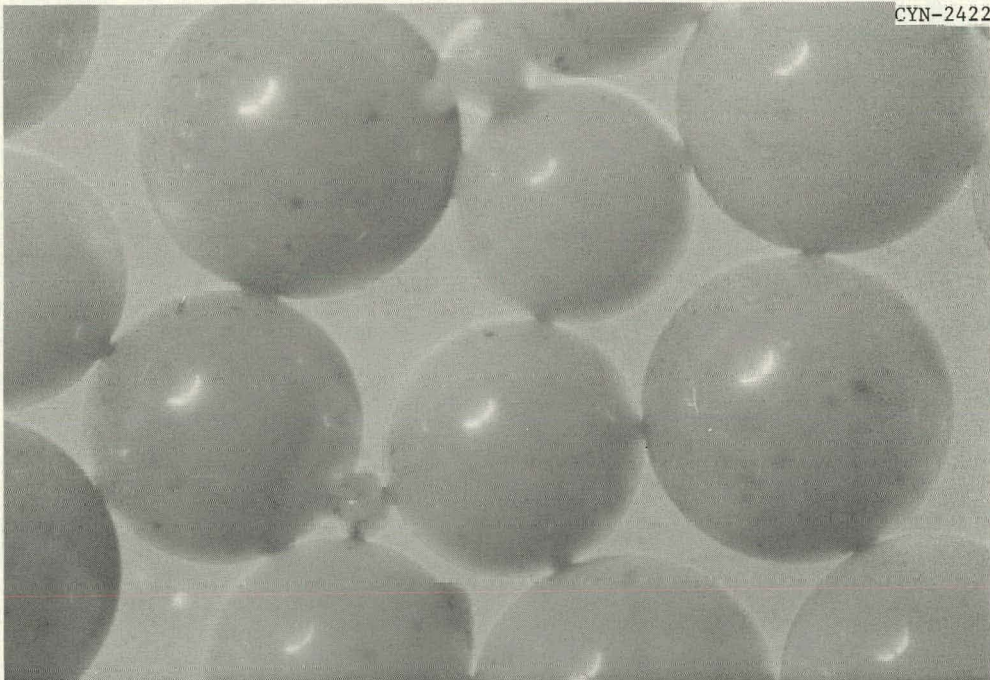
Figure 5 also illustrates a defect often observed in batches of resin microspheres; namely, clumps or clusters of small microspheres attached to the larger ones. The batch shown was shape separated by the vibrating plate technique⁸ which, while adequate for rejecting grossly out-of-round particles, is apparently inefficient in removing those with the small satellites. The satellites seem to be more prevalent in Amberlite IRC-72 resin than in Duolite C-464,* which is discussed later,

Fig. 5. Whole Uranium-Loaded Amberlite IRC-72 Weak Acid Resin Microspheres Selected at Random from the Same Normal Batch as the Pieces Shown in Fig. 4. 60 \times . Reduced 24%.

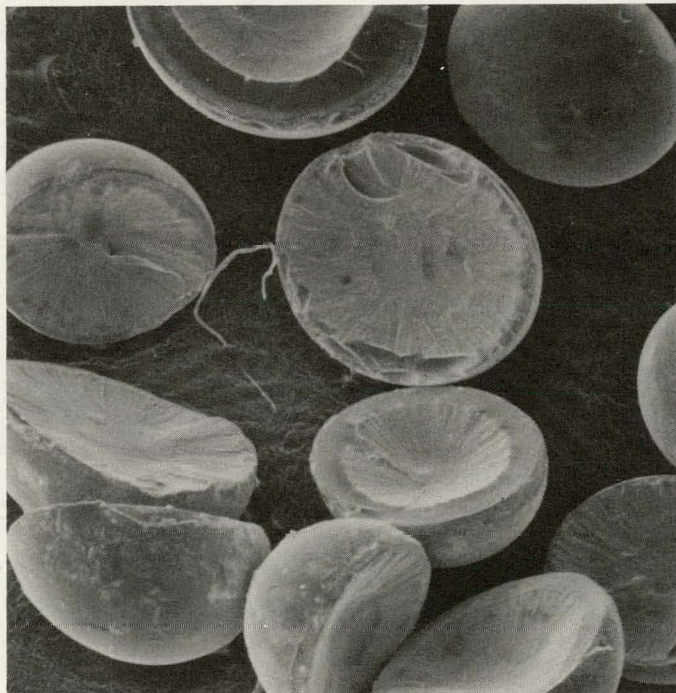
Figure 6 shows that the fracture of the particles that broke during the pneumatic transfer was essentially bimodal, characterized by an outer region in which the fracture surface is smooth and almost perfectly planar and a central region where the surface is wrinkled. The proportion of the two regions varies from particle to particle, but careful inspection does show some of each type in all the pieces. The piece in the center toward

Fig. 6. Scanning Electron Microscope (SEM) Photomicrograph of Pieces of Uranium-Loaded Amberlite IRC-72 Weak Acid Resin Broken During Pneumatic Transfer. 55 \times . Compare with Fig. 1.

the upper right, for example, has only a very small outer region compared with the one just below it or the one above it to the left. Notice too that the center region of the pieces appears to be collapsed, giving some of the pieces a shape resembling a cantaloupe half. It is not clear whether this is a region of ductile material that was under tension and collapsed inward when the microsphere broke or if it is perhaps an interface between a glassy region and a white central core that has been pulled out.

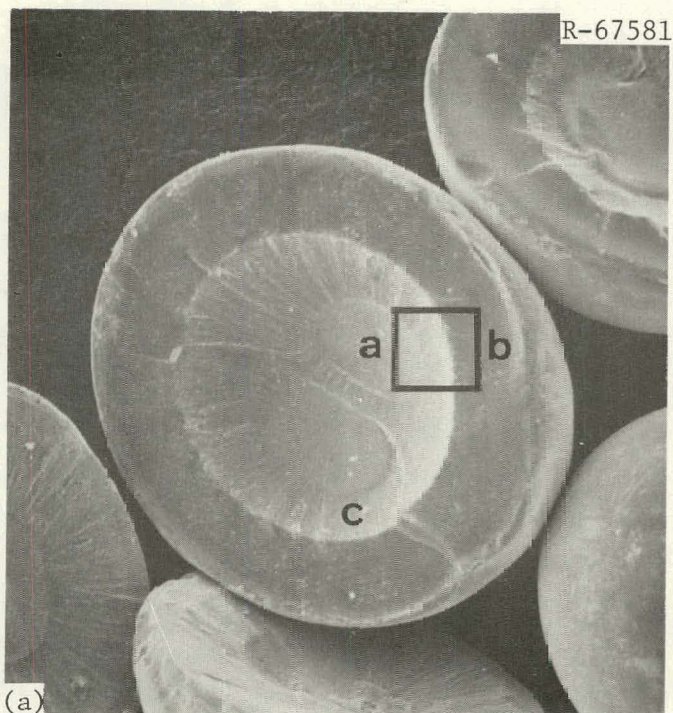
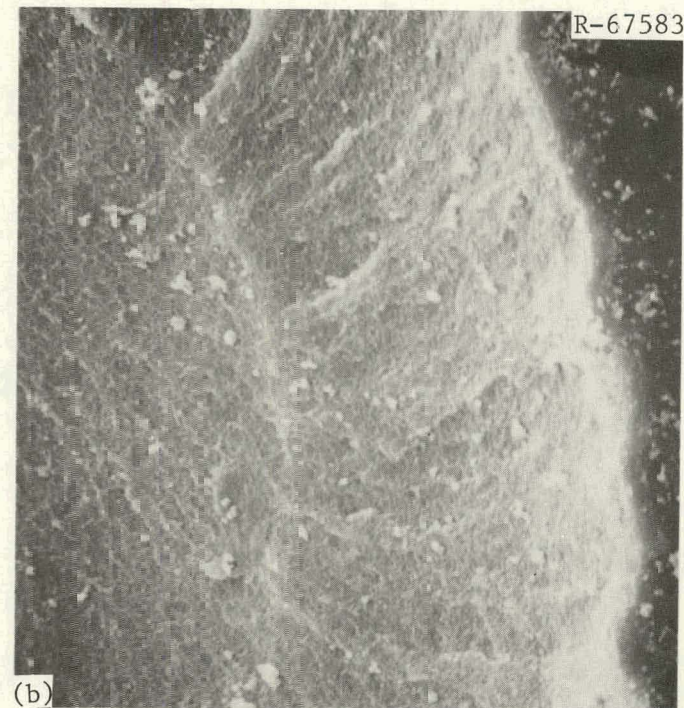
Fig. 7. SEM Photomicrographs of a Piece of Uranium-Loaded Amberlite IRC-72 Weak Acid Resin Microsphere Broken During Pneumatic Transfer. The points on (a) indicate where x-ray spectra were obtained. The letters on (a) indicate points corresponding to the spectra of Fig. 8. The box window on (a) indicates the area viewed in (b). (a) 100x. (b) 1000x.

Figure 7 shows closeup detail of such a particle. This one had the distinct white central areas seen in the pieces in Figs. 1 and 2. This white material appears in the SEM photomicrograph of Fig. 7(a) as the two kidney-shaped areas in the center. The material surrounding these areas is yellowish in color as is the smoother outer region. The window superimposed on Fig. 7(a) identifies the area viewed in Fig. 7(b). The letters on Fig. 7(a) indicate the points where x-ray spectra were taken, and the corresponding spectra are shown in Fig. 8(a)-(c). The spectral line of interest, U L-alpha, is shown bracketed in Figs. 8(a)-(c). The remainder of the lines are due to components of the SEM, not the specimen. From

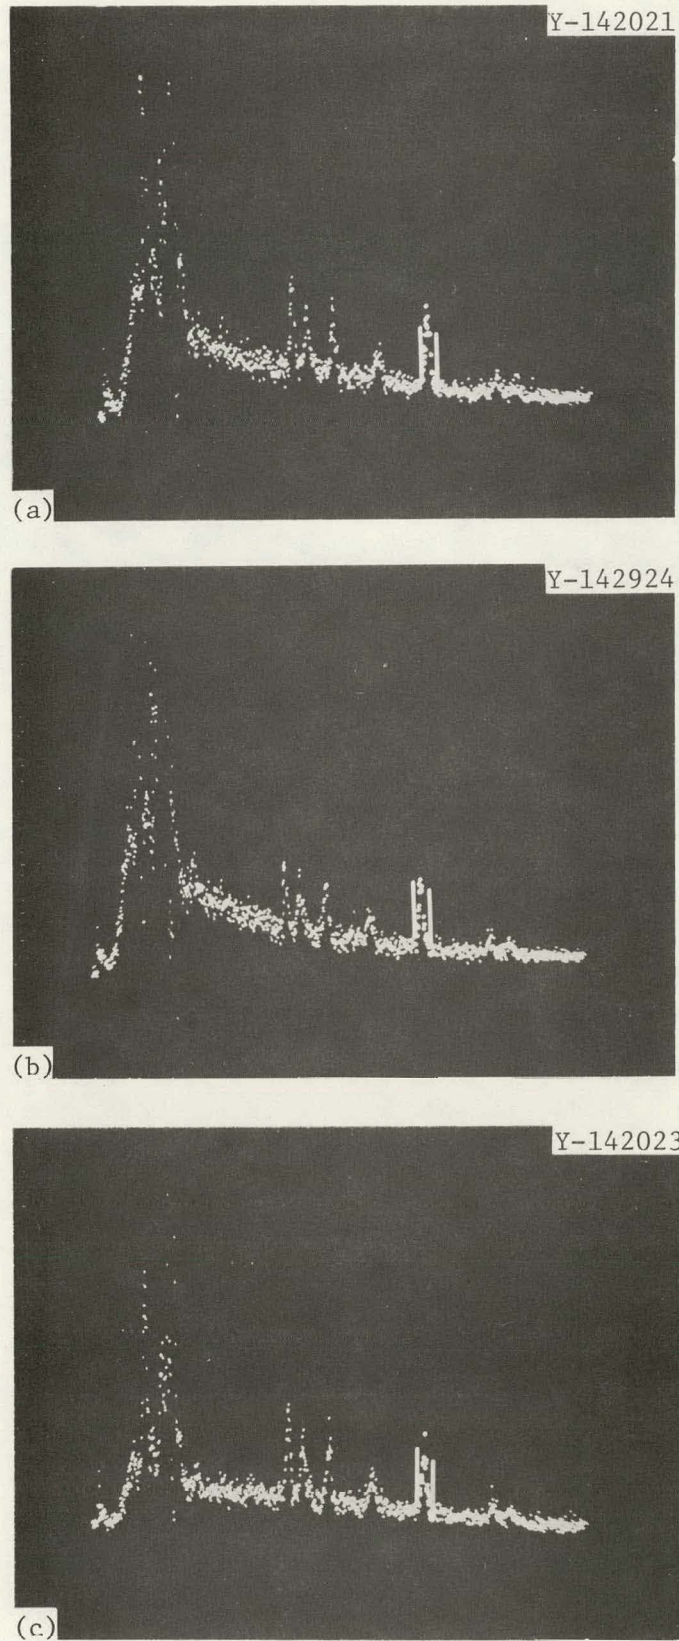
Fig. 8. SEM X-Ray Spectra from the Lettered Points on Fig. 7(a). The bracketed line is uranium L-alpha. The others are caused by the instrument, not the specimen.

Figs. 8(a)-(c) it appears that all points measured, including the white material, had about the same uranium content.

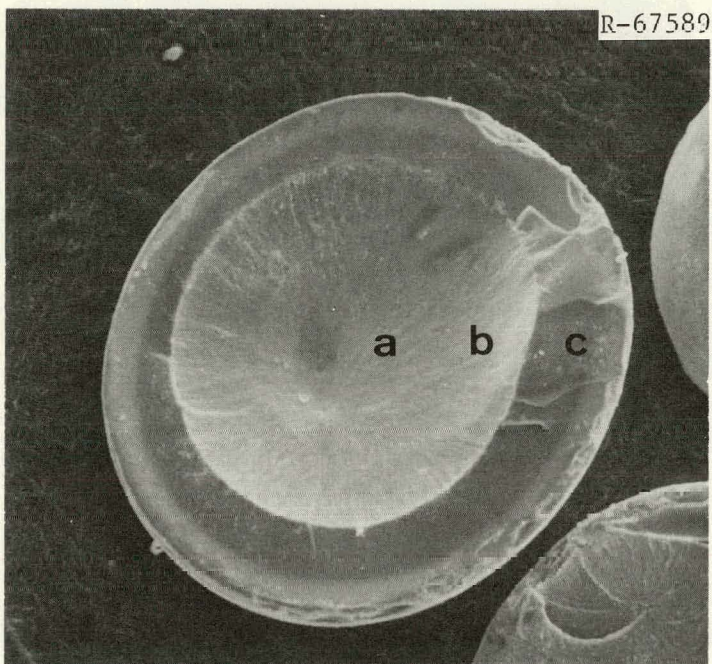
Fig. 9. SEM Photomicrograph of a Piece of Uranium-Loaded Amberlite IRC-72 Weak Acid Resin Microsphere Broken During Pneumatic Transfer. The spots indicate points where the x-ray spectra shown in Fig. 10 were taken. 100 \times .

Figure 9 shows an example of a piece with a thick, smoothly broken outer region, but no white area in the center. Spectra corresponding to the points superimposed on Fig. 9 are presented in Figs. 10(a)-(c). The intensities of the bracketed U L-alpha confirm the previous findings that all points have essentially the same uranium contents. In view of the electron microprobe results that follow, this result was probably not entirely correct. Unfortunately, no spectra were taken from the lighter outer portion of the smoothly broken region in Fig. 9.

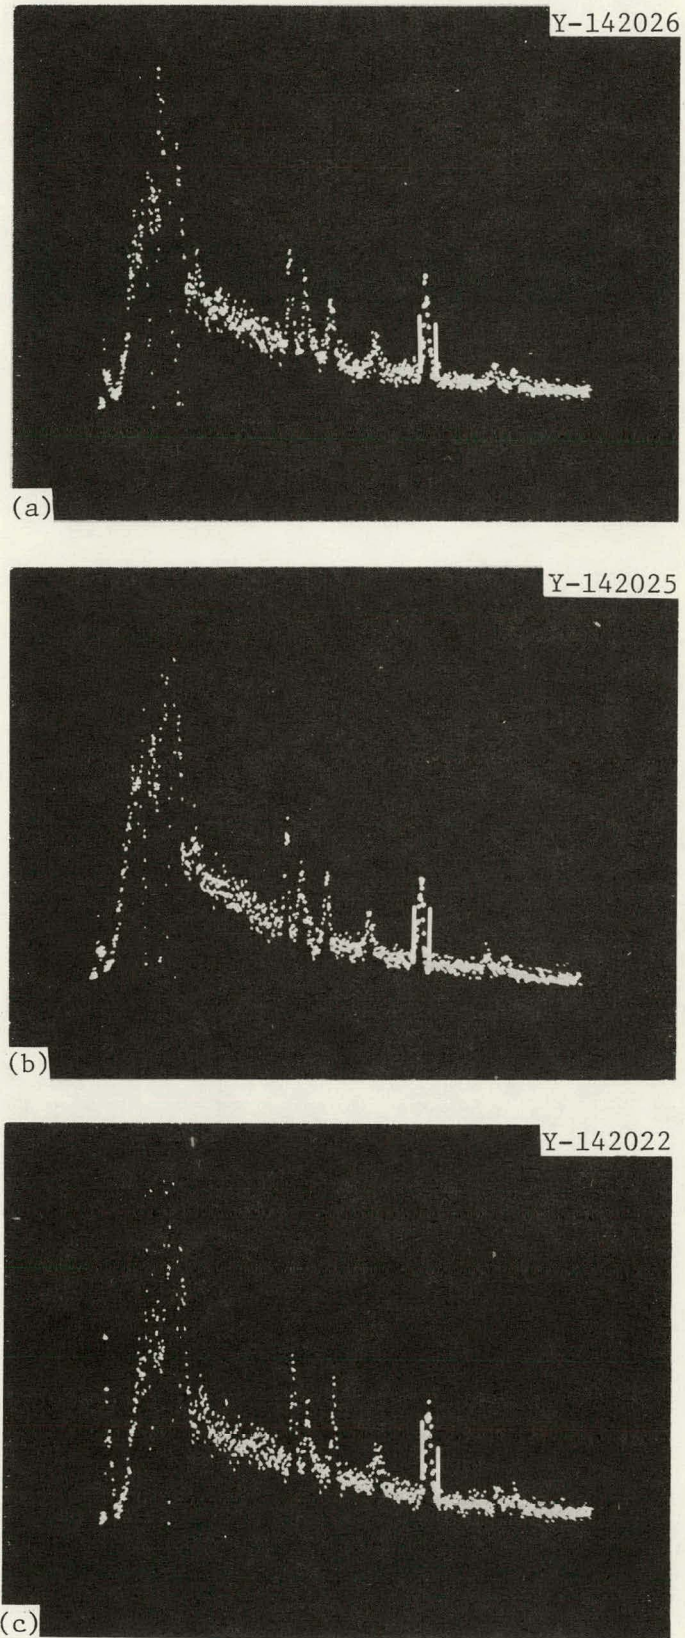
Fig. 10. SEM X-Ray Spectra from the Spots Indicated on Fig. 9. The bracketed line is uranium L-alpha. The others are caused by the instrument, not the specimen.

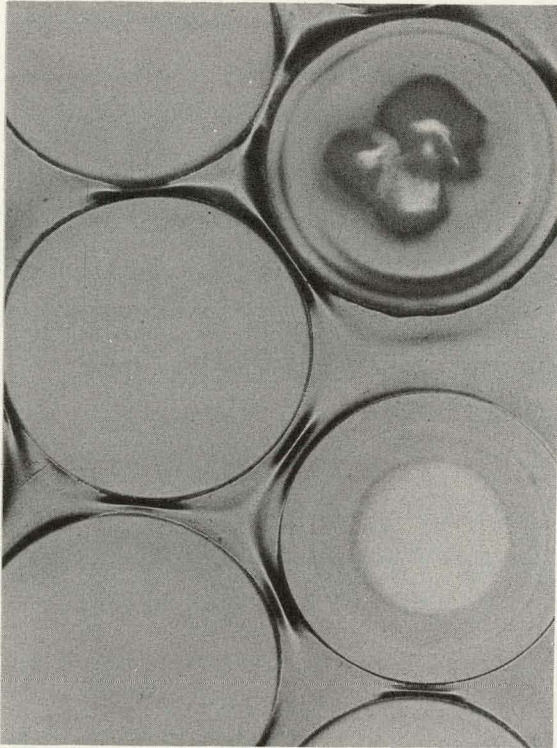
The particle in the upper rights of Figs. 11 and 12 is the type generally found among those that broke during the pneumatic transfer (Fig. 1). The microprobe scan (Fig. 13) confirms that the white material in the center does indeed have essentially the same uranium content as the yellowish glassy material surrounding it. However, it also shows that the yellowish translucent material toward the outer portion of the piece contains more uranium. This would not have been known without microprobe analysis.

The particle in the lower right of Figs. 11 and 12 is a type not generally seen in those that broke during pneumatic transfer but may be the precursor of the half cantaloupe-shaped particle in Figs. 7 and 9. It is characterized by a white circular center surrounded by yellowish glassy material and then yellowish translucent material. Close inspection of

Fig. 11. Uranium-Loaded Amberlite IRC-72 Weak Acid Resin Microspheres Selected at Random from the Batch that Exhibited Breakage During Pneumatic Transfer, Carbonization, and Conversion. These particles have been mounted metallographically, sectioned, and polished for electron beam microprobe analyses. 100 \times . Reduced 33%.

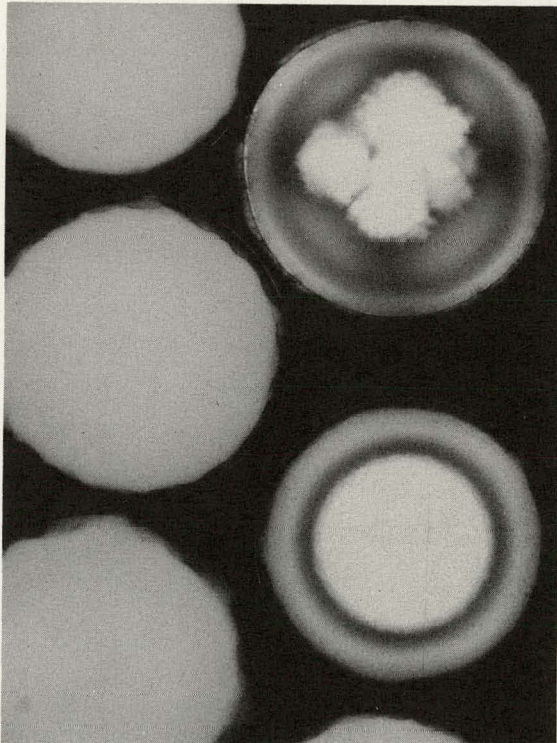
Fig. 12. Same View as Fig. 11 but Under Polarized Light. 100 \times . Reduced 33%.

Figs. 11 and 12 shows that this particle also has a thin outer shell of material, which appears similar to the glassy material, under polarized light (Fig. 12), only darker. The microprobe scan of this particle (Fig. 14) shows that the white center and the glassy material around it have lower uranium concentrations than the outer translucent material. The thin outer shell of glassy material seems to have about the same uranium concentration (perhaps a bit less) as the translucent material.

Inspection of the "normal" particles in polarized light (Fig. 12) readily reveals that even these have the thin outer shell of glassy material that is barely discernible in optical photomicrographs (Figs. 15 and 16). The scan (Fig. 15) indicates a lower concentration in the outer shell than in the inner translucent region. On the other hand, the scan in Fig. 16 suggests the outer shell in that case has about the same concentration as the center.

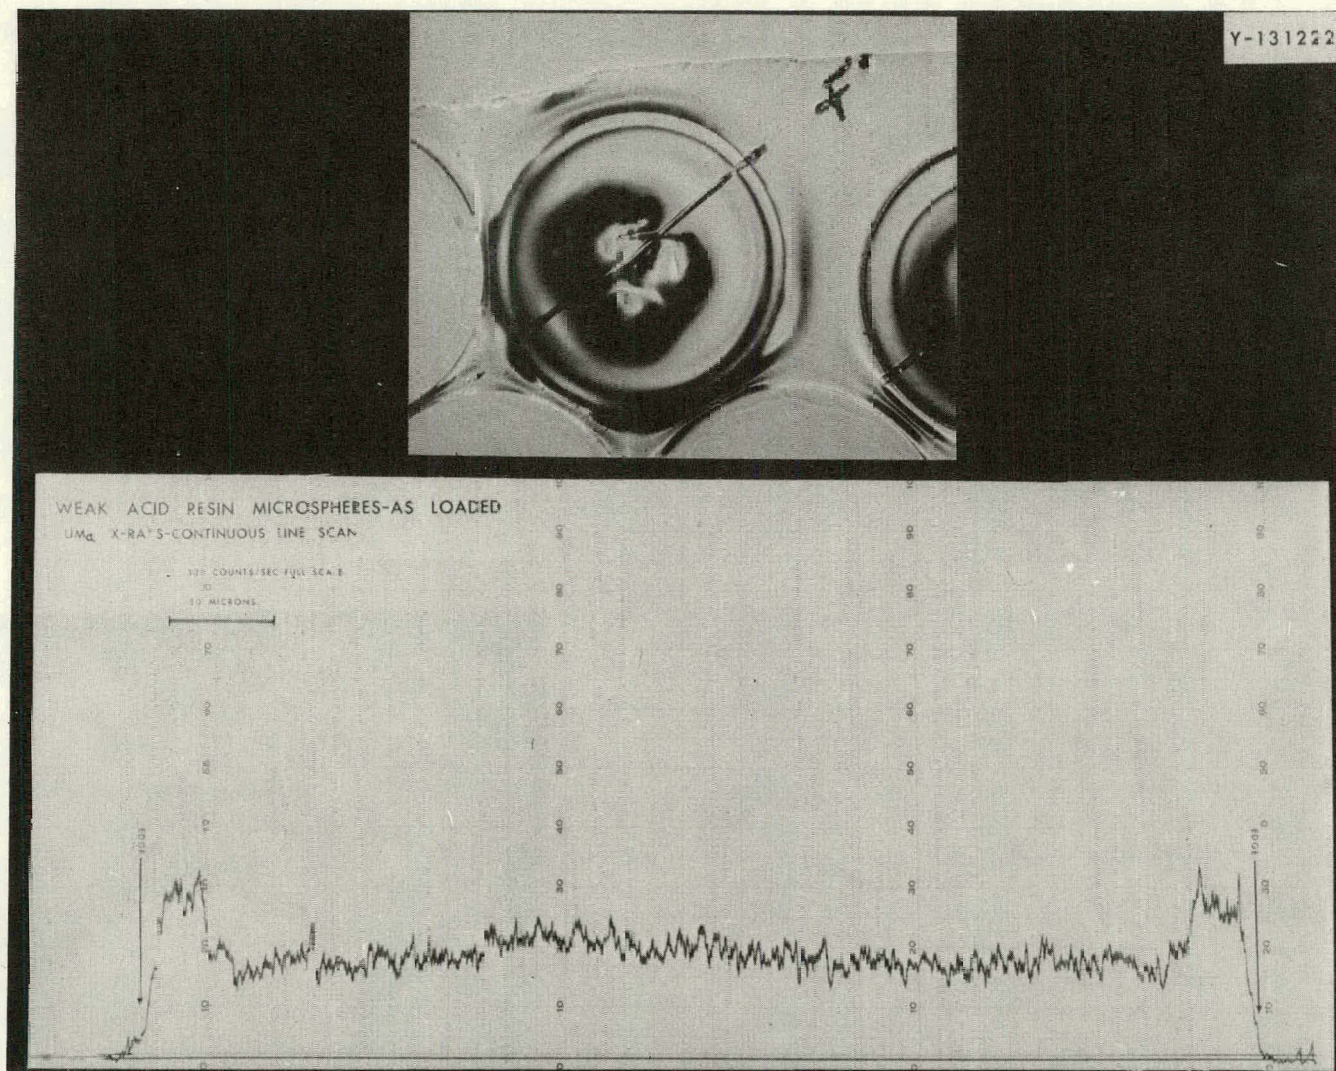
Fig. 13. Photomicrograph and Electron Beam Microprobe Scan of the Cross-Section of a Uranium-Loaded Amberlite IRC-72 Weak Acid Resin Microsphere from the Batch that Exhibited Breakage During Pneumatic Transfer, Carbonization, and Conversion. This is the type of particle that broke during pneumatic transfer. 100 \times . Reduced 32%.

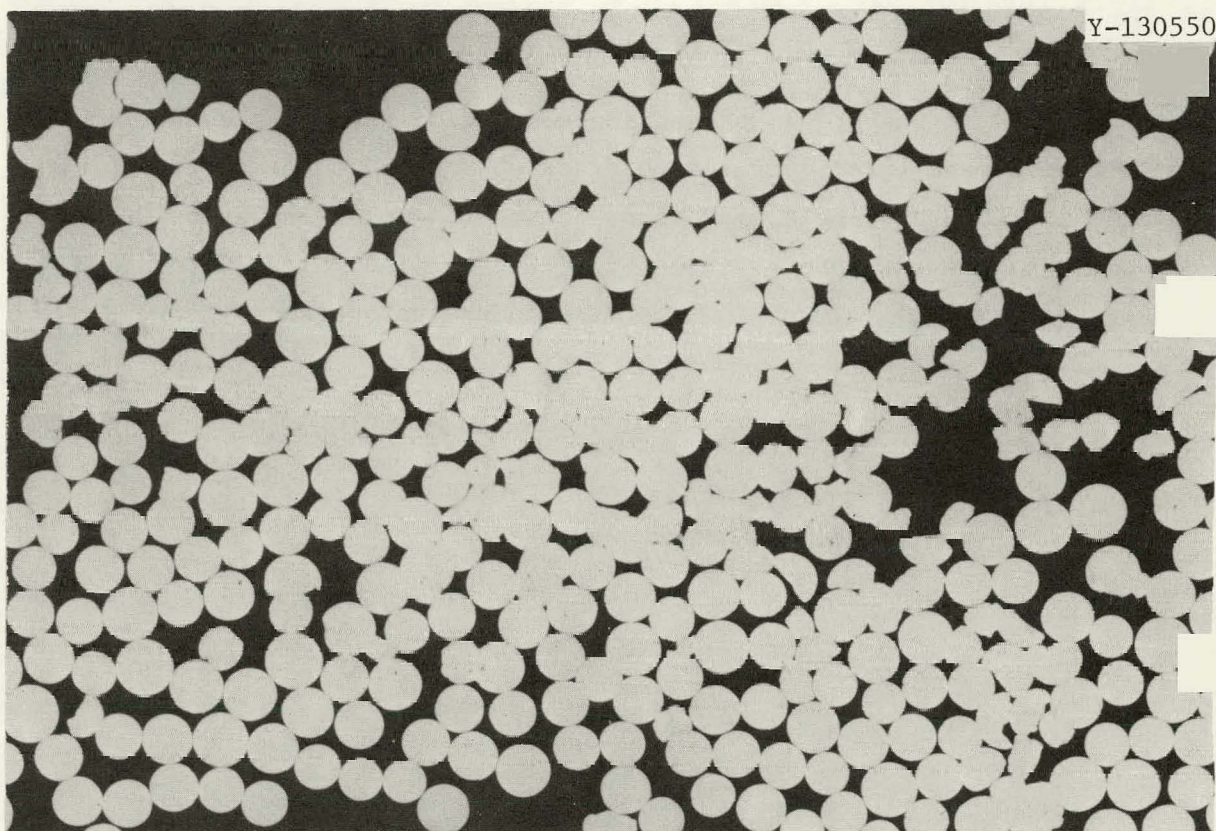
the converted product is shown in Fig. 17. In obtaining the size of the converted material from this radiograph, only whole particles were read. The high percentage of broken bits and pieces of particles is obvious. The results of the screen analyses (Table 2) show that about 10% of the total weight of the converted batch consisted of pieces that would pass a screen opening smaller than the smallest whole particle seen in the radiograph. By contrast, similar screen analyses of converted ORNL resin typically show less than 1%, as shown in Table 2, run V48, data for which were also given in Table 1.

Fig. 17. Radiograph of Carbonized and Converted Duolite C-464 Resin Uranium-Loaded by Ammonia Neutralization Method. 20 \times .

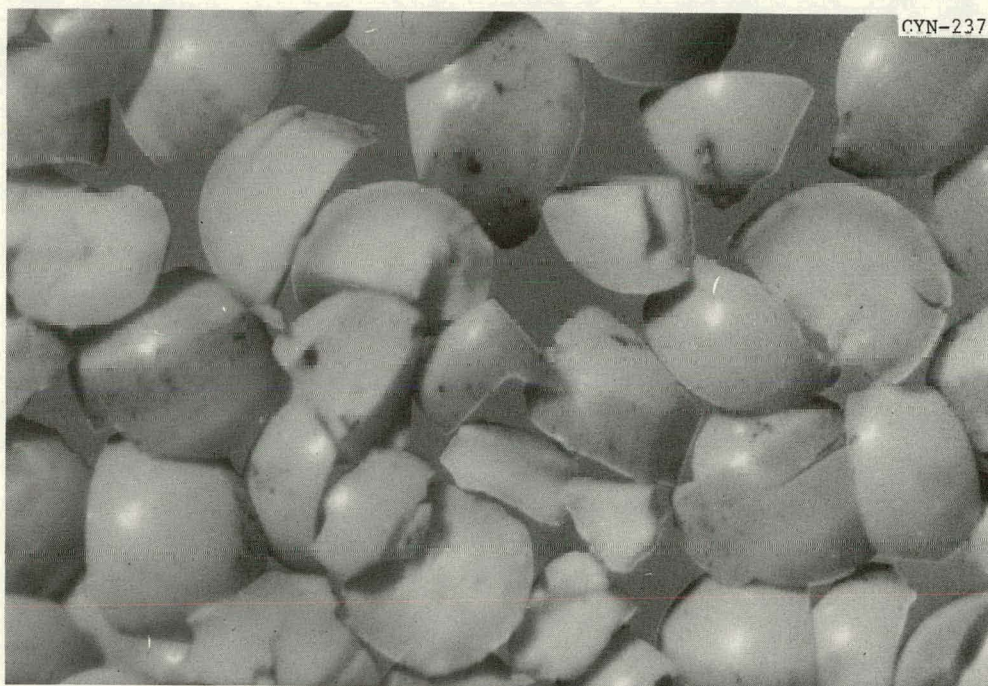
Based on the previous experience, as discussed in the section on Amberlite, the first step was to crack open some of the particles by crushing with hand-held micrometer calipers. Color gradation from the center to the edge can be seen (Fig. 18), but the white centers and glasslike material found in IRC-72 resin are not present.

Fig. 18. Duolite C-464 Weak Acid Resin Microspheres Uranium-Loaded via Ammonia Neutralization Method and Deliberately Cracked Open for Inspection. 80 \times . Reduced 24%.

The indication of nonuniform intraparticle loading was clear from the appearance of the cracked particles in Fig. 18. In order to assess

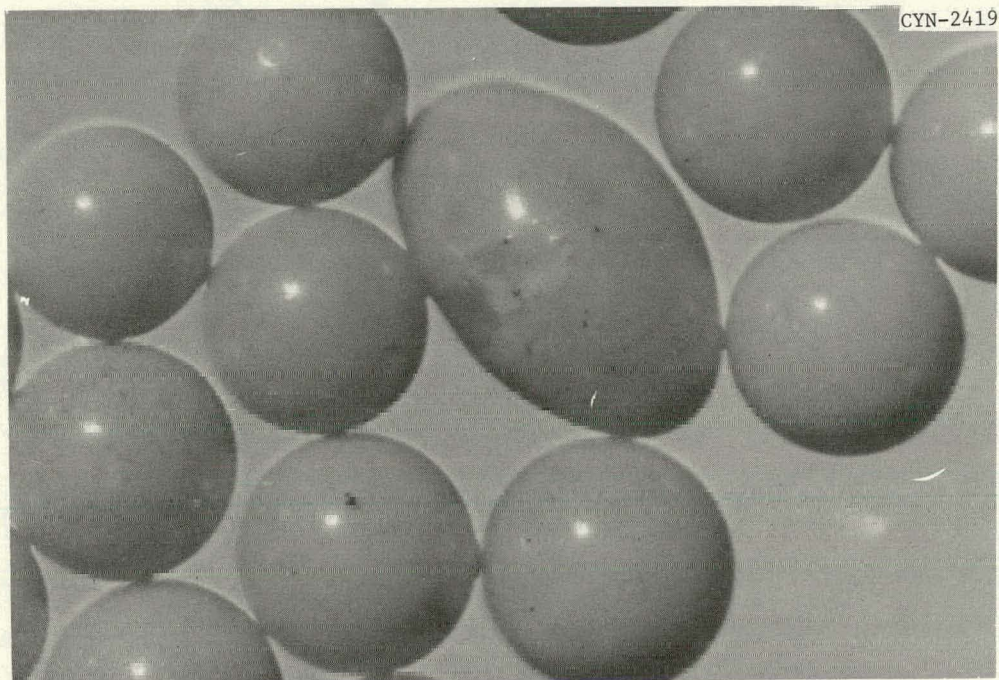
Photomicrographs of whole microspheres from this same batch revealed particles with two types of defects; namely, a football shape (Fig. 20) and a ruptured surface (Fig. 21).^{*} Such defects are common in commercially supplied weak acid resin microspheres. Shape separation by the vibrating table method⁸ removes many of the defective particles, but seems to be less effective in removing the types seen in Figs. 20 and 21. These types are more often found in Duolite C-464 than in Amberlite IRC-72.

Fig. 20. Duolite C-464 Weak Acid Resin Microspheres Uranium-Loaded by the UO_3 Method. Note the unusual football-shaped particle. 100 \times . Reduced 24%.

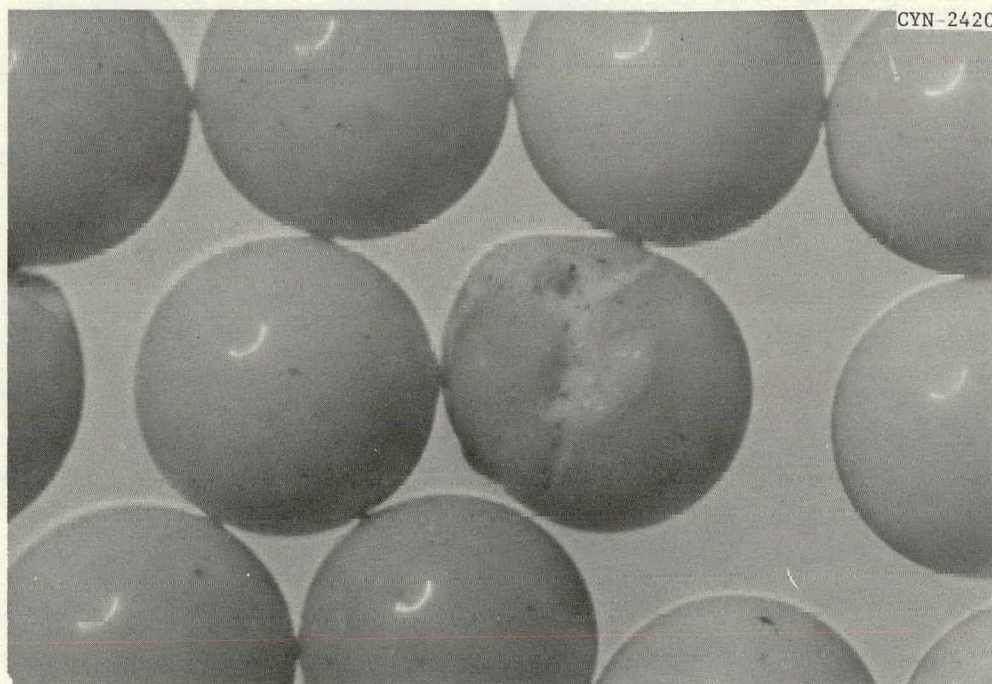
Fig. 21. Duolite C-464 Weak Acid Resin Microspheres Uranium-Loaded by the UO_3 Method. Note the relatively rare surface rupture in one of the particles. 100 \times . Reduced 24%.

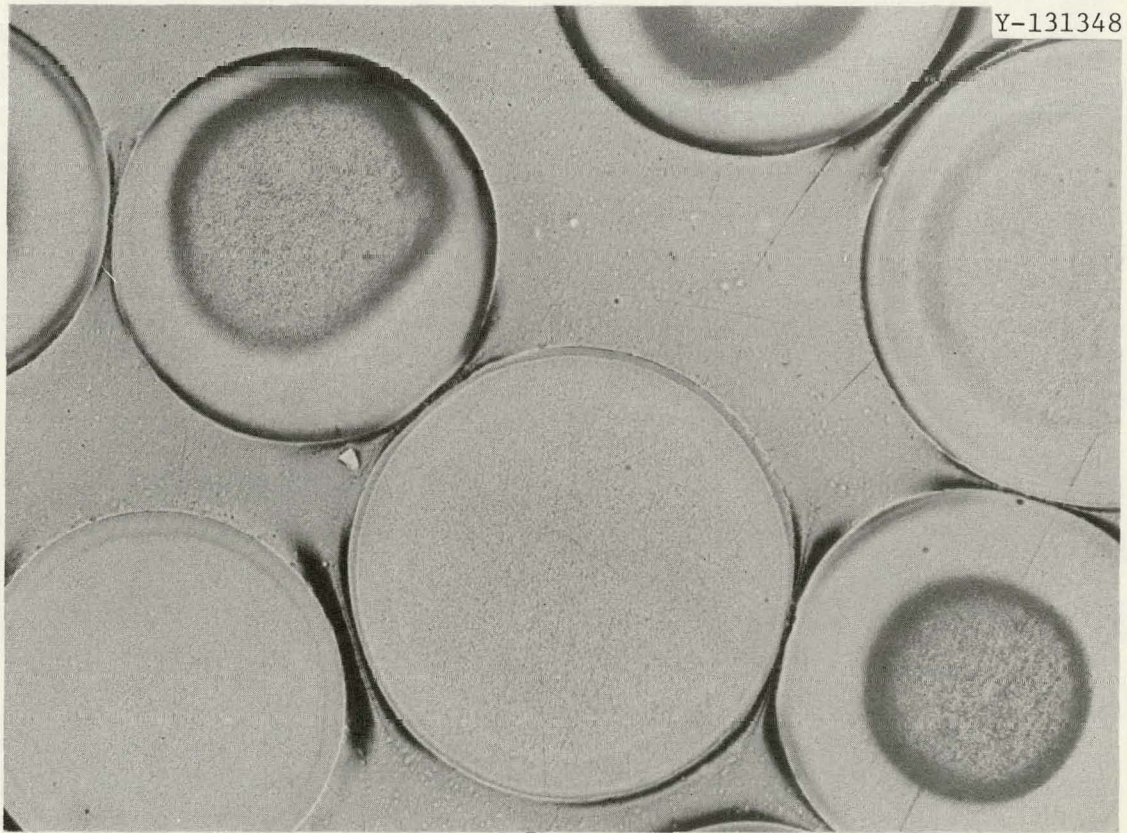
As seen in Fig. 22, most particles consist of a relatively rough-appearing core surrounded by a slightly smoother region, in turn surrounded by a much thinner outer shell. The thickness of all regions varies, especially the core and the material surrounding it. The thickness of the outer shell appears less variable. Under the instrument conditions used, the "effective diameter" of the electron beam, that is, the area from which the x-rays emanated, is estimated to be about 5 μm ; the actual beam diameter is much less. Judging from measurements made on the photomicrographs of Figs. 26 and 27, the width of the thin outer shell is about 15 μm . Some rounding of a scan at the edge of a

Fig. 22. Photomicrograph of Duolite C-464 Weak Acid Resin Microspheres Uranium-Loaded by the Ammonia Neutralization Method, Sectioned for Electron Beam Microprobe Examination. 100 \times .

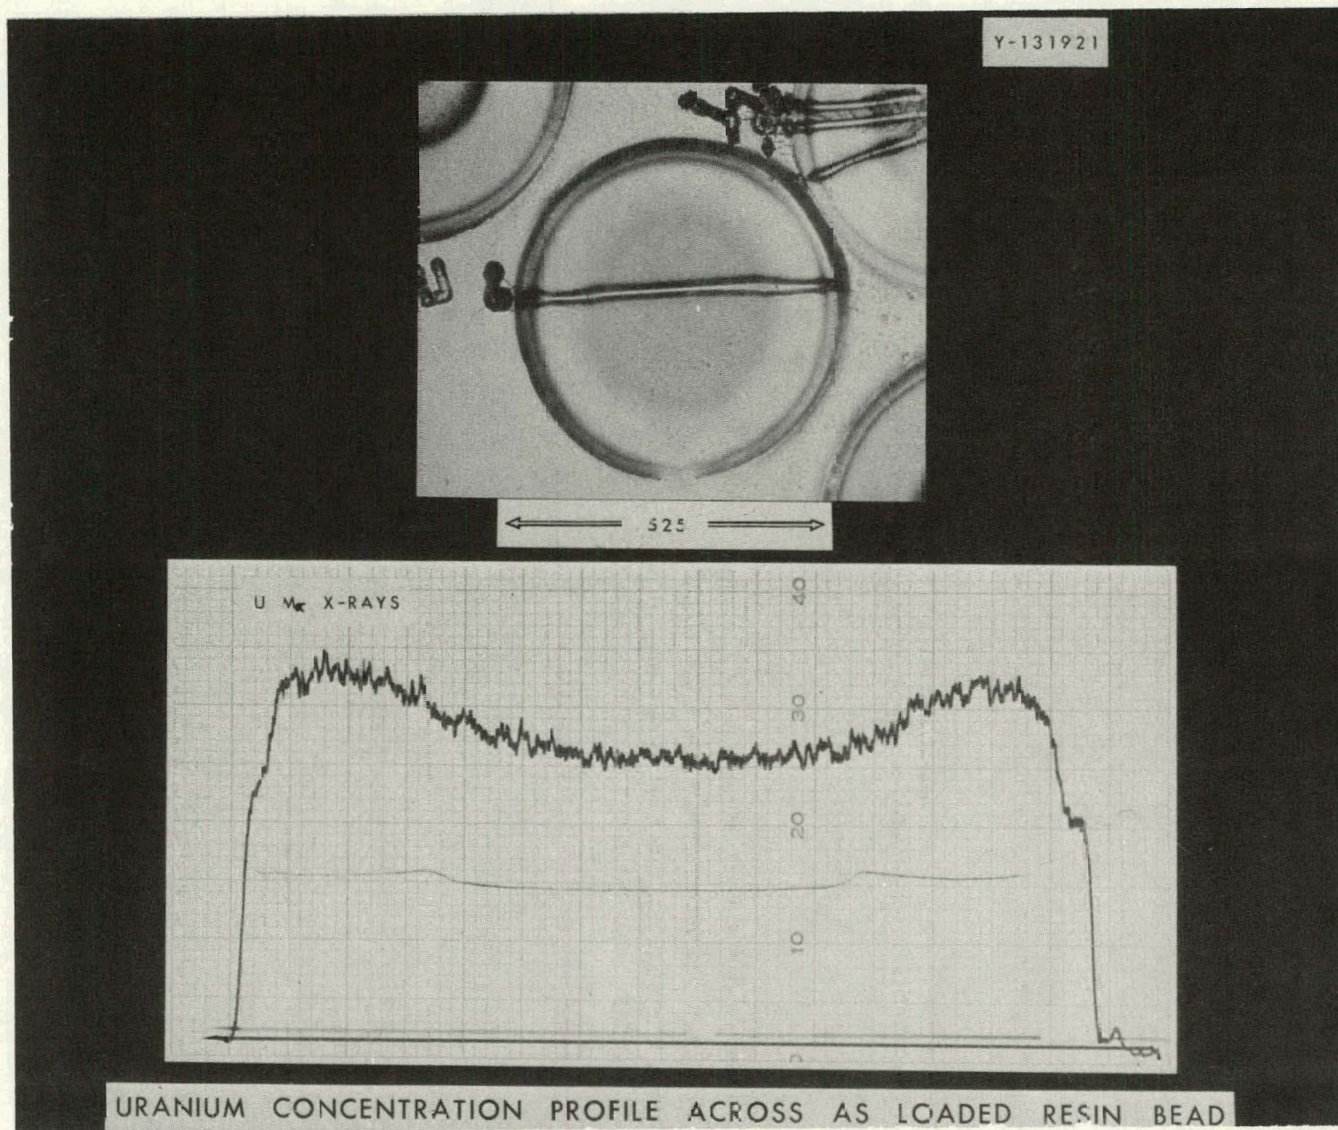
specimen due to the finite width of the beam is to be expected but the edge plateaus seen in the scans of Figs. 26 and 27 are too wide, and hence must be real.

From Figs. 26 and 27, it is apparent that the core and thin outer shell were considerably underloaded with respect to the other region. Though similar to the situation observed in the sample of Amberlite IRC-72 resin discussed earlier (e.g., Figs. 13 and 14), note that the change in concentration is much more gradual between the center and the high-uranium material surrounding it. This observation suggests that the problem in this instance is not one of a marked change in resin structure.

Fig. 26. Photomicrograph and Electron Microprobe Scan of Sectioned Duclite C-464 Weak Acid Resin Microsphere Uranium-Loaded by the Ammonia Neutralization Method. 110 \times . Reduced 29.5%.

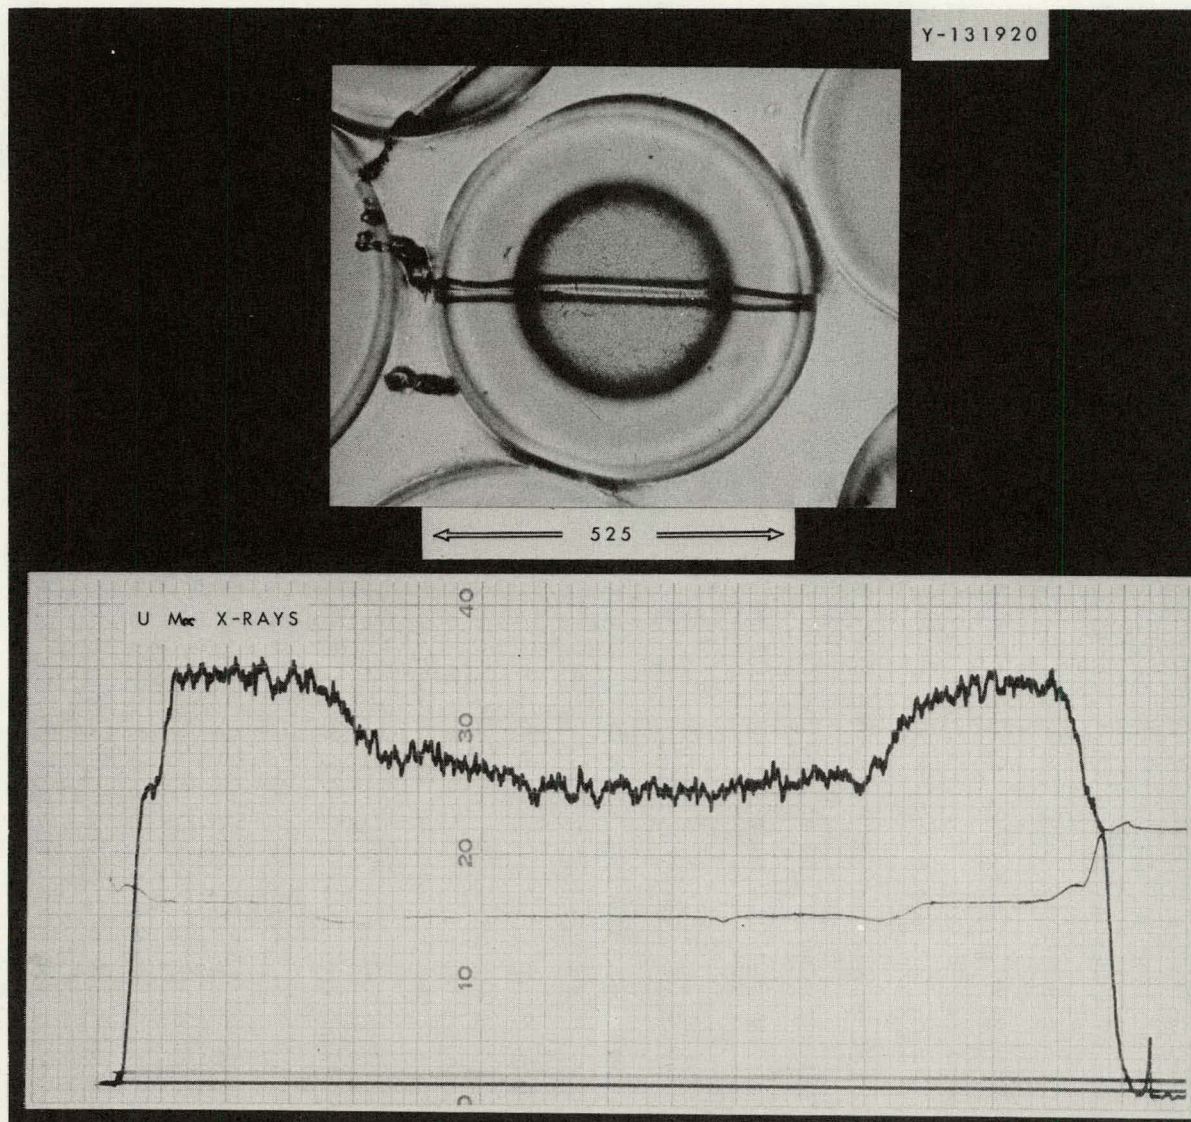
Fig. 27. Photomicrograph and Electron Microprobe Scan of Sectioned Duolite C-464 Weak Acid Resin Microsphere Uranium-Loaded by the Ammonia Neutralization Method. 110 \times . Reduced 22%.
