# **A STUDY OF IN-SERVICE ULTRASONIC INSPECTION PRACTICE FOR BWR PIPING WELDS**

**EPRI NP-436-SR  
(Technical Planning Study 75-609)**

**Special Report**

**August 1977**

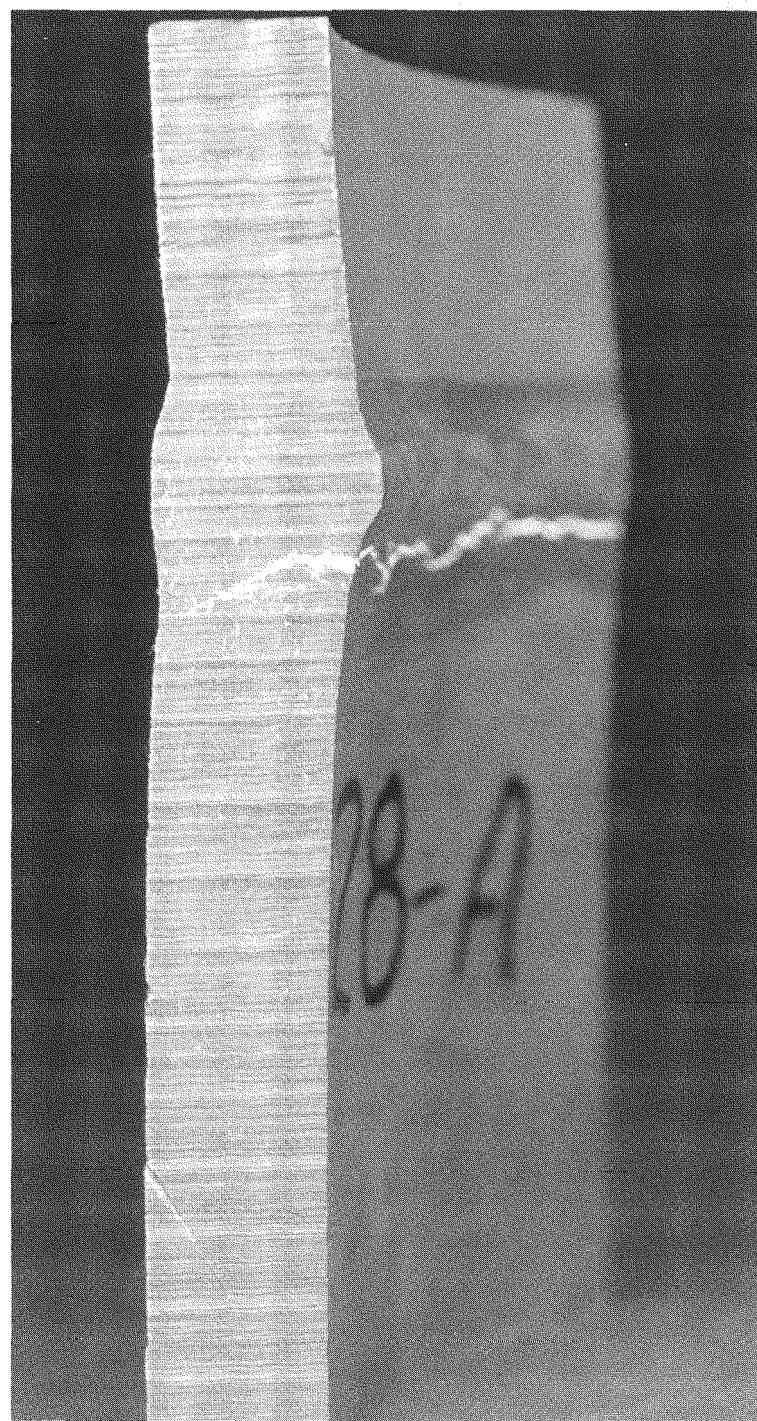
Figure 1-1 Fluorescent Dye Penetrant Indication of Intergranular Stress Corrosion Cracks in 10-in. Diameter Pipe Sample

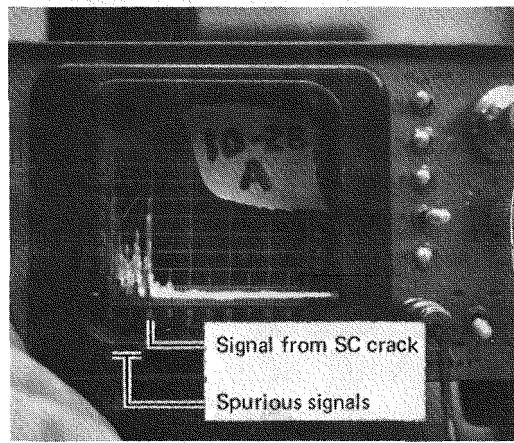
Figure 1-2 Ultrasonic Signal From Stress Corrosion Crack,  
Sample 1028A (IGSCC at 2 on 0 - 10 scale)

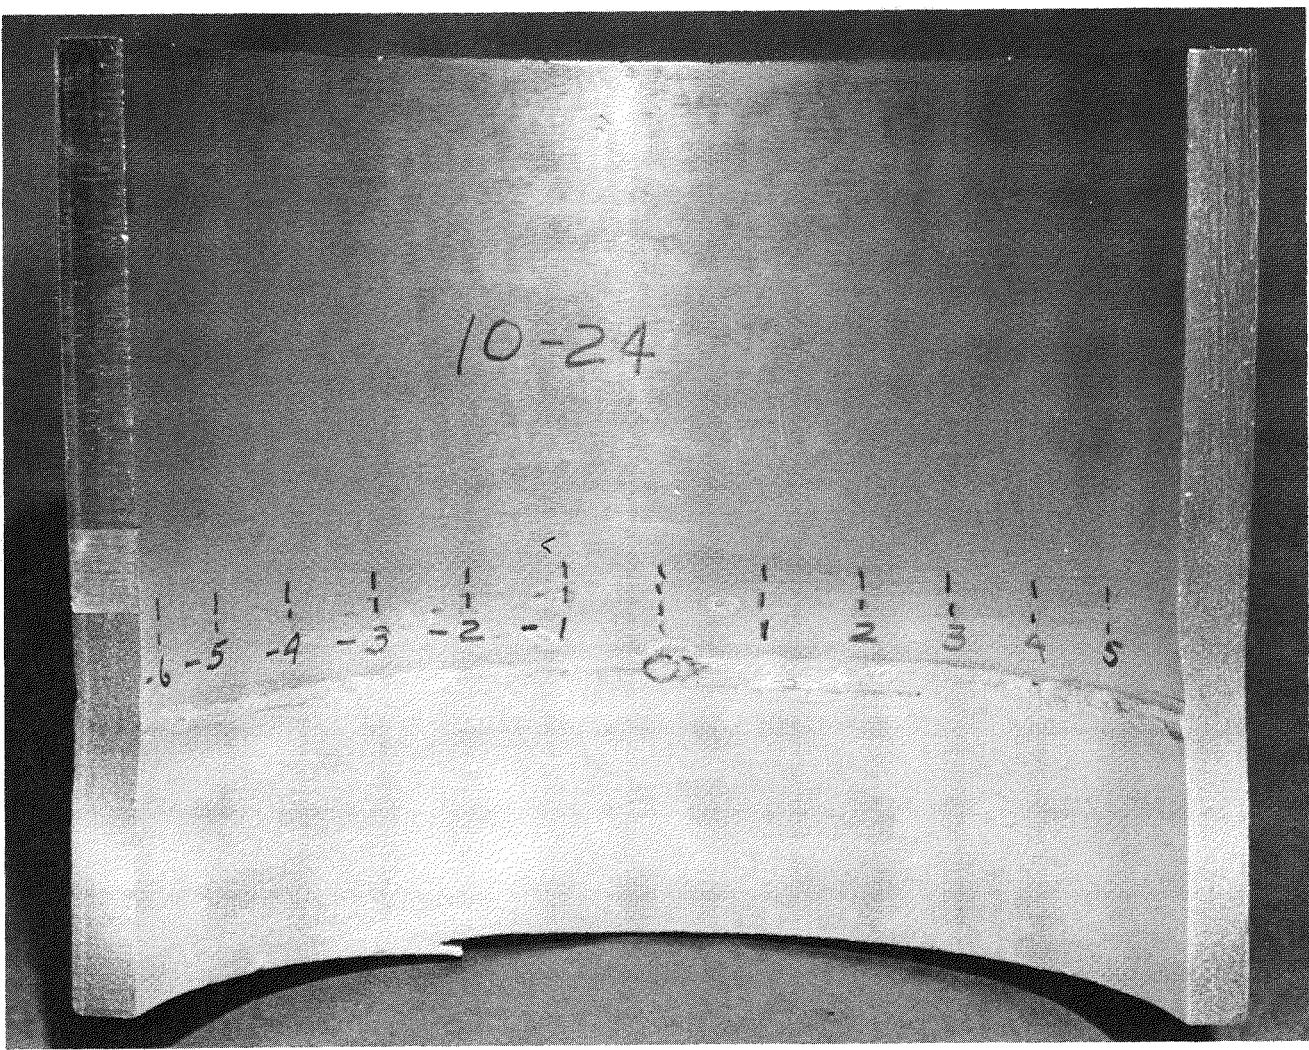
Figure 5-2 Inside Surface of Test Specimen 1024A

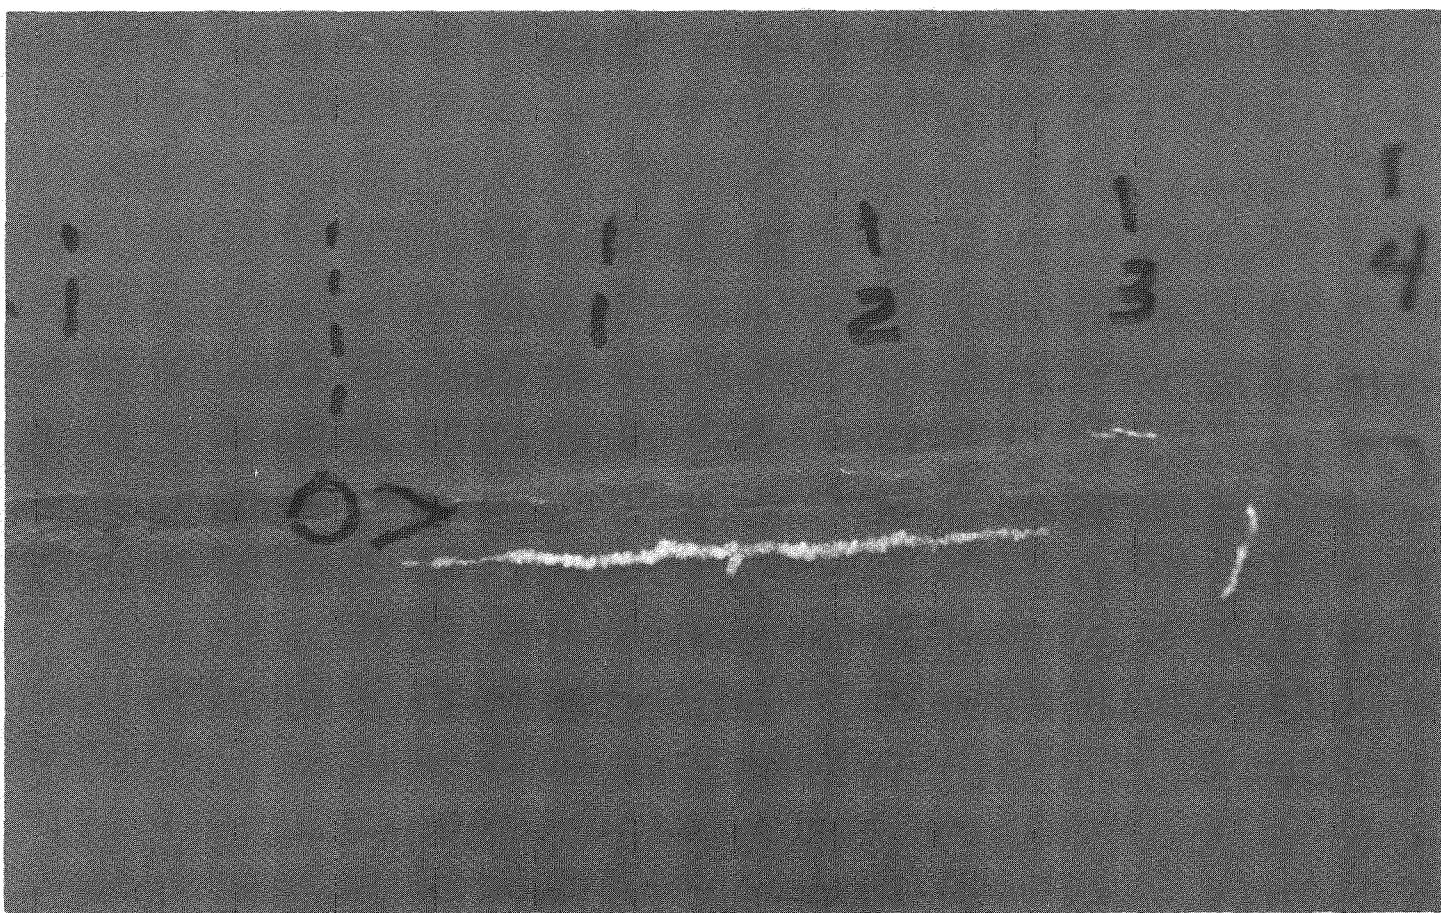
Figure 5-4 Fluorescent Dye Penetrant Indications of Two Radial Cracks and One Axial Crack (Slightly Skewed), Specimen 1024A, 0 to +4 in.

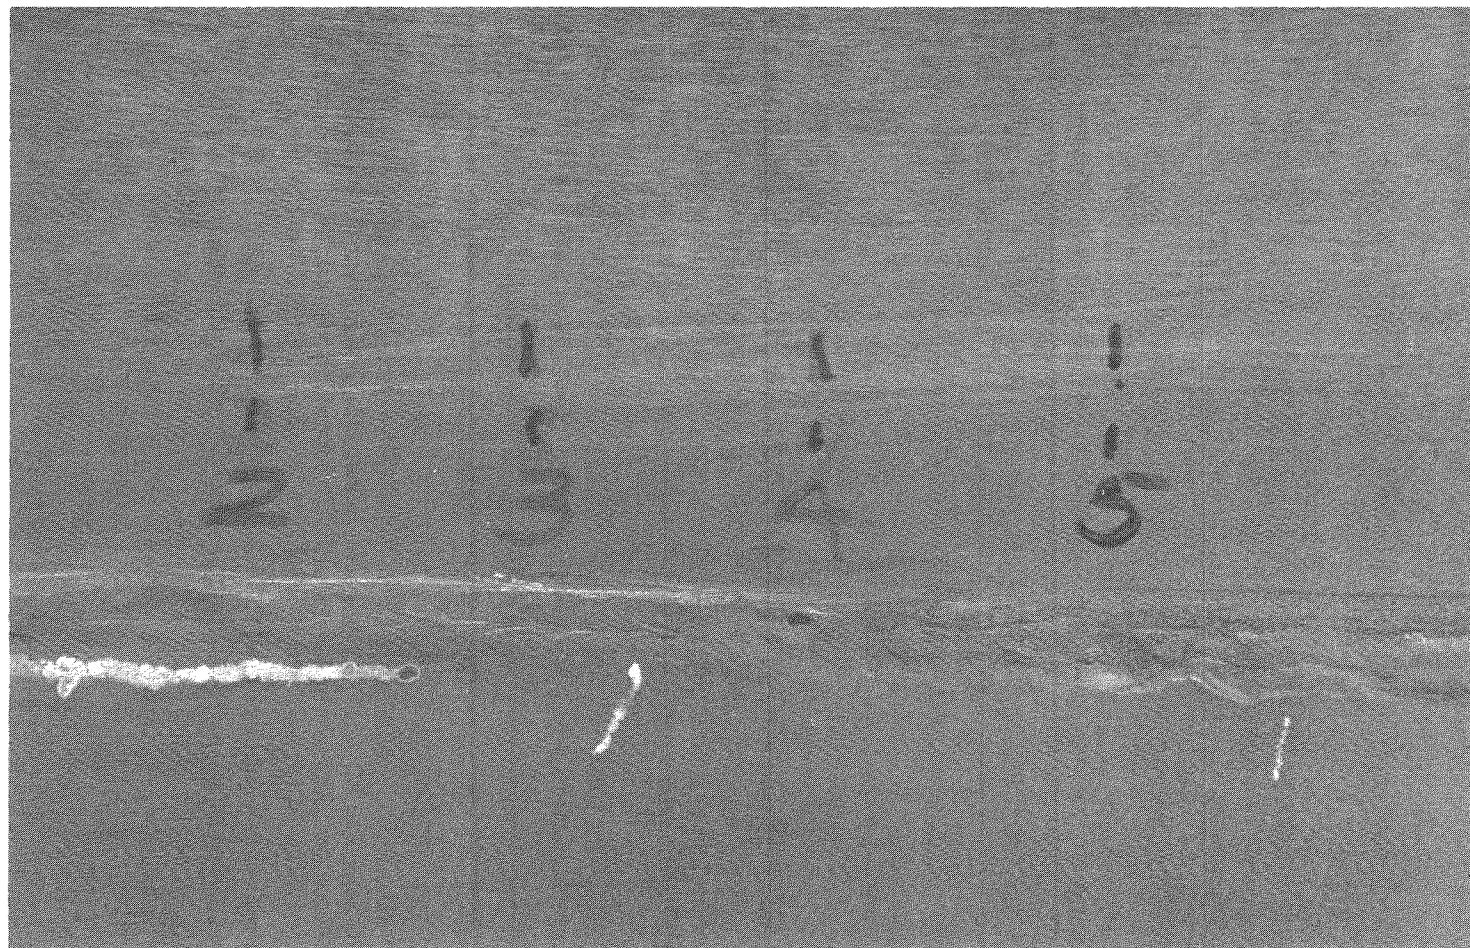
Figure 5-5 Fluorescent Dye Penetrant Indications of Radial and Axial Cracks in Specimen 1024A, +1 to +6 in.

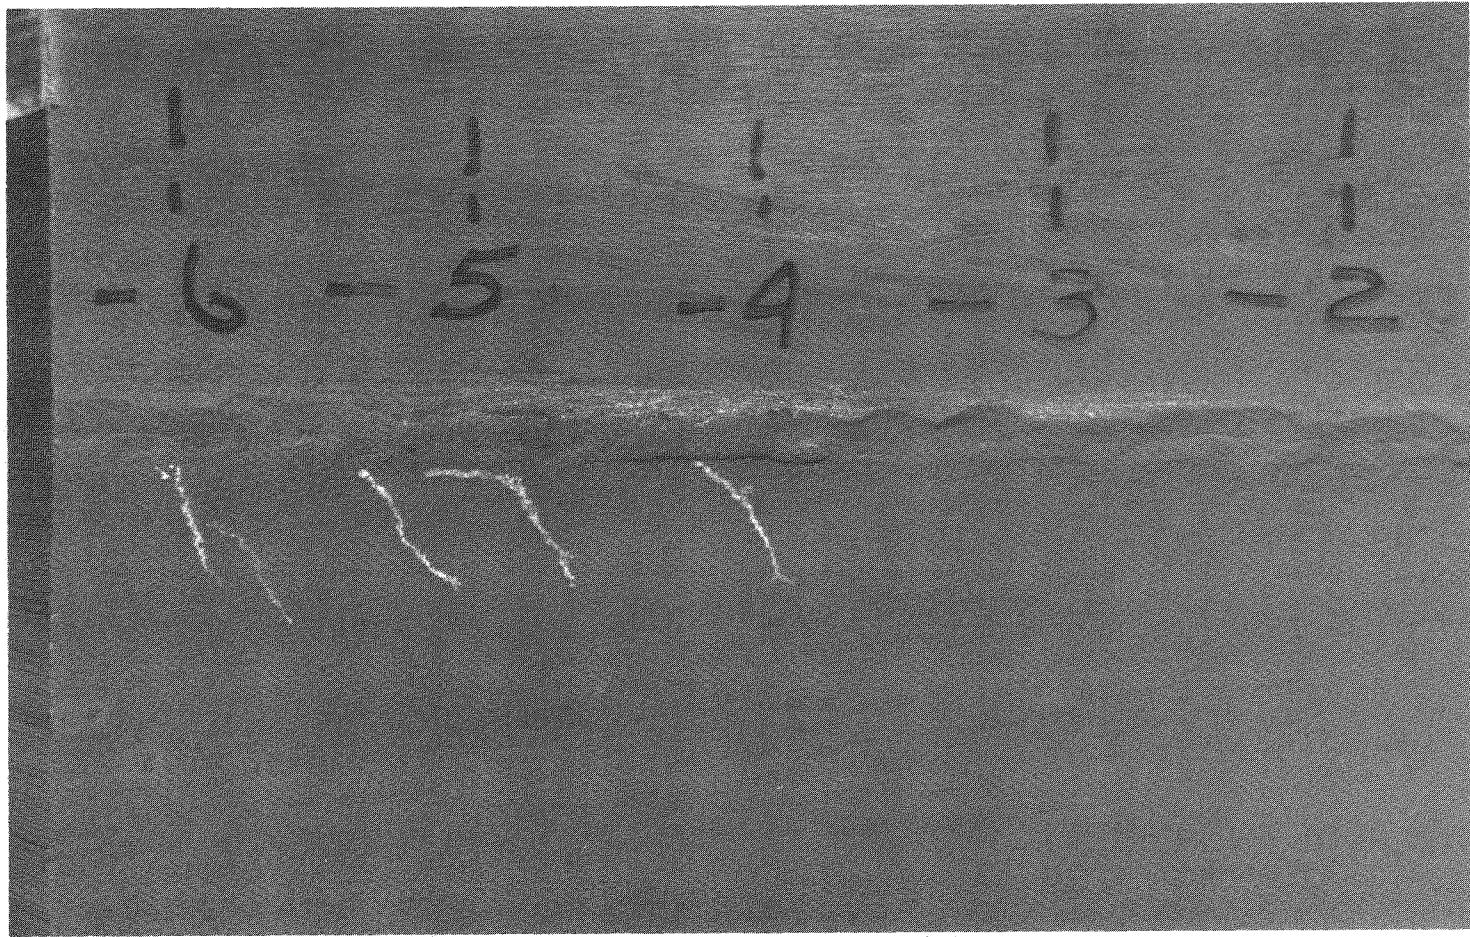
Figure 5-6 Fluorescent Dye Penetrant Indications of Five Skewed Cracks in Specimen 1024A, -1 to -6 in.

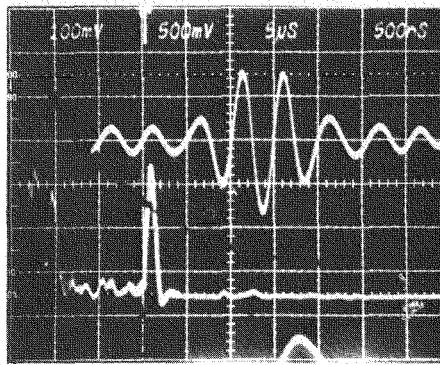
Figure 5-10 Photograph of CRT Screen Showing Processed and RF Signal From IGSCC in Specimen 1024A

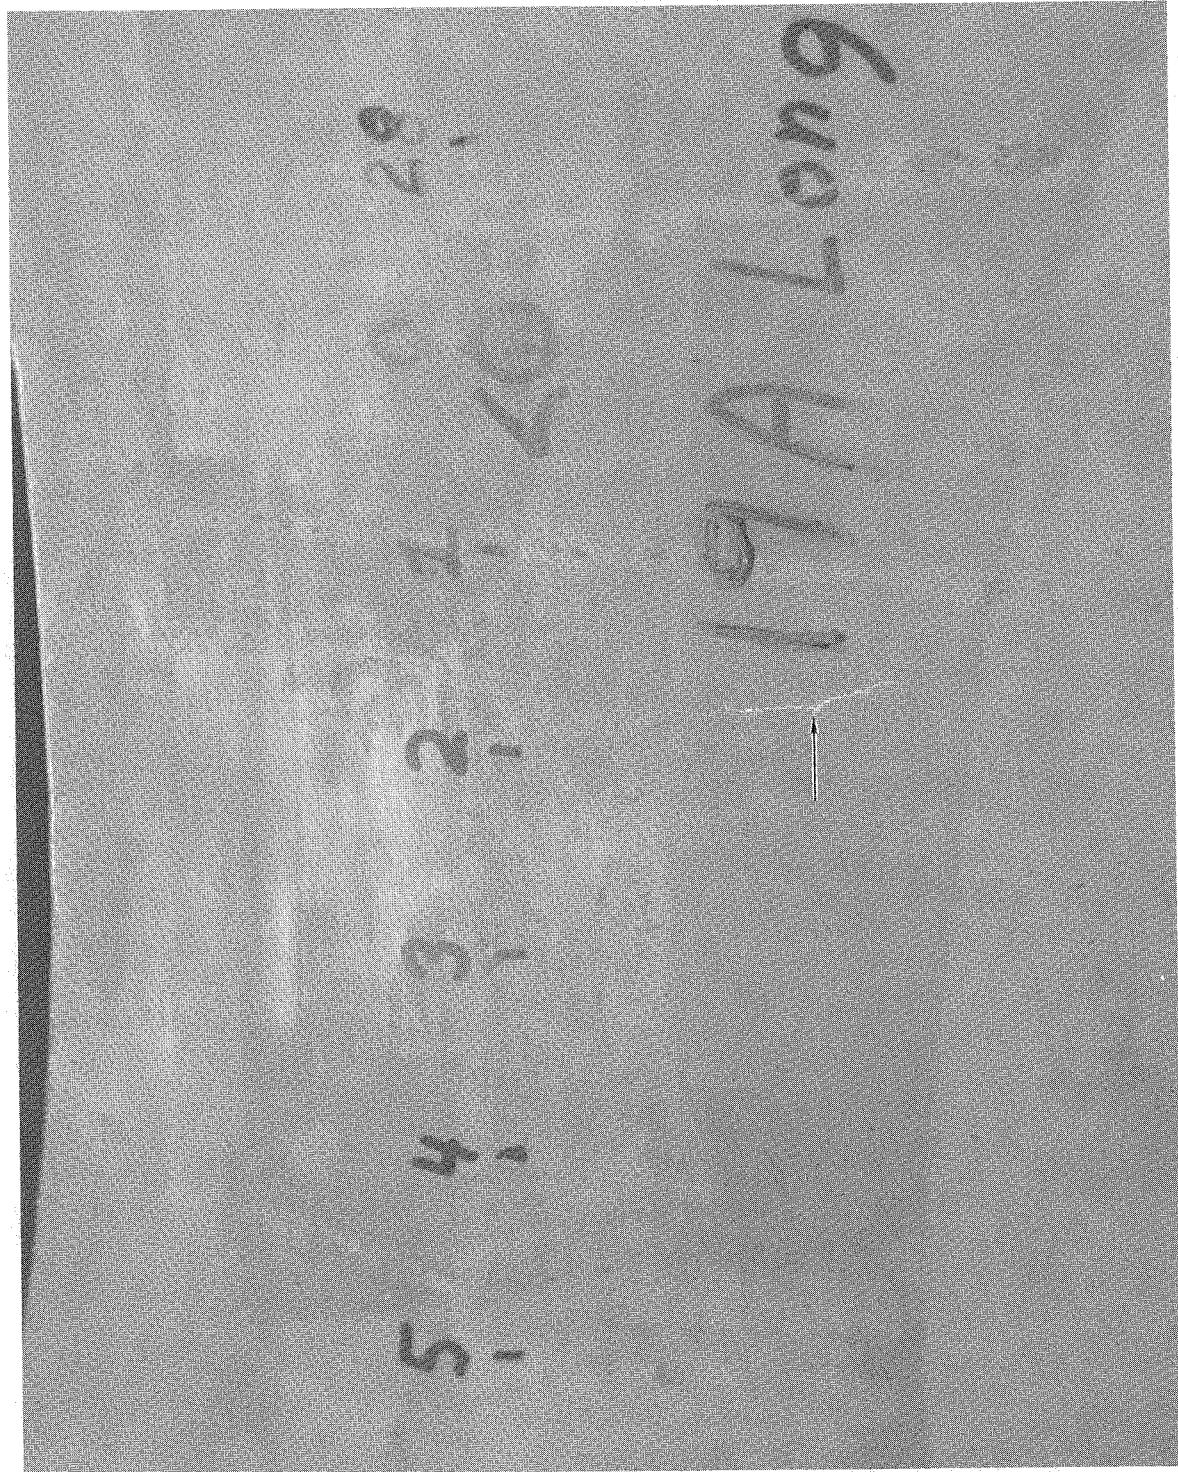
Figure D-8 IGSCC in 19AL, Inside Surface

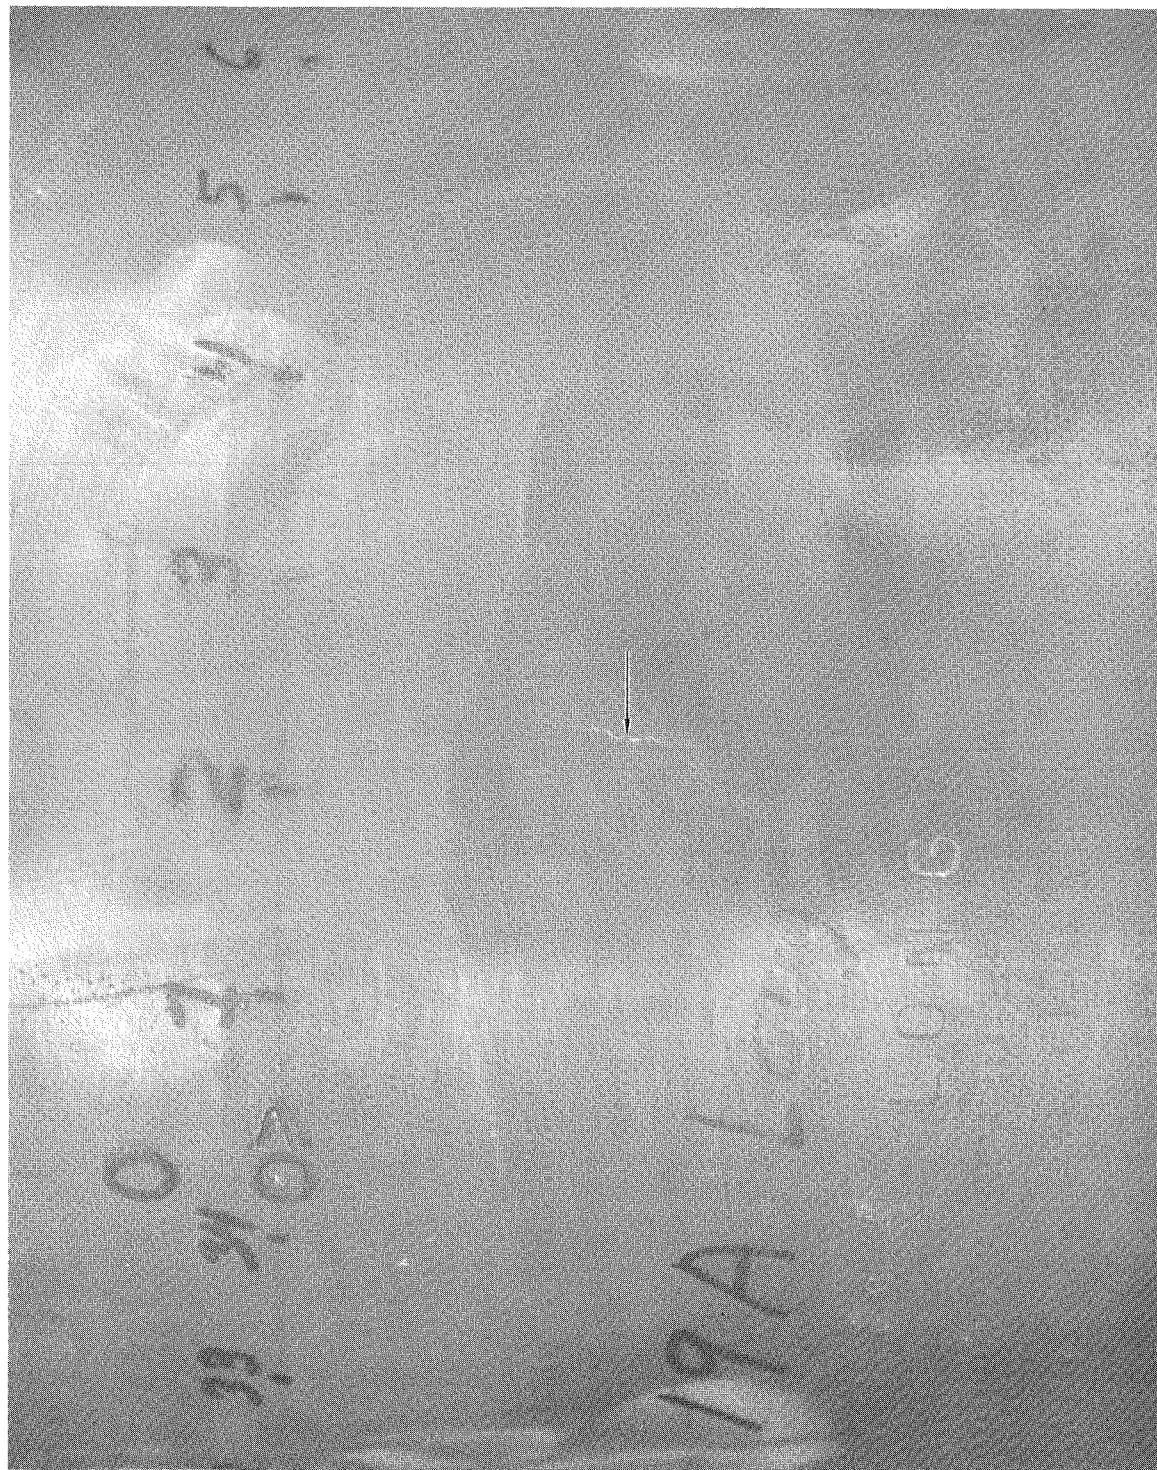
Figure D-9 IGSCC in 19AL, Outside Surface

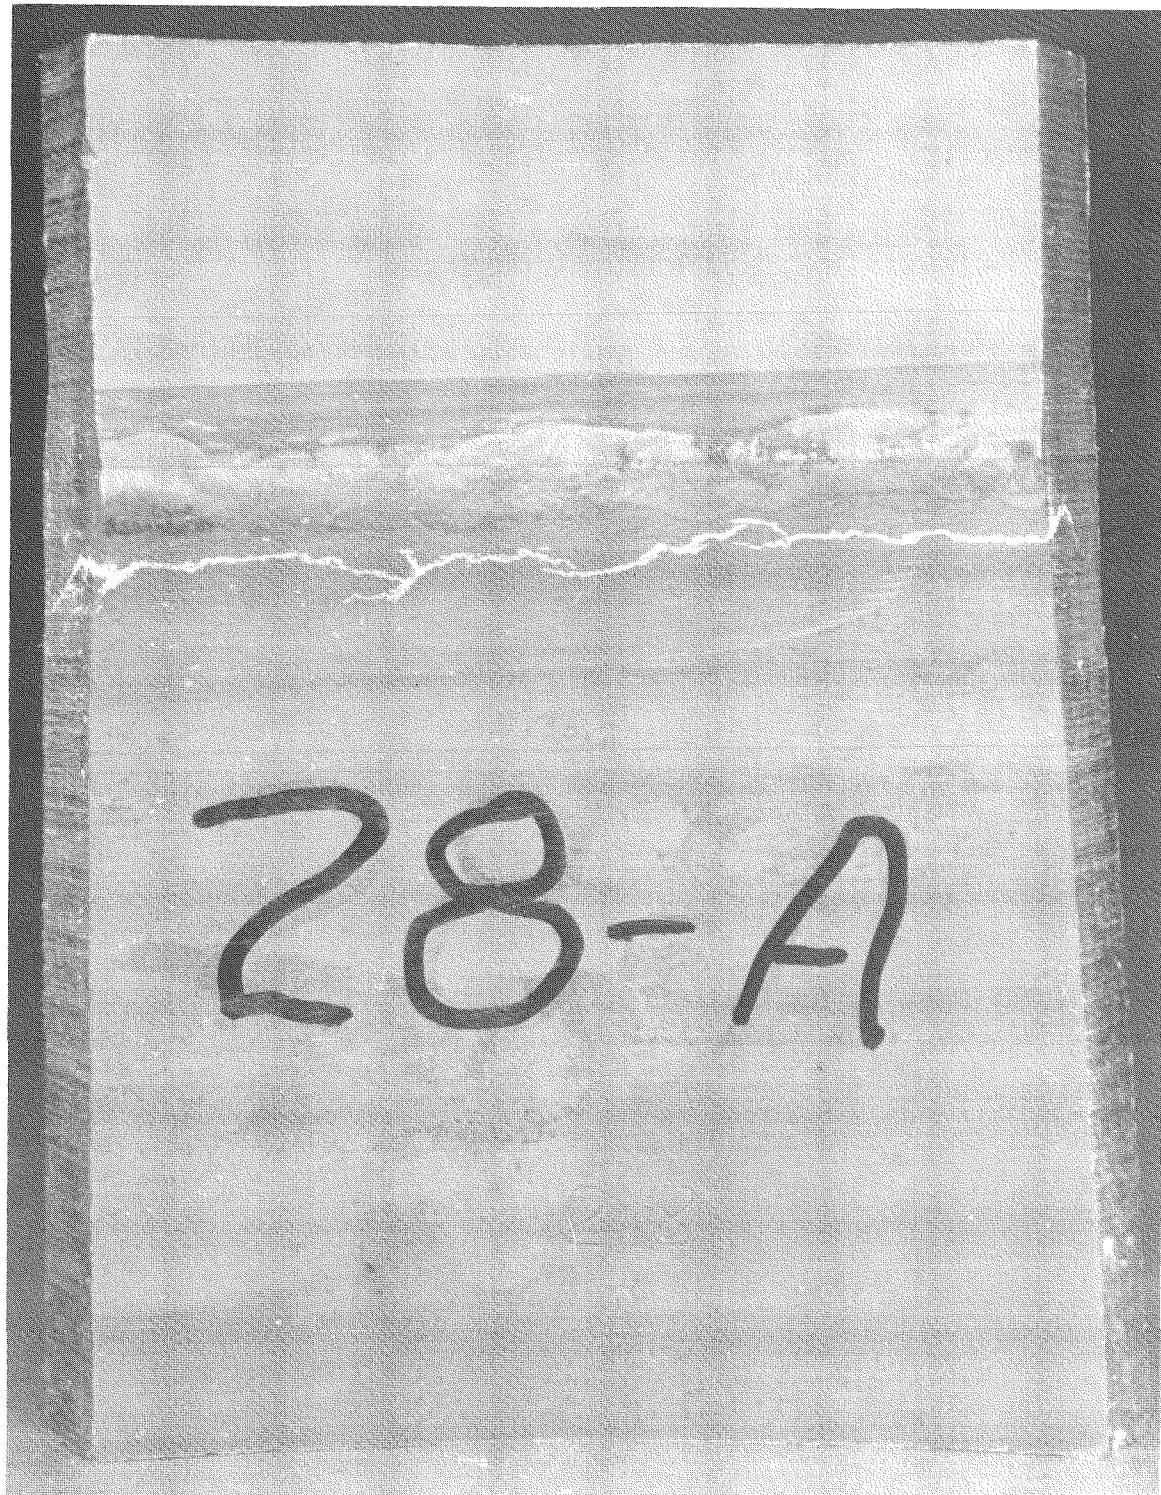
to ultrasonic scanning. Fluorescent penetrant photographs showing the length and depth of the crack are shown in figures D-12 and D-13. This sample was not characterized any further.

Figure D-12 IGSCC in 1028A, Inside Surface

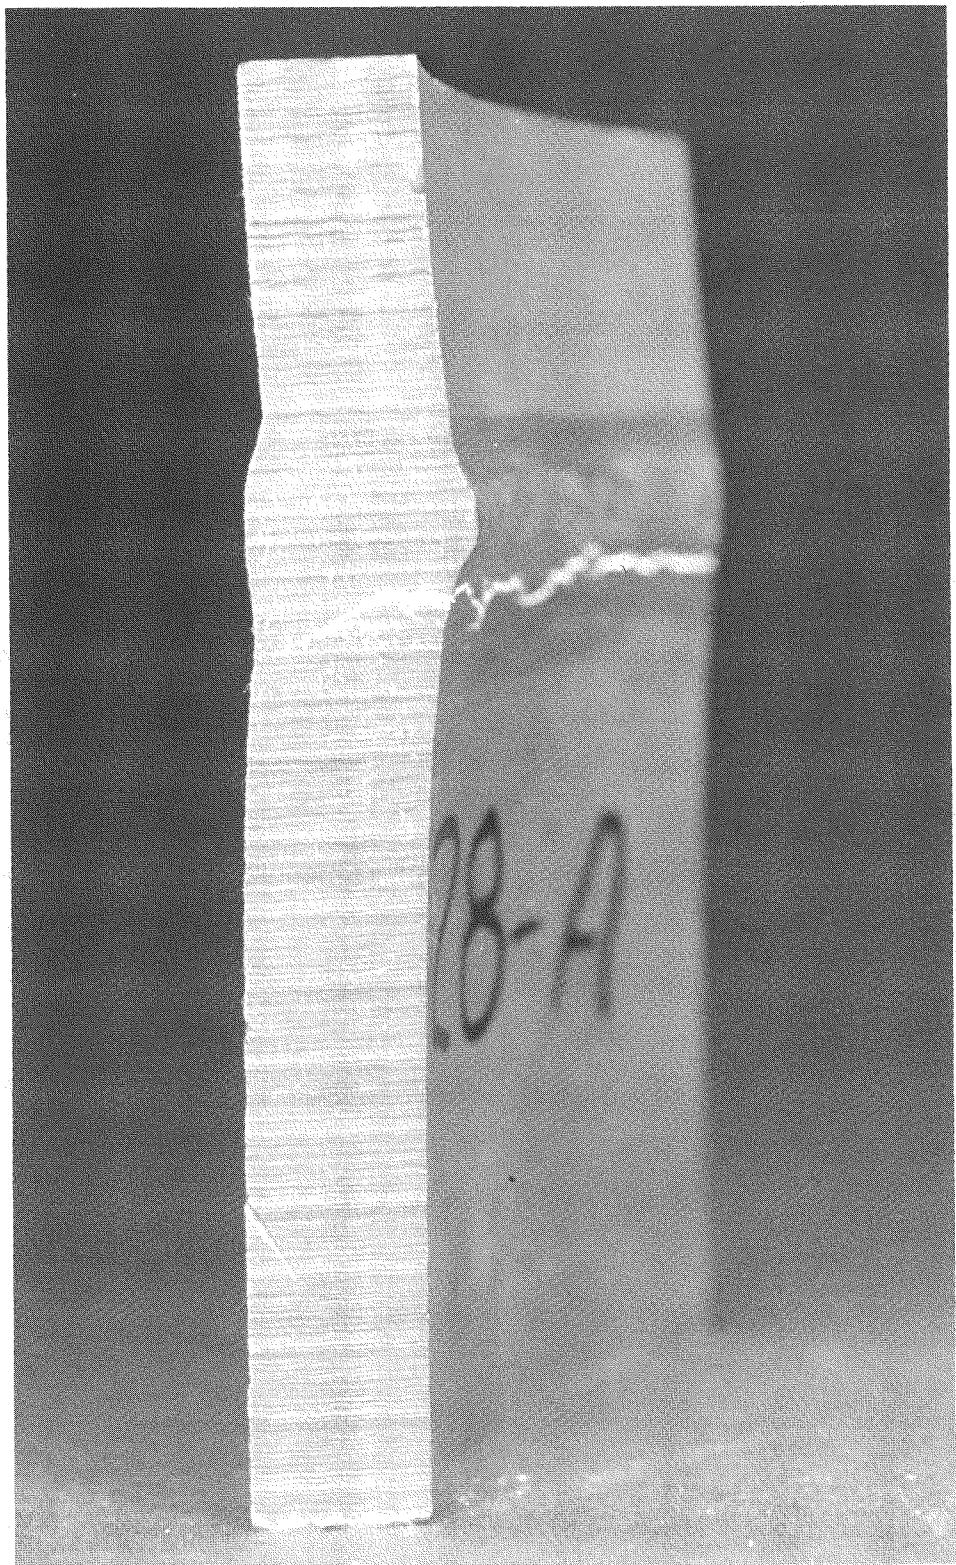
Figure D-13 IGSCC in 1028A, Cross Section

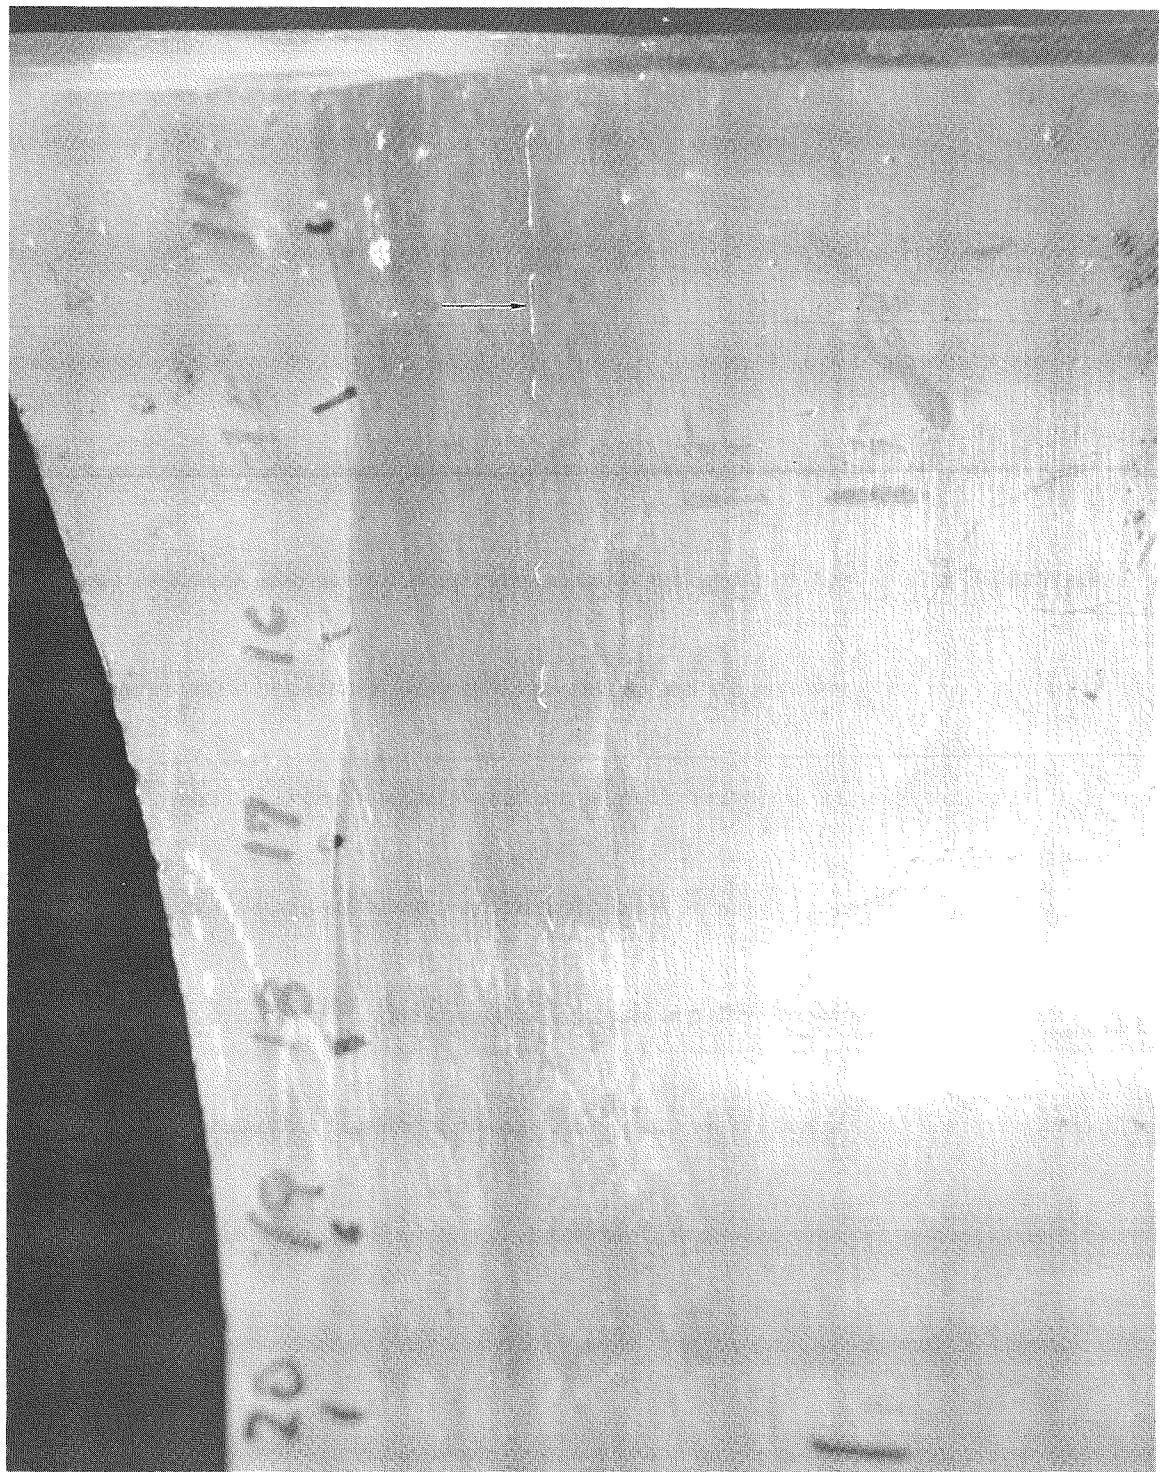
Figure D-16 Lap Defect in 1021

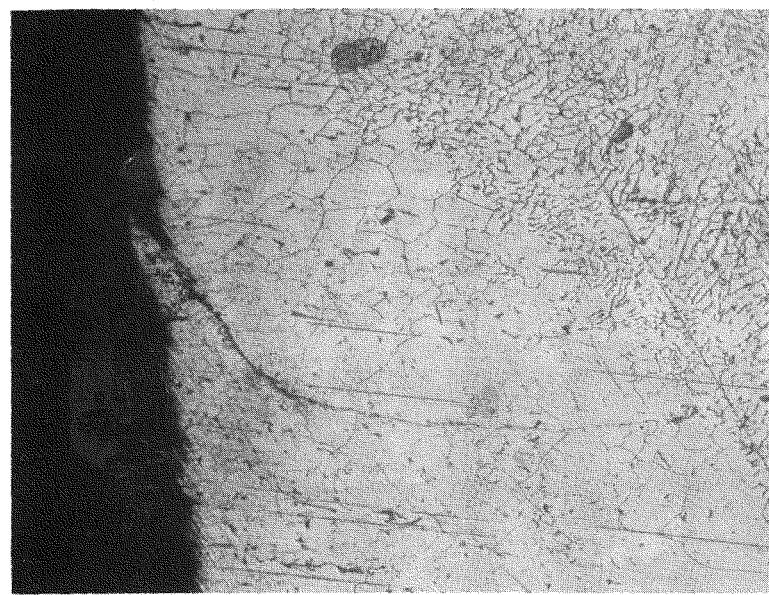
Figure D-17 Lap Defect in 1021, x125

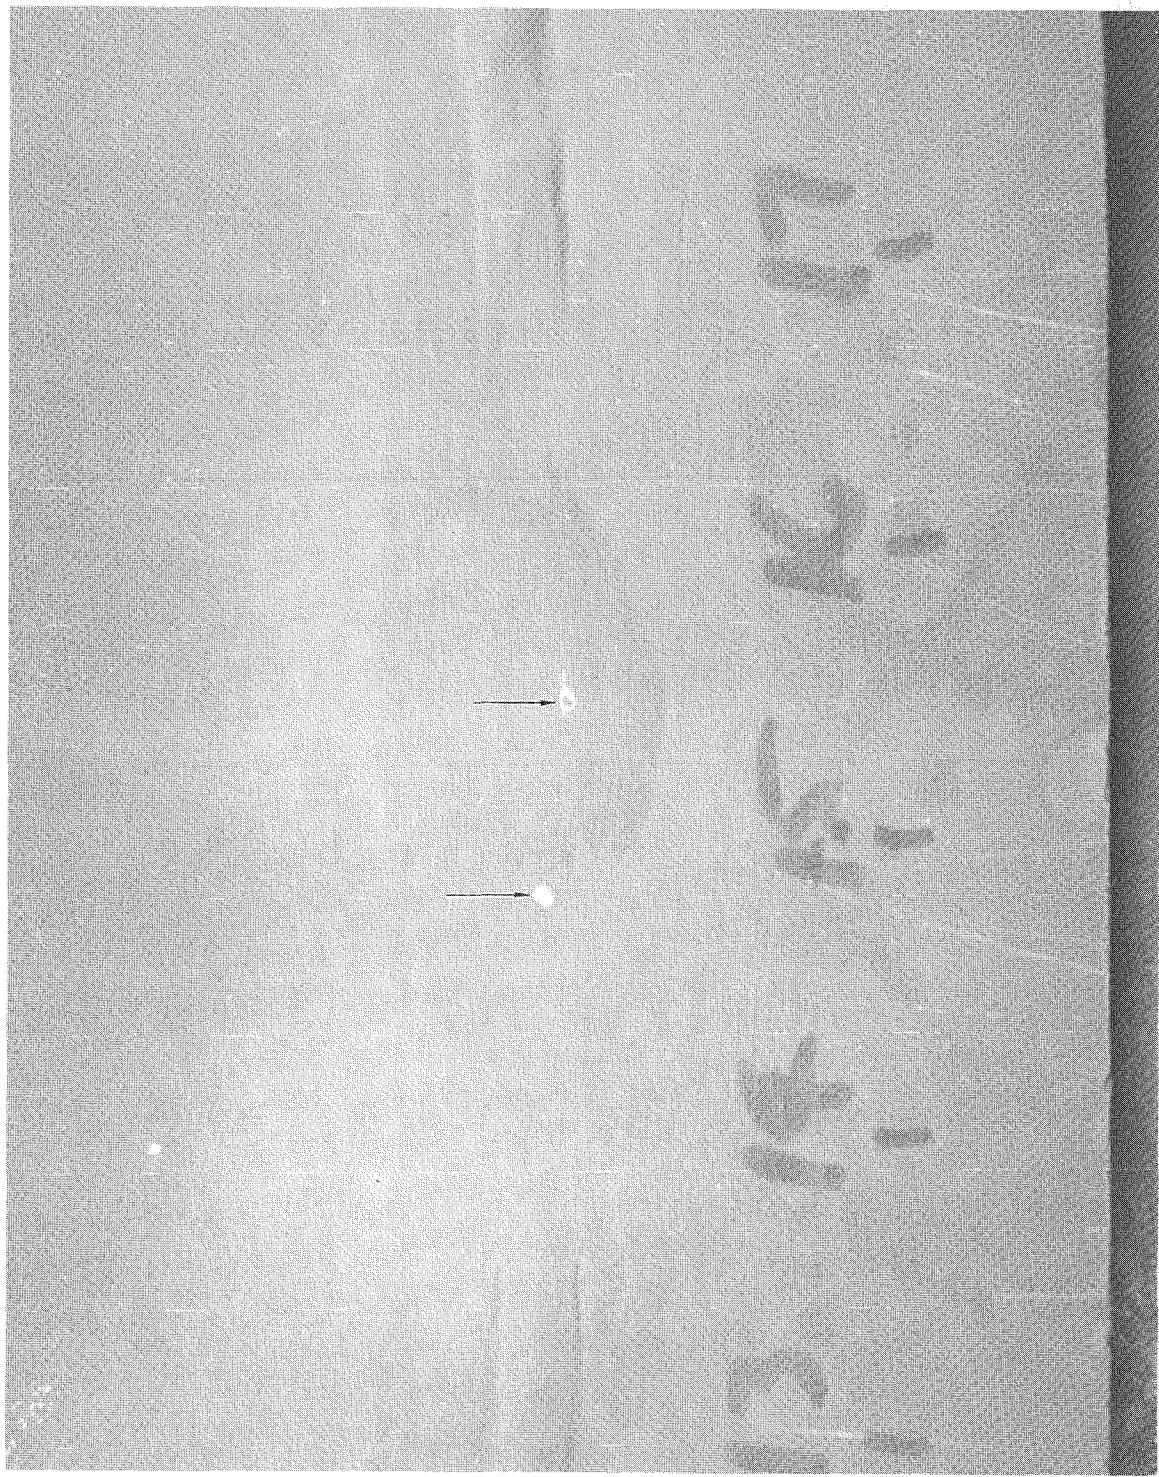
Figure D-20 DPT Indications, 10K17L

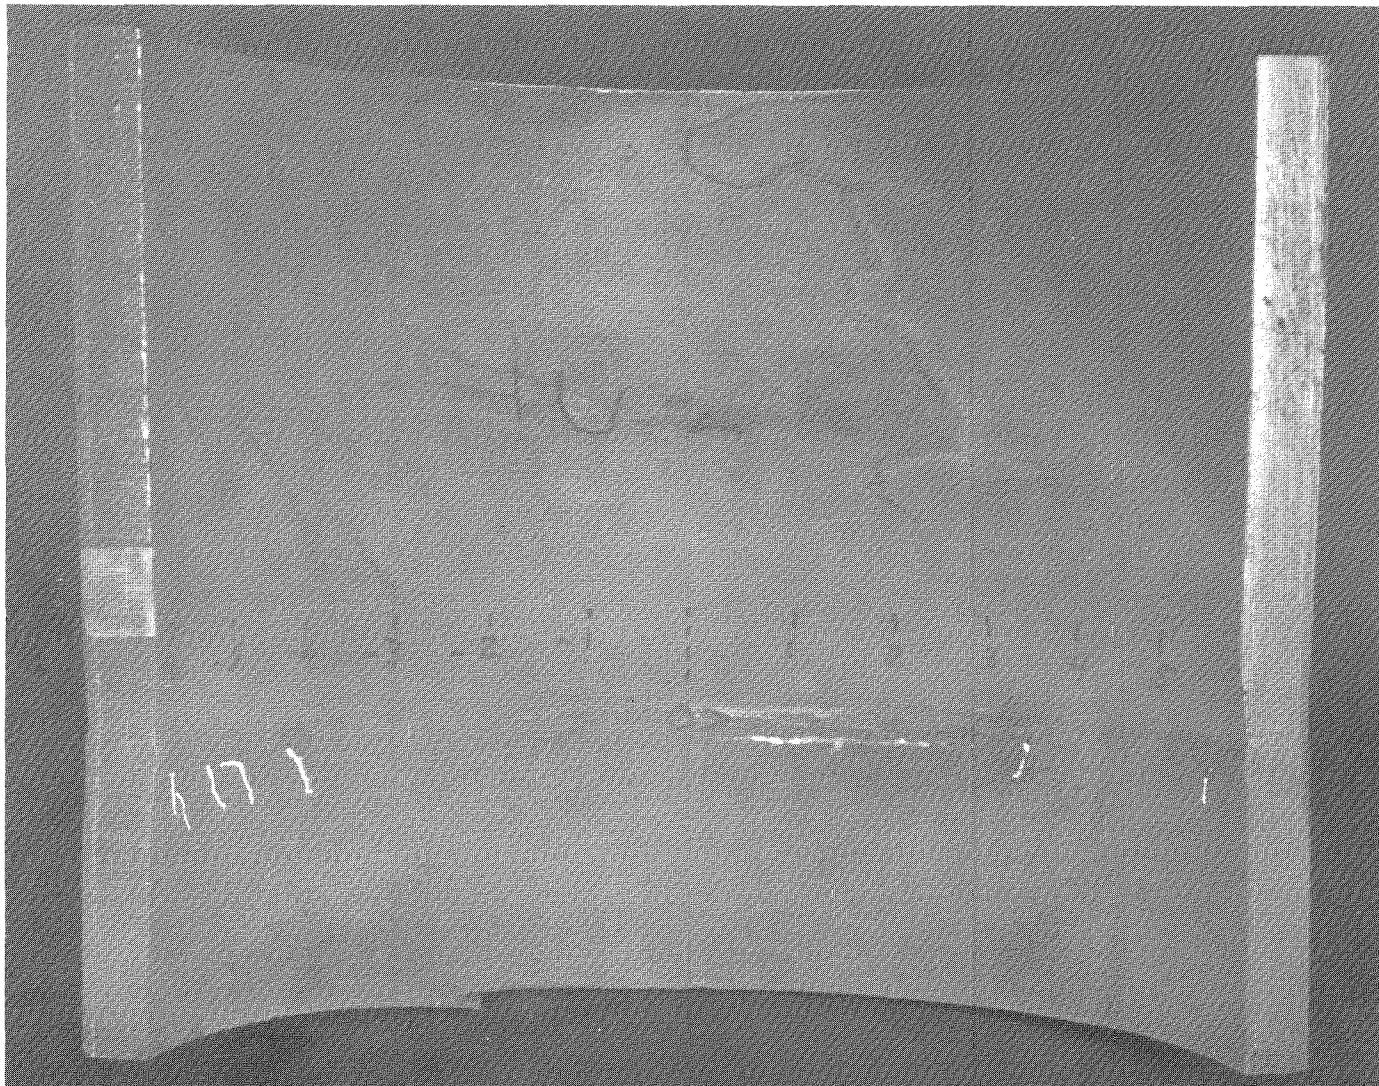
1024A contains a number of cracks, some of which had not been reported previously. The location and orientation of all cracks identified by penetrant testing are summarized in Figure D-24. A general white light ID view of 1024A is shown in Figure D-25. An ID penetrant view in Figure D-26 shows the longitudinal indication

Figure D-26 DPT Indications, 1024A

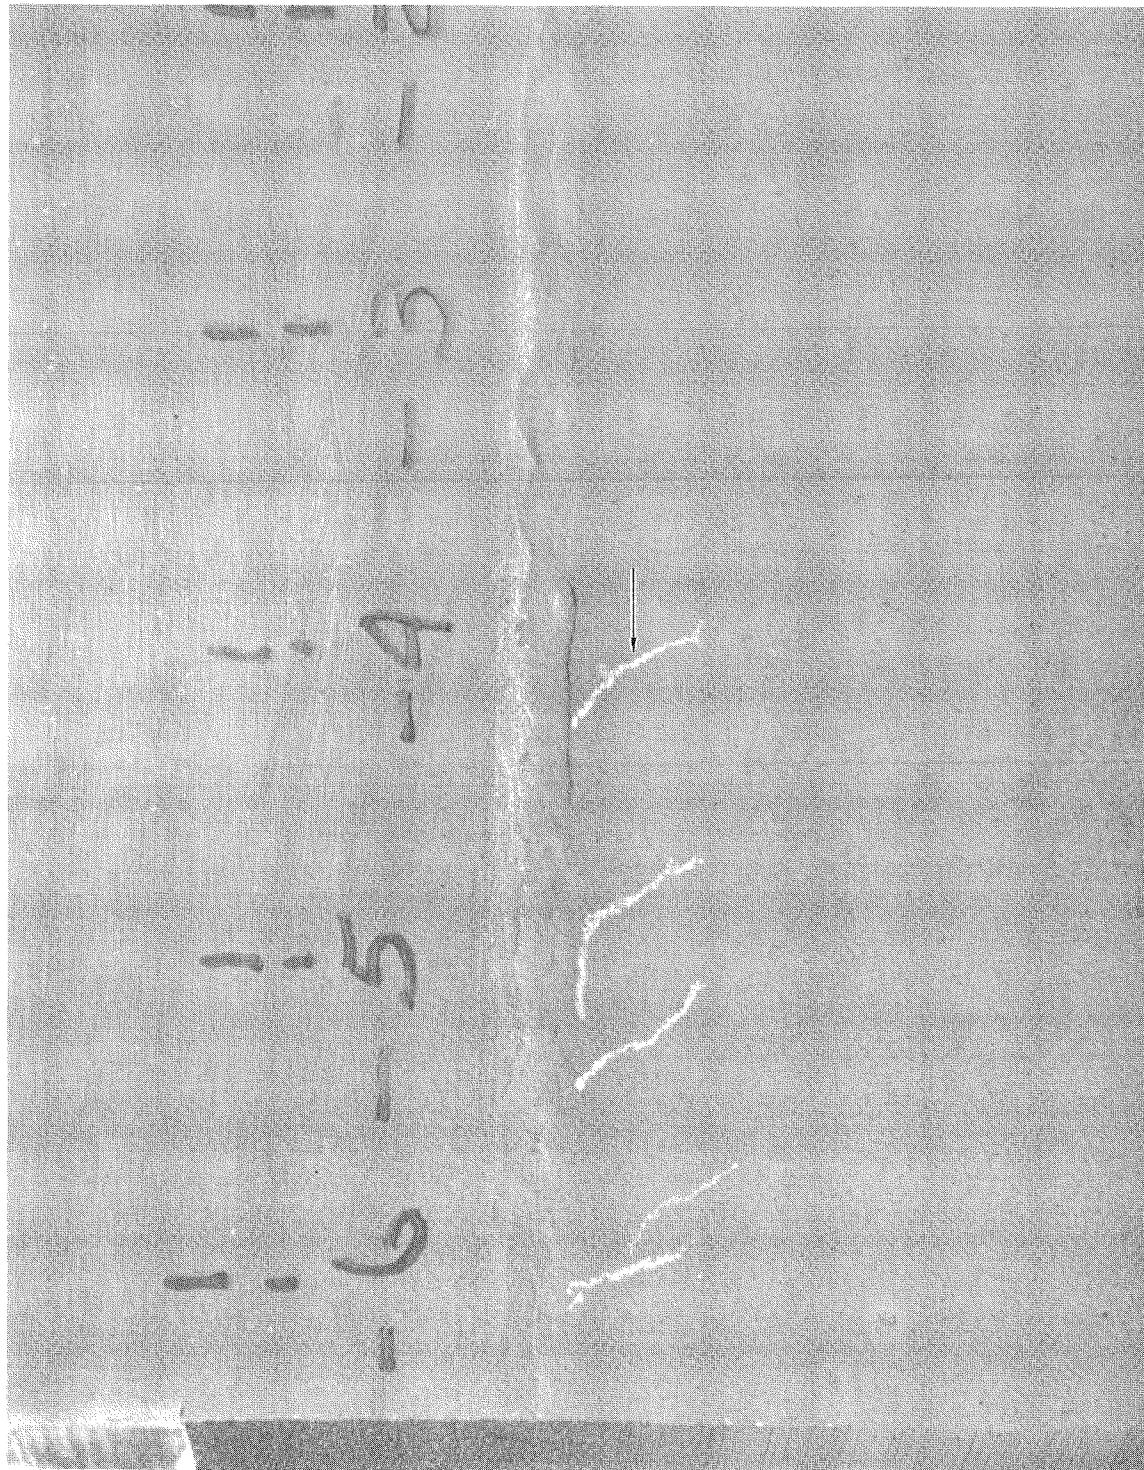
at +5.5 in. and the circumferential indication at +3 in. not reported previously. Close-up penetrant photographs are shown in figures D-27 and D-28.

Figure D-27 Skewed DPT Indications, 1024A

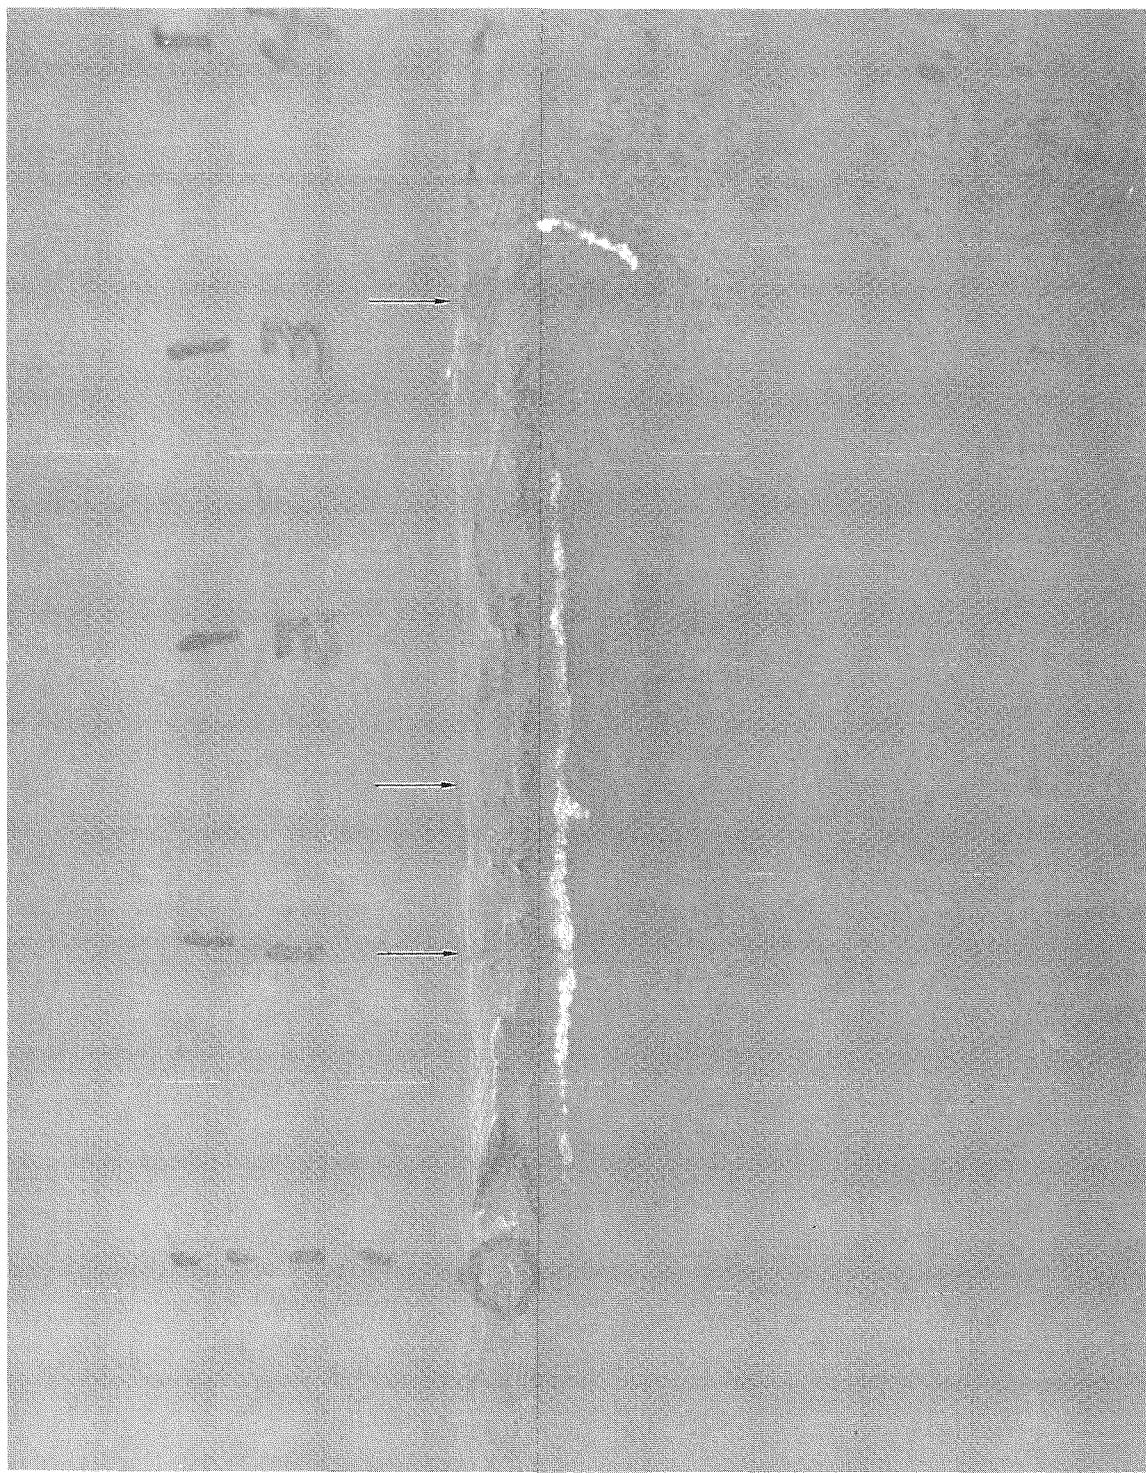
Figure D-28 Radial DPT Indications, 1024A
