# **A STUDY OF IN-SERVICE ULTRASONIC INSPECTION PRACTICE FOR BWR PIPING WELDS**

**EPRI NP-436-SR  
(Technical Planning Study 75-609)**

**Special Report**

**August 1977**

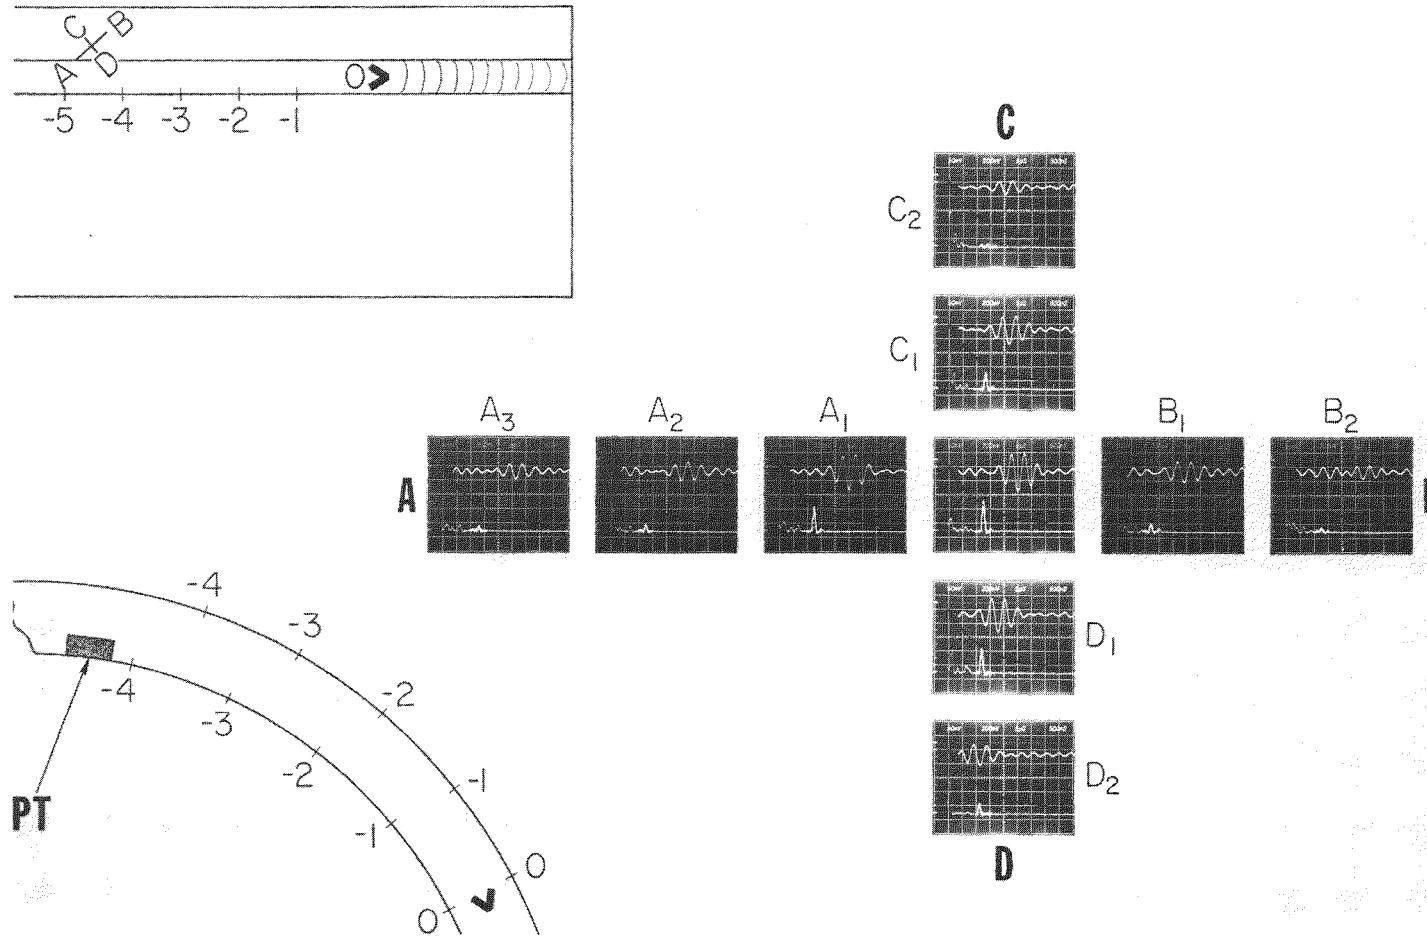
The single angled crack at 31 in. to 32 in. OD (or -4 in. ID on the penetrant photographs) was also characterized ultrasonically. The results of the characterization are shown in Figure D-35. The scanning sensitivity in this case was five times that of the DAC sensitivity. The crack was scanned at 1/16-in. increments in directions parallel and transverse to the crack major axis. This crack is typical of the angled cracks: even though the crack's location and orientation were known from the penetrant, it was somewhat difficult to locate ultrasonically. A circumferential metallographic section through the crack is shown in Figure D-36. The measured depth of the crack is approximately 83% through the wall. This is truly outstanding when one considers the difficulty in trying to isolate these cracks ultrasonically and radiographically.

Figure D-35 UT Characterization of Angled Crack, 1024A

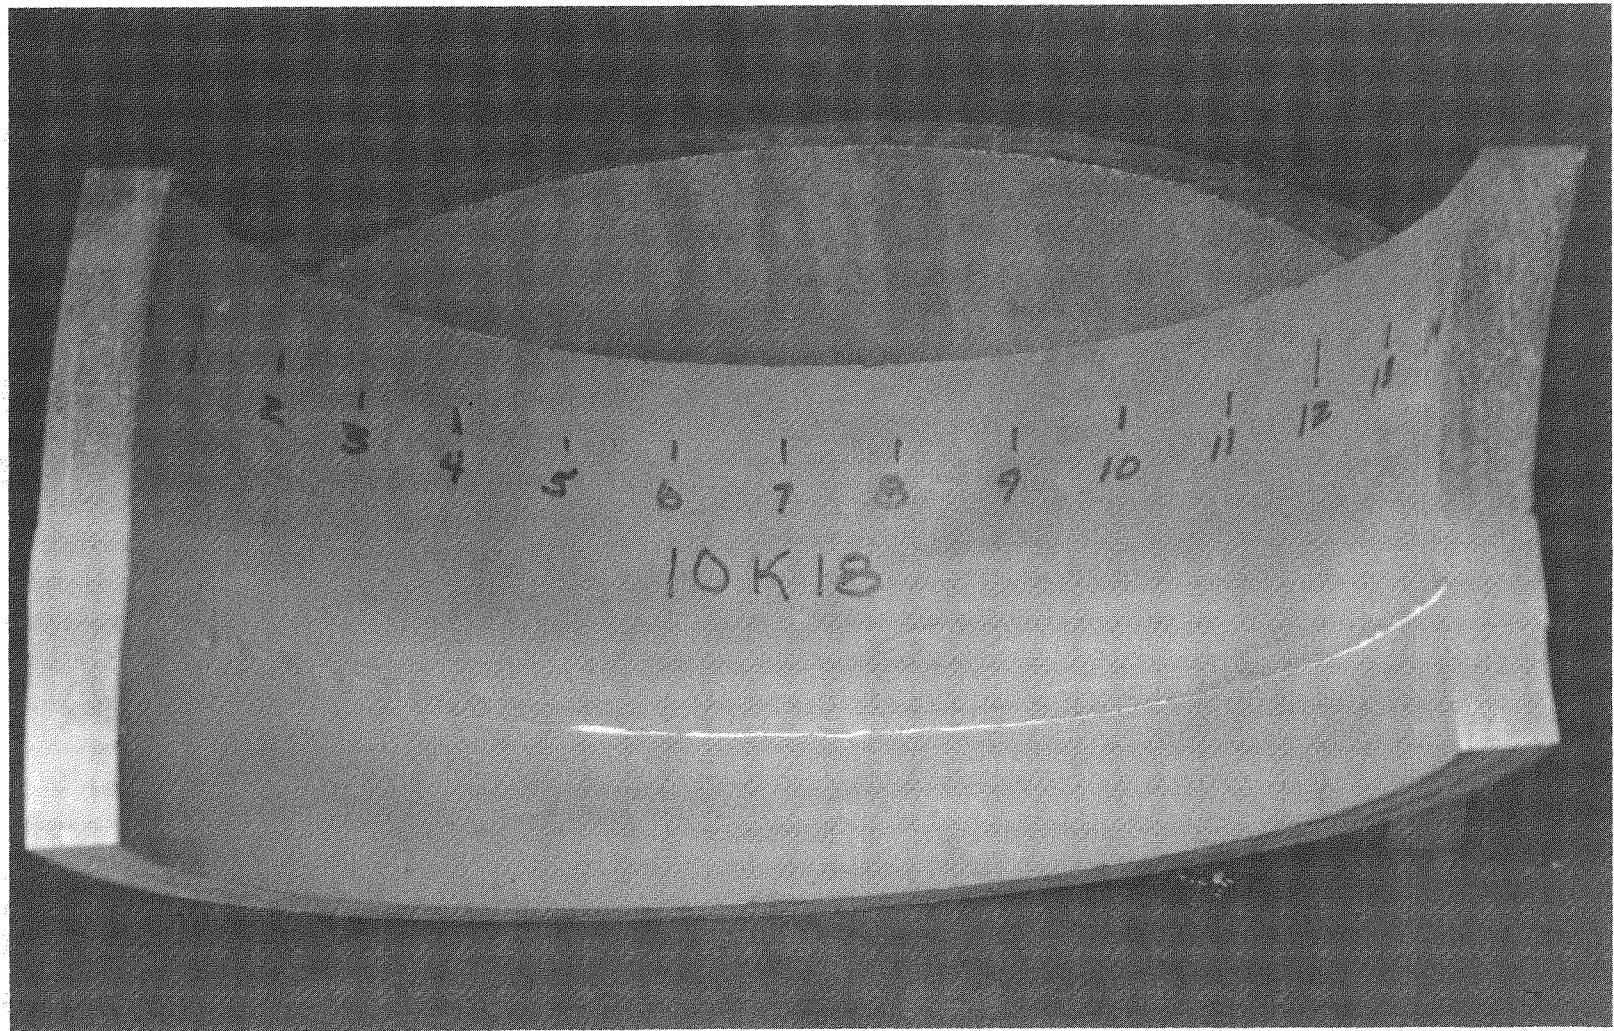
Figure D-39 DPT Results, 10K18

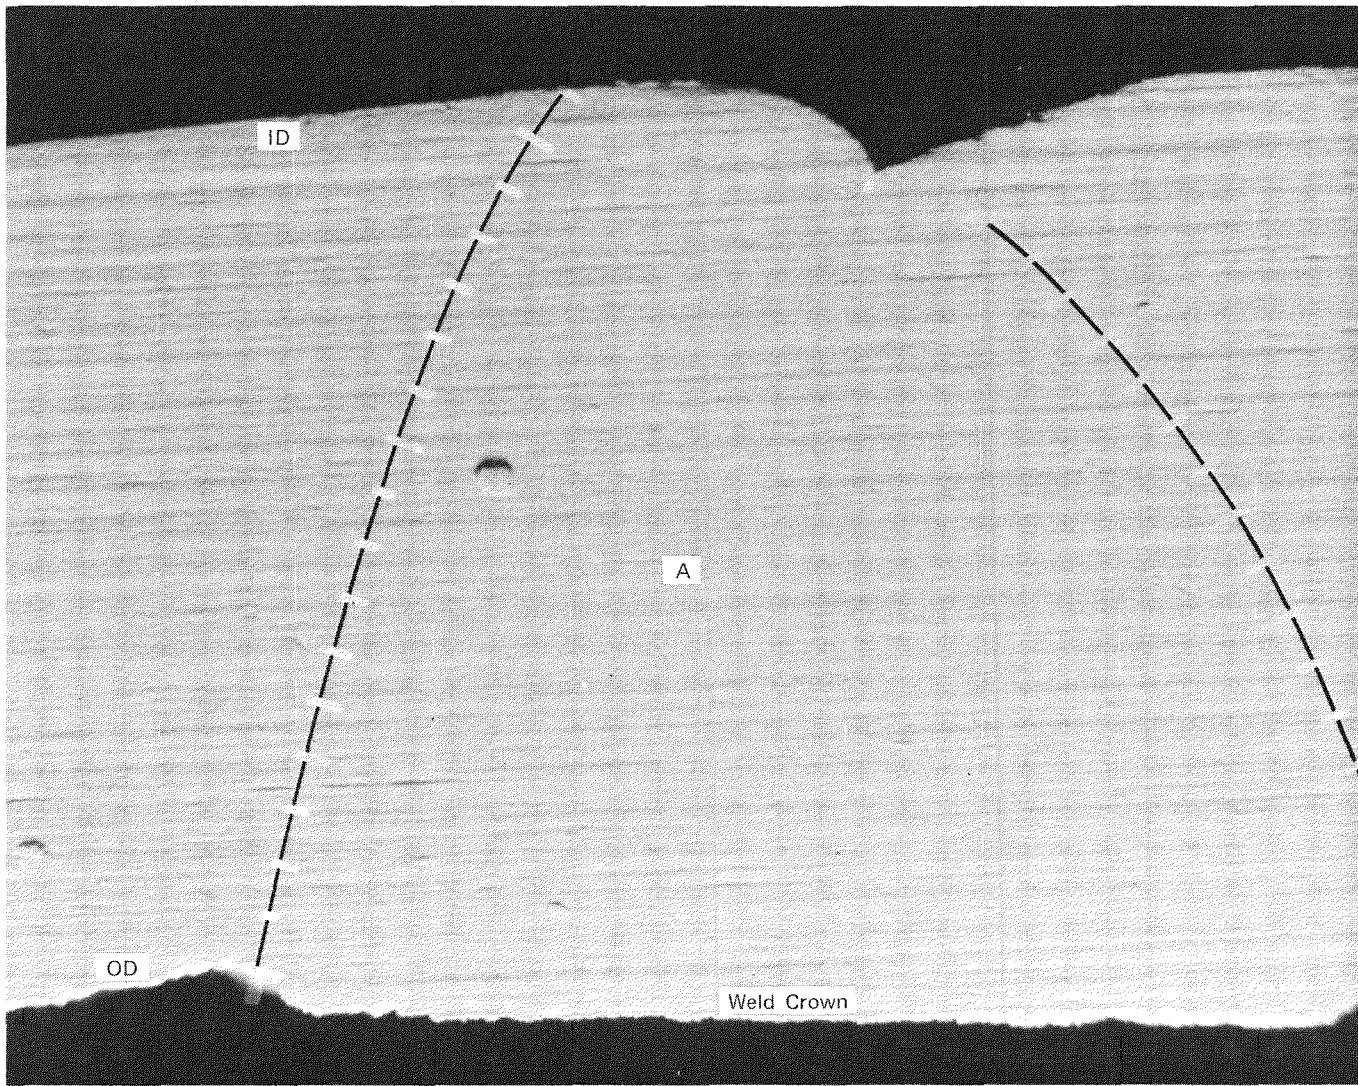
Figure D-40 DPT Results from Cross Section of 10K18

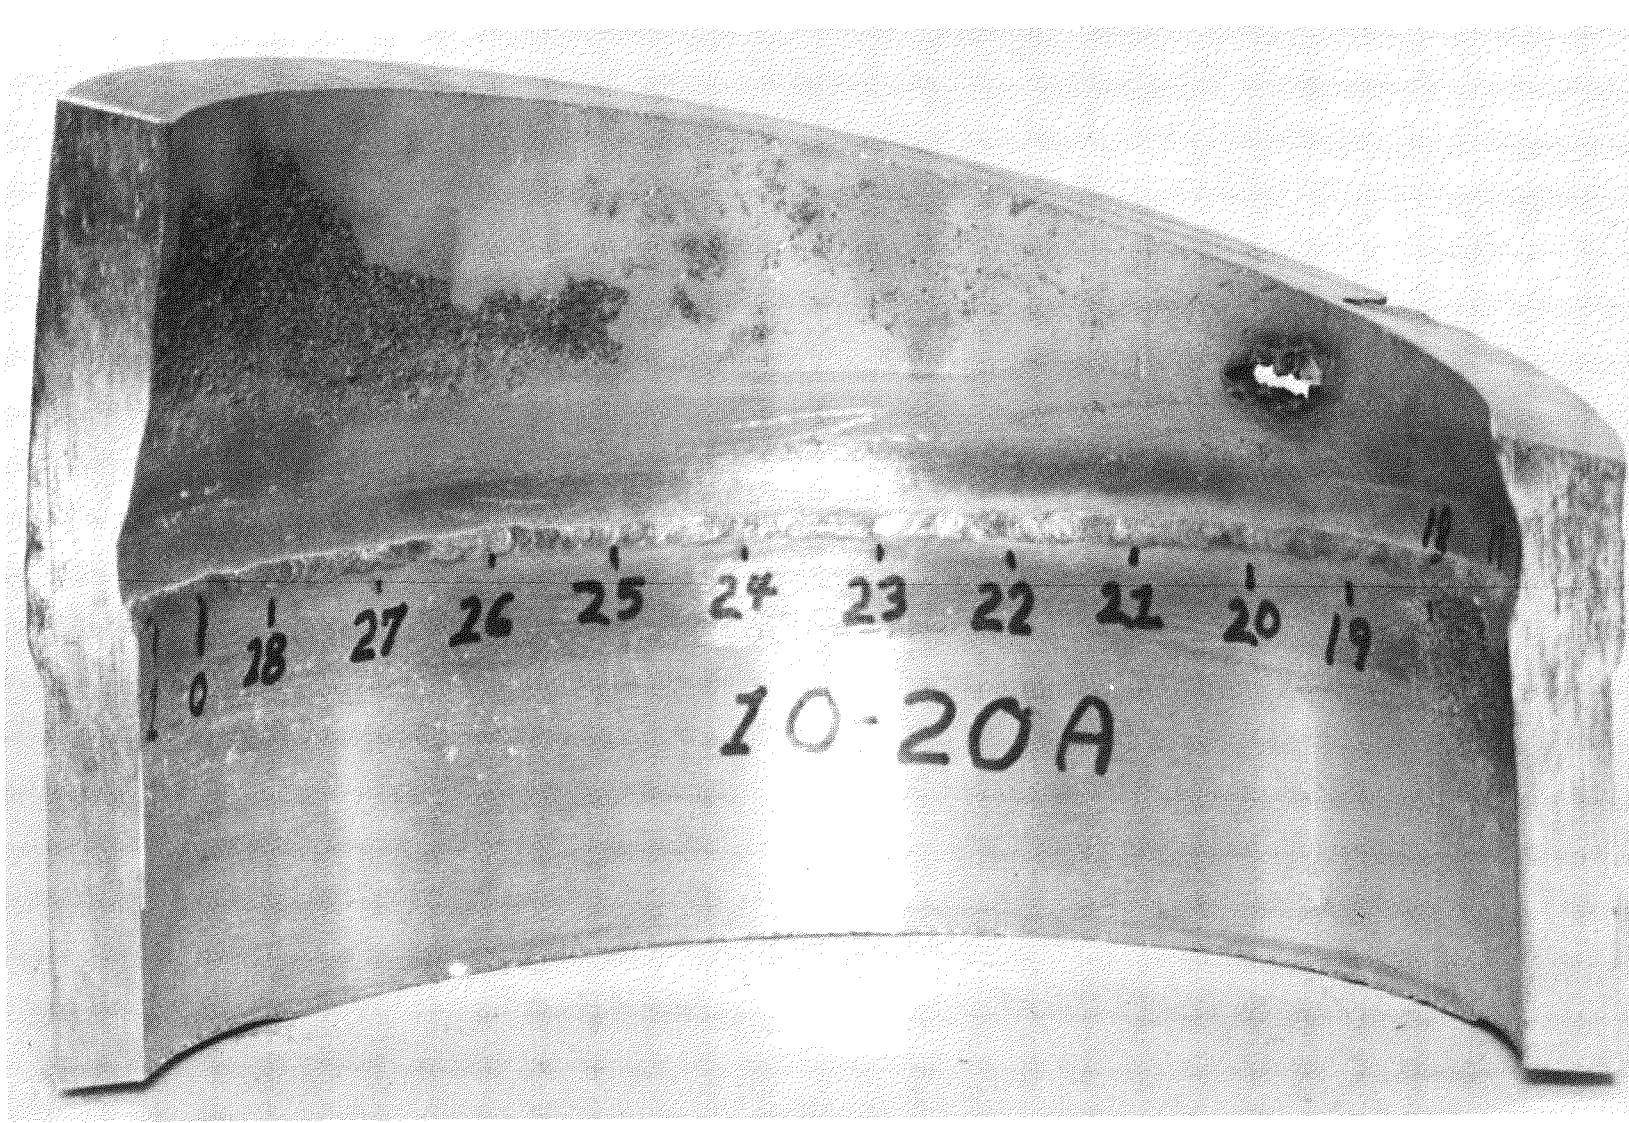
the specimens was in general fair, although in some instances excessive internal scale made fluorescent penetrant testing difficult. Figure D-46 shows the ID surface of 1020A, with an excessive scaling condition.

Figure D-46 Inside Surface of 1020A
