POSTTEST EXAMINATION RESULTS OF RECENT TREAT TESTS ON METAL FUEL*

International Conference on
RELIABLE FUELS FOR LIQUID METAL REACTORS

POSTTEST EXAMINATION RESULTS OF RECENT TREAT TESTS ON METAL FUEL

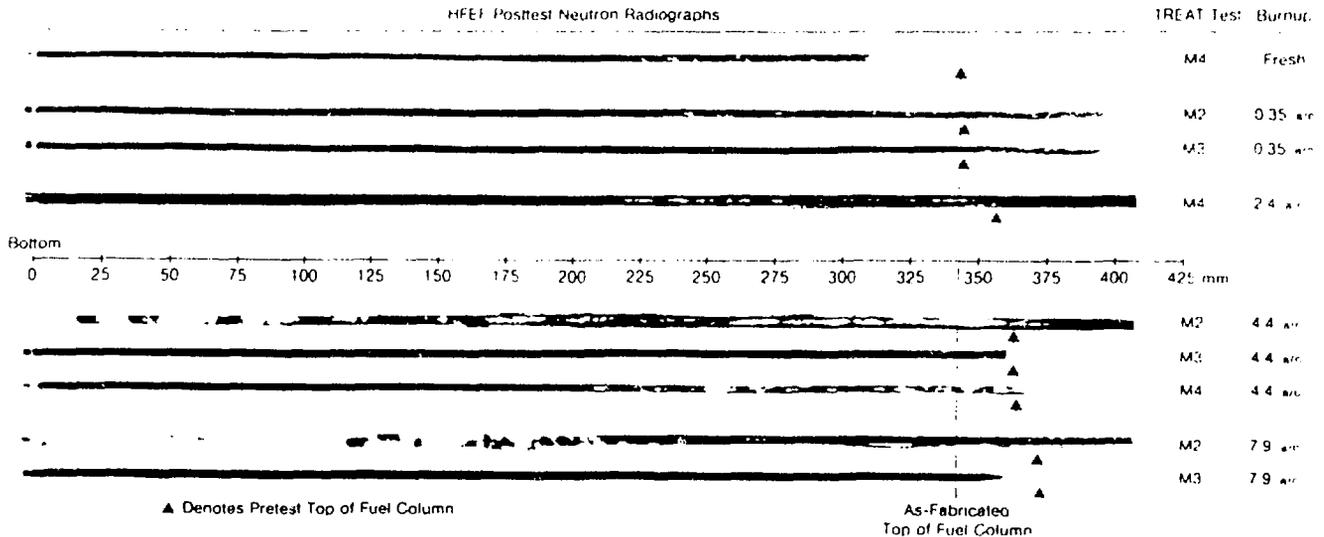
Fig 1

Neutron radiographs of the individual intact pins, shown in Fig. 1, provide evidence of the prefailure fuel elongation experienced during the tests. Total prefailure elongation was more than 17% (relative to the pretest fuel length) in the 0.35 at.% burnup fuel. Prefailure fuel elongation in the fuel pins that failed has been reported to be about 7% for the 2.4 at.% burnup pin, and only about 4% for the 4.4 and 7.9 at.% burnup pins.¹ The propensity for fuel elongation increases after extensive fuel melting occurs; bubble expansion to equilibrium is rapid, and coalescence of small fission gas bubbles is likely since surface tension no longer constrains the expansion. The amount of axial extrusion is effected principally by allowing the volume of fission gas dissolved in the molten fuel to expand to the pressure of the pin plenum.¹ Therefore, high burnup pins, which contain high pin plenum pressures, would be expected to experience less axial fuel extrusion than pins with lower burnups and plenum pressures.

The extent of postfailure fuel motion from the three failed pins in tests M2 and M4 is illustrated in the neutron radiographs shown in Fig. 1. All three pins failed near the top of the active fuel column where the cladding was the hottest. Massive ejection of 30-50% of the fuel occurred in all cases through a localized cladding breach. Nearly all of the ejected fuel monotonically dispersed upward beyond the initial fuel zone. In the 2.4 at.% burnup pin, the ejected fuel originated from the upper 3/4 of the fuel column. More than half of the fuel initially in the top half of the fuel

column left the cladding, and there was significant density reduction below the midplane. Within the 4.4 at.% burnup pin, voiding began in the lower 2/3 of the original fuel zone, and the bottom half of the fuel column had less than half of its initial amount of fuel when fuel motion stopped. Within the 7.9 at.% burnup pin, fuel voiding in the lower half of the fuel column was nearly complete. A likely cause of the rapid fuel dispersal upon cladding failure is sudden flashing of sodium, logged within the fuel porosity, as the pin rapidly depressurizes. The greater disruption in the high burnup pin correlates with the greater depressurization.

HFEF Posttest Neutron Radiographs

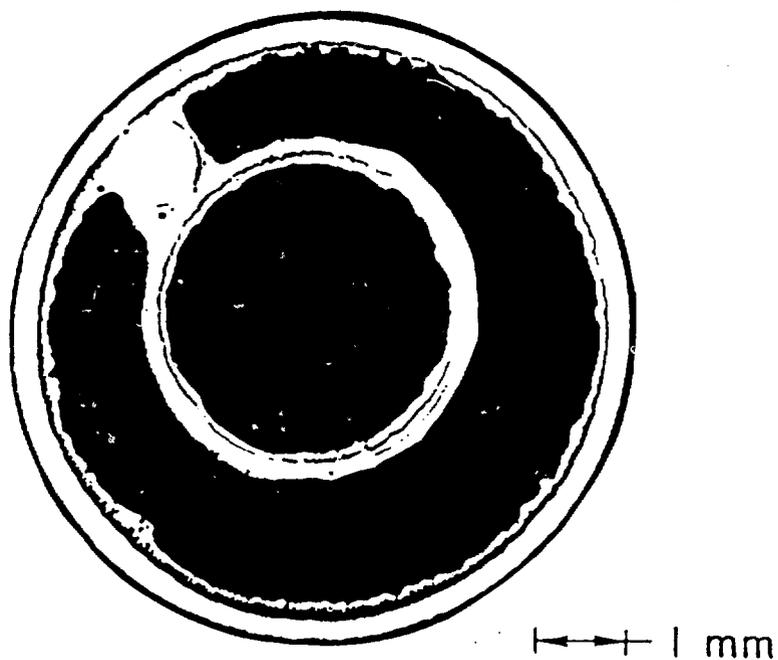
Fig. 4

Metallographic examination of the failed pins from M2 provided ample evidence of fuel/cladding interaction leading to formation of low-melting phases. A large inventory of molten fuel existed at the time of fuel-pin failure; the molten fuel and a much smaller amount of fuel/steel low-melting materials were ejected upward. Only small quantities of molten material entered the plenums. The bulk of the material exited the breaches and contacted the outer surfaces of the cladding, the spacer wires, and the interior surfaces of the flowtubes. A representative cross section of the medium-burnup pin from M2 is shown in Fig. 4. Fuel/steel phases line the inner and outer surfaces of the cladding, surround the spacer wire, and coat the inner surface of the flowtube in Fig. 4(a). A higher magnification micrograph of the cladding and adherent material is shown in Fig. 4(b). Only 20% of the original cladding thickness remains as a narrow horizontal band across the center of Fig. 4(b).

The optical metallograph could not resolve the characteristic eutectic structure that should have been present in the specimen shown in Fig 4. Formation of the fuel/steel phases shown in the figure were caused by molten fuel that was well above the temperatures of formation for the two eutectics in the Fe-U system. The same specimen was examined on the scanning electron microscope in an attempt to resolve the eutectic structure and to qualitatively identify the phases present in the microstructure. A series of increasingly higher magnification secondary electron images of the specimen are shown in Fig. 5. The remaining intact cladding is shown as a black horizontal band across Fig. 5(a) and at the top of Fig. 5(b). The cladding is layered between two 25- μ m-thick bands of fuel/steel material that is contacted by a region containing a fine-structured eutectic. The fine-structured fuel/steel eutectic penetrated into the boundaries around U-rich grains. Fig. 5(c) is useful to qualitatively describe the phases present in the system. The large, dark grains surrounded by a lighter phase at the top of the figure are stainless-steel-like grains surrounded by UFe_2 . The fine-structured eutectic was harder to identify because of the size of the electron beam

CLADDING AND FLOWTUBE OF 4.4 % BURNUP
U-5Fs FUEL PIN. $X/L=1.30$
