HEDL-SA-902

MODE OF FAILURE OF LMFBR FUEL PINS

D. F. Washburn

For presentation at the meeting
of the American Nuclear Society
New Orleans, Louisiana, June 8-13, 1975

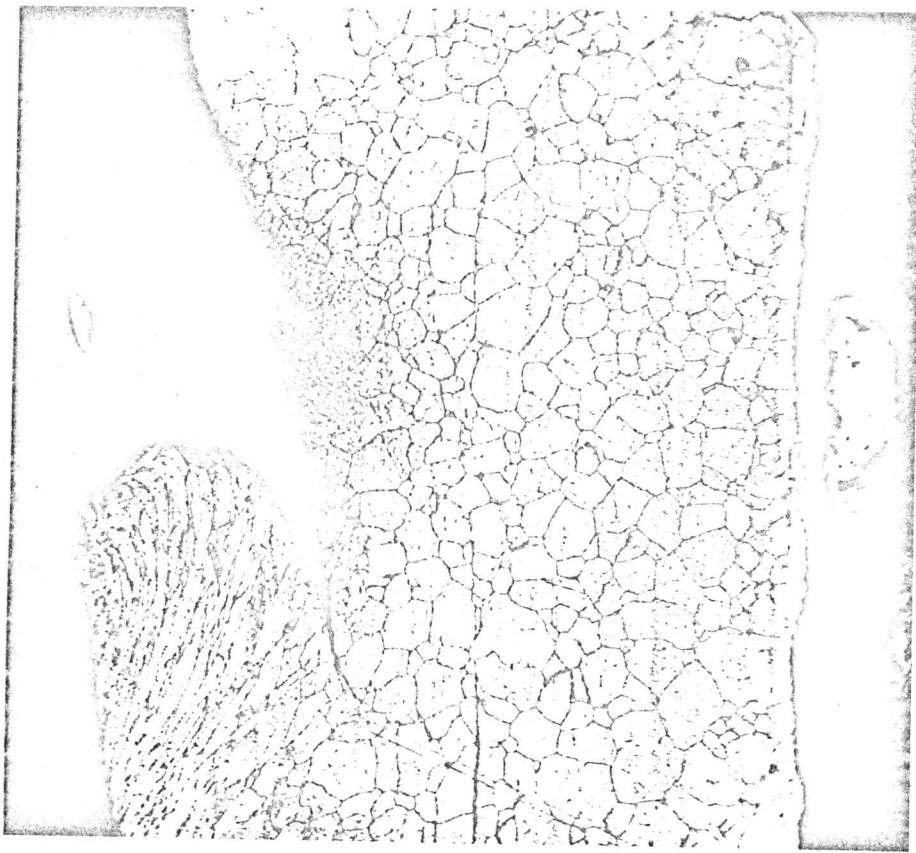
The cladding on the side of fuel pin PNL 5-2 nearest the hex duct contained a deep gouge over a length of about one inch with intermittent depths as much as 0.007 inch, Slide 6. A longitudinal section through this gouge showed the direction of metal flow was downward, Slide 7, suggesting it was caused when the hex duct was lowered into place during reconstitution of the bowed fuel pins from the original PNL-5 subassembly. It is believed that twisted pins forced pin 5-2 into a position where it was subjected to high axial forces necessary to produce the gouge.

LONGITUDINAL Section through the
Gouge on PNL 5-2

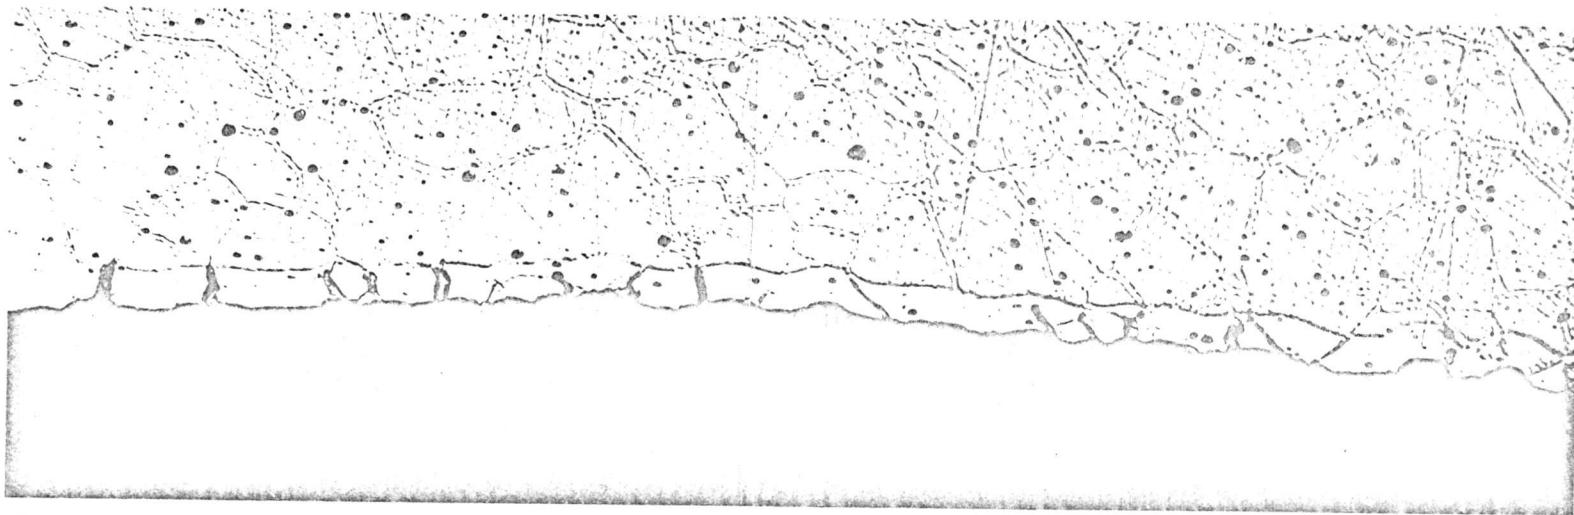
uniform layer of palladium was profusely cracked but there was no other indication of cladding attack at the inner surface.

Uniform layer of fission-product palladium on inner
surface of cladding of PNL 5-1 and PNL 5-2
