# Technical Memorandum

MC2736 Lot 9 Daily Lot Sample Failures

R. A. Pike  
Product Engineer  
Product Engineering

March 4, 1991

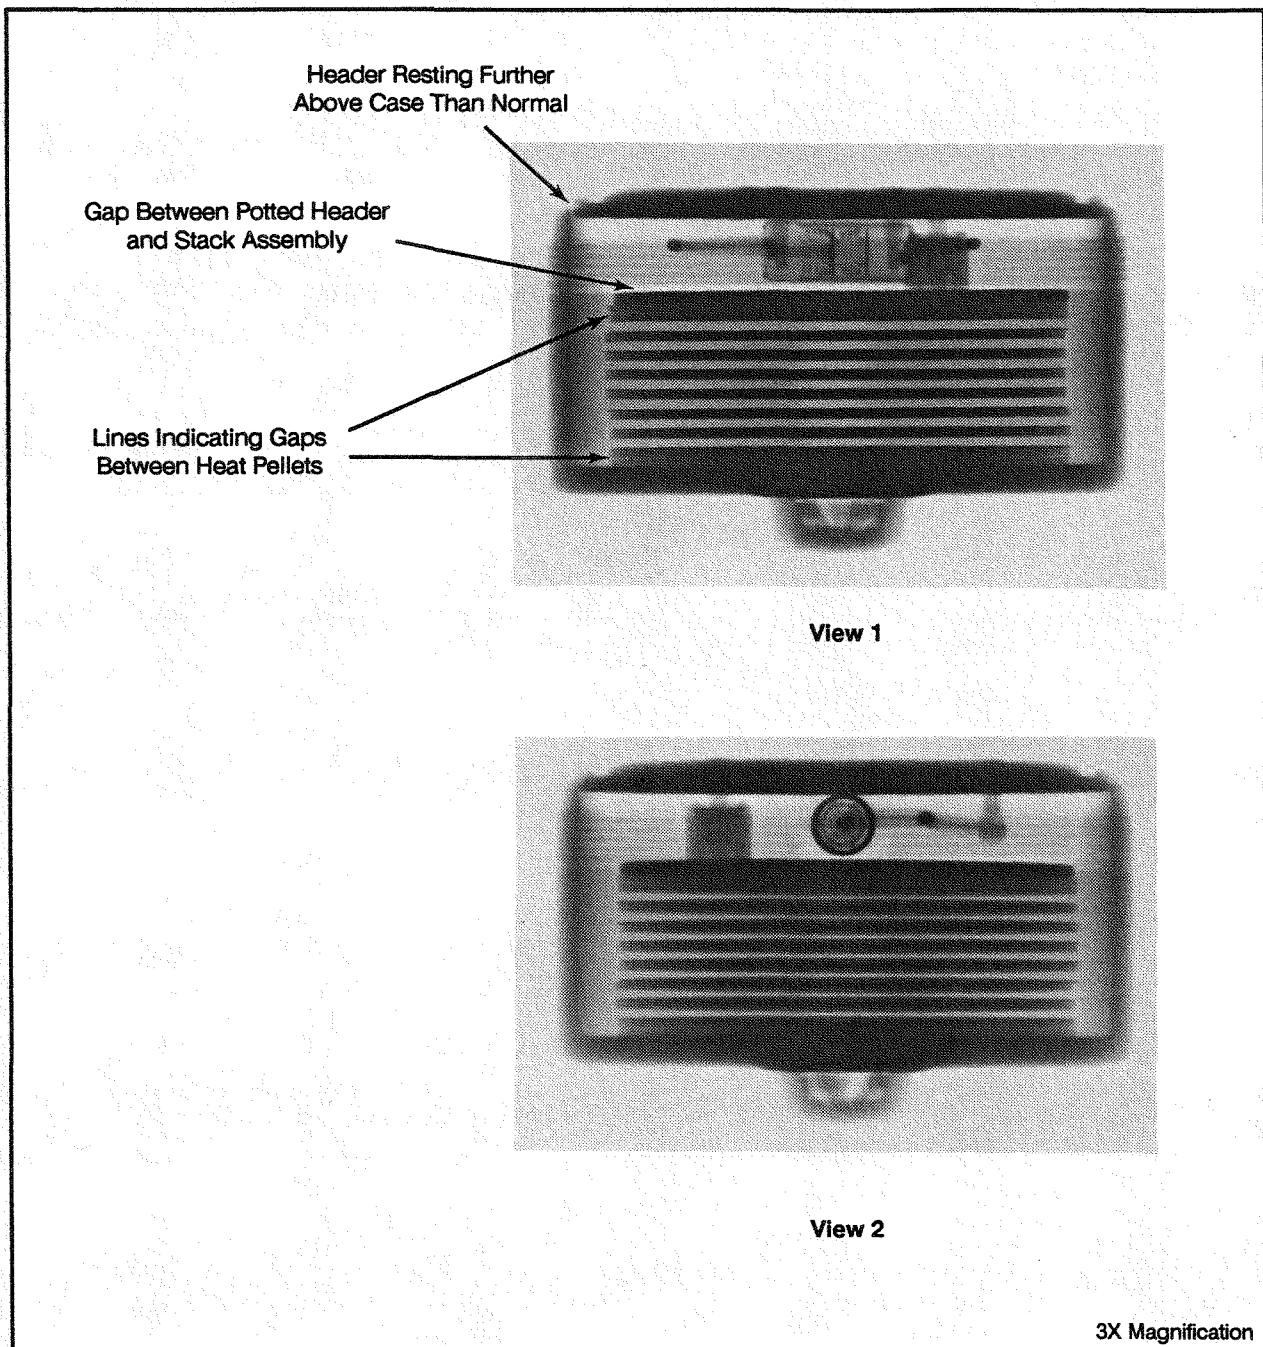
Figure 1. X-ray of Failed MC2736 Battery, Serial No. 4422

After the failure, the tester load was verified to be correct. Prior to cutting open Serial No. 4422, the x-rays were carefully reviewed for evidence of any condition which would impact battery performance. It had previously been noted that a gap was visible between the two heat pellets in each pair of heat pellets, one pair at each end of the stack assembly. Further, a gap was visible between the potted header and the stack assembly. Additional review led to the observation that the header was welded resting further above the case than normal. These observations suggested that the battery was not closed properly. An x-ray of Serial No. 4422 is shown in Figure 1. For comparison purposes, an x-ray of a normal battery (Serial No. 4586) is shown in Figure 2.

All three batteries were cut open and carefully disassembled. The test failure, Serial No. 4422, exhibited larger than normal areas of unreacted calcium on the bimetal. However, the cause of its poor performance was noted by the observance of the header potting appearing to be oval shaped. Measurements of the largest potting width yielded the following dimensions: 0.896", 0.887", 0.906", and 0.901". The drawing (No. 290424-200) calls for a potting diameter of 0.875"  $\pm$  .002". For the inner diameter of the insulator sleeve placed into the case, the specification was 0.888" + .004"/-.000" (Drawing No. 290417-200).

Based on the data from these tests and measurements, it was concluded that Serial No. 4422 failed because of the oversized header potting. This condition may have been caused by inadequate trimming of the sprue from the potting. The result was oval-shaped potting, with the largest dimension being greater than the inside diameter of the inner Vespel\* insulation sleeve. Thus, when the normal stack force used for closure welding was applied, it forced the header potting into the insulation sleeve. As a result, no pressure was applied to the cell stack. Further information on this investigation is detailed in a SNL memorandum dated August 8, 1990 (see Appendix A).

To prevent the reoccurrence of any similar problems, the remaining potted header assemblies were screened for potting diameter. Also, based on the x-ray data gathered in this study, all x-rays for MC2736 Lot 9 were screened for separations in the two pairs of heat pellets located on each end of the cell stack. This condition was seen on the x-rays as dark visible lines between the two end pairs of heat pellets. Gaps between the header potting and the top heat pellet and the positioning of the header in the case were other conditions searched for in the x-rays which might signal a stack force problem. The x-rays for Serial No. 4647 (near zero closure force - unacceptable), Serial No. 4411 (reduced closure force - marginal), and for all the standard closure batteries, such as Serial Nos. 4620 and 4621, (standard closure - fully acceptable) were used as comparison standards. Upon screening, no other batteries were found which showed any evidence of this condition.

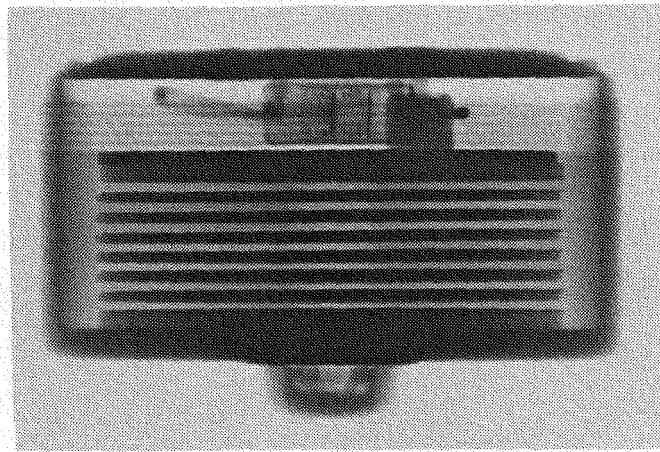
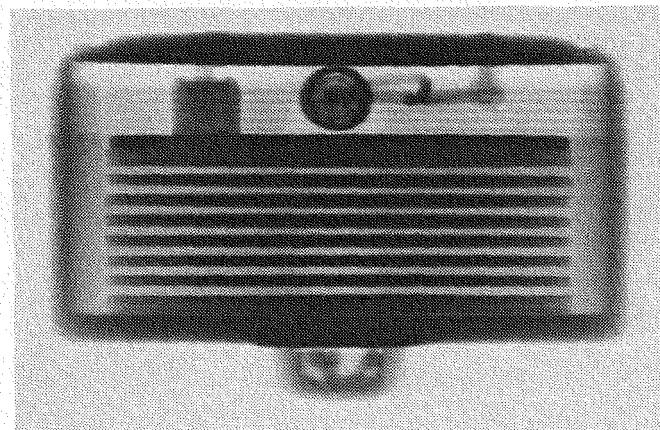
**Figure 3. X-ray of MC2736 Battery, Serial No. 4647, Intentionally Welded Closed Using No Stack Force**

Prior to identifying the probable cause of this failure, Sam Mack (EPI) suggested that the closure force on Serial No. 4422 might have been less than required. Serial No. 4411 was closed with a stack force in the 50- to 100-lb range. (Due to gauge limitations, accurate readings cannot be made at pressures lower than approximately 100 lbs.) This reduced stack force battery was functionally tested and performed normally. To test the validity of this hypothesis as the cause of failure for Serial No. 4422, a MC2736 battery was welded closed with as little stack force as possible (nearly zero). This battery (Serial No. 4647) was measured for overall height in the same manner as the previous three batteries. The average of three measurements was 0.596", similar to the height of the failed unit (Serial No. 4422 - 0.593"). Serial No. 4647 passed the MC2736 functional test requirements, but showed a reduced level of performance similar to the failed unit. Peak voltage was only 9.0 V; detailed test data is given in Table 1. The Visicorder trace for Serial No. 4647 was smooth, with a long life above 5.0 V, similar to the trace observed with Serial No. 4422. A review of the x-rays for Lot 9 revealed that other batteries exhibited faint lines between the upper and lower pairs of heat pellets. Two of these batteries, Serial Nos. 4620 and 4621, which appeared to have the darkest lines, easily passed functional testing. This test data is also shown in Table 1. X-rays of Serial Nos. 4647 and 4620 are shown in Figures 3 and 4, respectively.

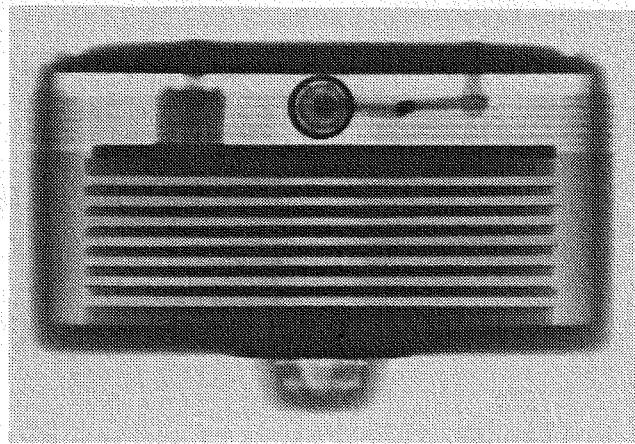
**Figure 4. X-ray of MC2736 Battery, Serial No. 4620, Exhibiting Faint Lines Between Heat Pellets**

As a continuing part of this investigation, Eagle-Picher has repeated the failure in one of three MC2736 tests. A review of the production x-rays produced two units with what appeared to be extra wide spacing between the cells. S/Ns 4620 and 4621 were tested at -25°C. Both units functioned satisfactorily. A third unit, S/N 4627, was assembled with "zero" stack force and tested at -25°C. The peak voltage was only 9.0 v and the rise time was 200 ms to 5.0 v. The battery met the peak voltage requirement of 8.2 v and the activated life; however, the peak voltage is approximately 2.0 v lower than average for the lot. The activated life was also greater than 1.0 seconds, which was identical to the failed unit. The typical life above 5.0 v is only 90 ms. The slow rise, low voltage, and what for this battery is an abnormally long life, confirms that low or "zero" stack force caused the failure.

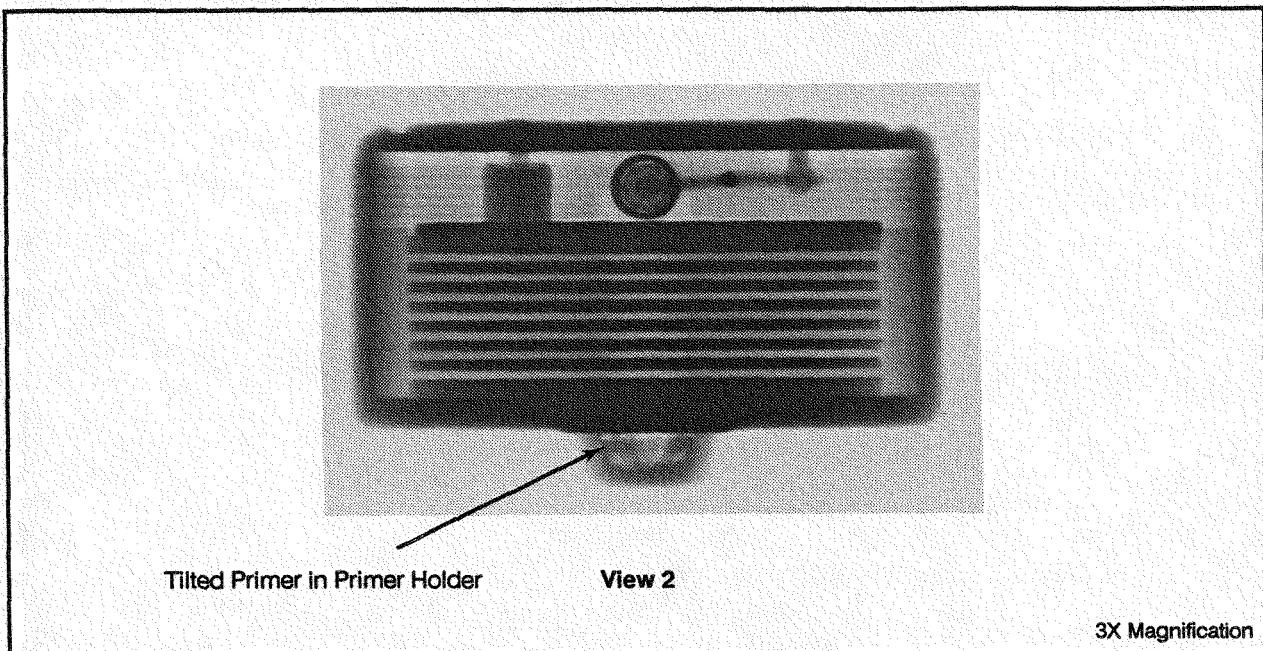
Figure 5. X-ray of MC2736 Battery, Serial No. 4590, Showing Tilted Primer

The postmortem for this failure was conducted at EPI. [Further information on the postmortem is given in a SNL memorandum dated August 16, 1990 (see Appendix B)]. First, the failed unit was visually examined. It was noted that the primer had been struck by the firing pin, and this produced a dent that appeared normal but slightly off center. Other daily lot samples were found which had primers with dents that were off center, so this did not appear to be an unusual occurrence. Review of the x-ray for this battery showed the primer to be slightly tilted within the primer holder (see Figure 5); other battery x-rays showed the same condition. Plans were made to screen some of the primers before their insertion into the primer holders to determine if the primer case had been cut squarely.

Continuing this investigation, Serial No. 4590 was cut open and examined. The heat pellets were unlit, the cells unreacted, and the primer did not fire. The primer was examined under magnification. Other than a small drop of red lacquer on one side of the inside of the case, no other imperfections or abnormalities were noted. In comparison, primers awaiting insertion into battery cases were also visually examined. The anvil appeared to be off center or tilted in one-third to one-half of the more than 120 primers that were reviewed.

4. X-rays taken of the failed battery after removal from the adapter showed that the primer was slightly cocked in the primer pocket. The primer anvil was bottomed in the pocket. The primers are screened to a height of .114/.116 inches at Mound. The primer pocket is .109/.111 deep. The primer insertion tooling is designed so that the primer is inserted into the pocket flush with the top giving .002 to .006 inches of reconsolidation of the anvil into the primer pyrotechnic. The firing pin impact distorts the primer case making it difficult to determine if the primer was inserted flush to the top. There was nothing to indicate that the primer was not flush or that the reconsolidation was not satisfactory.
