**EG&G**  
**ENERGY MEASUREMENTS**  
**KIRTLAND OPERATIONS**

**REGIONAL SEISMIC TEST NETWORK (RSTN)  
OPERATIONS FINAL REPORT**

**AUGUST 1989**

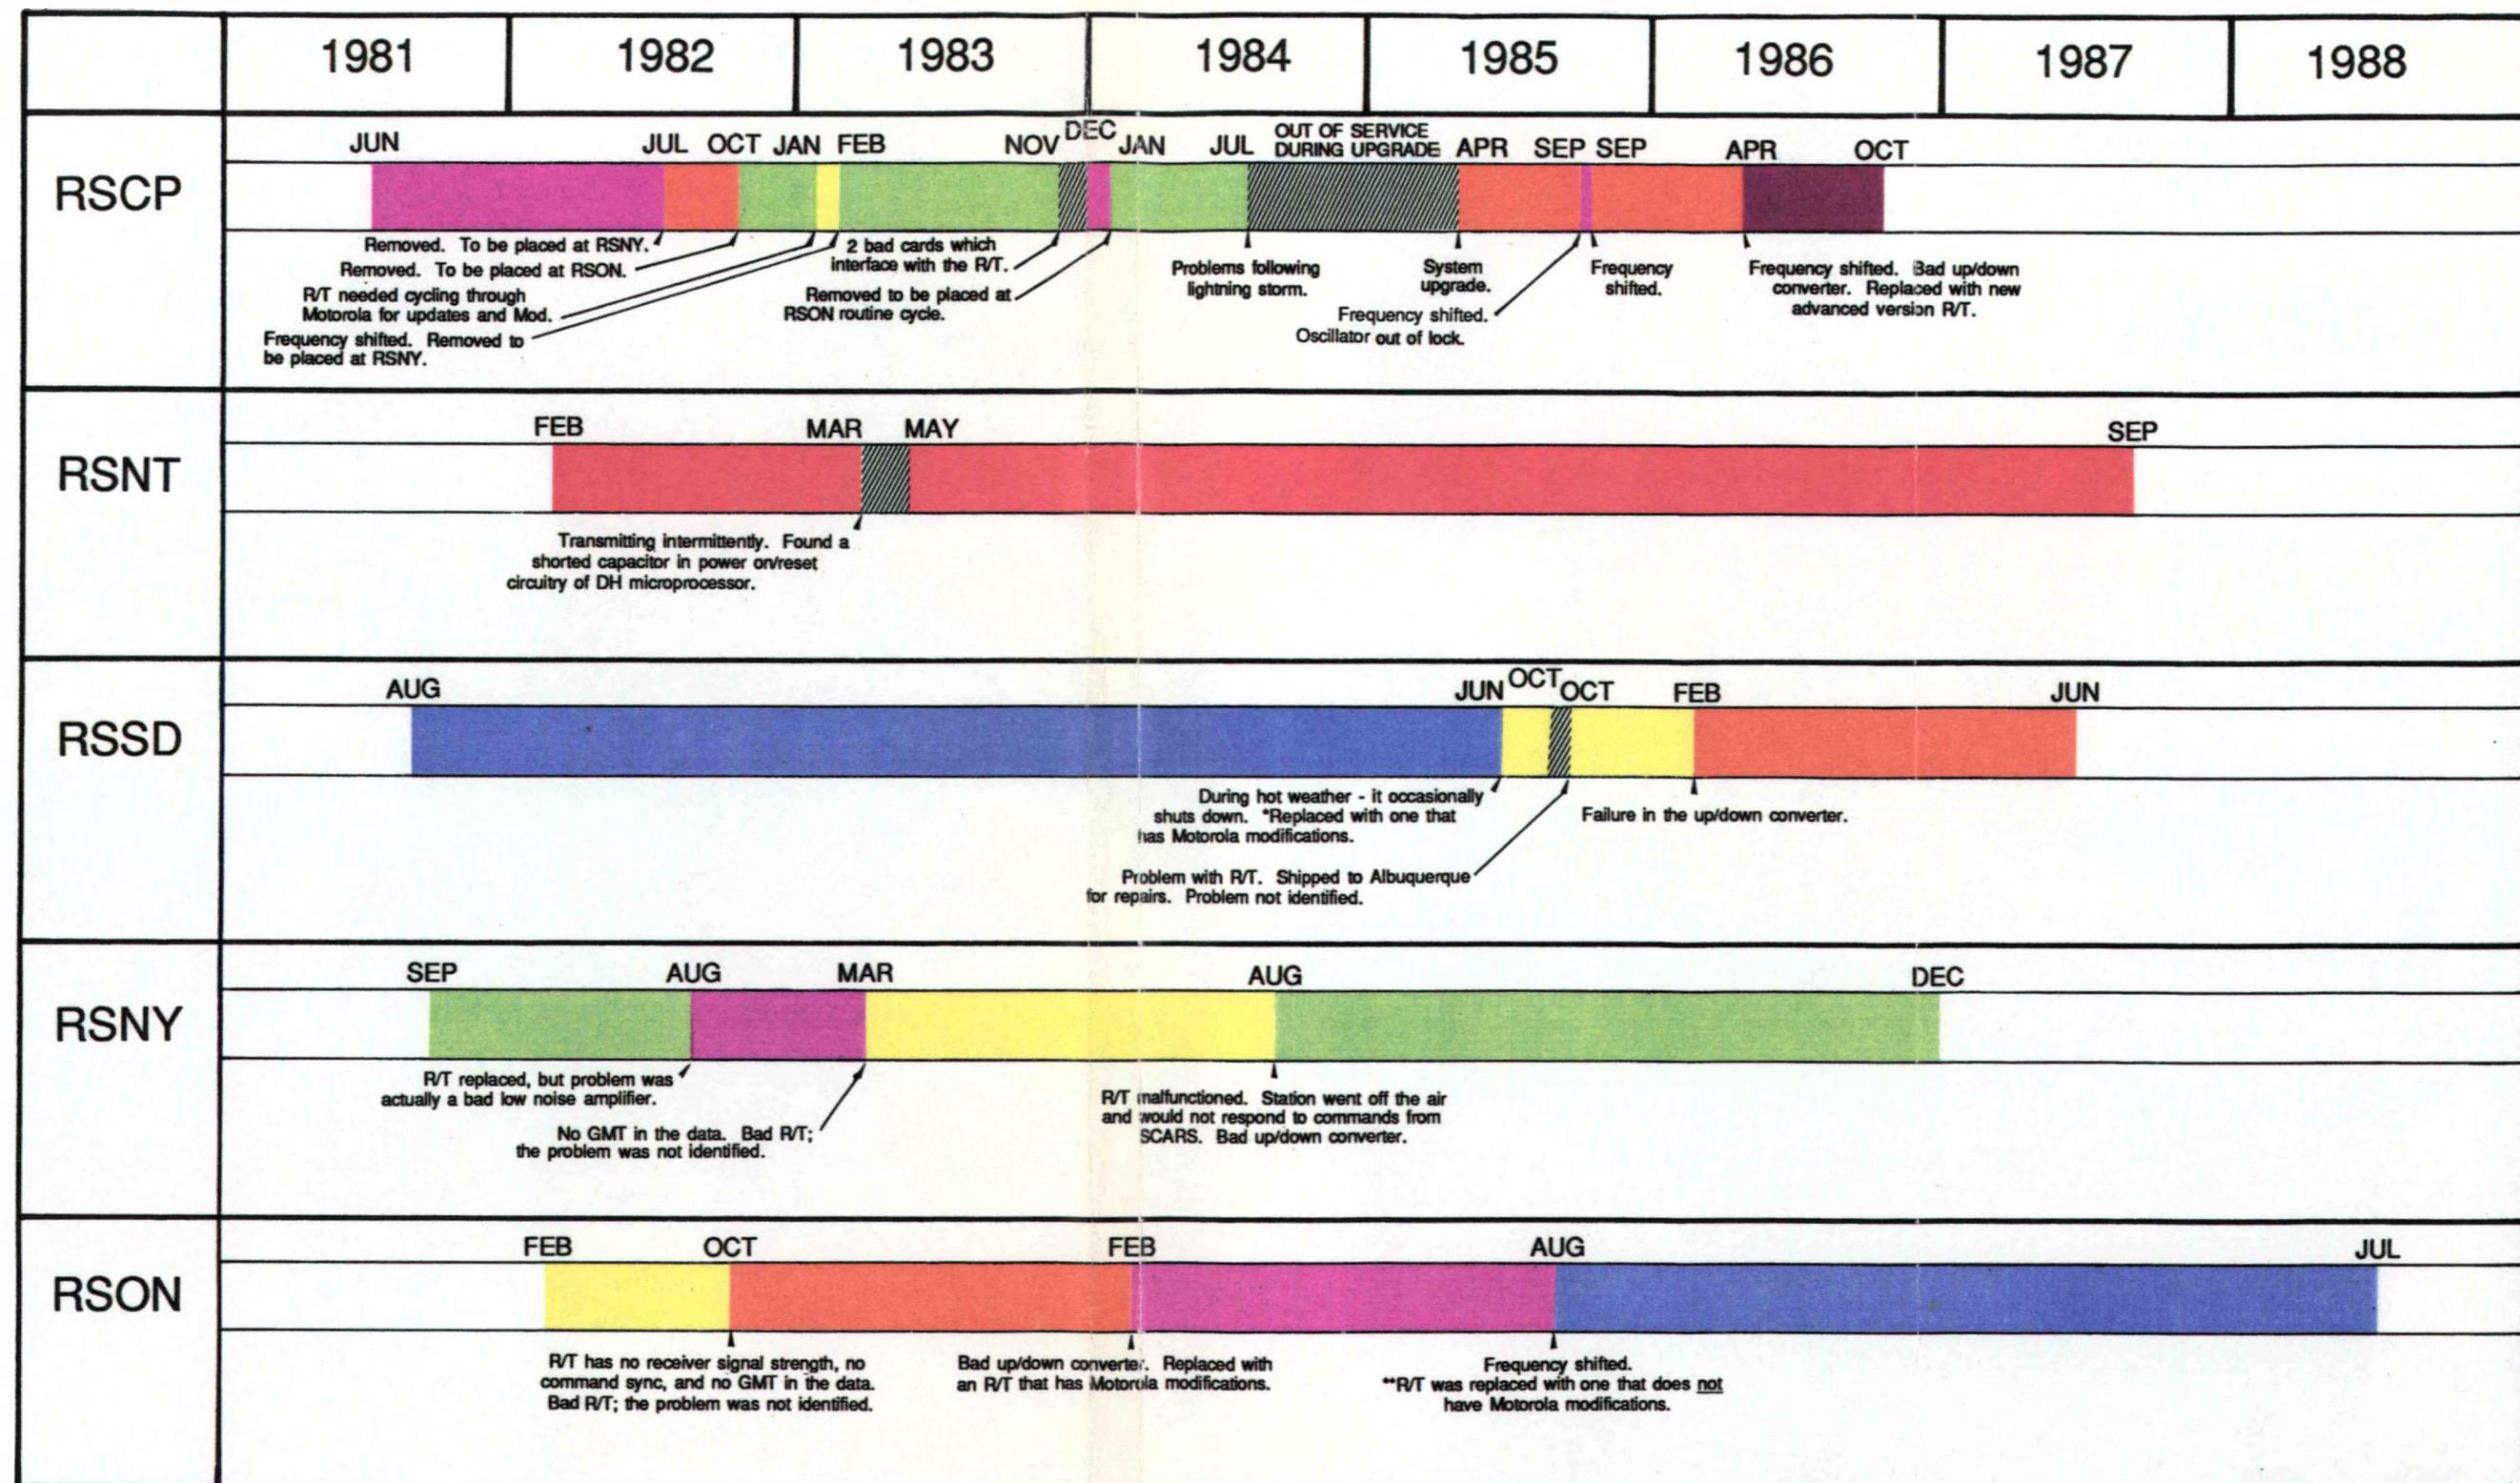
Figure 2. Problems involving Receiver/Transmitter (R/T) units.

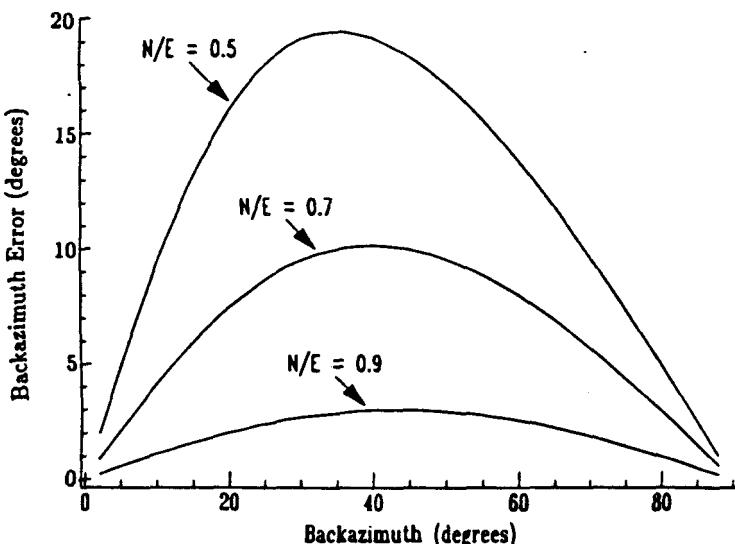
FIG. 2. Error in backazimuth estimation as a function of true backazimuth for uncorrected mismatches in amplitude response for the horizontal components.  $N/E$  values are ratios of the actual amplitude response values for the horizontal components.

backazimuth error as a function of backazimuth for various mismatches in horizontal component responses. For the case of data recorded on the RSON KS36000 seismometer, if an event is actually at a backazimuth of 40°, a backazimuth estimate using uncorrected data would be in error by as much as 20°.
