Analysis of Ultrasonic Inspection Data for Pilgrim 1 Reactor Nozzle N-2B

ANALYSIS OF ULTRASONIC INSPECTION DATA FOR
PILGRIM 1 REACTOR NOZZLE N-2B

The ultrasonic examination data relative to the discontinuity located in the Pilgrim I Reactor Vessel Nozzle N-2B weld was reviewed. The data was obtained during the 1976 in-service inspection. The results of the review of several examinations are tabulated, test conditions discussed, and a conclusion made as to probable flaw size.

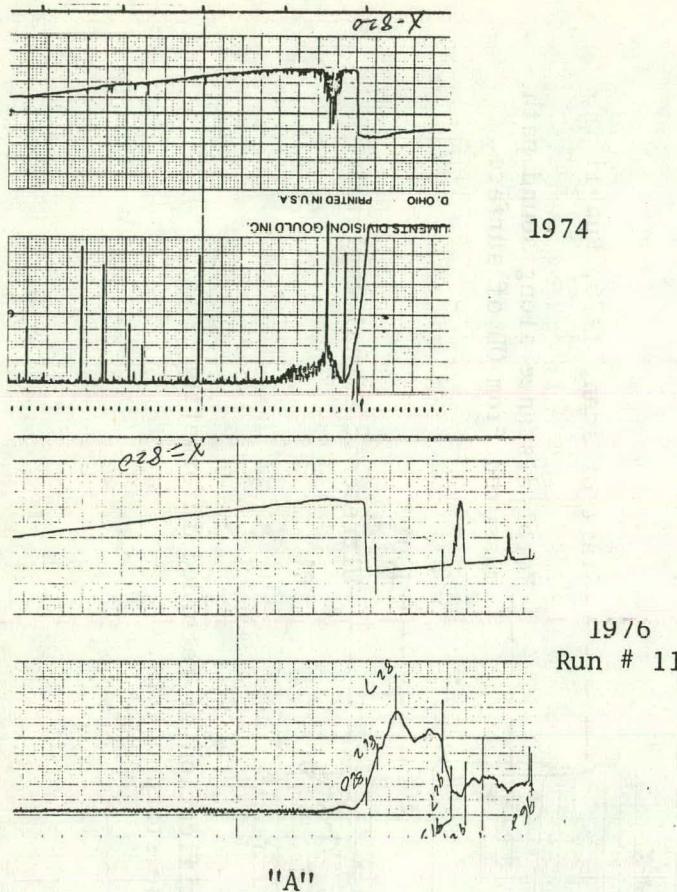
Figure 2. Recording at $X = 820$ counts (281°)

At $X = 820$, the 1974 amplitude shows a saturated signal condition at the start of the scan, and therefore can not be compared in shape to 1976. However, since the 1976 signal is smaller, no flaw growth is indicated signal amplitude. The metal distance is nearly the same in each. The drop in signal amplitude occurs at about the same location indicated by "A".

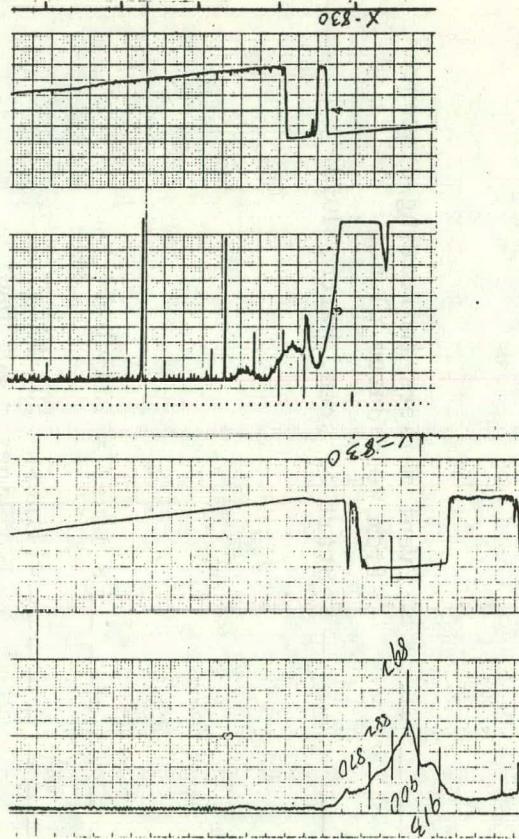
Figure 3. Recording at $X = 830$ counts (285°)

At $X = 830$, the 1974 chart again shows a signal of saturated amplitude which can not be compared to 1976. The drop in amplitude does not occur at the same time in the two scans. Correlation is poor.

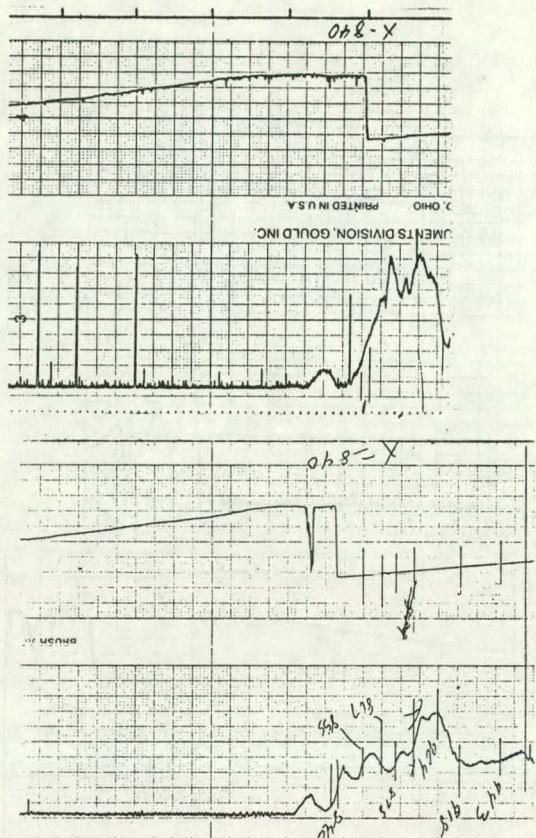
Figure 4. Recording at $X = 840$ (288°)

At $X = 840$, there is a fair correlation between 1974 and 1976. The rise and fall of the high amplitude part of the signal occurs at about the same location and the part of the signals above 50% DAC is of about equal length. The difference in amplitudes is not large.

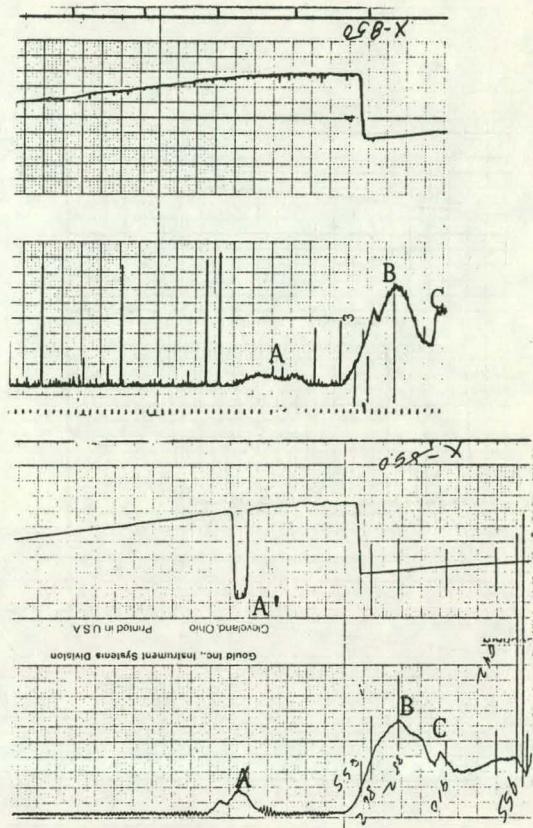
Figure 5. Recording at $X = 850$ (292°)

At $X = 850$ the correlation is very good. The shapes of the amplitude traces are similar with three peaks (A, B, & C) occurring at about the same location. The amplitudes are close to the same. The traces of the metal path length are almost identical with the exception of the excursion at A' where the amplitude of signal A reached an amplitude sufficient to get into the metal distance gate and produce an output signal.

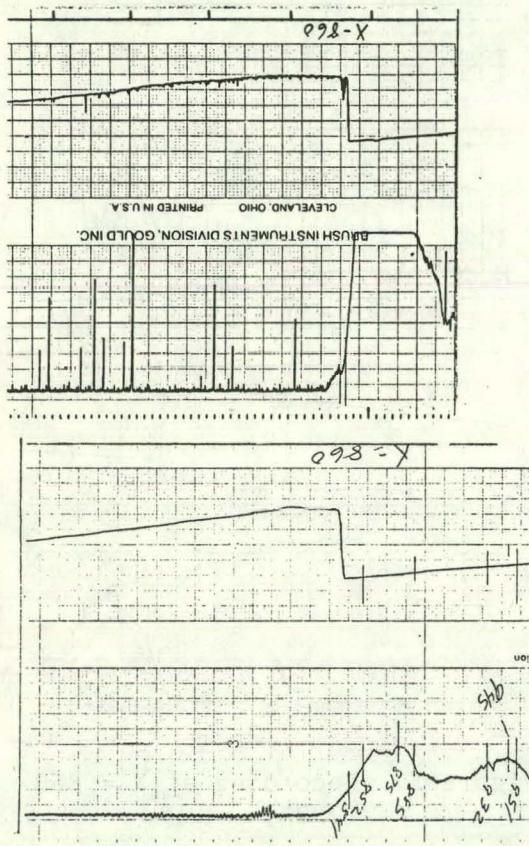
Figure 6. Recording at $X = 860$ (295°)

At $X = 860$ the amplitude in 1974 was much greater than in 1976. The drop in signal, however, occurred at the same point indicating that the outside edge of the flaw has not moved perceptively. This is also shown by the metal distance trace.

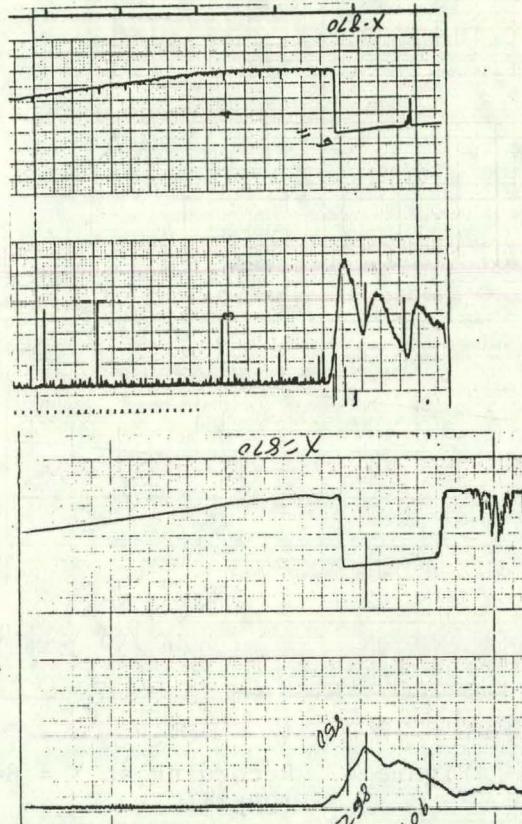
Figure 7. Recording at $X = 870$ (299°)

At $X = 870$ there is fair correlation of shape of the amplitude trace. Although the 1974 inspection produced a higher amplitude, the point at which the signal dropped is about the same.

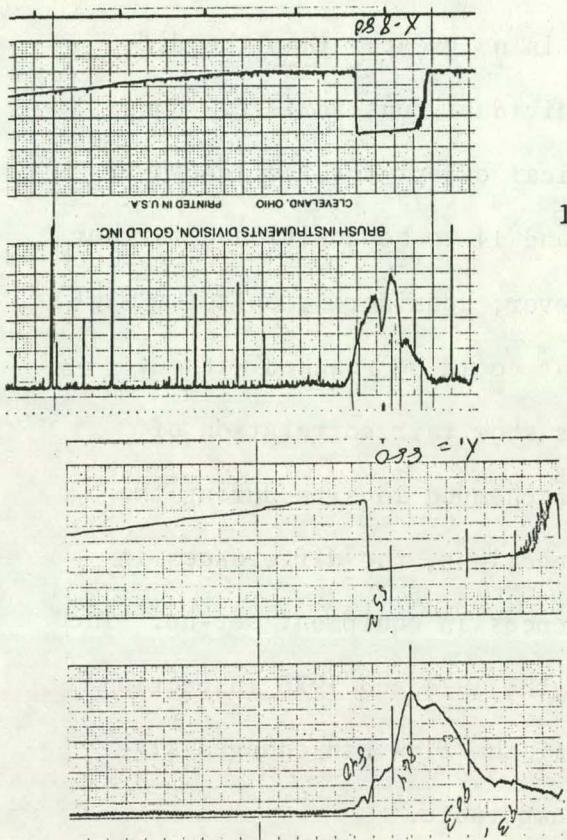
Figure 8. Recording at $X = 880$
(302°)

At $X = 880$, both the shape and amplitude of the signal are similar showing good correlation between 1974 and 1976.

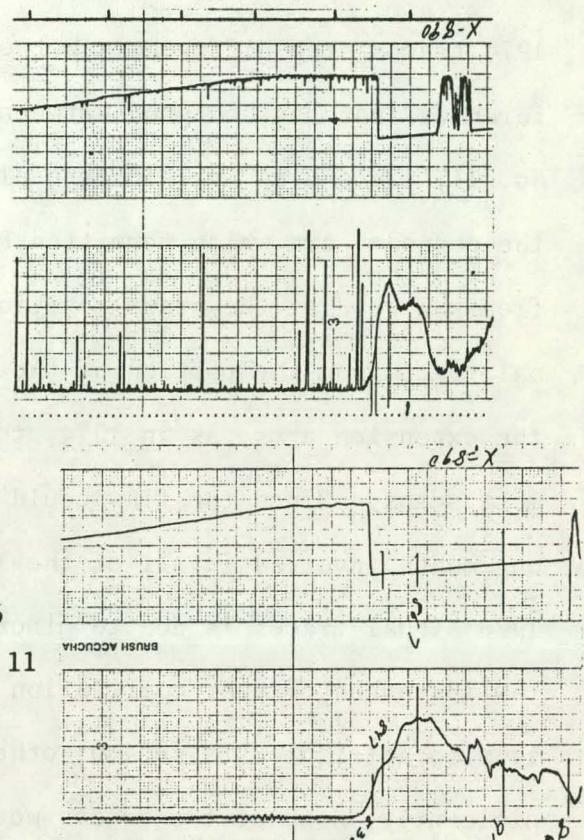
Figure 9. Recording at $X = 890$
(306°)

At $X = 890$, fair correlation exists. The shape of the signal traces compare favorably at the left edge of the peak as the sound beam passes over the top of the flaw

nearest the outside surface of the vessel is recorded. The two traces are oriented so that identifying features in the main part of the flaw are vertically aligned.
