A Chronology of the Beryllium-Replacement Shutdown at the High Flux Isotope Reactor

A CHRONOLOGY OF THE BERYLLIUM-REPLACEMENT SHUTDOWN
AT THE HIGH FLUX ISOTOPE REACTOR

W. H. Culbert

Date Published: December 1976

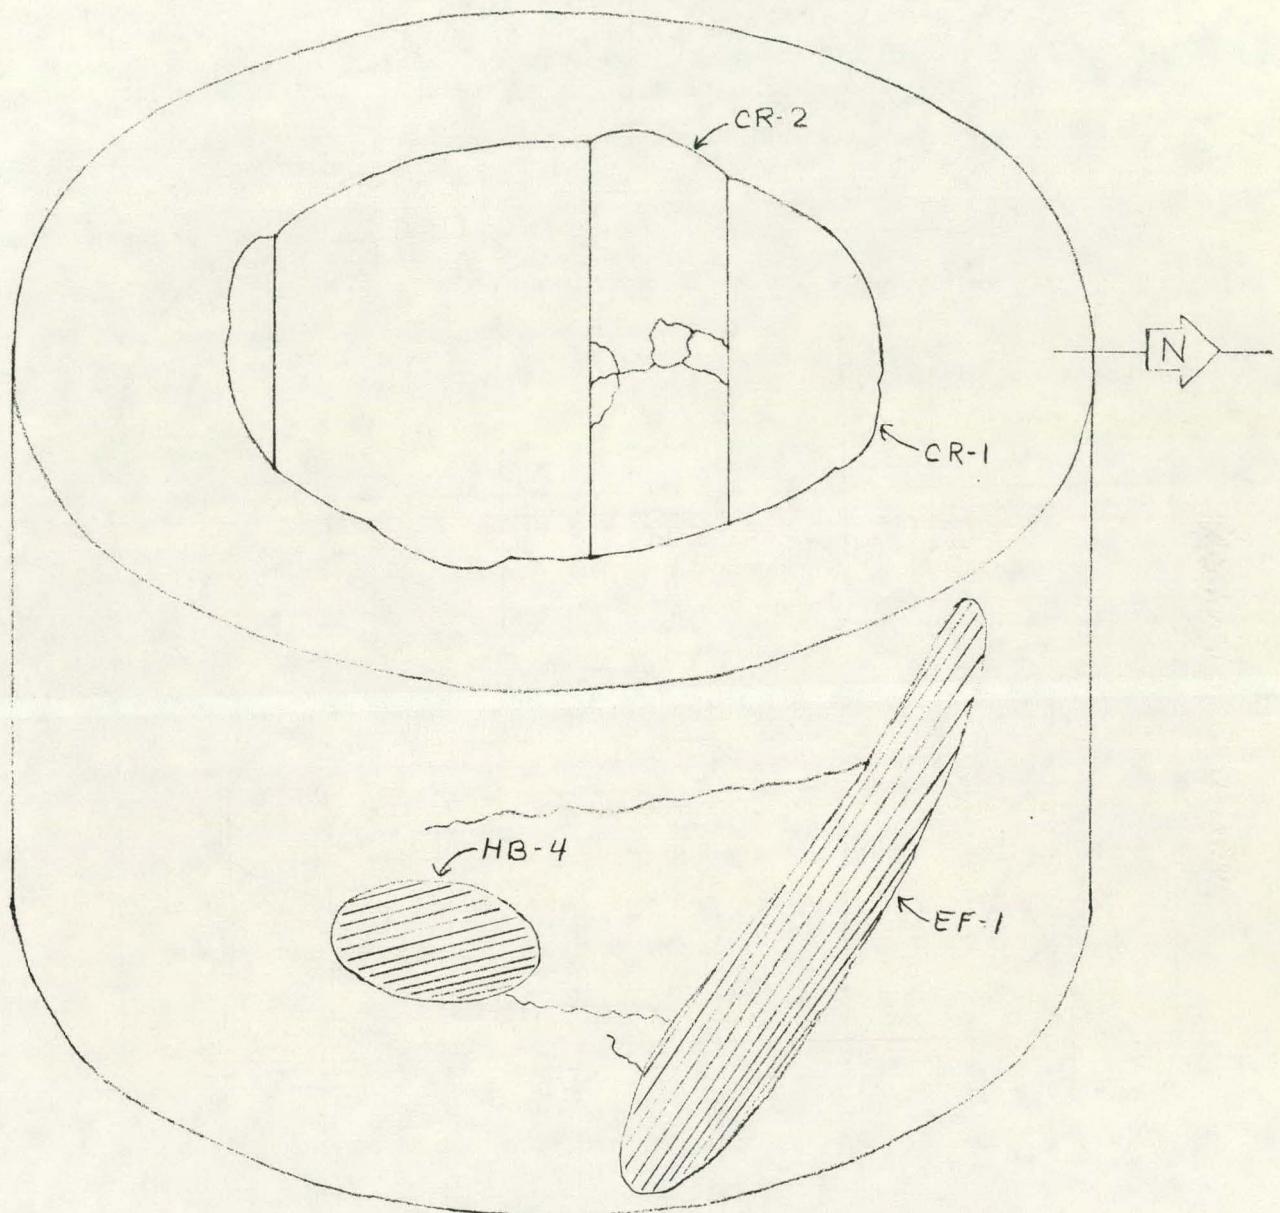
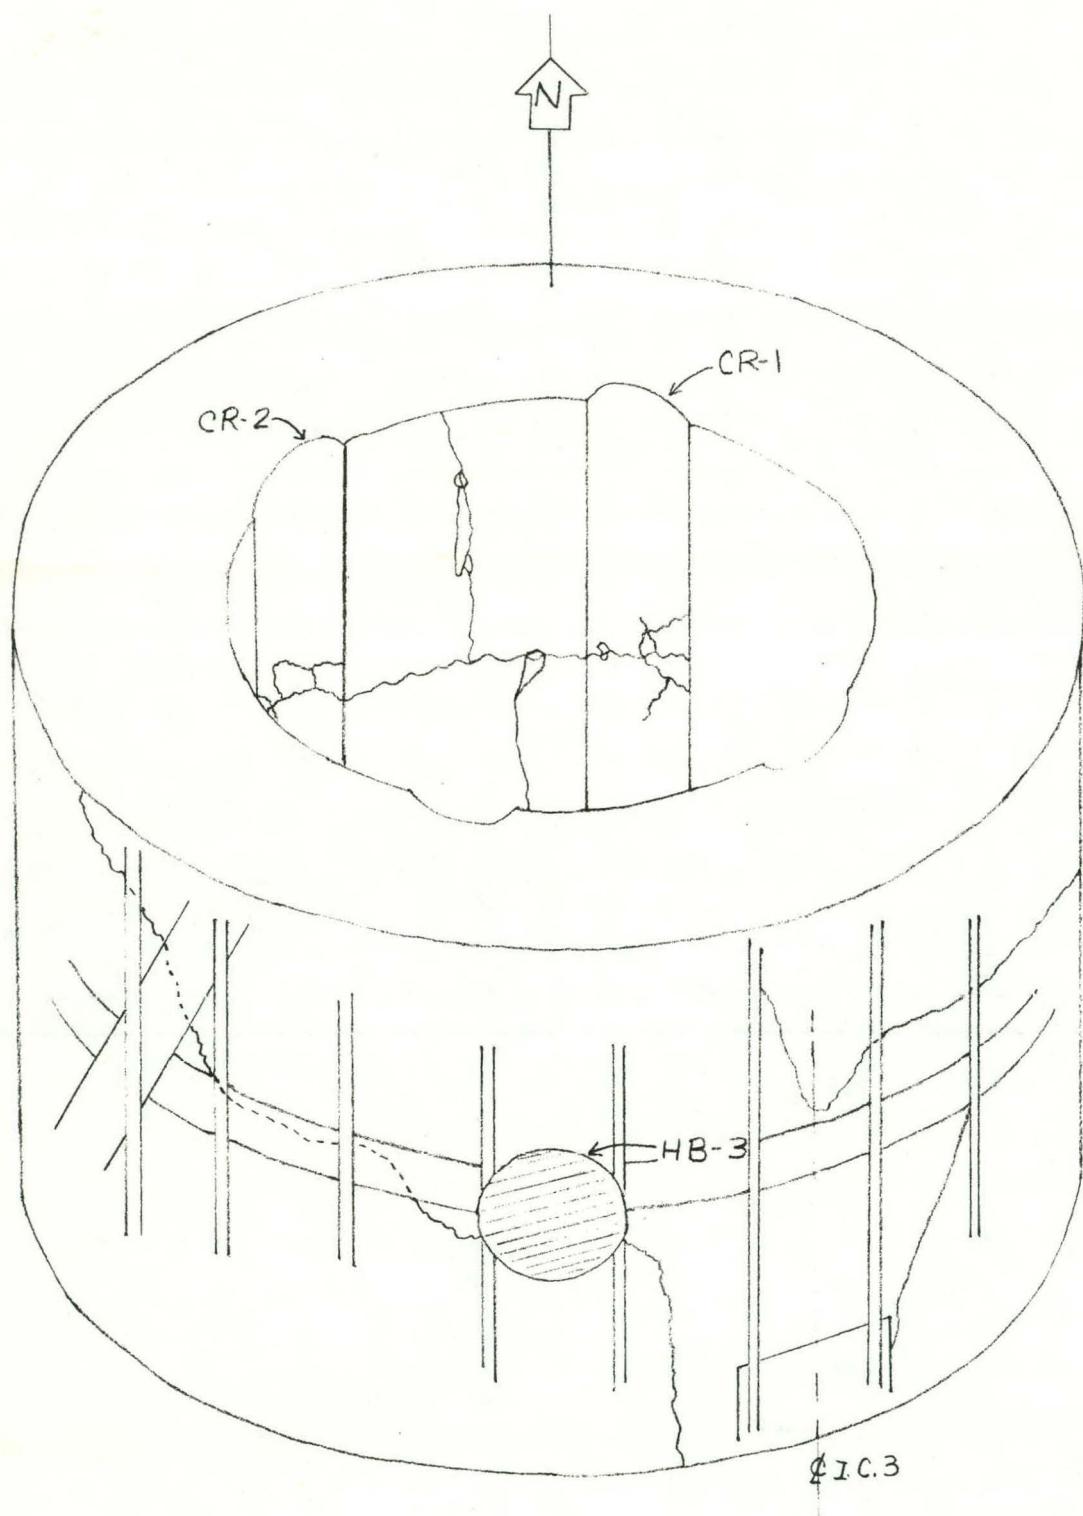
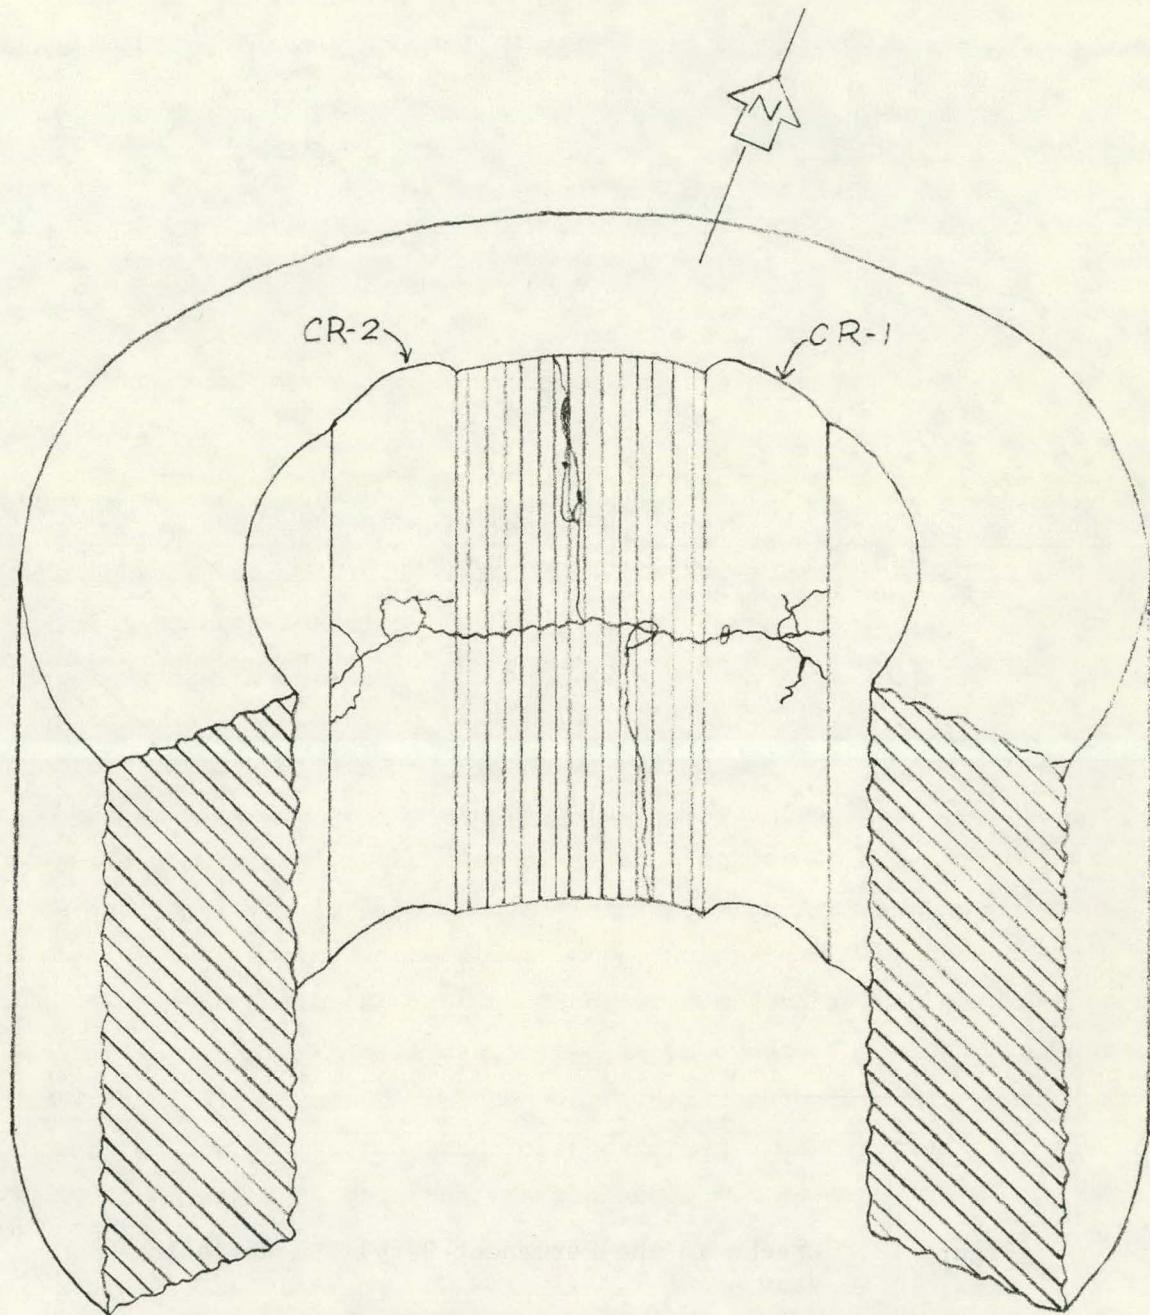
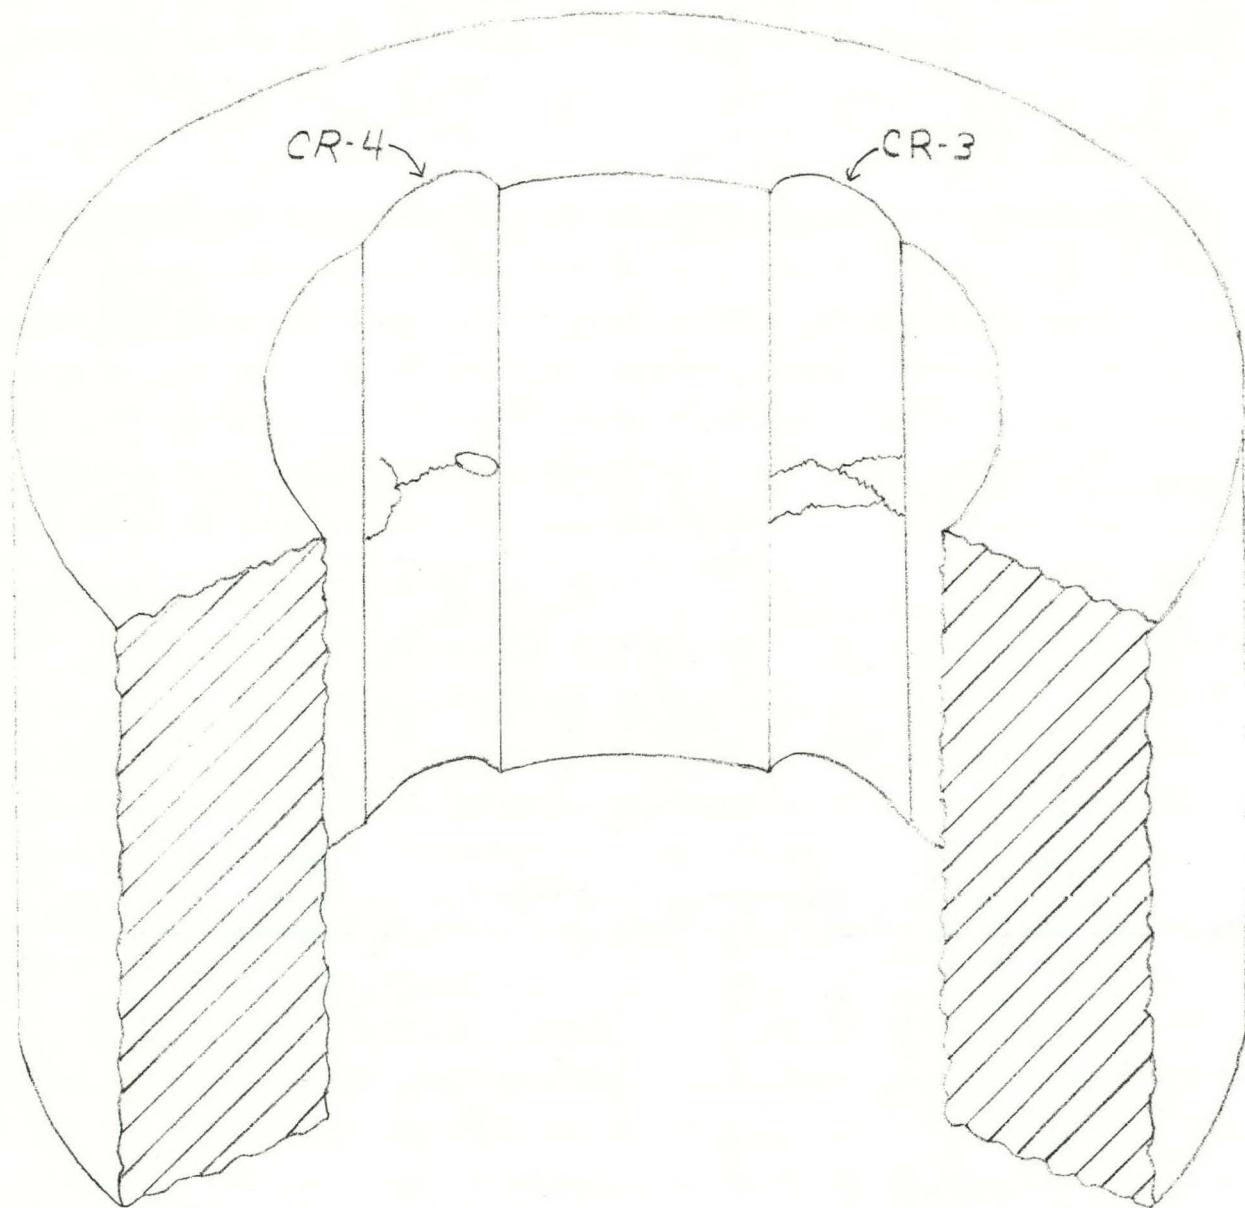
During a routine inspection of the components in the reactor vessel in February of 1974, a few cracks were discovered in the permanent beryllium reflector. This component is the outermost of three reflector rings which surround the HFIR fuel element. The damage, attributed to the internal stresses caused by the buildup of helium in the crystalline structure of the beryllium metal, was not unique; however, the permanent beryllium was designed for a nominal life time of ten years. At the time the cracks were discovered, the reactor had been in service for 7.1 years with an accumulated energy of 235×10^3 MWD and with annual operating times of between 90% and 94%.

result of the cracked beryllium reflector. In addition, more frequent visual inspections of the permanent beryllium were initiated to monitor the propagation of the cracks. Before the replacement shutdown was begun, the cracking had become worse. (See Figures 10 through 13.)

Figure 10. Cracks in the Permanent Beryllium Reflector
View 1

Figure 11. Cracks in the Permanent Beryllium Reflector
View 2

Figure 12. Cracks in the Permanent Beryllium Reflector
View 3

Figure 13. Cracks in the Permanent Beryllium Reflector
View 4

In view of the difficulty of assessing the damage and the desire to avoid major cracking, it was decided to replace the permanent beryllium. Since there was no immediate problem relative to the safe operation of the reactor, the HFIR was operated at the design power level of 100 MW while preparations were being made for the beryllium replacement.

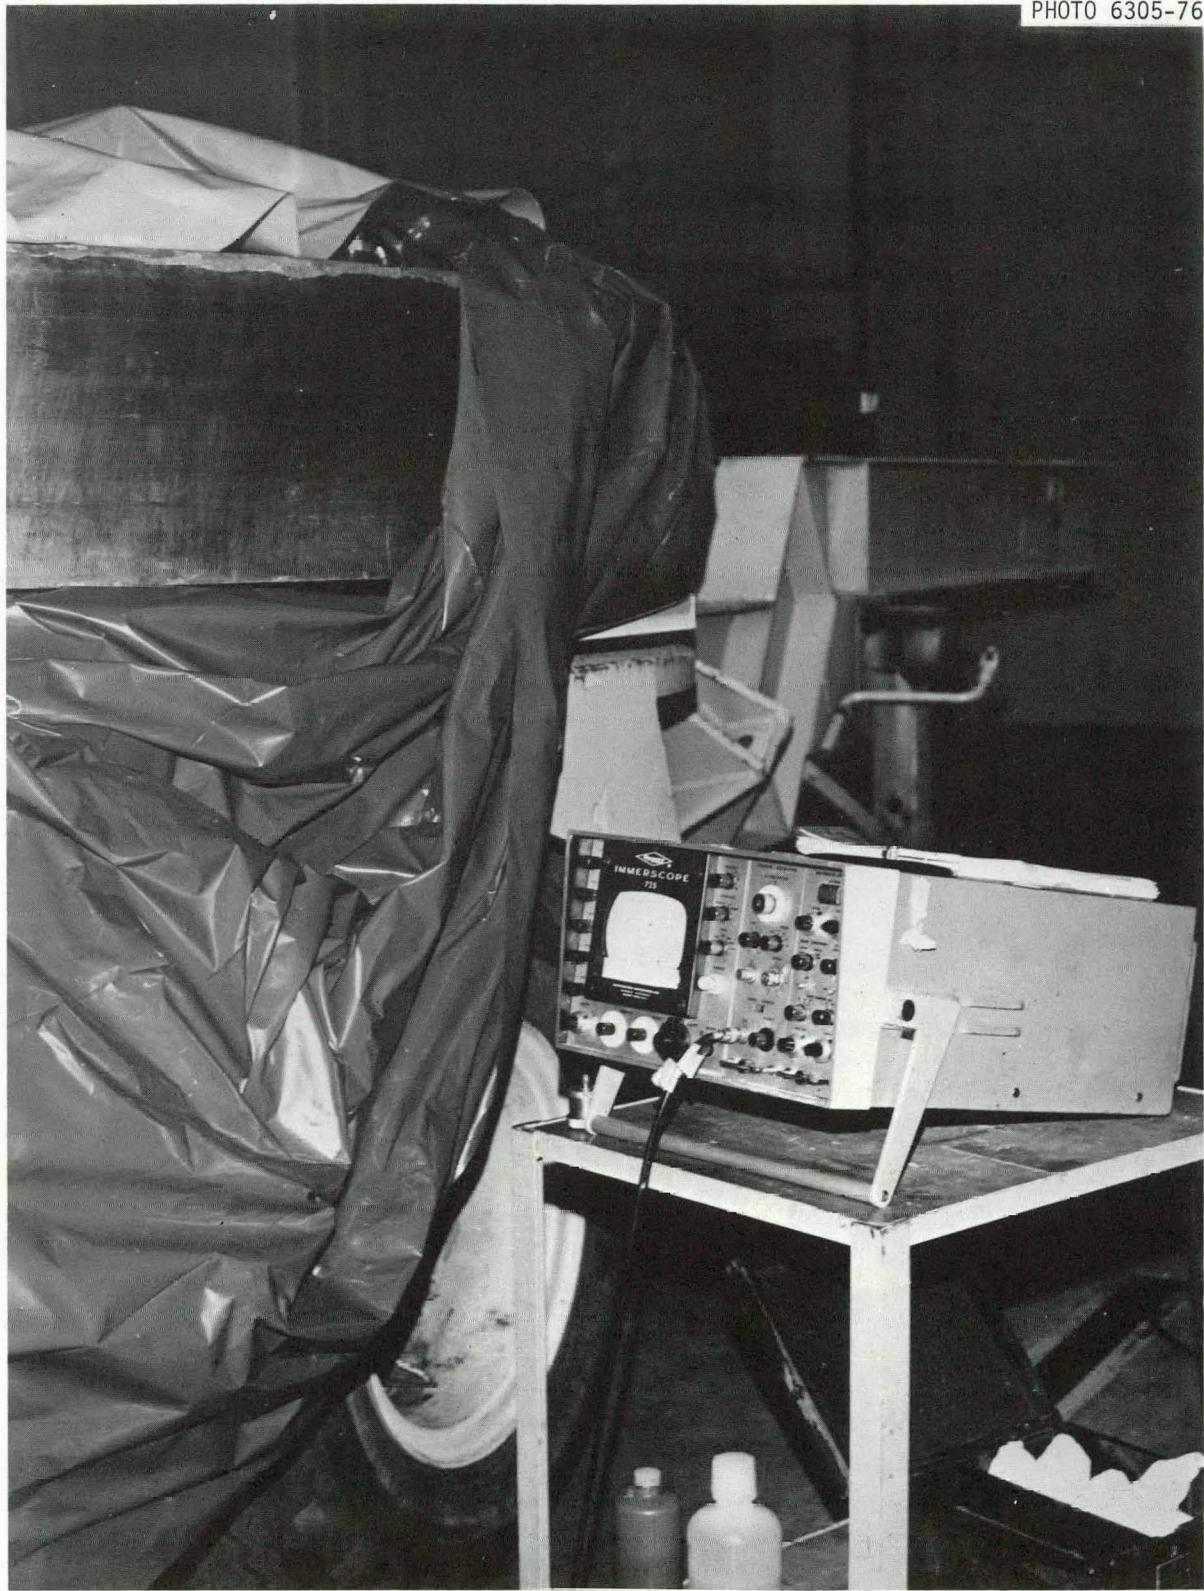
The vessel head was transferred to the storage truck. Prior to removal from the reactor bay, the vessel head was subjected to an ultrasonic test to determine if any cracks had developed. (See Figure 17.) No abnormalities were detected.

Figure 17. The Ultrasonic Testing of the Reactor Vessel Head After It Was Placed on the Truck for Storage

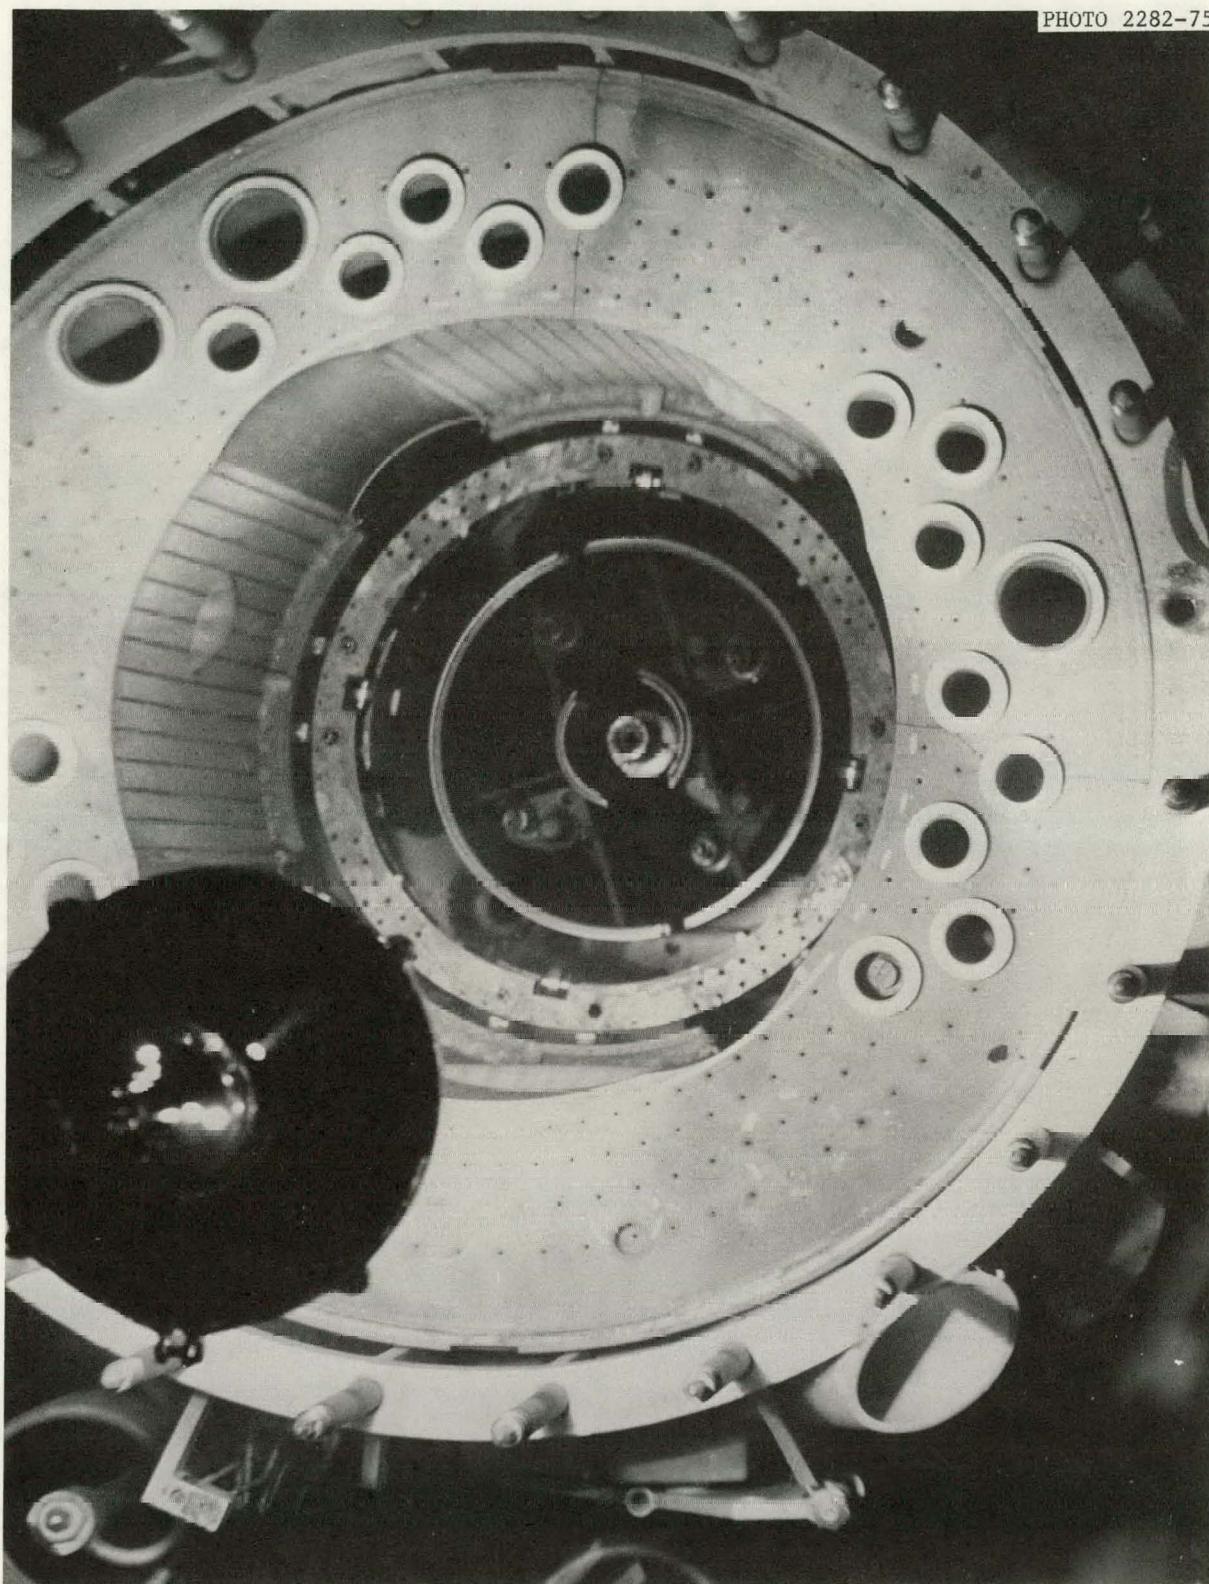
After the outer shroud was removed, the top surface of the permanent beryllium was exposed and could be inspected. Four cracks on the top side were visible; two extended from the outer periphery of the beryllium to the inside surface and two extended from the periphery to two of the experiment holes. (See Figure 24.)

Figure 24. The Permanent Beryllium Reflector Showing the Cracks in the Surface (Underwater Photograph)

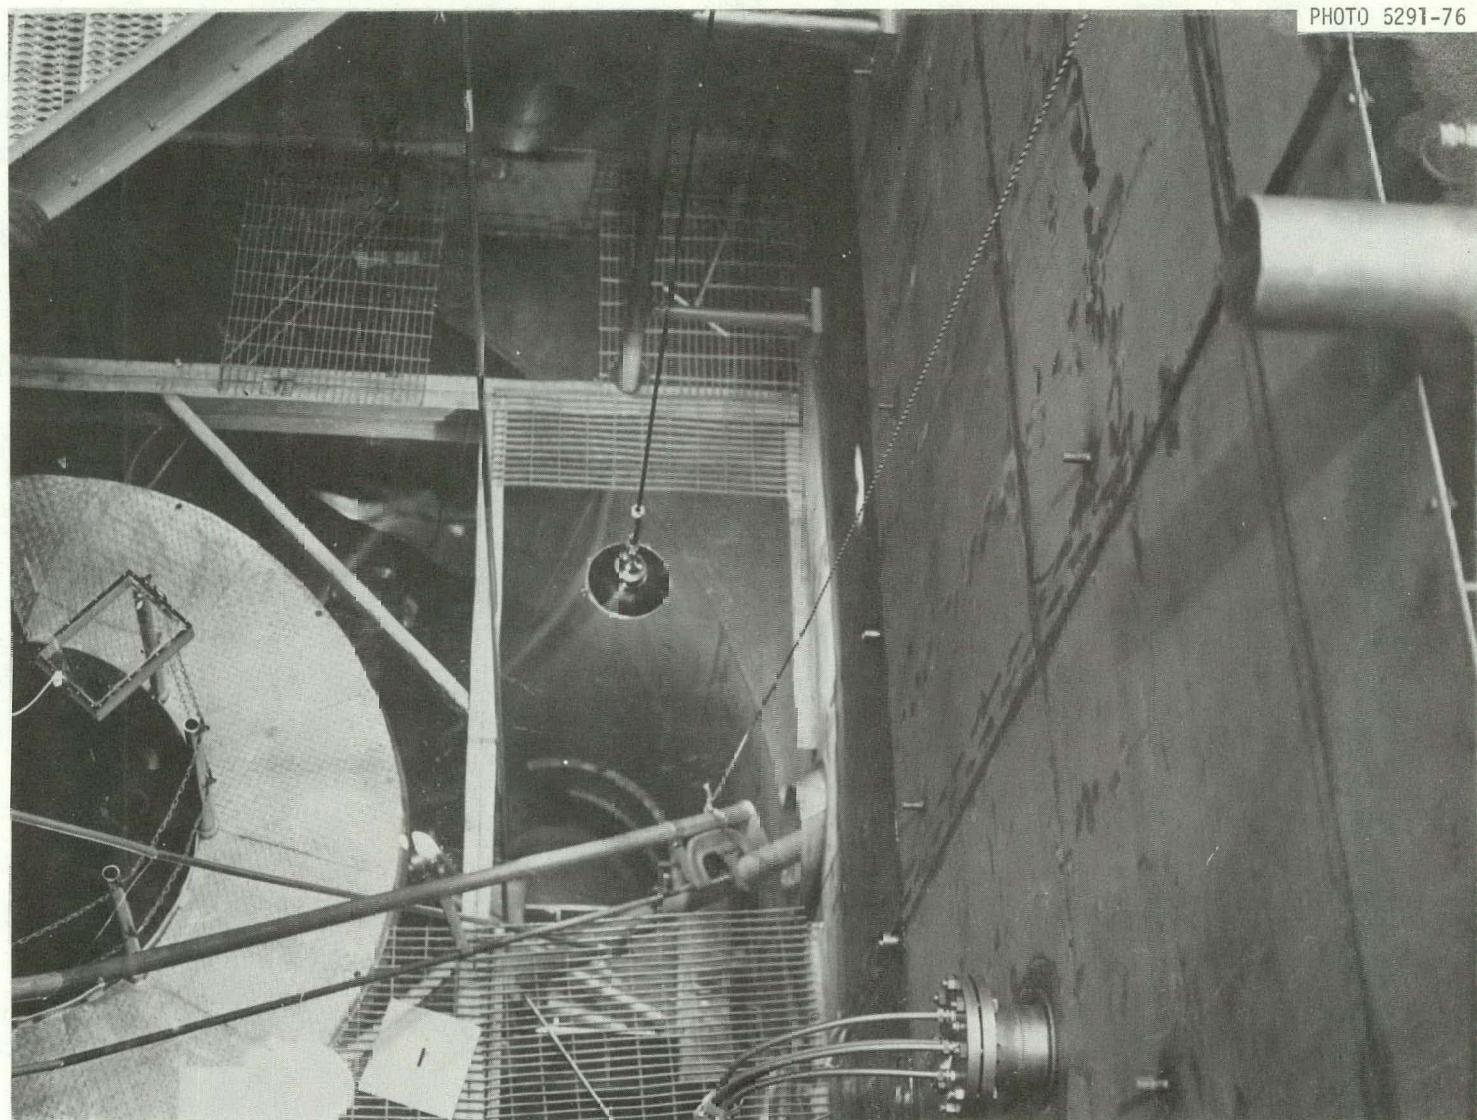
Some difficulty was encountered with cutting the water-guide sleeve, and considerable difficulty was encountered with cutting the fluted tube. Broken cutting wheels were replaced on several occasions. (See Figure 35.) A different type of cutting wheel was installed, and the beam-tube-cutting tool was tried (the beam-tube-cutting tool was straight while the EF cutting tool was offset by 41°). Eventually, a hacksaw was used to complete the cuts.

Figure 35. The EF-2 Water-Guide Sleeve Being Cut into Sections in the Reactor Pool
(Underwater Photograph)

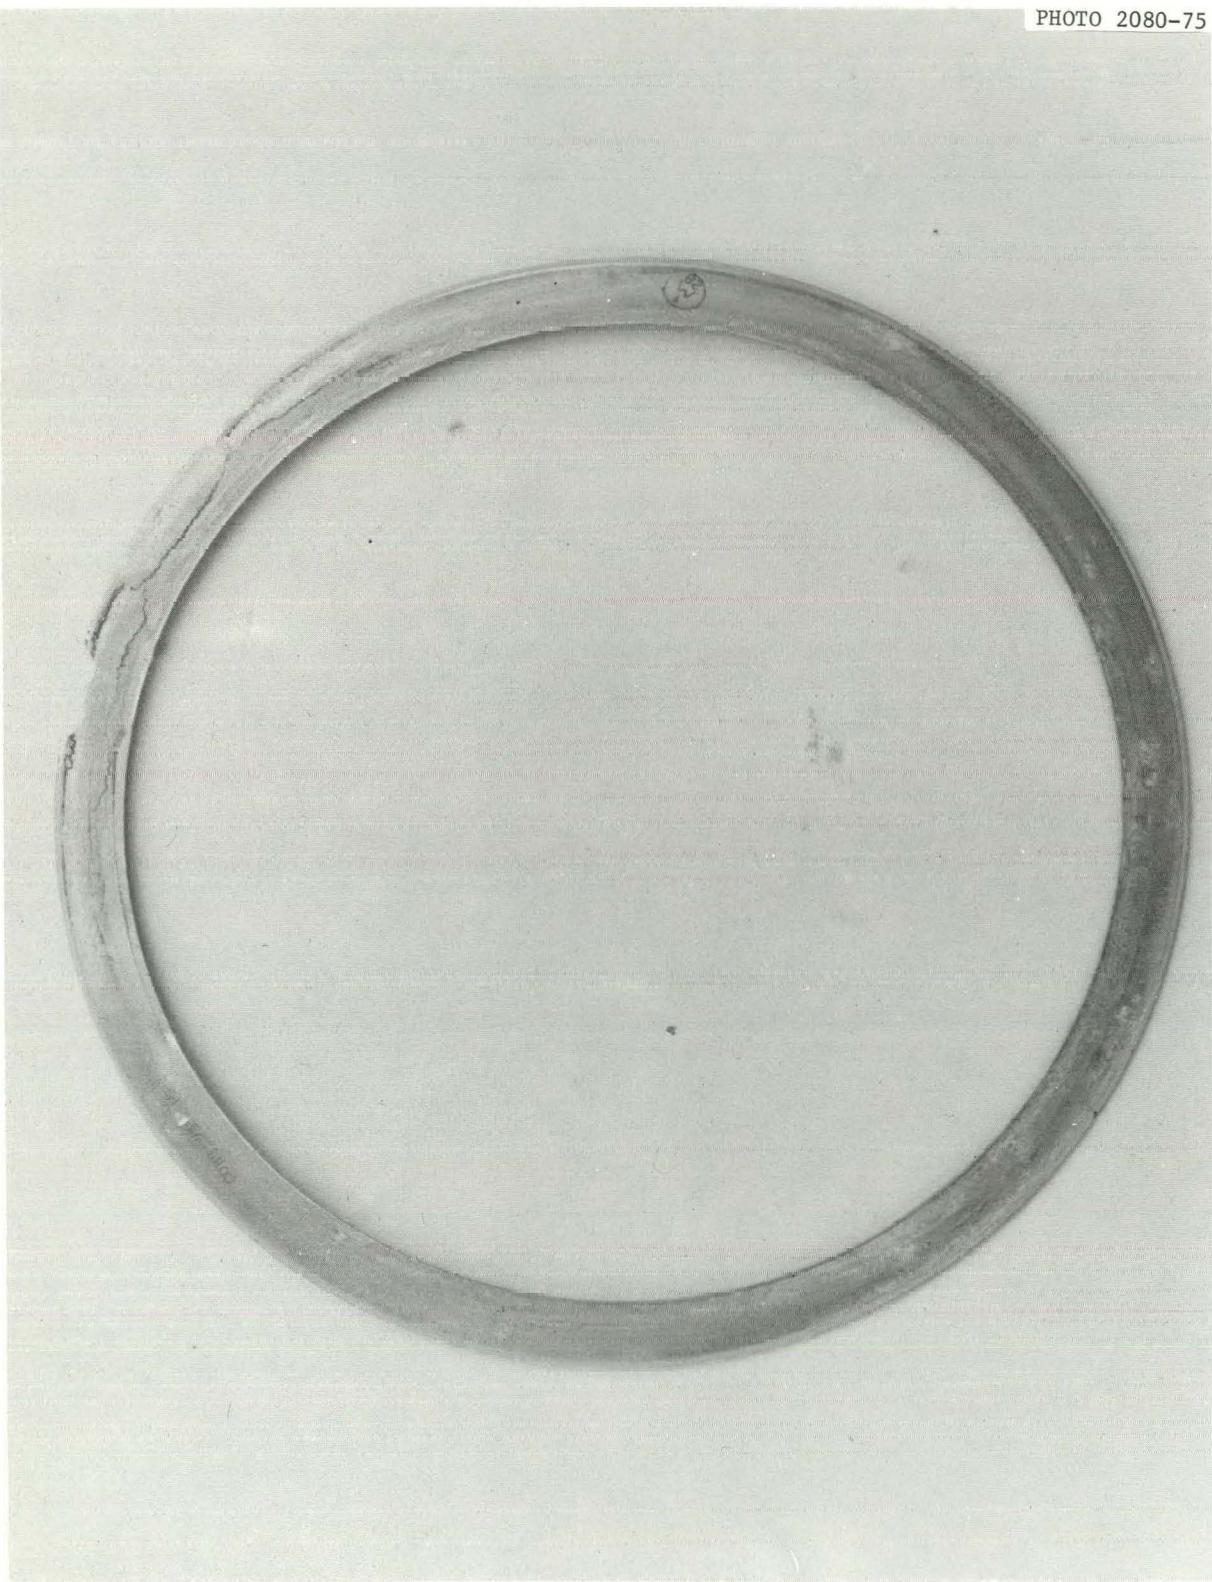
Using the underwater periscope, the cut section of the HB-1 facility tube containing the adaptor flange was examined to help determine the cause of the in-pool leak which had existed for the past five years. A groove in the adaptor flange, about 1/8 in. in diameter, was detected. Impressions were made of the eroded surfaces using Apeizon and then plaster of paris. The HB-1 Conoseal gasket was found to have two places where pieces of the seal were missing; these places were believed to coincide with eroded places on the adaptor flange. (See Figure 41.) The surfaces of the HB-3 and HB-4 adaptor flanges on the vessel were examined also and were found to be satisfactory. Blank flanges were installed in the adaptor flanges of the disassembled beam tubes to ensure that their sealing surfaces did not become marred during the remainder of the shutdown.

Figure 41. The Damaged Conoseal Gasket Removed from the HB-1 Adaptor Flange

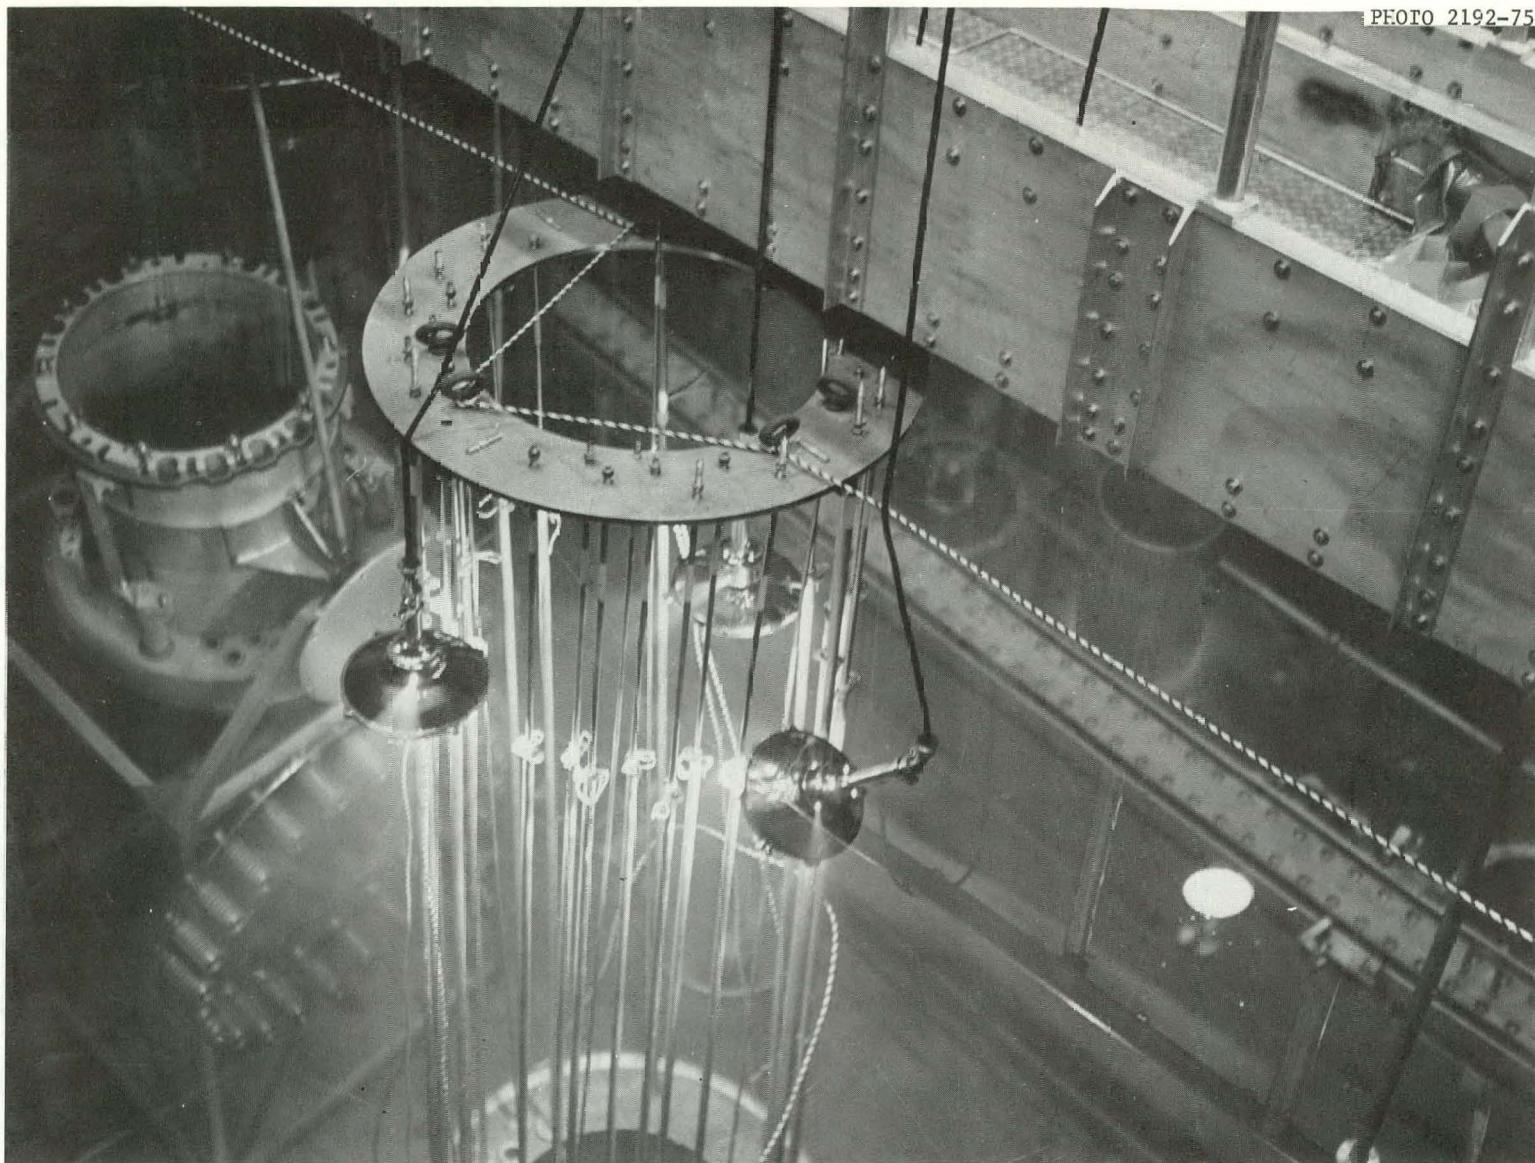
An inspection of the beryllium at this time, prior to removal from the reactor vessel, revealed that the bottom corners were sharp and clean and that the inside surface was intact. One small piece of debris (about a 1-in.-diameter section) was observed to be atop the pedestal after the beryllium was raised; no other fragmentation of the beryllium was noted. The debris was not confirmed to be beryllium and was not retrieved at this time. After the beryllium was removed from the vessel, it was placed in the east storage pool. (See Figure 45.)

Figure 45. The Damaged Beryllium and Lifting Rig after Transfer to the East Storage Pool (Underwater Photocgraph)
(The outer shroud and the Belleville spring may be seen in the storage rack to the left)
