**GEOTHERMAL SYSTEMS MATERIALS:
A WORKSHOP/SYMPORIUM**

Proceedings, May 23-25, 1978

CORROSION PROBLEMS IN KLAMATH FALLS, OREGON

Gene Culver

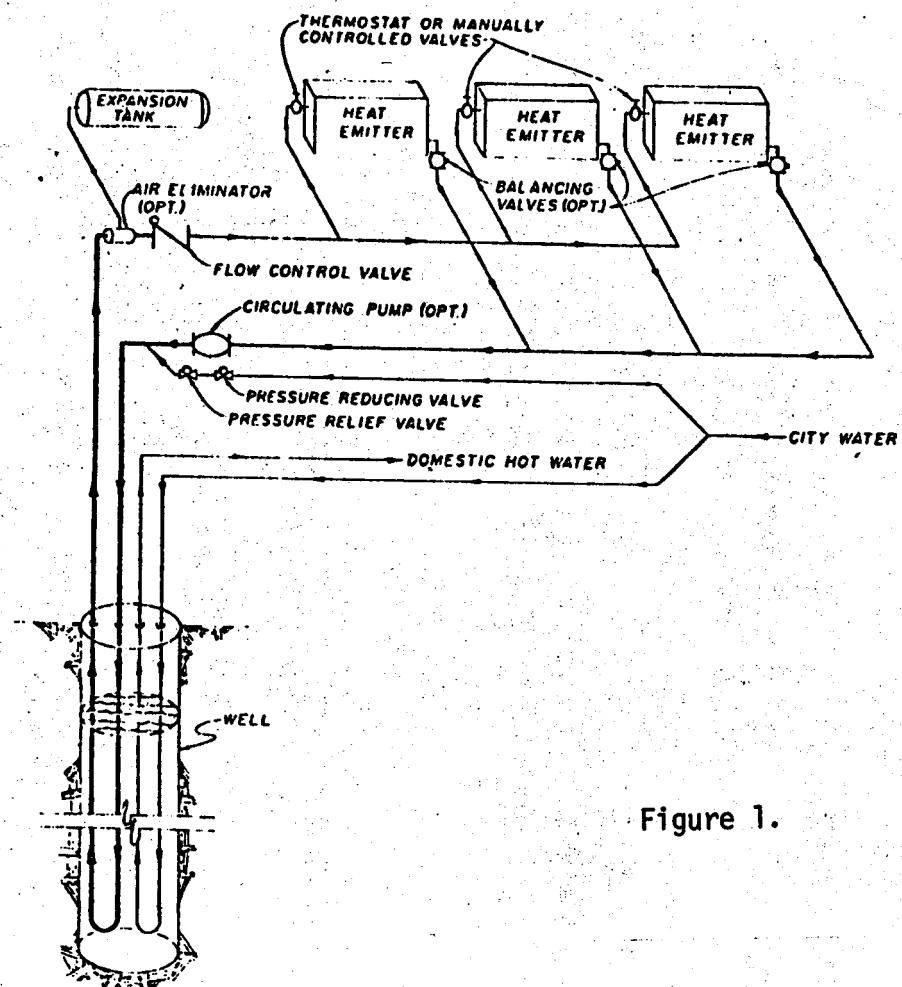
Figure 1.

There are approximately 450 geothermal wells in Klamath Falls, used primarily for space heating of 500-550 homes. Most of the home heating wells have downhole heat exchangers installed, (Figure 1) the first one being installed in about 1930.
