# Application of TIVA in Design Debug

Siva Kolachina, Bill Taylor, Kendall Scott Wills  
Texas Instruments Inc., Stafford

Edward I. Cole Jr.,  
Sandia National Laboratories, Albuquerque

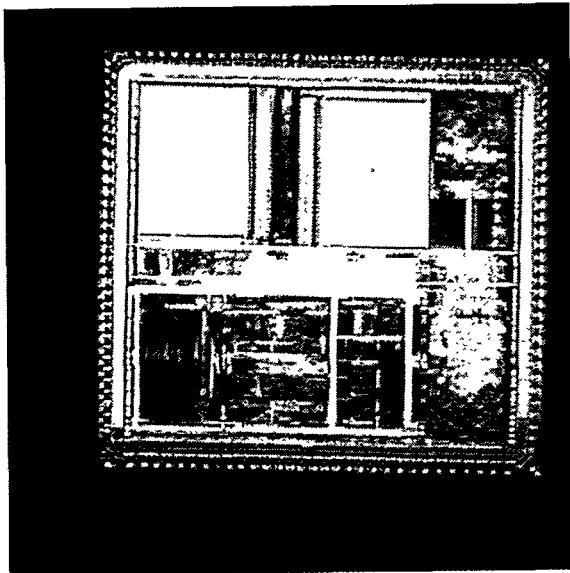
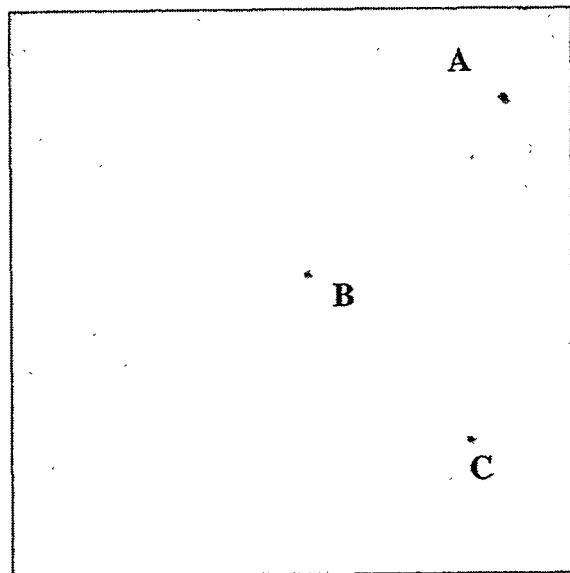
An optical image of the die is shown in Fig.1A. The corresponding TIVA image of the die is shown in Fig.1B. It can be seen in Fig.1B that there exists a TIVA signal at three locations on the die labeled A, B and C. Figures 2A and 2B show the high magnification optical and TIVA images respectively at site A. Figures 3A and 3B show the high magnification optical and TIVA images respectively at site B. Figures 4A and 4B show the high magnification optical and TIVA images at site C.

Fig.1A Optical image of the entire die under study.

Fig.1B TIVA image of the device shown in Fig.1A. Image shows three locations, labeled A, B and C, which exhibit the TIVA signal.

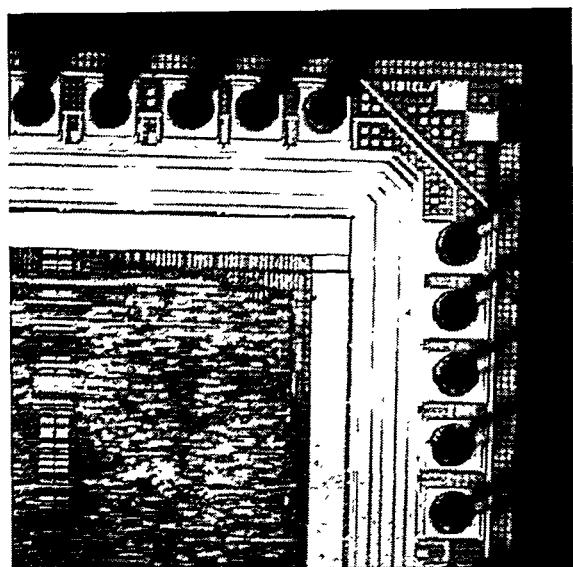
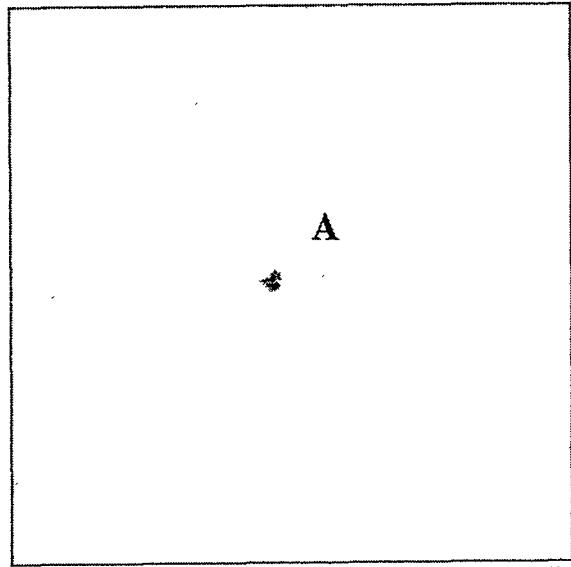
The three locations observed by TIVA were first closely inspected using design tools. It was observed that a chain of inverter circuits is present at the three locations where the TIVA signals were observed. These inverters are part of the spare Focused Ion Beam (FIB) gates designed into the device for future design debug needs. These inverters were linked together which resulted in the formation of a ring oscillator (Fig.5). The presence of the ring oscillator can potentially lead to an increased  $I_{DDQ}$  due to continuous transistor switching processes in the oscillator. Microsurgery using a Focused Ion Beam tool was then performed to verify that the ring oscillator is the source of excess  $I_{DDQ}$ . The interconnections between the transistors wiring the oscillator chain were disconnected and the transistors were then tied to ground.  $I_{DDQ}$  testing of the modified device resulted in an acceptable value for the  $I_{DDQ}$ .

Fig. 2A High magnification optical image of the die pinpointing the location A.

Fig. 2B High magnification TIVA image of the die shown in Fig.2A indicating the location of the failsite.

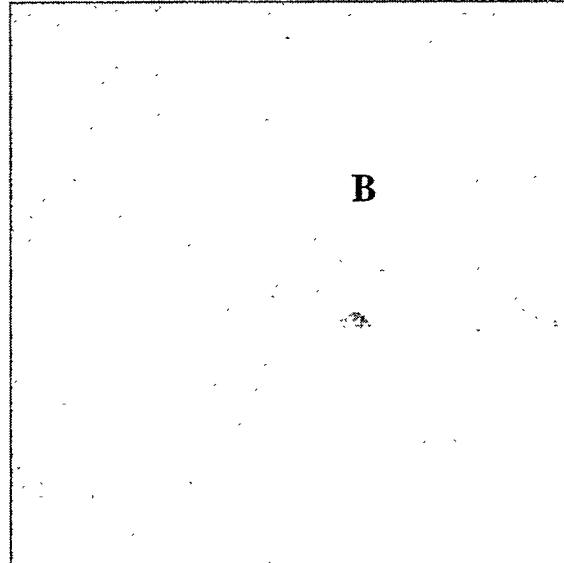
Fig. 3A High magnification optical image of the die pinpointing the location B.

Fig. 3B High magnification TIVA image of the die shown in Fig.3A indicating the location of the failsite.

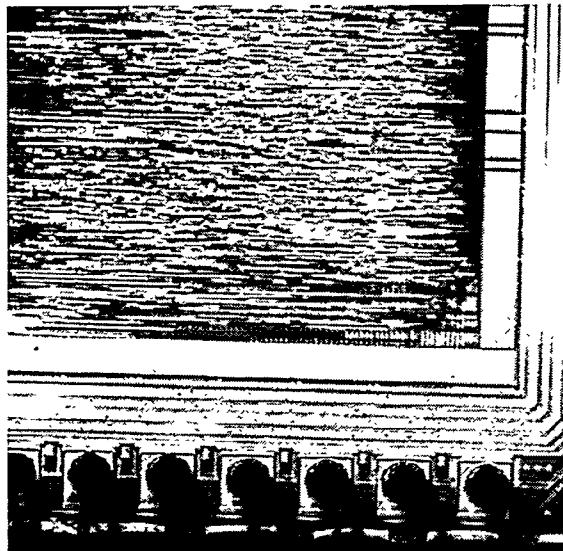
Fig. 4A High magnification optical image of the die pinpointing the location C.

Fig. 4B High magnification TIVA image of the die shown in Fig.4A indicating the location of the failsite.

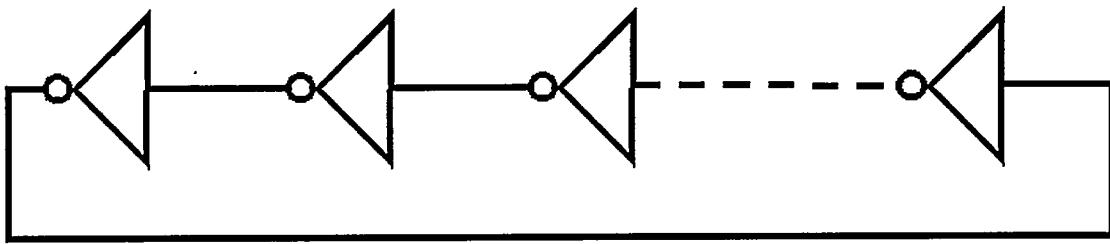
In the current study, localized heating of the ring oscillator chain resulted in a change in the voltage across the current source powering the device. The current through the device is a function of the transistor switching time, which is inversely proportional to the supply voltage. Localized heating can cause changes in several electrical parameters that are sensitive to temperature. These can result in variation of the transistor switching speeds, which result in a corresponding variation of the power demand from the constant current source.

Fig. 5 Schematic of a ring oscillator. In the device analyzed with TIVA, many spare FIB gates were linked together resulting in the formation of the oscillator.

An application of TIVA in successfully isolating a design anomaly is presented. TIVA analysis resulted in localization of the source of excess  $I_{DDQ}$ . Instead of a physical defect, the source of excess  $I_{DDQ}$  was found to be a set of spare gates which inadvertently formed a ring oscillator. Modifications with FIB corroborated the conclusion drawn from the TIVA analysis that the ring oscillator is the source of the excess  $I_{DDQ}$ . It was thus shown that the TIVA setup could be used to localize non-physical defect related anomalies.
