INEEL/EXT-99-01109

Corrosion Evaluation of INTEC Waste Storage Tank WM-182

Published November 15, 1999

**Idaho National Engineering and Environmental Laboratory
High Level Waste Program Division
Bechtel BWXT Idaho, LLC
Idaho Falls, Idaho 83415**

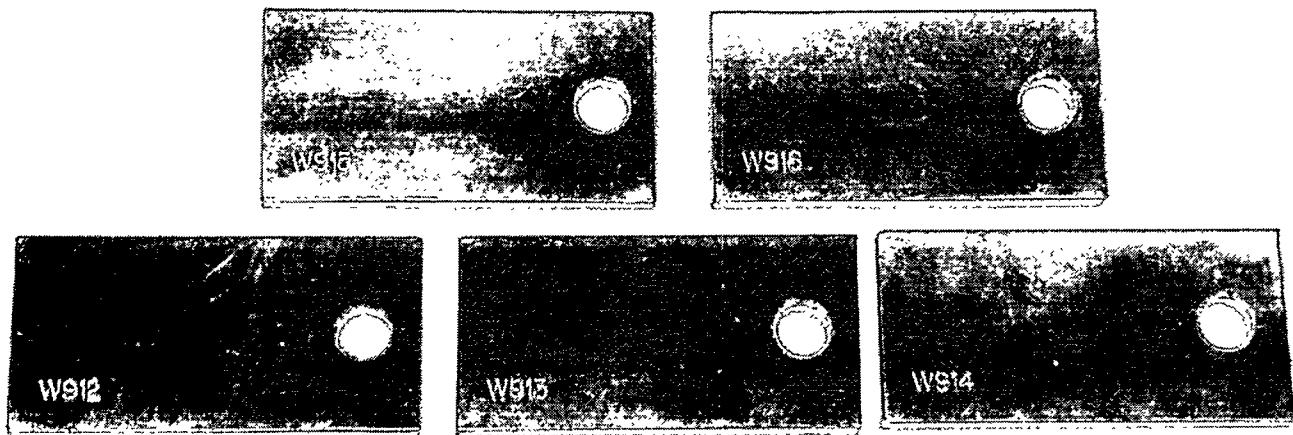
**CORROSION COUPON- VESSEL WM-182
BOTTOM – 11.4 YEARS EXPOSURE**

Figure 8. Welded Bottom Type 304L Stainless Steel Coupons – 0 Inch Level (Tank Bottom).

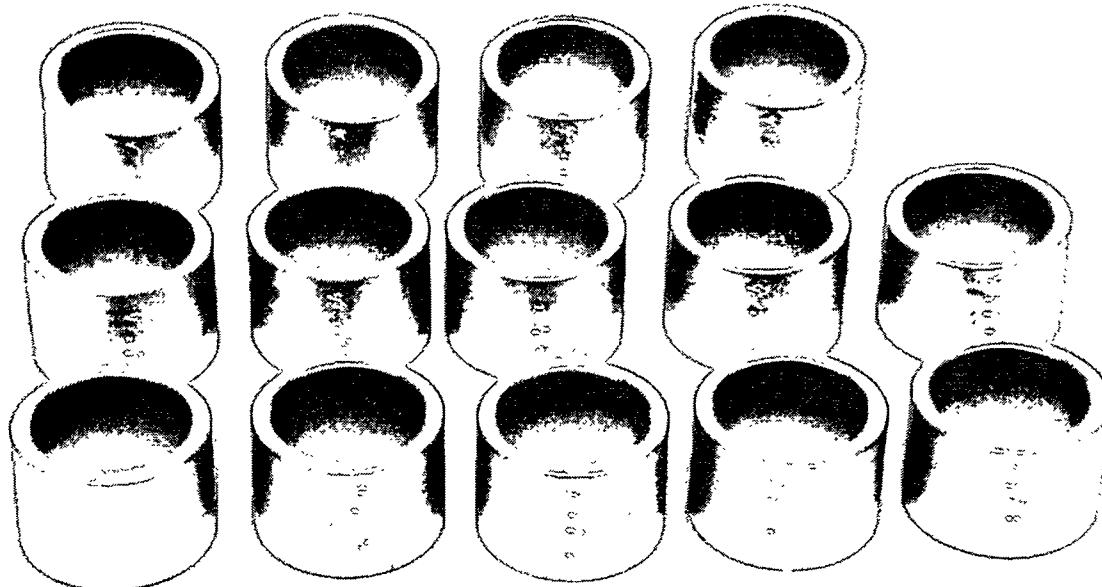
**CORROSION COUPONS - VESSEL WM-182
18 INCH LEVEL - 30.5 YEARS EXPOSURE**

Figure 9. Seamless Type 304L Stainless Steel Pipe Corrosion Coupons – 18 Inch Level.
(Coupons fabricated from 1-inch Schedule 40 pipe)

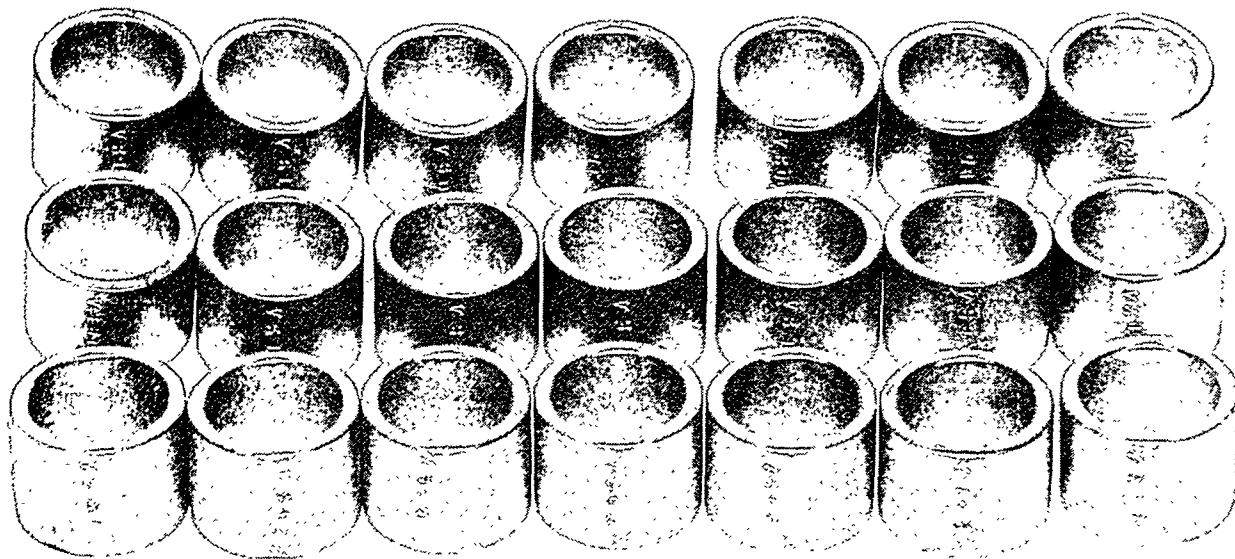
**CORROSION COUPONS - VESSEL WM-182
36 INCH LEVEL - 28.3 YEARS EXPOSURE**

Figure 10. Seamless Type 304L Stainless Steel Pipe Corrosion Coupons – 36 Inch Level.

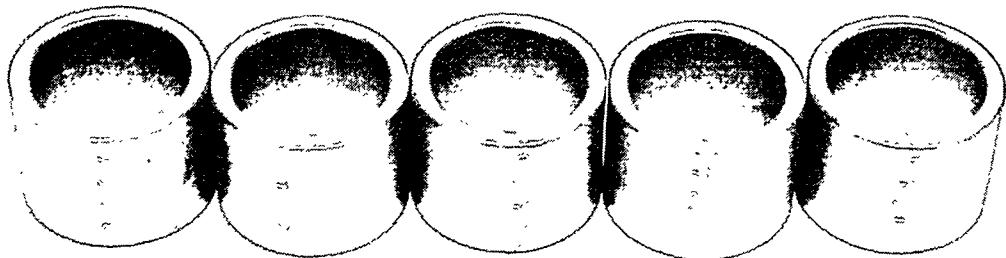
**CORROSION COUPONS – VESSEL WM-182
72 INCH LEVEL – 26.5 YEARS EXPOSURE**

The highest average corrosion rate for a set of coupons exposed at any level in the tank was 1.2×10^{-2} mil per year at the 72-inch level (Table 2). This calculates to a maximum average metal loss of 5.1×10^{-1} mil (0.00051 inch or 0.16% of the thickness of the tank wall) over 44.4 years of vessel service. The maximum corrosion rate observed for any single coupon from this tank was 1.24×10^{-2} mil per year. Calculations using this maximum corrosion rate indicate a metal loss from the internal surfaces of the vessel of 5.5×10^{-1} mil (0.00055 inch or 0.18% of the thickness of the tank wall) over the 44.4 years of tank service. WM-182 has a corrosion allowance of 50 mil (0.050 inch).

Figure 11. Seamless Type 304L Stainless Steel Pipe Corrosion Coupons – 72 Inch Level.
