The Remediation of Abandoned Iron Ore Mine Subsidence in Rockaway Township, New Jersey

Report Type Semi-Annual Technical Progress Report.

Reporting Period Start Date – March 29, 1999
End Date - September 29, 1999

Principal Author Gary Gartenberg, P.E., P.P.

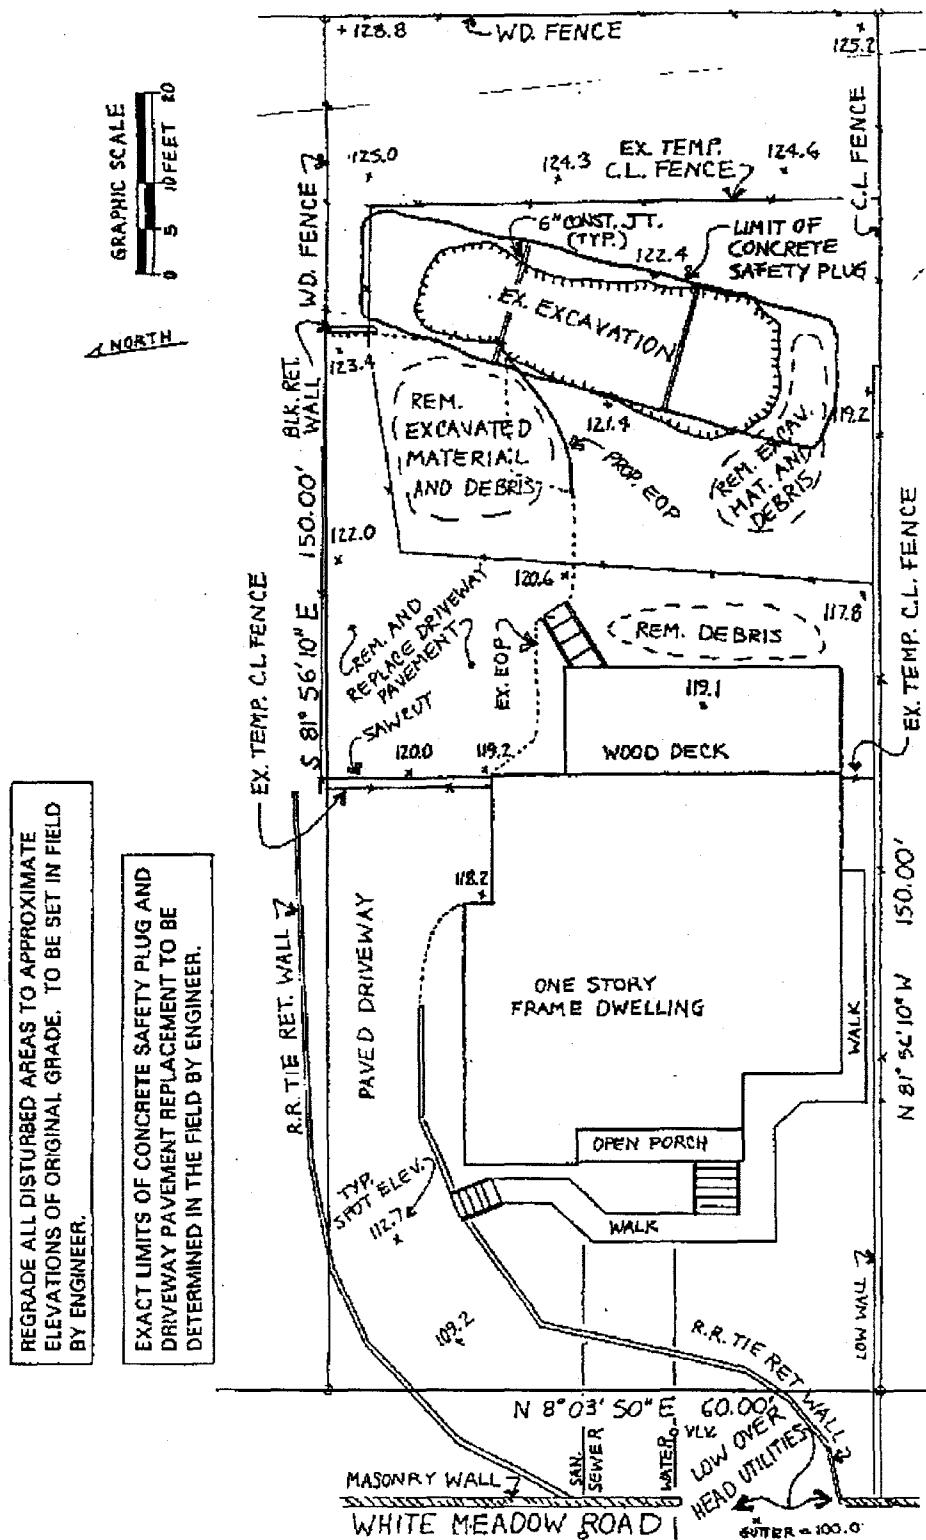
WHITE MEADOW MINE – CONSTRUCTION PLAN

The basic remediation consists of installation of a three part concrete safety plug between the head wall and foot wall traversing the rear yard area. The longitudinal dimension of the safety plug will be approximately fifty five (55') feet. The intended location of the concrete safety plug and other pertinent site elements can be seen in the Construction Site Plan in the Appendix, Page A-11.

The remediation of the subsidence at the White Meadow Mine site anticipates in general terms, excavating the existing pit, benching of the rock ledge at the head wall and foot wall, placement of a concrete safety plug, back-filling, and clean up and site restoration.

At the conclusion of the work, the excavated area will be back filled and the original grade re-established and driveway pavement restored as noted on the Construction Site Plan, Appendix Page A-11.

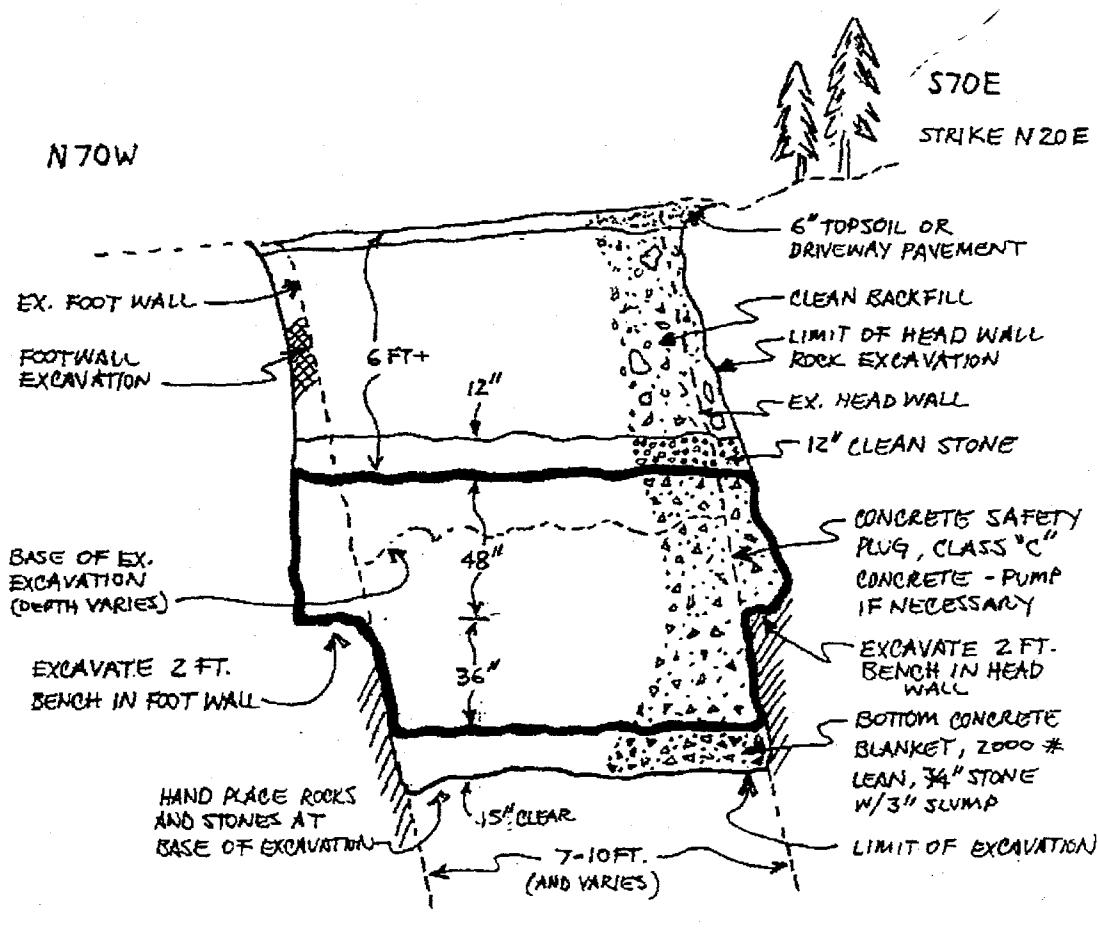
WHITE MEADOW MINE – SECTION THROUGH STRIKE

The design anticipates excavating down approximately thirteen (13') feet. The head wall and foot wall will be benched to allow a "T" shaped cross section of the plug. Vertically, approximately four (4') feet of the concrete will be at an elevation above the base of the rock bench, with three (3') feet of the plug below the elevation of the bench. The width of area which was previously mined varies from seven to ten (7' to 10') feet between the foot wall and head walls.

Six (6") inch construction joints will be installed dividing the length of the safety plug into three independent sections along the longitudinal axis. Should shifting of subsurface subsidence occur, this three piece design will allow some independent movement of the individual sections. Page A-12 in the Appendix shows a typical cross section extending through the existing and proposed excavated area at the site showing the concrete safety plug typical detail.

Placement of the safety plug will include the installation of steel reinforcement bar installed from the top of the concrete toward the surface. The surface markers will then allow for subsequent monitoring of the sub surface concrete plug. Additionally, a twelve (12") diameter observation casing will be installed approximately three (3') feet below grade through the center of the safety plug allowing future access to this area for additional subsurface gravity or hydraulic placement of fill, or video observations.

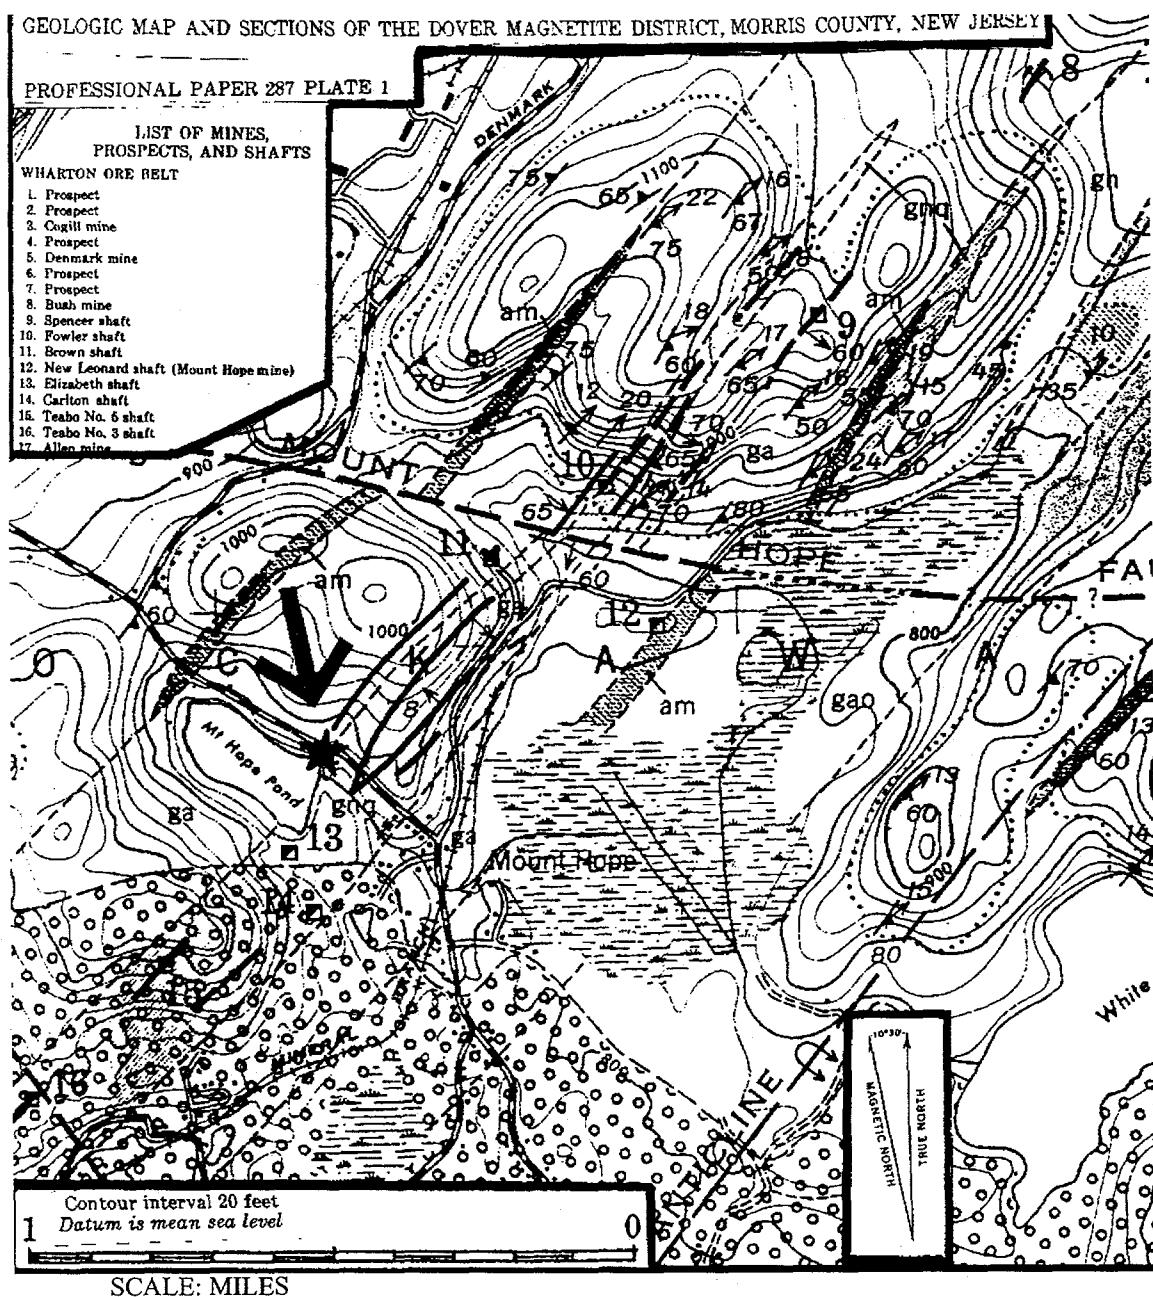
MOUNT HOPE ROAD SUBSIDENCE – LOCATION MAP

The location of the subsidence is shown in the Appendix, Page A-13. The subsidence surface feature is approximately twenty five (25') feet in diameter, conical shaped with an axis length of approximately fifteen (15') feet at the center. An Outline Specifications with a Scope of Work has been developed to provide immediate temporary relief to this location. This includes clearing and cleaning of the existing subsidence area and adjacent work areas including the subsidence cone which contains large organic debris and small trees, limited excavation would be then conducted including a small bench at the perimeter of the cone with cleaning and scraping of the walls of the existing subsidence cone. The area would be back filled with shot rock approximately two (2') feet in diameter with mix sizes. Near the upper portion of the excavation, a concrete matrix would be introduced of approximately twelve (12 cy) cubic yards to the back filled area. The area would then be back filled to the surface.

Initial review of the available documentation at the Mount Hope Road location indicates the subsidence is related to abandoned mining activity. This site is located adjacent to mining features, and is midway between the general location of the Brown shaft and Elizabeth shafts.

Work to eliminate the immediate safety hazard associated with the subsidence adjacent to Mt. Hope Road is anticipated to be conducted during the subsequent reporting period. This work should provide immediate term relief addressing the safety concerns at this location.
