Degradation and Failure Characteristics of NPP Containment Protective Coating Systems

Preliminary Evaluation of Plant Coating Specimens

Division of Engineering Technology
Office of Nuclear Regulatory Research
U.S. Nuclear Regulatory Commission
Washington, DC 20555
NRC Job Code W6959

DOCUMENT: WSRC-TR-2001-00163

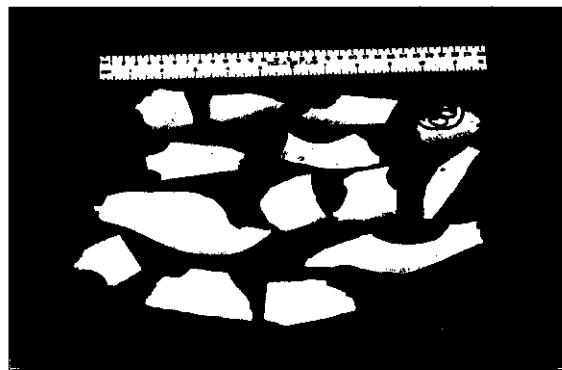
Figure 2-1. As-received chips

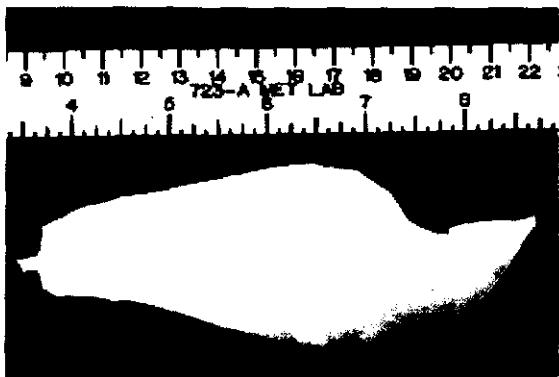
The topcoat is off-white and the IOZ primer is gray in color. A close-up view of the largest coating chip is shown in Figures 2-2 and 2-3, with the topcoat side up. Although the primer was observed to be well adhered to the topcoat, powder residue was readily removed during routine handling. In addition, the topcoat thickness appeared to be greater than that of the primer adhered to the topcoat. The amount of primer remaining on the substrate is currently unknown. It is assumed that the majority of primer thickness was left on the carbon steel substrate.

Figure 2-2. Overall photograph of largest chip as-received (topcoat-side)

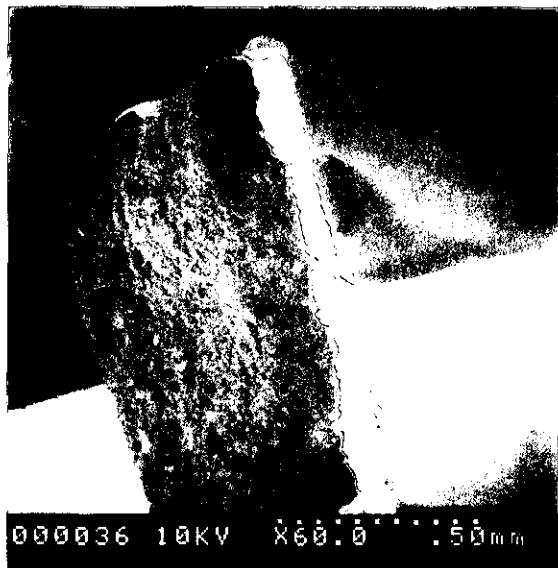
The chip samples were examined using an SEM to reveal surface morphology and characteristics of the IOZ primer. Samples were examined using a Hitachi scanning electron microscope at low voltage (10-20KV). A low magnification view of a chip sample is shown in Figure 2-4, with the topcoat (white) charging slightly due to its non-conducting nature. Samples were grounded in the microscope using conductive carbon tape to minimize such effects. Non-conducting samples can be sputter-coated with gold or carbon, but surface defects and other important features can often be masked or covered at microscopic levels. From Figure 2-4, the overall chip thickness was estimated to be approximately 180 microns or approximately 7 mils. Although only a rough estimate from an angular view, this is consistent with a 4-6 mil thick topcoat and a 2-3 mil primer which has cohesively split (2-3 mils for the primer would be acceptable, with all other application factors ideal).

Figure 2-4. SEM photomicrograph of a representative paint chip (60X)

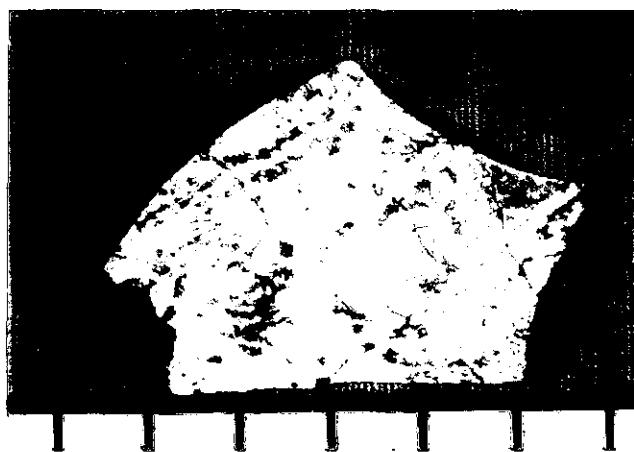
Figure 2-16. IOZ side up of chip specimen exposed to 300°F steam following additional radiation to 0.2×10^9 R.

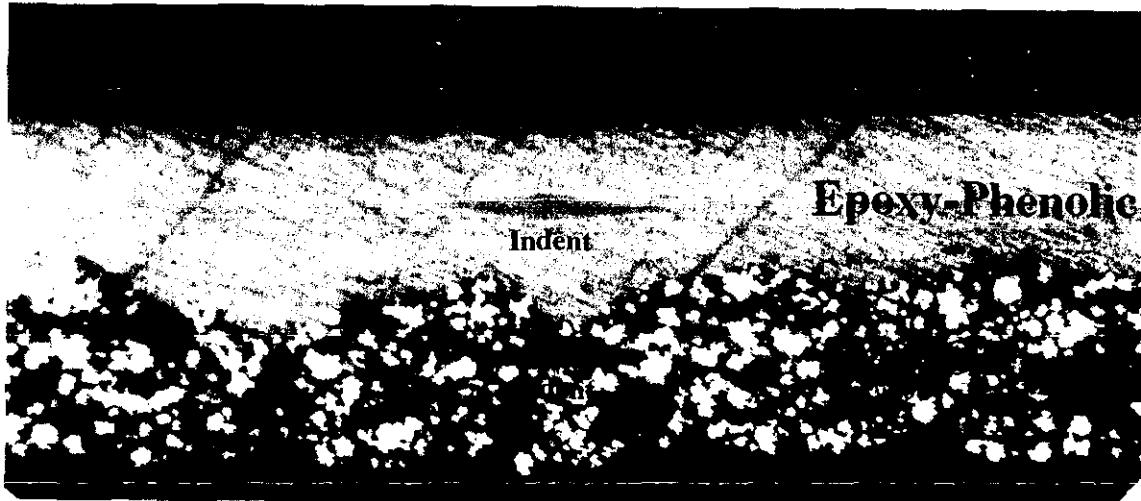
Additional characterization of the failed chips was performed. The as-received chips were mounted in cross-section and polished to show the two-layer system (see Figure 2-20). The Knoop hardness (HK) was determined using a 10 gram load. Measurements were made in the epoxy-phenolic layer with an average hardness number of 15.9 HK of five data (17.3, 15.5, 15.9, 15.8, 14.8). Measurements in the IOZ layer were more difficult to make because the contrast of the structure obscured the indentation. The average hardness number is 33.4 HK of three data (44.9, 28.2, 27.2).

Figure 2-20. Photomicrograph of the failed chip in cross section showing the two-layer system with the Knoop hardness indents in the epoxy-phenolic and IOZ layers

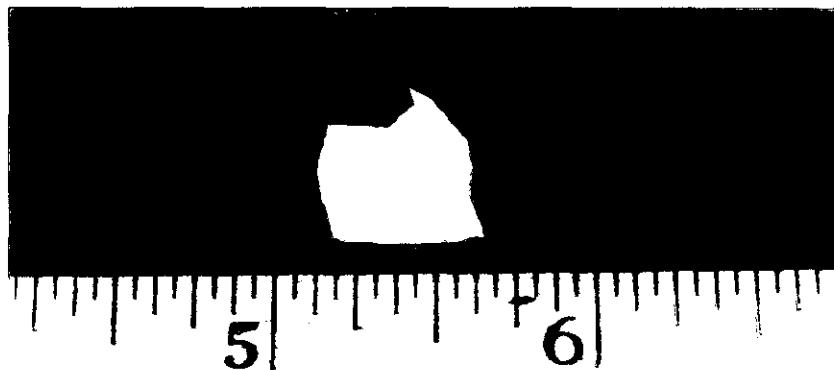
Figure 3-1. As-received coating chip, topcoat side – Rx Polar Crane location

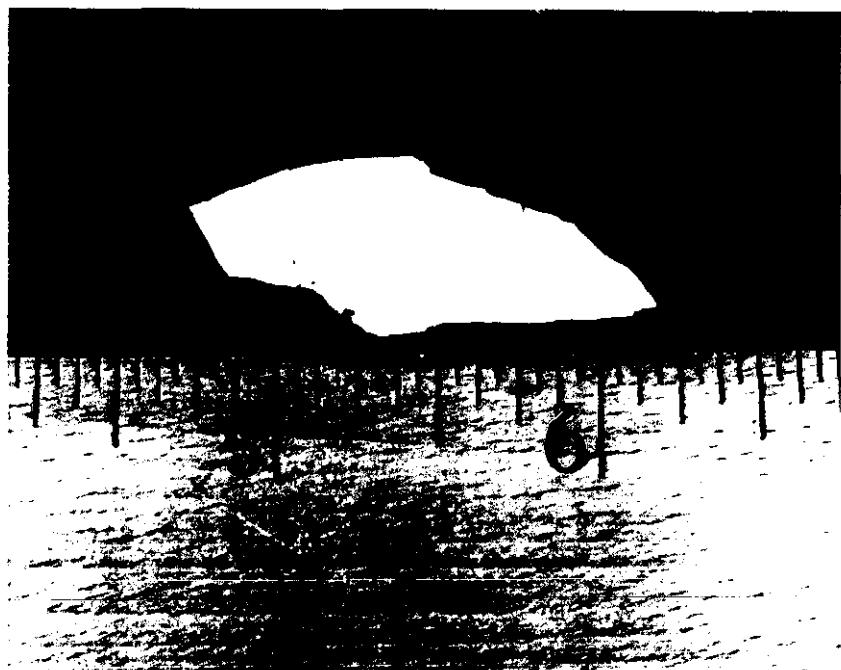
Figure 3-3. As-received debris, ceilings/wall location, 3rd Floor ceilings– topcoat with surfacer attached (note ¼" cracks)

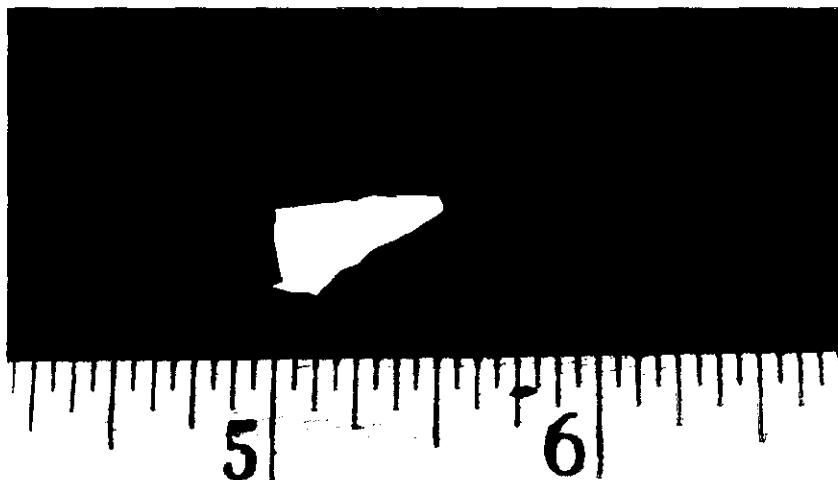
Figure 3-4. As-received chip from Rx spray – header steel location

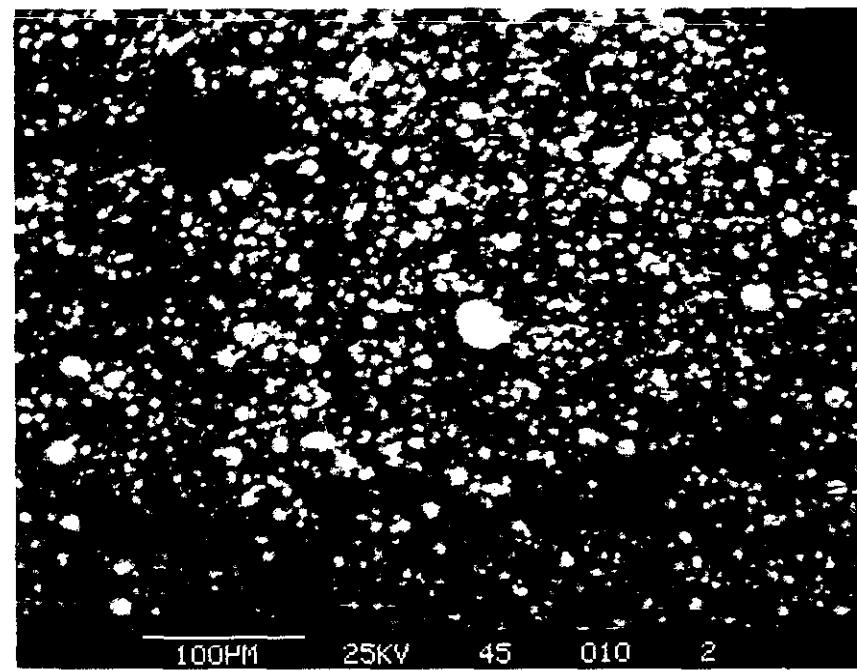
A backscattered electron image of the same area shown in Figure 3-5 is provided in Figure 3-6 to show the relative difference between the two imaging techniques. In the backscattered image, the conductive areas are shown in white with the non-conductive areas being darker. The relevant fact to note from these images is that although the inorganic zinc primer was assumed to be polymerized/oxidized, it was still relatively conductive even in the uncoated condition (uncoated with either gold or carbon typically used for imaging of non-conductive materials).

Figure 3-6. Backscattered image of inorganic zinc primer – header steel location (200X)
(same area as Figure 3-5)

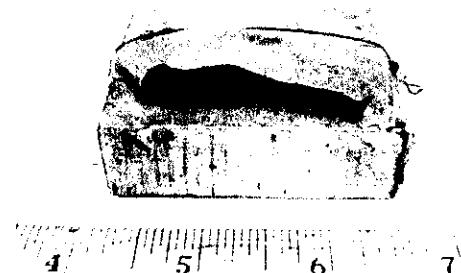
difference in depth of damage can, perhaps, be explained as a difference in the depth of oxidation of the coating, which occurred prior to irradiation.

Figure 4-10. Bottom view of the irradiation-aged specimen illustrating the delamination that occurred in the immersed portion of the specimen during DBA/LOCA testing. The coating was split intra-coating (i.e., a portion of the coating remained on the steel substrate).

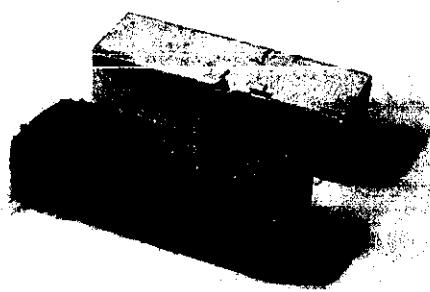
Figure 4-13. Immersion test specimens following removal from the test vessel. No evidence of coating degradation was observed on the non-aged specimen.

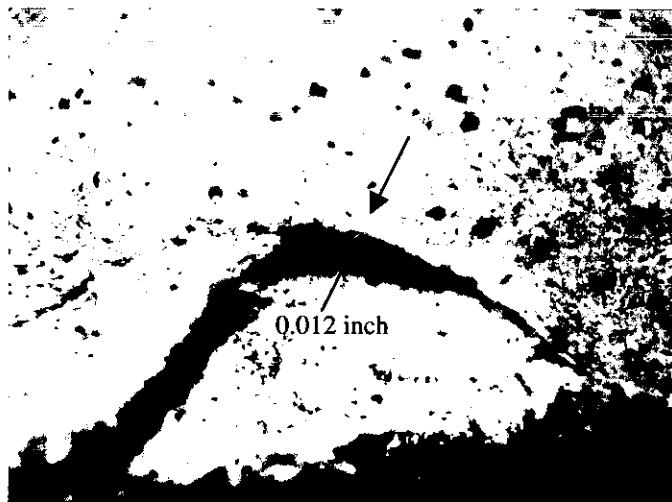
Microscopic examination of the irradiated specimen revealed an extensive network of pores and blisters throughout the coating. Measurements of the coating thickness made in broken blisters revealed a delamination depth similar to that seen in the DBA/LOCA testing. As before, a remnant of coating remained on the substrate beneath the blisters (Figure 4-14).

Figure 4-14 Photomicrograph of the surface of the irradiation-aged specimen following immersion testing. The thickness of the broken blister is approximately 0.012 inch – which is consistent with the delamination observed in the DBA/LOCA test. Note, also, the presence of minor blisters and pores in the surface of the coating. Magnification approximately 10x.

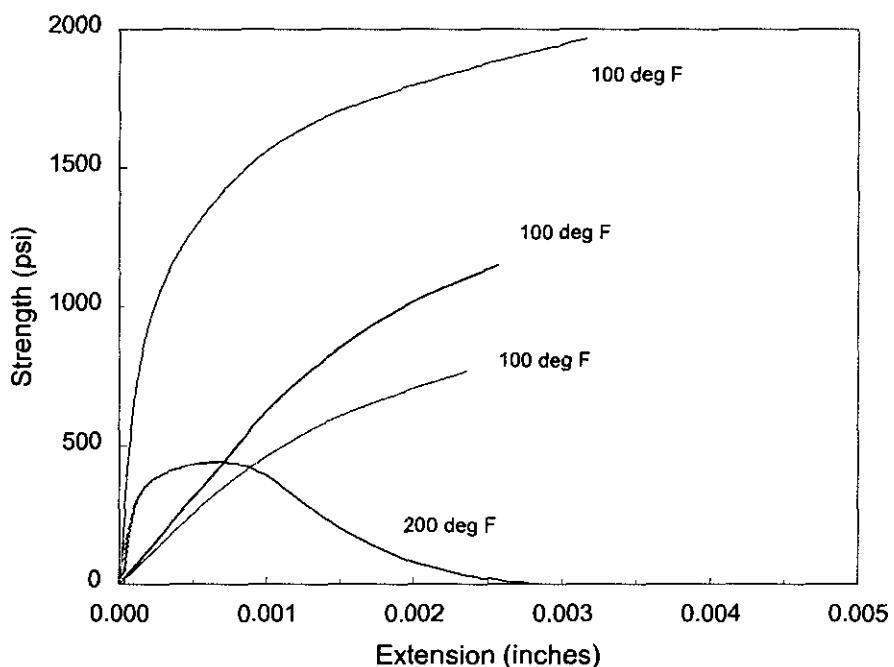
the adhesion strength under the failed chip was zero. These results indicate that the quality of the coating/substrate bond can vary substantially over only a very small sample area.

Figure 4-15. Adhesion pull test results from the as-received snubber plate at 100°F and 200°F in the dry condition
