Nevada
Environmental
Restoration
Project

DOE/NV-739

Post-Closure Inspection Report for
Corrective Action Unit 453:
Area 9 UXO Landfill
Tonopah Test Range, Nevada
Calendar Year 2000

June 2001

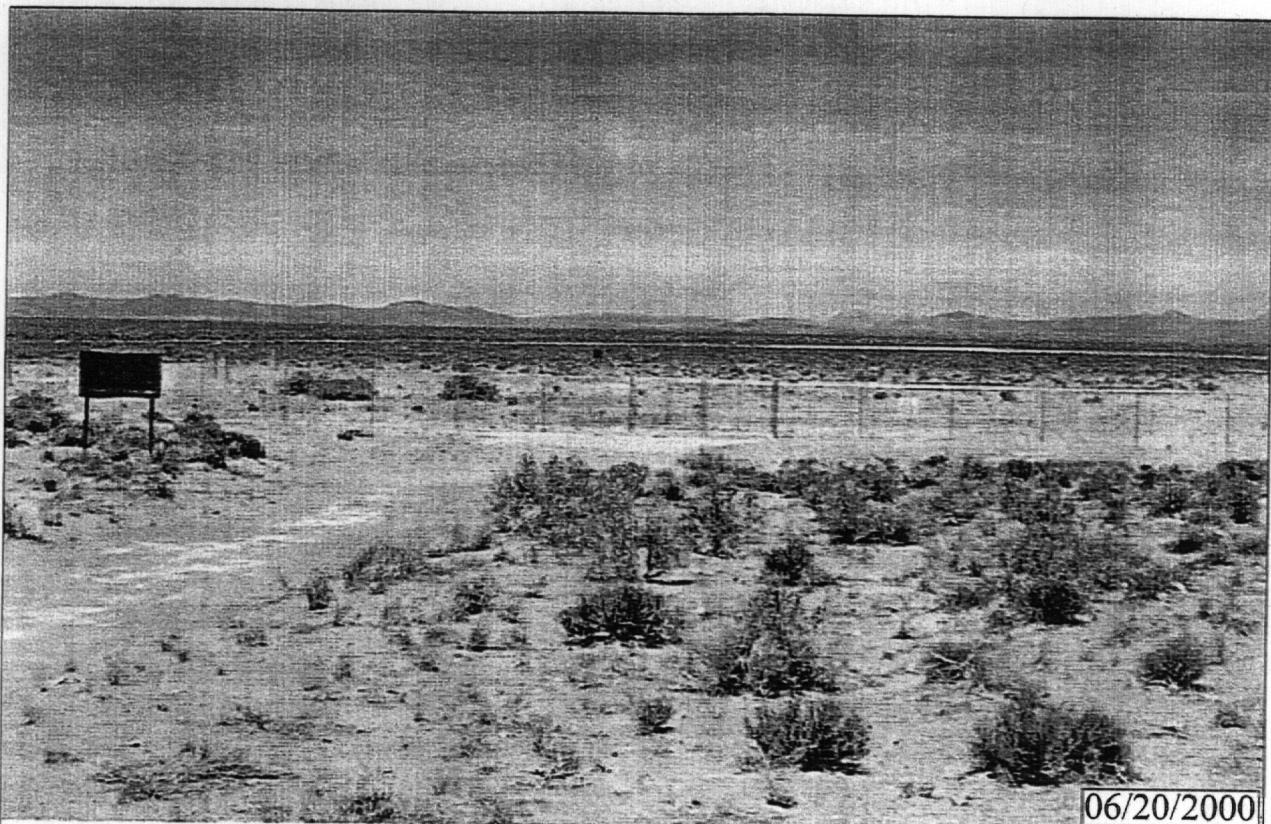
PHOTO NUMBER	DATE	DESCRIPTION
1	6/20/2000	View to northwest from outside of perimeter fence near gate. Concrete monuments indicate locations of the northeast and southwest ends of Landfill Cells A9-1, A9-2, and A9-3. Signs on south fence line visible and in good condition
2	6/20/2000	View to west from outside of perimeter fence. Concrete monuments indicate locations of the southeast ends of the Landfill Cells A9-1, A9-2, and A9-3.
3	11/21/2000	View to northwest from outside of perimeter fence near gate. Concrete monuments in right half of photograph indicate locations of the northeast ends of Landfill Cells A9-1, A9-2, and A9-3. Concrete monuments in left half of photograph indicate the locations of the southwest ends of Landfill Cells A9-1, A9-2, and A9-3.
4	11/21/2000	View to west from outside of perimeter fence. Concrete monuments indicate locations of the northeast, middle, and southwest ends of the Landfill Cells A9-1, A9-2, and A9-3.
