DOE/NV--794

Post-Closure Inspection Report for
Corrective Action Unit 404: Roller
Coaster Lagoons and Trench
Tonopah Test Range, Nevada
Calendar Year 2001

January 2002

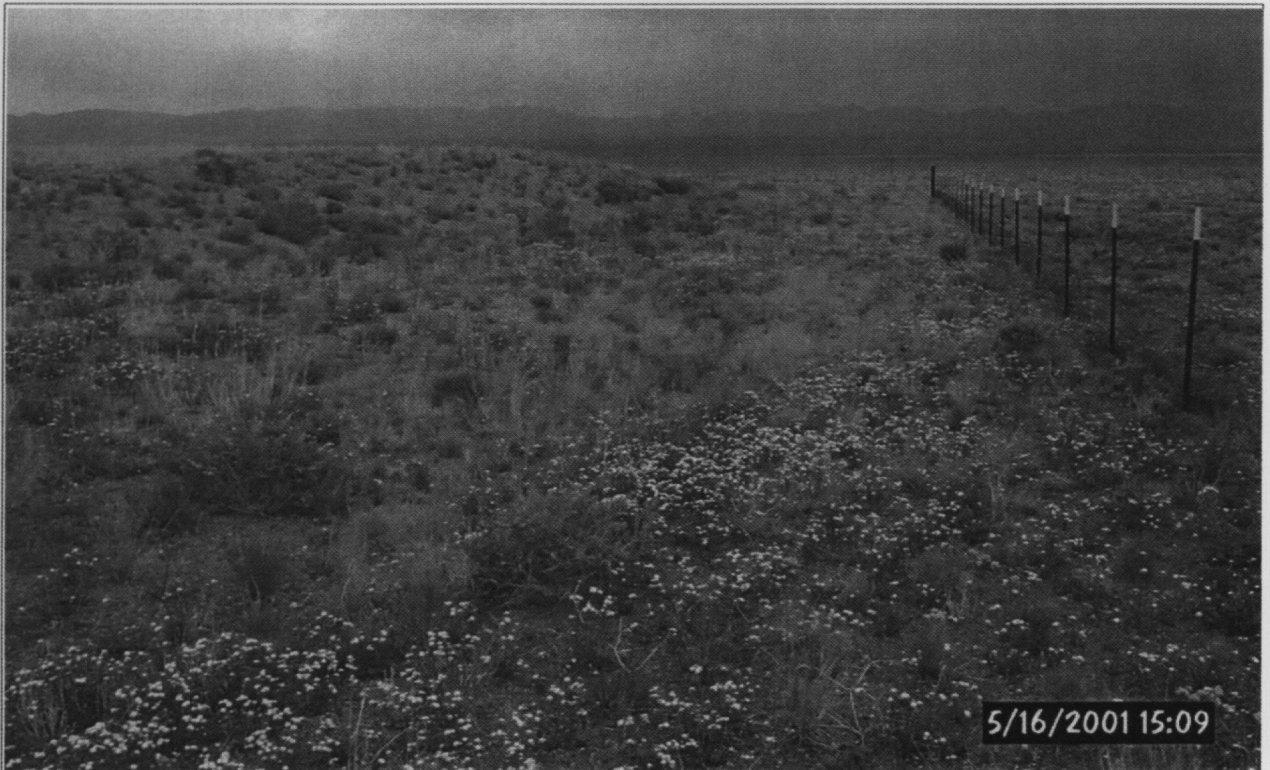
PHOTO NUMBER	DATE	DESCRIPTION
1	05/16/2001	View to the east along southern fence line.
2	05/16/2001	View of cover looking northwest from southeast fence corner.
3	05/16/2001	View to the northeast along northern fence line.
4	05/16/2001	View of the east of cover from inside fence line. Note the presence of sparse healthy native grass and brush species.
5	11/06/2001	View looking east from outside fence at site.
6	11/06/2001	View looking east at cover from inside fence. Note the presence of sparse healthy native grass and shrub species on and about cover.
7	11/06/2001	Small mammal burrow holes inside fence line.
8	11/06/2001	View to southwest of cover and associated revegetated area.
