Nevada
Environmental
Restoration
Project

DOE/NV--795

Post-Closure Inspection Report
for Corrective Action Unit 453:
Area 9 UXO Landfill Tonopah Test
Range, Nevada
Calendar Year 2001

January 2002

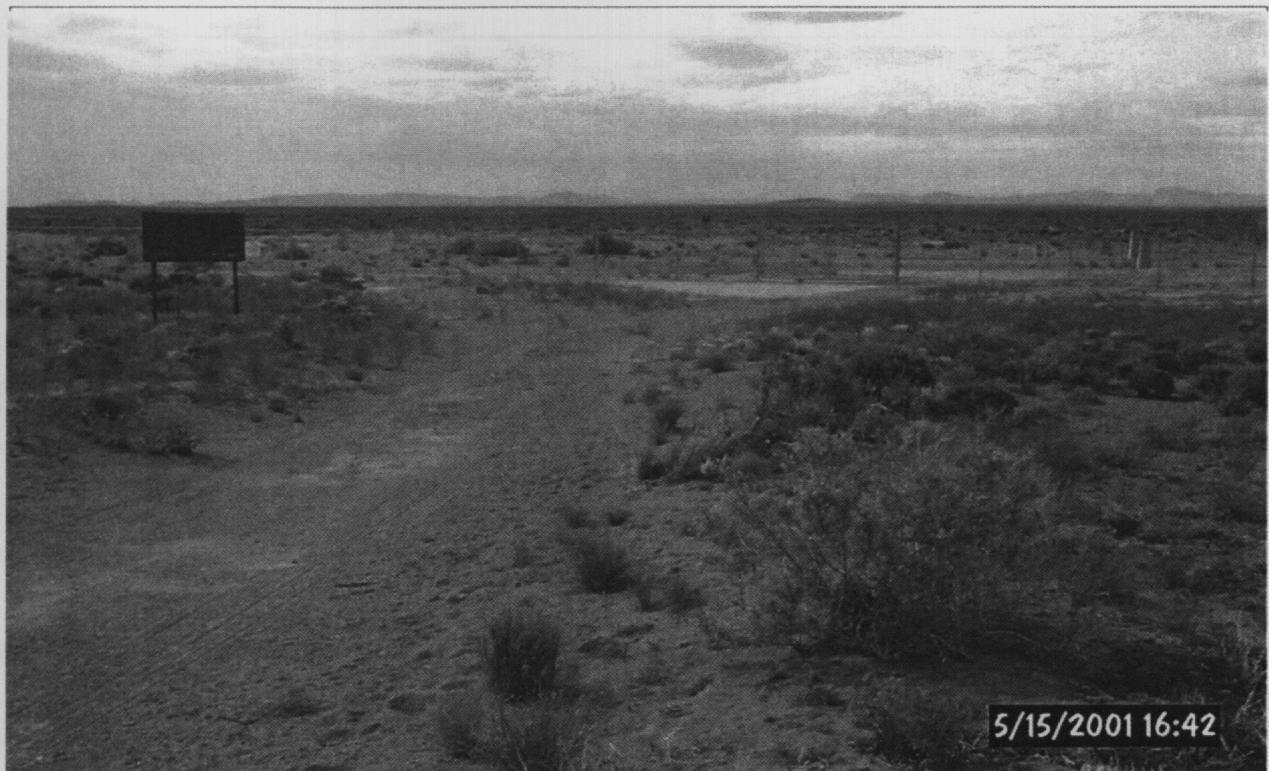
PHOTO NUMBER	DATE	DESCRIPTION
1	05/15/2001	View to northwest from outside of perimeter fence near gate. Concrete monuments indicate locations of the northeast and southwest ends of Landfill Cells A9-1, A9-2, and A9-3. Signs on south fence line visible and in good condition
2	05/15/2001	View to west from outside the southeast corner of perimeter fence. Concrete monuments indicate locations of the landfill cells.
3	05/15/2001	View to west from inside of the perimeter fence showing the A9-1 Landfill Cell cover subsidence area in the foreground. Concrete monuments indicate locations of the landfill cells.
4	05/15/2001	View to east from inside of perimeter fence. Concrete monuments indicate locations of the corners of the Landfill Cells A9-1, A9-2, and A9-3. Sparse vegetation inside fence is healthy native grass and brush species.
5	11/06/2001	View to the north from outside perimeter fence. Gate signs and landfill cell corner monuments are visible and in excellent condition.

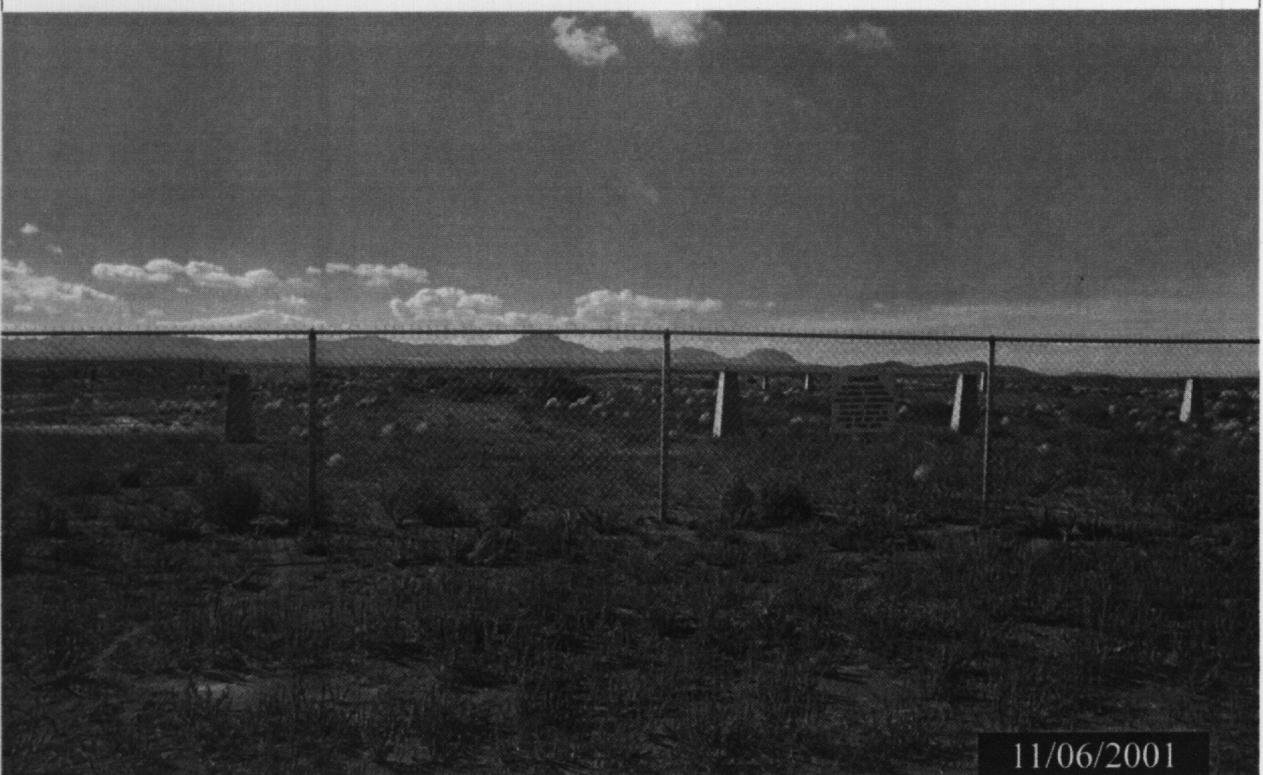
6	11/06/2001	View to west from outside perimeter fence.
7	11/06/2001	View to east of subsidence area at eastern end of A9-1 Landfill Cell. Sparse vegetation of native grasses, shrubs, and halogeton are present inside the fenced area.
8	11/06/2001	View to northeast from outside perimeter fence at southwest corner.

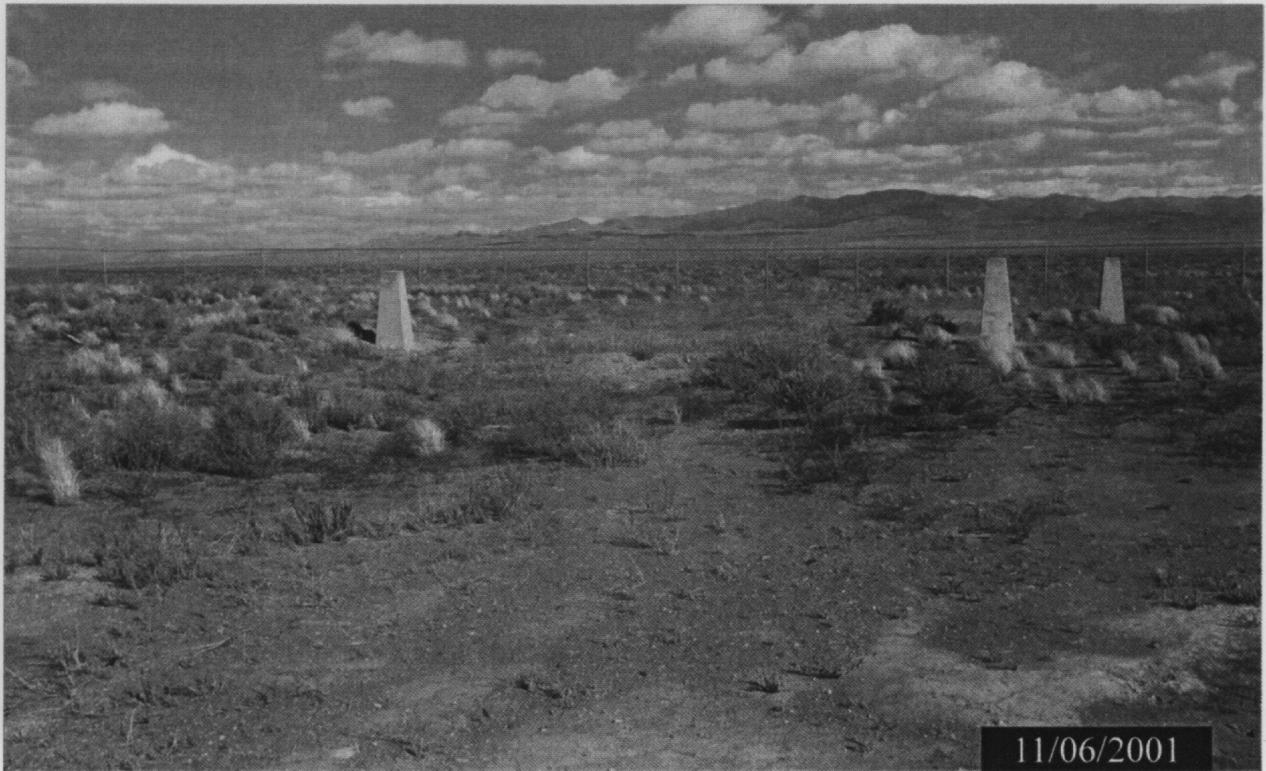
7

Note for D.4. - an area (approx 15' x 20') along the northern portion of trench A9-1 appears to be noticeably lower than the surrounding ground surface and may be a result of subsidence in the landfill.

0 in the Northeast end of trench A9-1 has apparently
subsided. This area was noticeably lower than the surface
grade of the remainder of the site.

On November 15 and 16, 2001, the area of subsidence located at the east end of Landfill Cell A9-1 was repaired. Ninety-one cubic meters (120 cubic yards) of clean fill was placed in the area and compacted by back-dragging the area with the backhoe bucket. Final touch-up grading was made to bring the cover up to the pre-existing grade.
