HNF-4453
Rev. 0

HAZARD EVALUATION FOR 244-AR VAULT FACILITY

Prepared by:
Fluor Daniel Northwest, Inc.

Date Published
June 1999

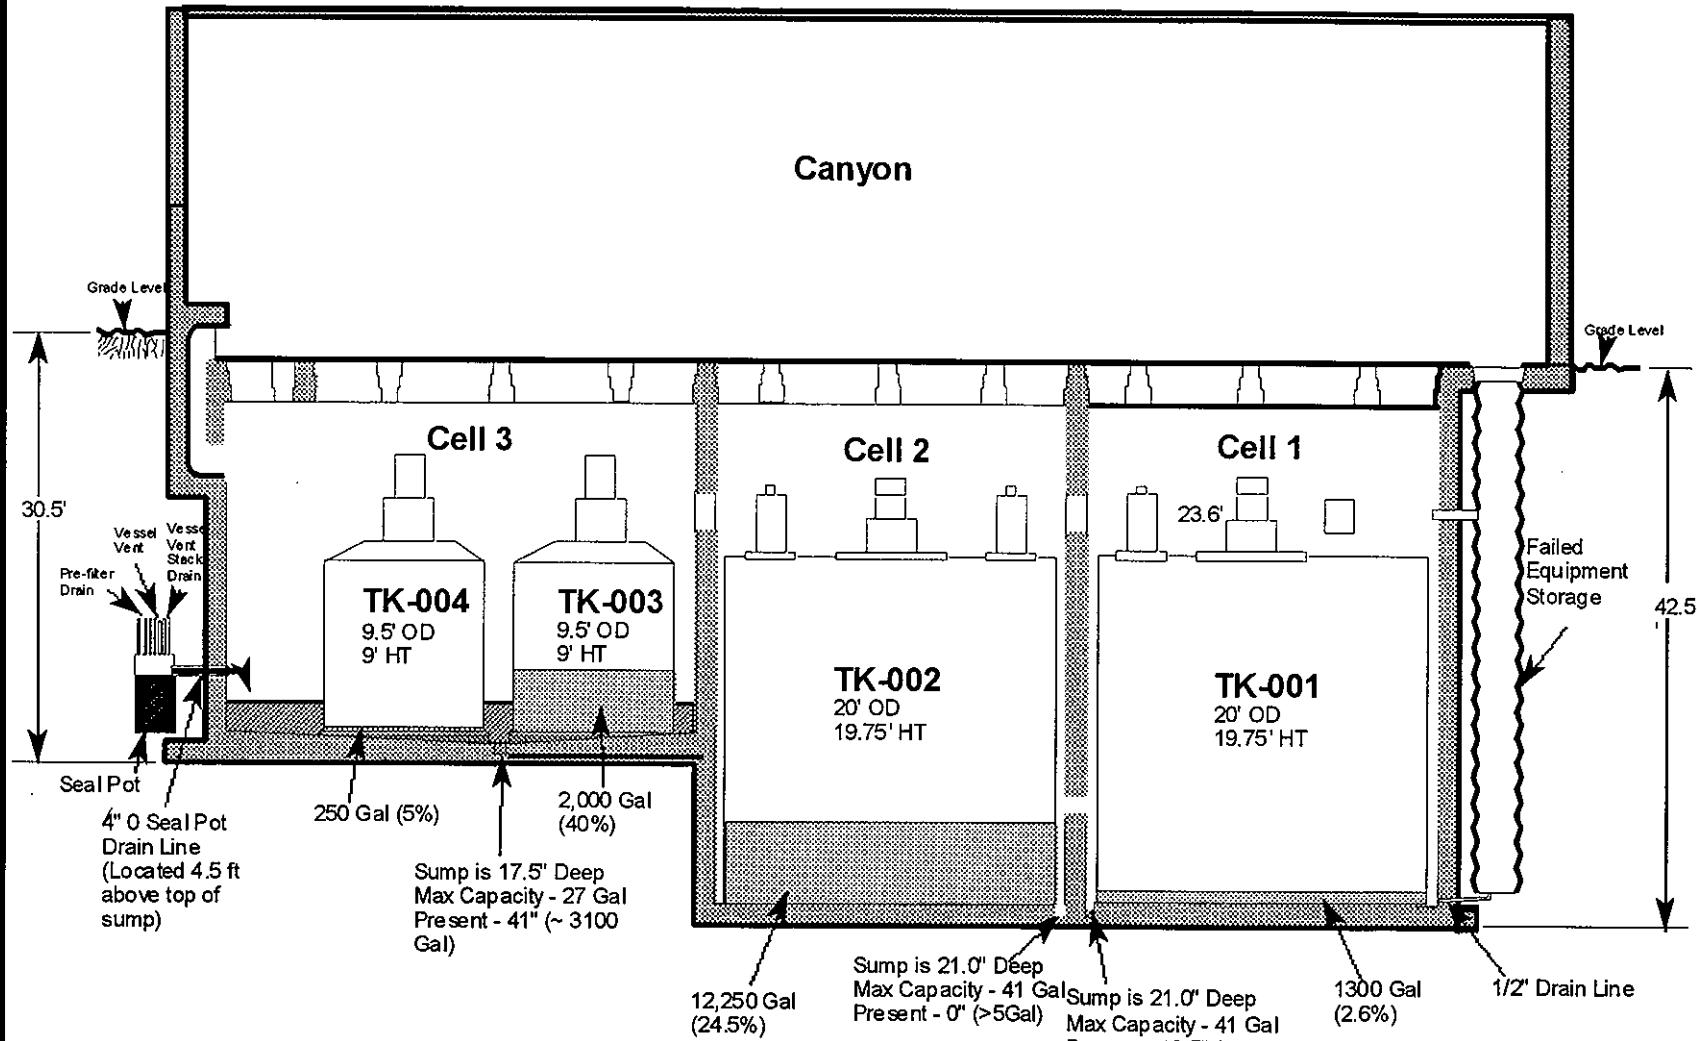
Figure 2-1. 244-AR Vault Facility Schematic

1. The important features of 244-AR vault are captured in the 244-AR Vault Facility Schematic, Figure 2-1 of the preceding section.
2. The existing AB Hazard Analysis except for the flooding of the 244-AR vault cells adequately addresses hazardous conditions associated with the 244-AR Vault Facility. The intent of this HAZOP was to identify the hazardous conditions related to the flooding of the vault cells of the 244-AR Vault Facility.
3. The contents of the failed equipment storage tubes were unknown at the time the HAZOP was conducted for the 244-AR Vault Facility.

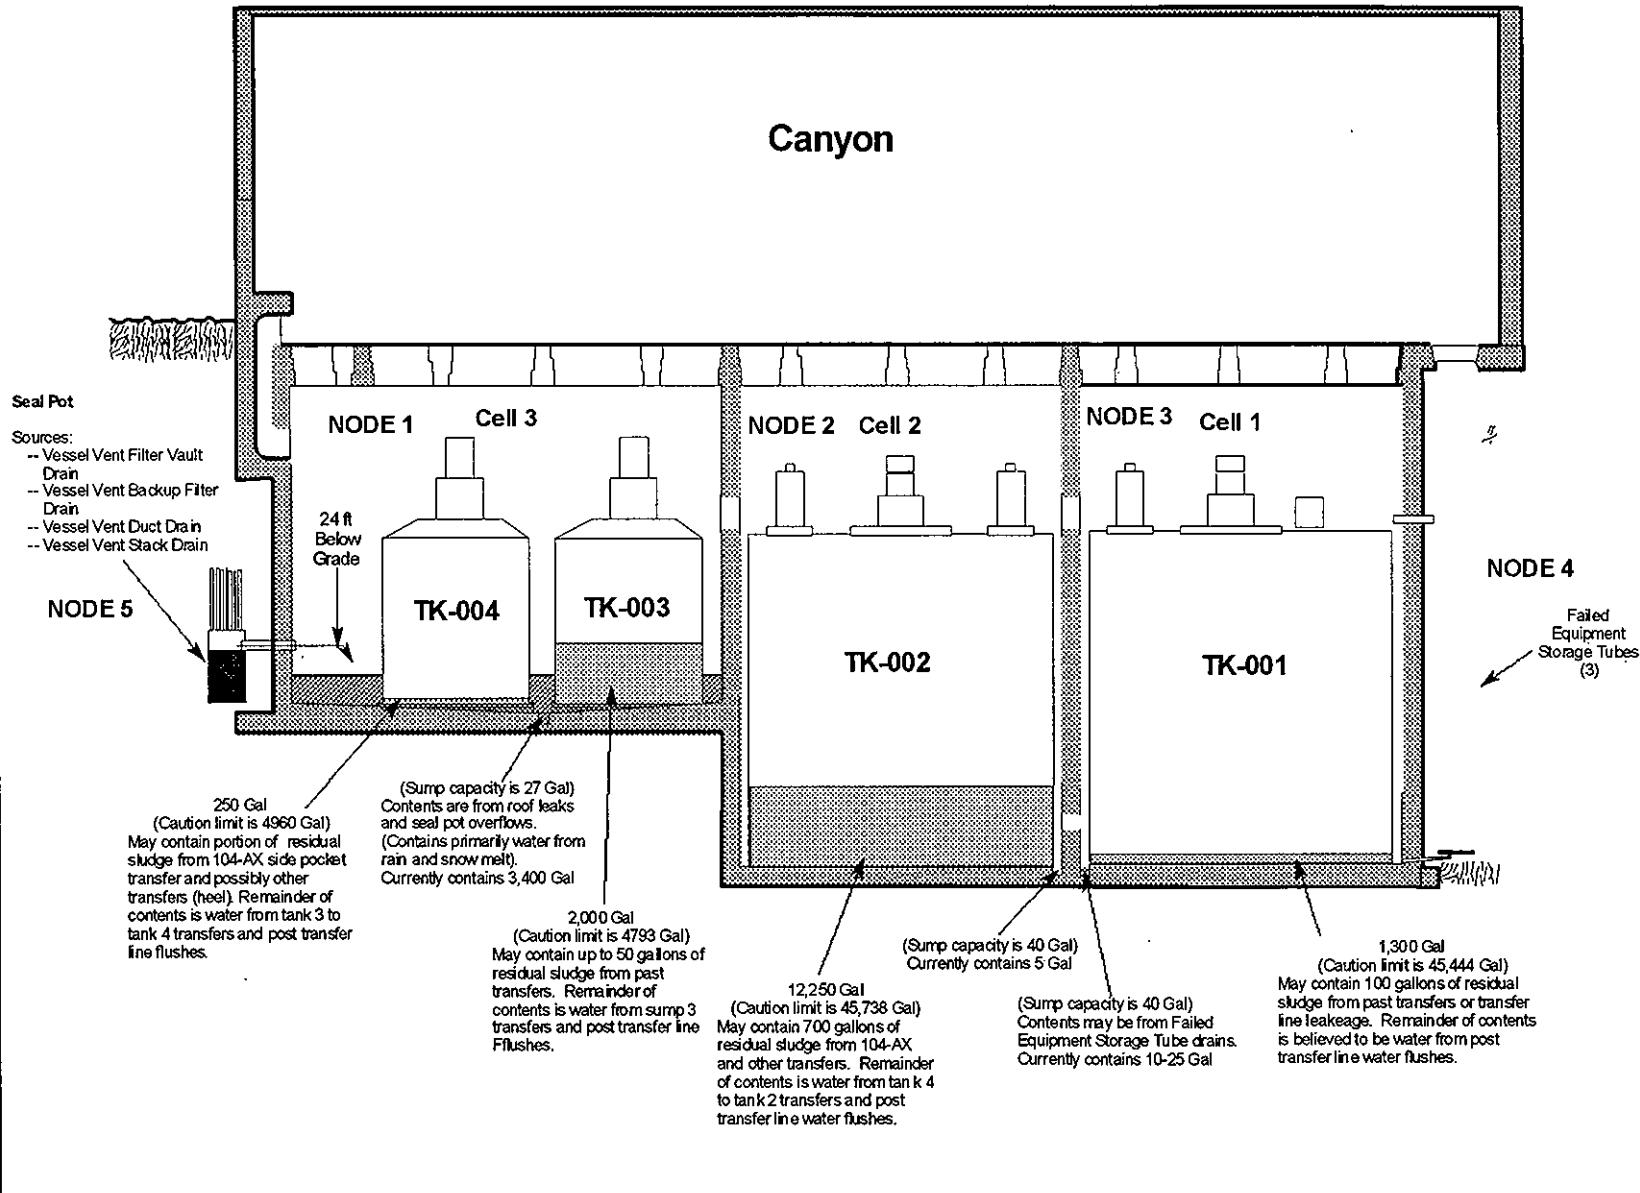
Figure 3-1. 244-AR Vault Facility HazOp Node Diagram

- Node 1: Cell 3 including TK-003 and TK-004
- Node 2: Cell 2 including TK-002
- Node 3: Cell 1 including TK-001
- Node 4: Failed Equipment Storage Tubes
- Node 5: Seal Pot Pit

Thirty-four hazardous conditions were identified as a result of the HAZOP process and are shown in Table B1, Appendix B. The hazardous conditions developed during the HAZOP were only for flooding of the vault cells. The hazardous conditions are sorted with respect to the five nodes listed in Section 3.1 and shown in Figure 3-1.
