**INTEGRITY ASSESSMENT REPORT
OF
TANKS TK-101 AND TK-102**

**PROJECT W-178
219-S SECONDARY CONTAINMENT UPGRADE**

Prepared for
Waste Management Hanford

Prepared by
David S. McShane P.E.
Fluor Daniel Northwest

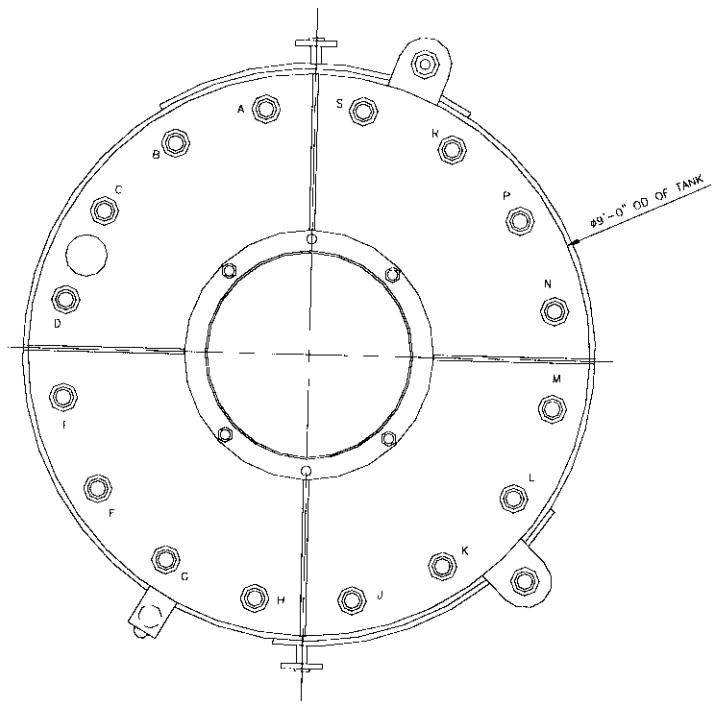
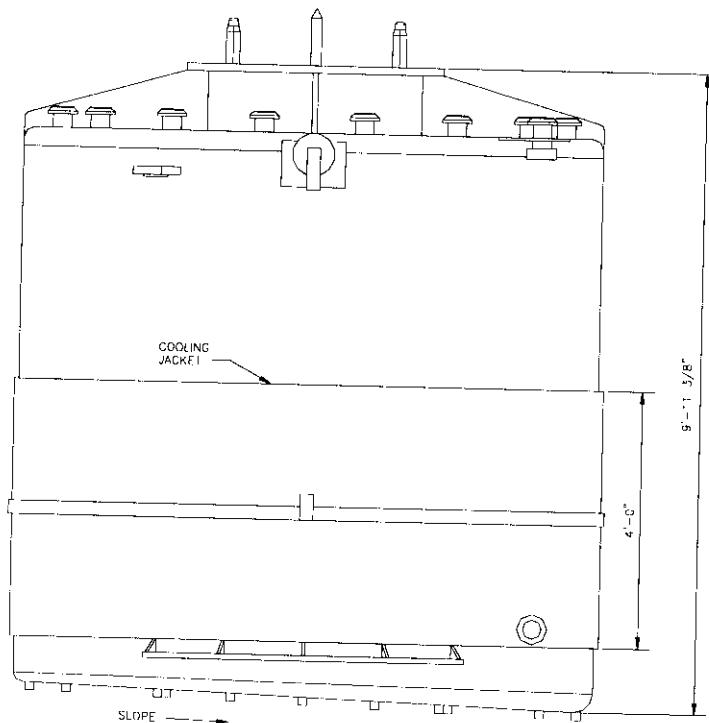
Figure 1,
Sketch of Tanks 101 and 102

Tanks 101 and 102 are 4300 gallon (9 ft-0 in. diameter by 9 ft-8 in. tall) stainless steel tanks fabricated in 1943 for U Plant (see Reference 2). The U Plant work was canceled before the tanks were installed. The tanks were secured for the 219 S Facility and placed into service in 1951. Both tanks were built to ASME standards (non code stamped) from Type 347 stainless steel with a shell thickness of 0.5 inches. The tanks were fabricated from plate connected with full penetration welds. The welding was radiographed. Each tank is equipped with a cooling jacket that covers the lower half of the tank. The tanks are designed to be operated at atmospheric pressure. The high-level alarm on Tank 101 set at 3600 gallons and Tank 102 set at 3800 gallons. A sketch of the tanks is shown in Figure 1. When installed in 1951, Tank 102 (functioning as a chemical treatment tank) was equipped with an agitator. Tank 101 (functioning as a collection tank) was not equipped with an agitator.

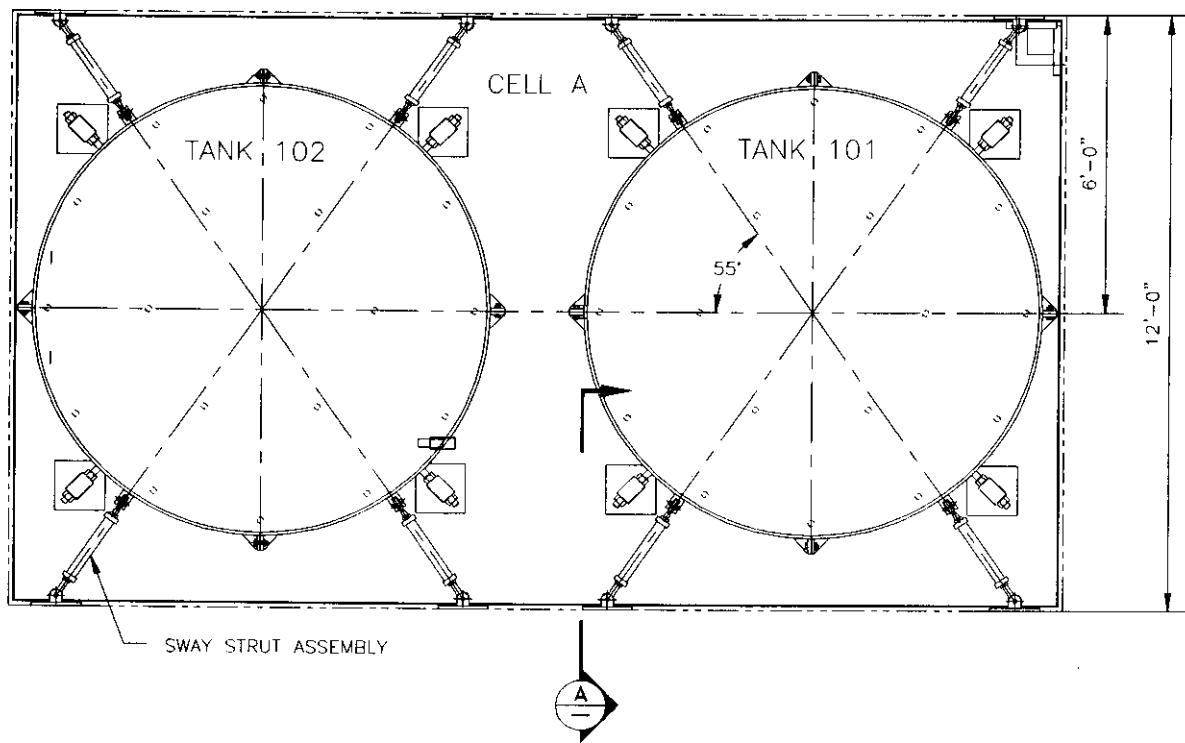
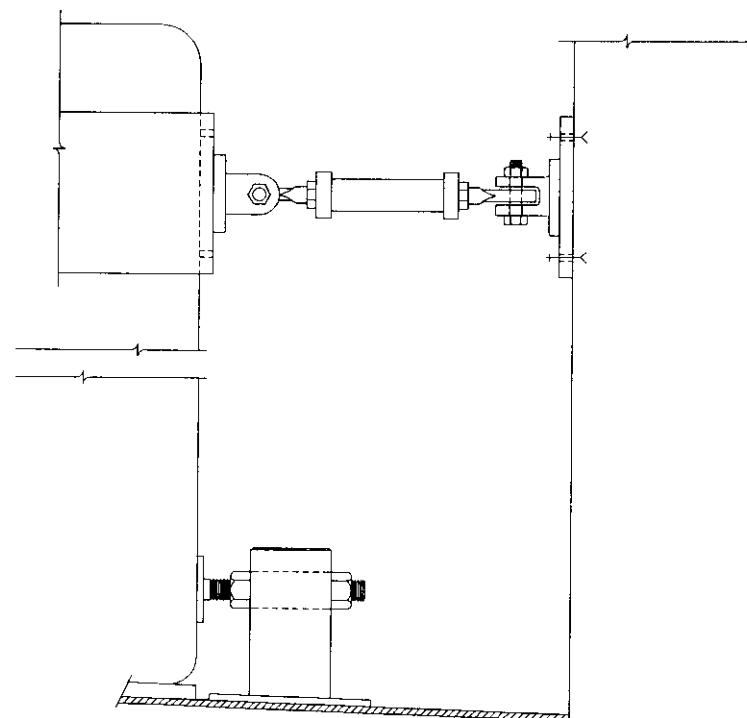
Figure 3,
Seismic Restraints for Tanks 101 and 102

The analysis showed the need for additional seismic restraints. These restraints were installed as part of project W-178. Seismic restraints were placed at the top and bottom of the tanks as shown in Figure 3. The analysis of the restraints is presented in calculation W-178-C02 (Reference 10). The analysis also demonstrated that nozzle reinforcement is not required.
