1 ECN 657602

PFP EMERGENCY LIGHTING STUDY

EDT/ECN	657602	UC	506
Org Code	15510	CACN	110793
B&R Code	EW7002000	Total Pages	31

Abstract This engineering study documents PFP's current emergency light configuration and light levels, identifies deficiencies in the emergency lighting system and proposes lighting upgrades to more closely comply with NFPA 101 Section 5.9 requirements

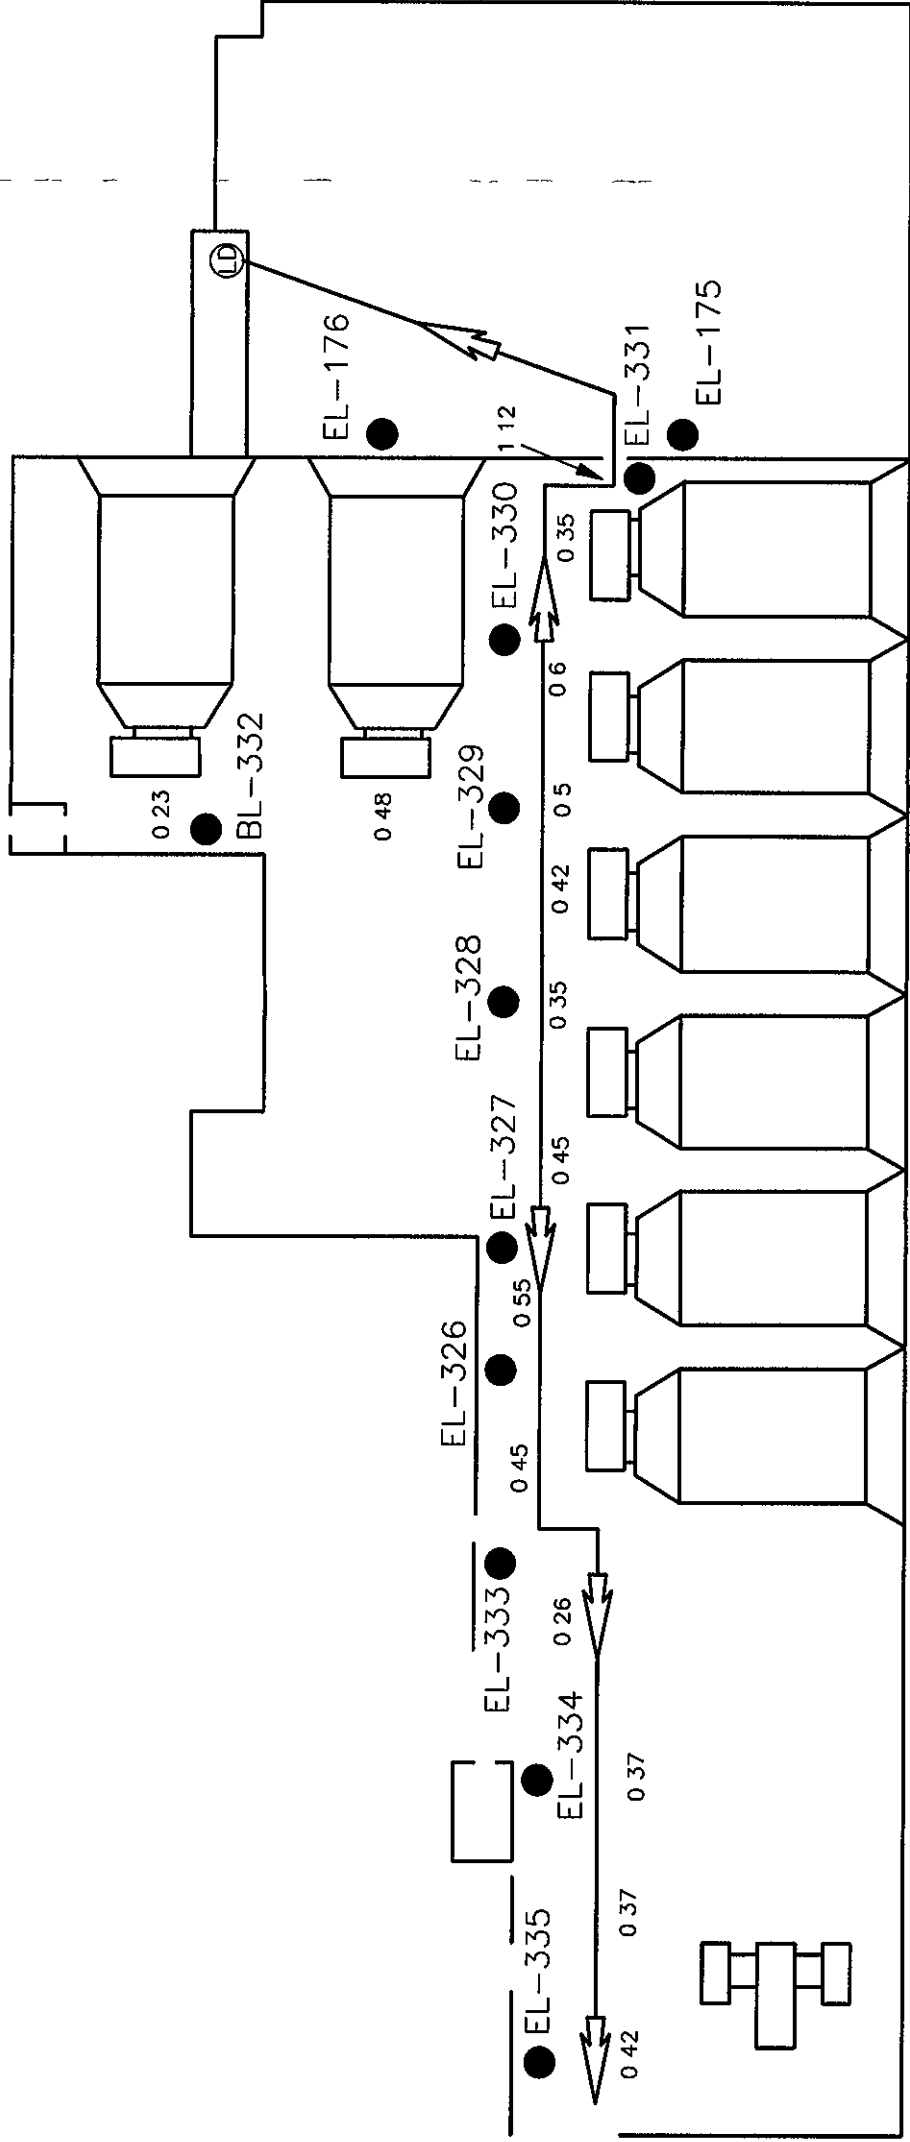
GROUP	I
BUILDING	234-5Z
LOCATION	Room 321
PRIORITY	1

This area had no emergency light coverage and was completely dark during a normal lighting outage. Room 321 provides the only egress for the Control Room, which is manned 24 hours per day, 7 days a week. No other area had this high of an occupancy with such low emergency light levels. Additionally, Room 321 contains many safety hazards, including rotating machinery, bump and trip hazards, and a non-standard room configuration with smaller adjoining rooms and offices.

THIS AREA WAS UPGRADED IN 11/98 BY
WORK PKG 97-1694 NO FURTHER ACTION
IS NECESSARY

As shown in Appendix A, 10 Emergency Lights were added along the egress routes in this room under work package 97-1694. Light levels along the egress routes now measure about 0.5 footcandles. No further upgrades will be made to this room. The west roof emergency lighting was previously upgraded under Work Package 2Z-96-2410 to provide lighting from the Room 321 exit onto the west roof to the two ladders down the south walls.

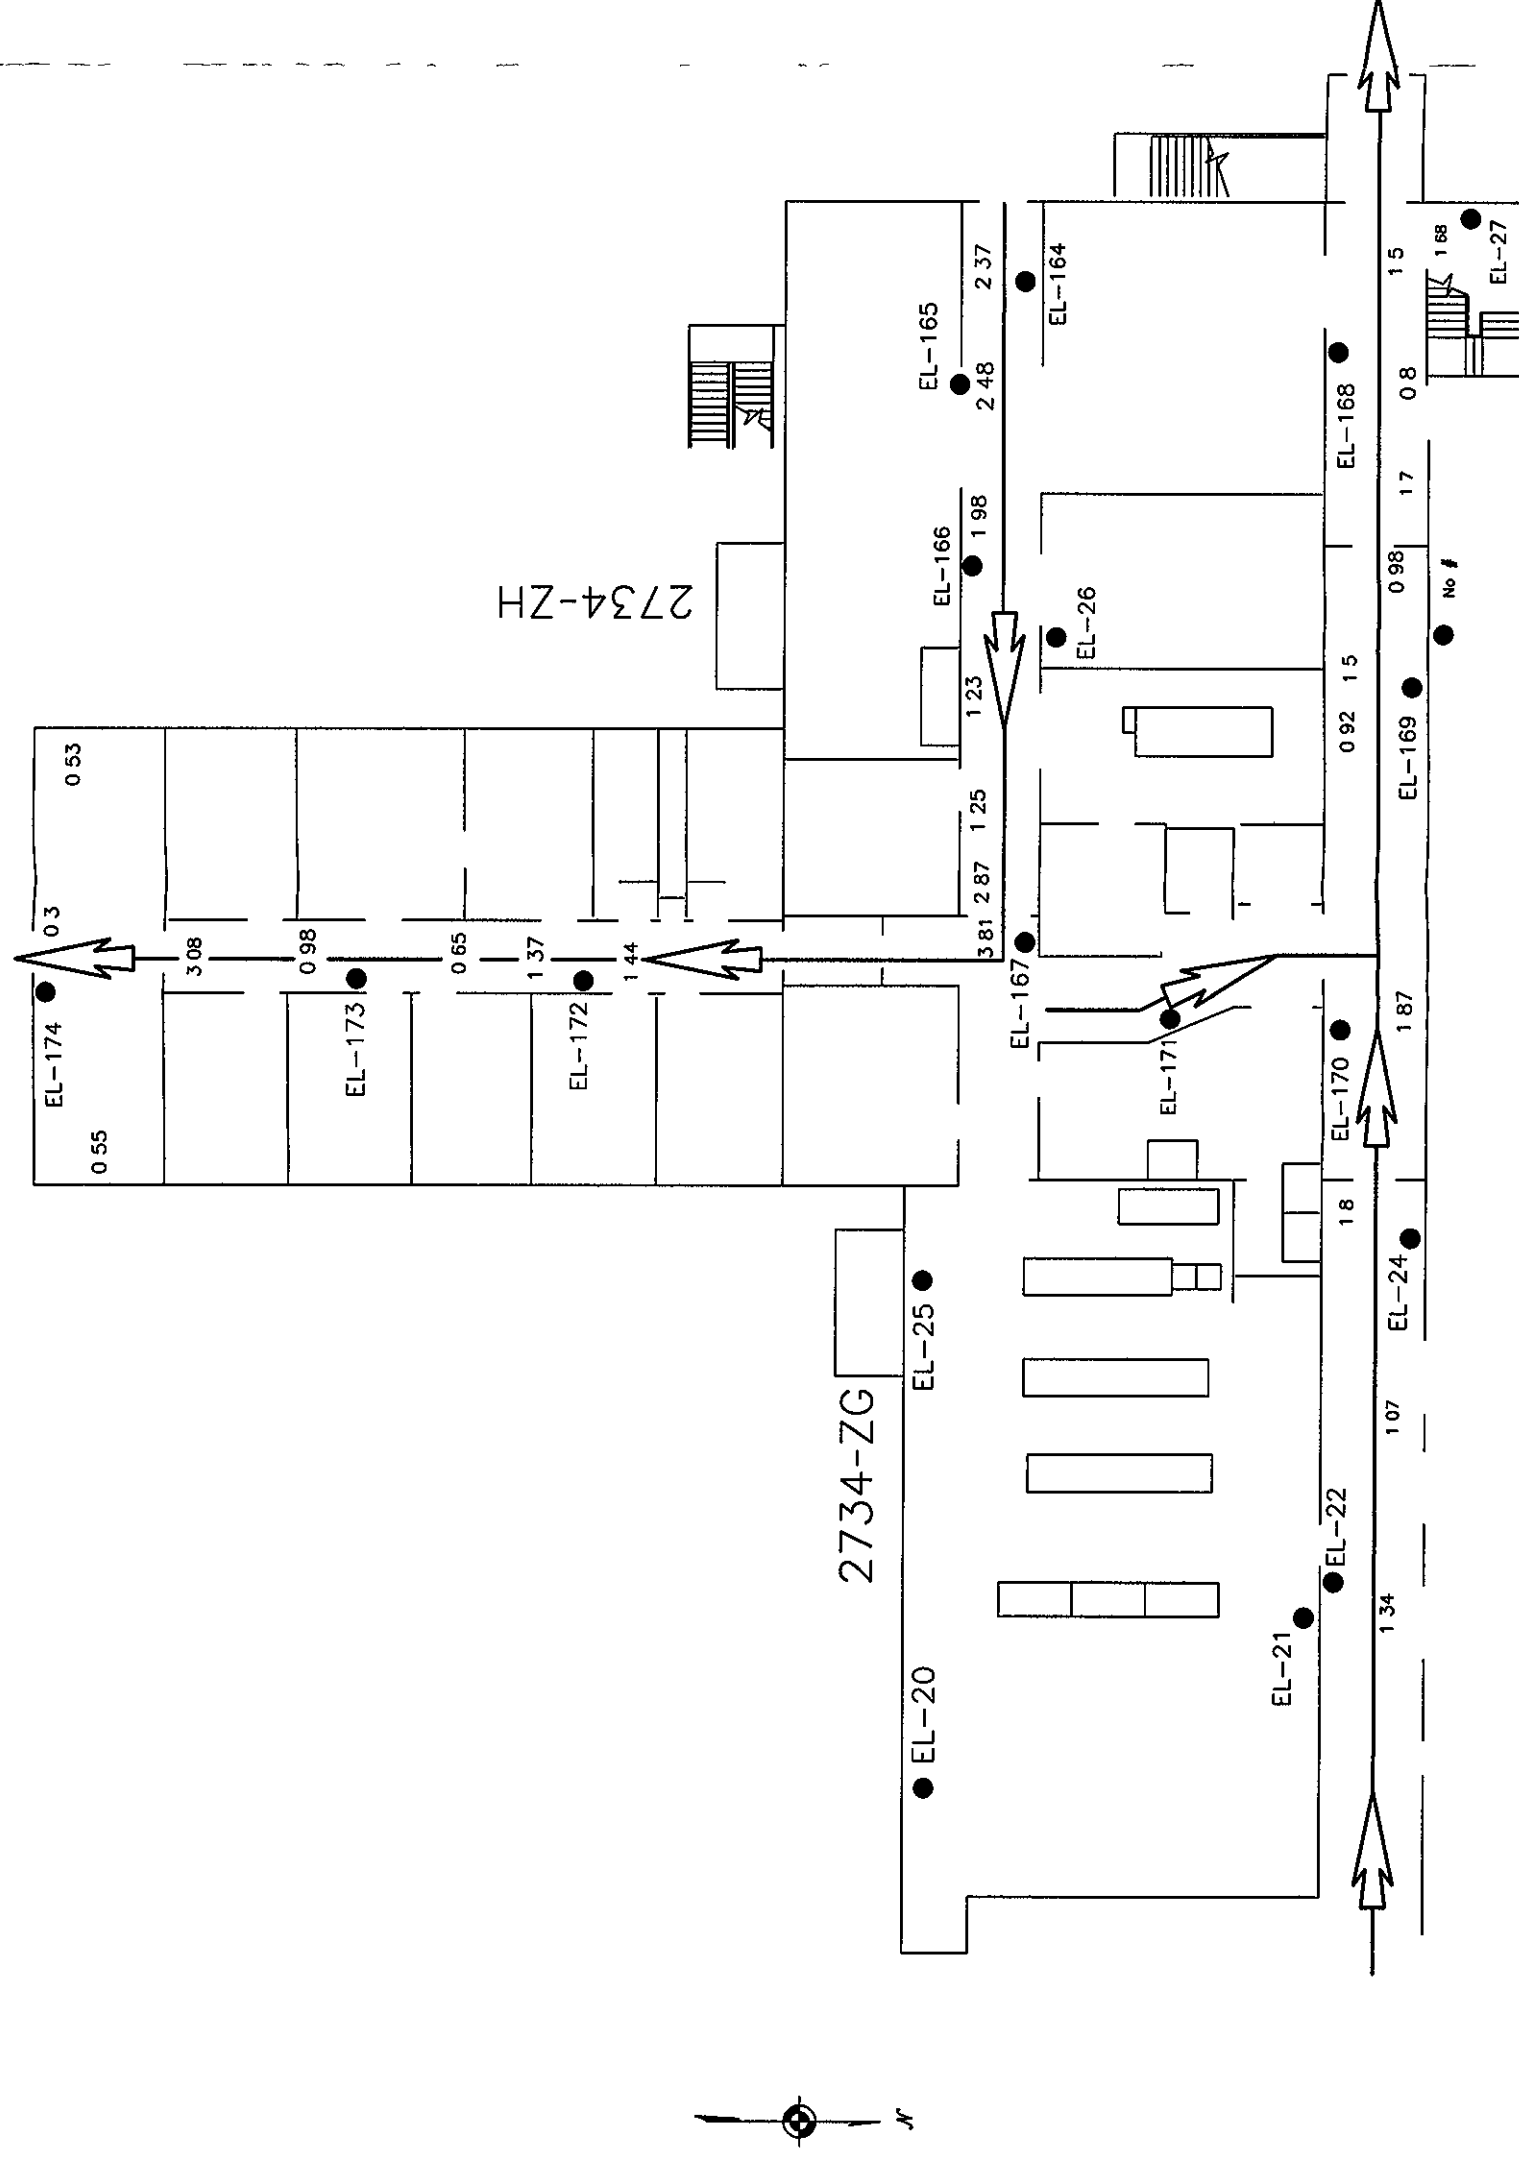
GROUP	D
BUILDING	234-5Z
LOCATION	LAB ANNEX
PRIORITY	2

These corridors provide access to the three main exterior exits from the southwest corner of the building. Although this area is a fairly standard office configuration, it had no emergency lighting at the time of the survey. As such, it was listed as priority two.

These corridors were upgraded with 11 new lights installed as shown in Appendix A under Work Package 2Z-97-1992. All light levels now meet or exceed the NFPA requirements.

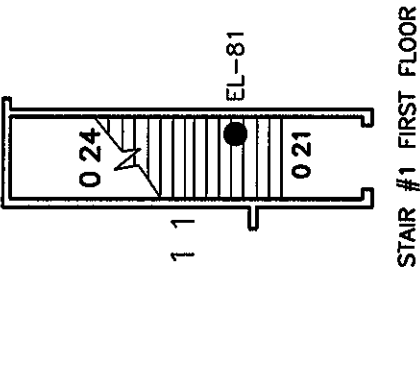
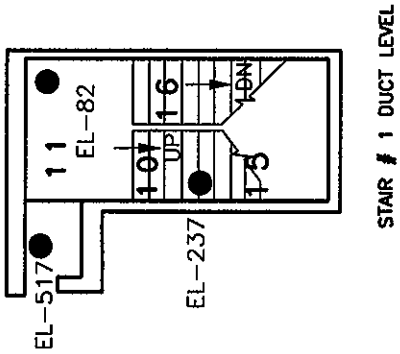
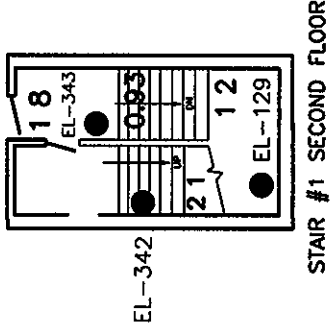
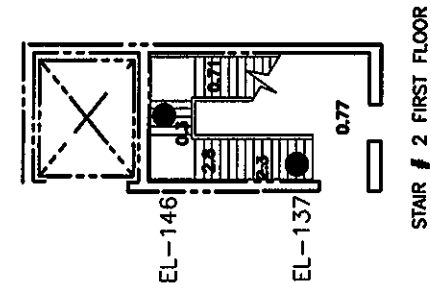
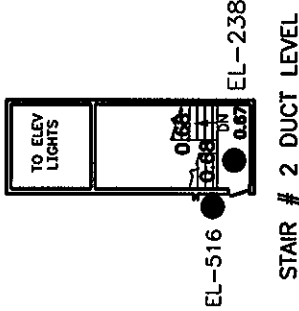
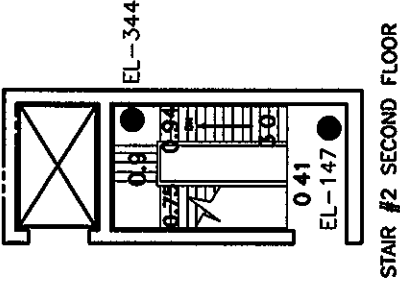
GROUP J
BUILDING 234-5Z
LOCATION Stairs
PRIORITY 3

The stairs in building 234-5Z did not meet the NFPA requirements. Most had areas of low light levels, and some had flights with no emergency light coverage. These deficiencies represented significant trip and fall hazards during a lighting outage, especially during a building evacuation. The stairs are the only emergency egress routes available from the second floor and duct level. Since most stairs had at least some levels of emergency lighting, they were assigned a priority of three.

THIS AREA WAS UPGRADED IN 1/99 BY
WORK PKG 98-1374 NO FURTHER ACTION IS NECESSARY

As shown in appendix A, 16 additional lights were installed in stairs under Work Package 2Z-98-1374 to raise the stair emergency light levels to NFPA requirements. The lighting level average for all the stairs now meet or exceed the NFPA requirements. Stair 6 was upgraded under a previous package and did not require any additional lighting.

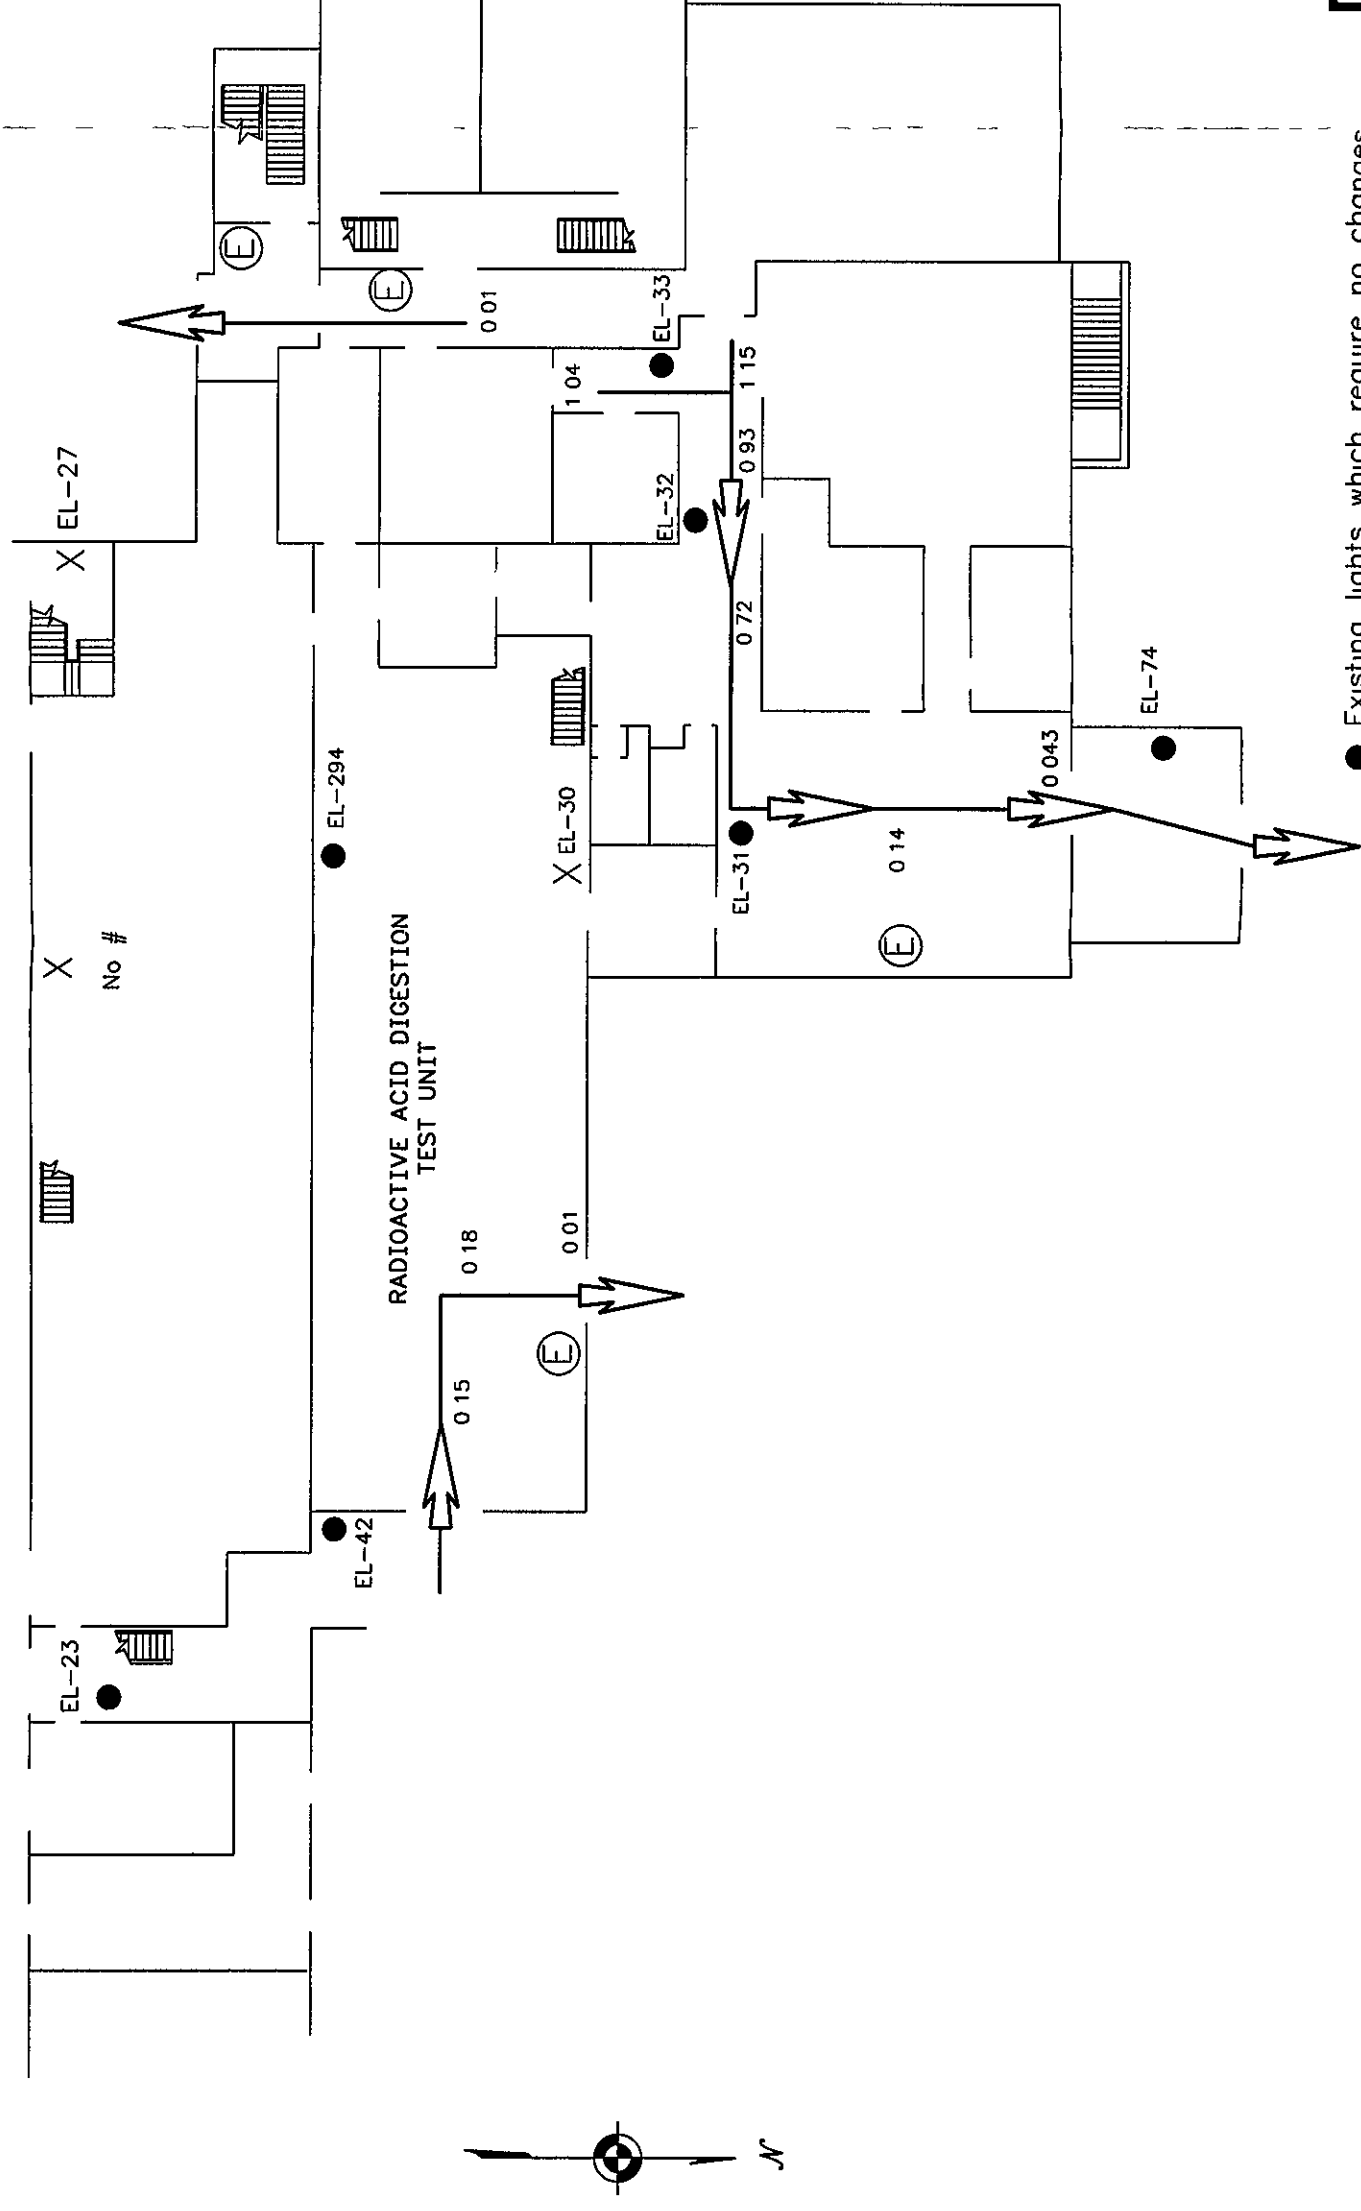
GROUP	C
BUILDING	234-5Z
LOCATION	RADTU
PRIORITY	4

The egress routes in this backside area provide two of the three exterior exits for the northwest part of the building through large open areas with non-standard room and hallway configurations. This RADTU area has numerous areas well below the 1.0 footcandle average requirement coupled with several dark spots also below the 0.1 footcandle minimum. Due to the level of existing emergency light coverage and the absence of the trip and fall hazards associated with stairs, this area was placed fourth on the prioritized list.

● Existing lights which require no changes
 (E) Lights to be added (4)
 X Lights to be removed (3)

Upgrading the emergency lighting will require 5 additional lights as shown in Appendix A. There are also 3 lights to be removed and 1 light on an incorrect power source.

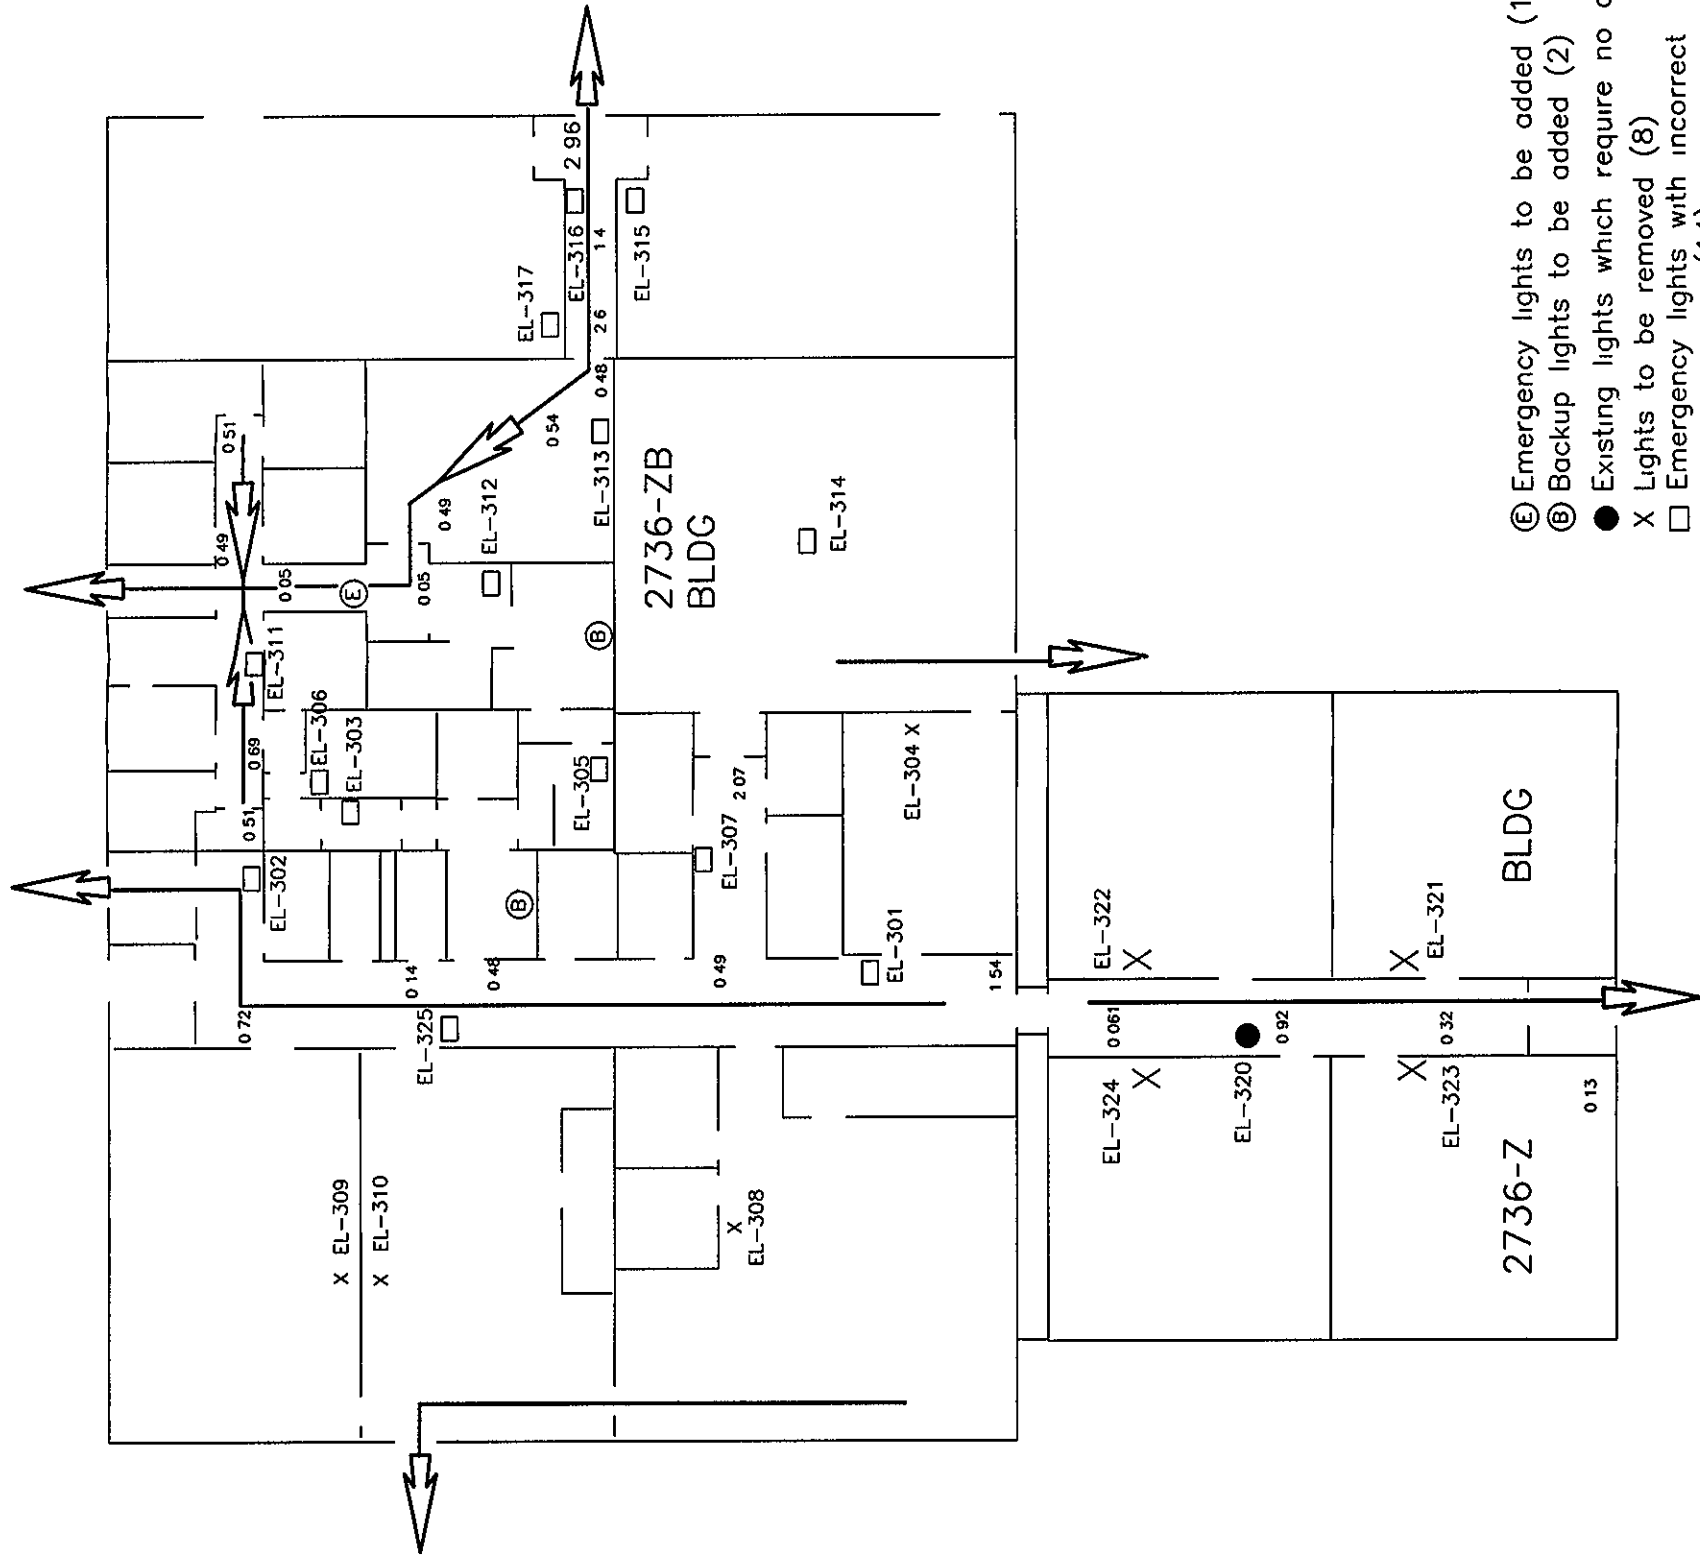
GROUP	O	2736-Z & ZB
BUILDING		
LOCATION	All	
PRIORITY	6

Although these buildings already have installed Emergency Lights, the lights are connected to the emergency lighting panels instead of the normal lighting panels. All lights in these buildings will be rewired to the normal lighting circuit in that area. Since the existing lights will illuminate if power is lost to the emergency panels and the existing light levels are approximately 0.5 footcandle average, this group was placed sixth on the priority list.

- ⓔ Emergency lights to be added (1)
- ⓑ Backup lights to be added (2)
- Existing lights which require no changes
- X Lights to be removed (8)
- Emergency lights with incorrect power sources (14)

One new Emergency Light will be added as shown in Appendix A to correct a low intensity area in the entry corridor. For the remainder of the building, even though the current light levels do not quite meet the NFPA requirements, new Emergency Lights will not be added due to the reasonable existing coverage. Two Backup Lights will be added to the change room exits for added personnel safety during normal egress during a lighting outage. The 8 lights in the 2736-Z and ZB vaults will be removed since the vault doors remain open if people are inside. In an egress situation, illumination will be provided from the corridor Emergency Lights. This represents a significant exposure and manhour reduction.

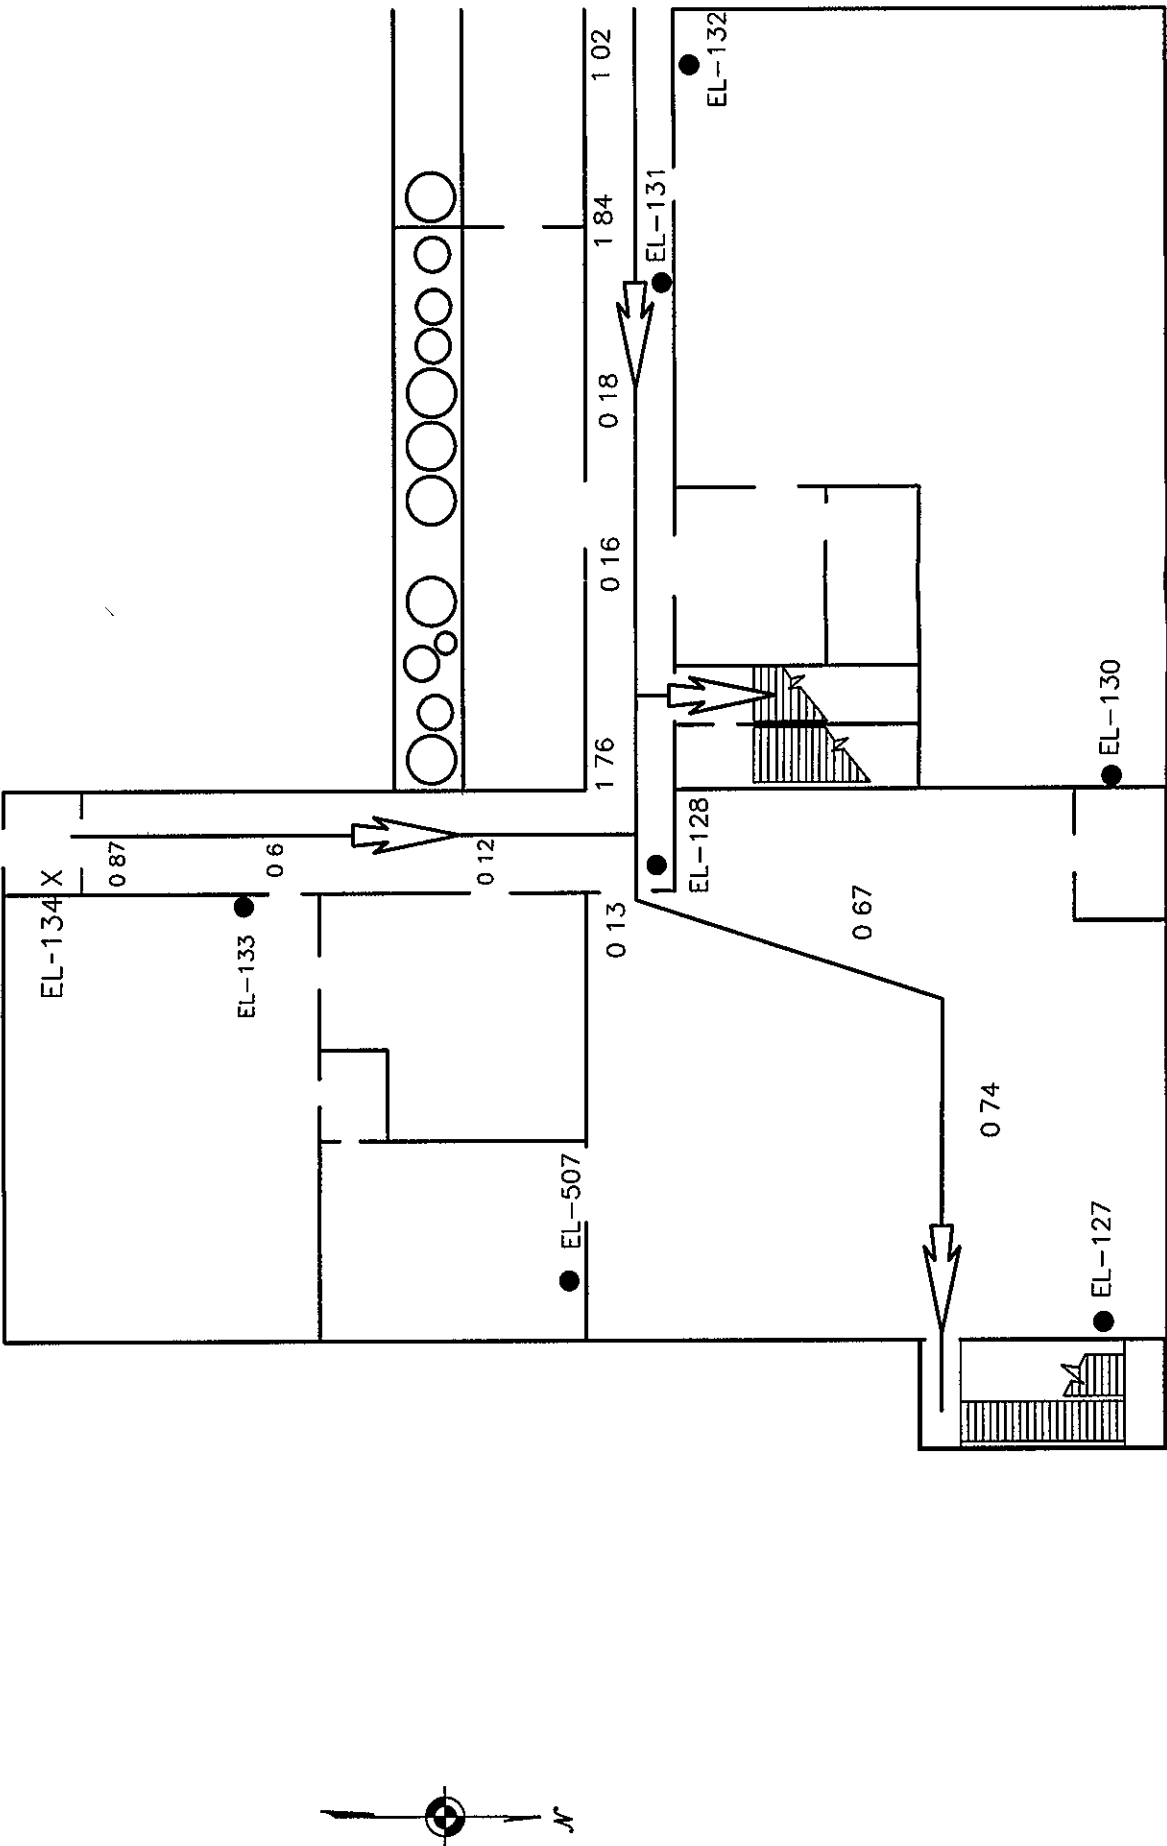
GROUP	G
BUILDING	234-5Z
LOCATION	2nd floor east
PRIORITY	7

This is a standard hallway/office area with a few dark spots along the egress route. These low intensity spots below the 0.1 footcandle minimum will be upgraded with 3 additional lights as shown in Appendix A. The remainder of the egress routes will not be upgraded as explained above due to the limited life expectancy of the facility and the existing light levels. There are 2 lights to be removed and 2 lights with incorrect power sources.

● Existing lights which require no changes
X Lights to be removed (1)
Note Numbers along egress routes are light level measurements taken under WP 95-959

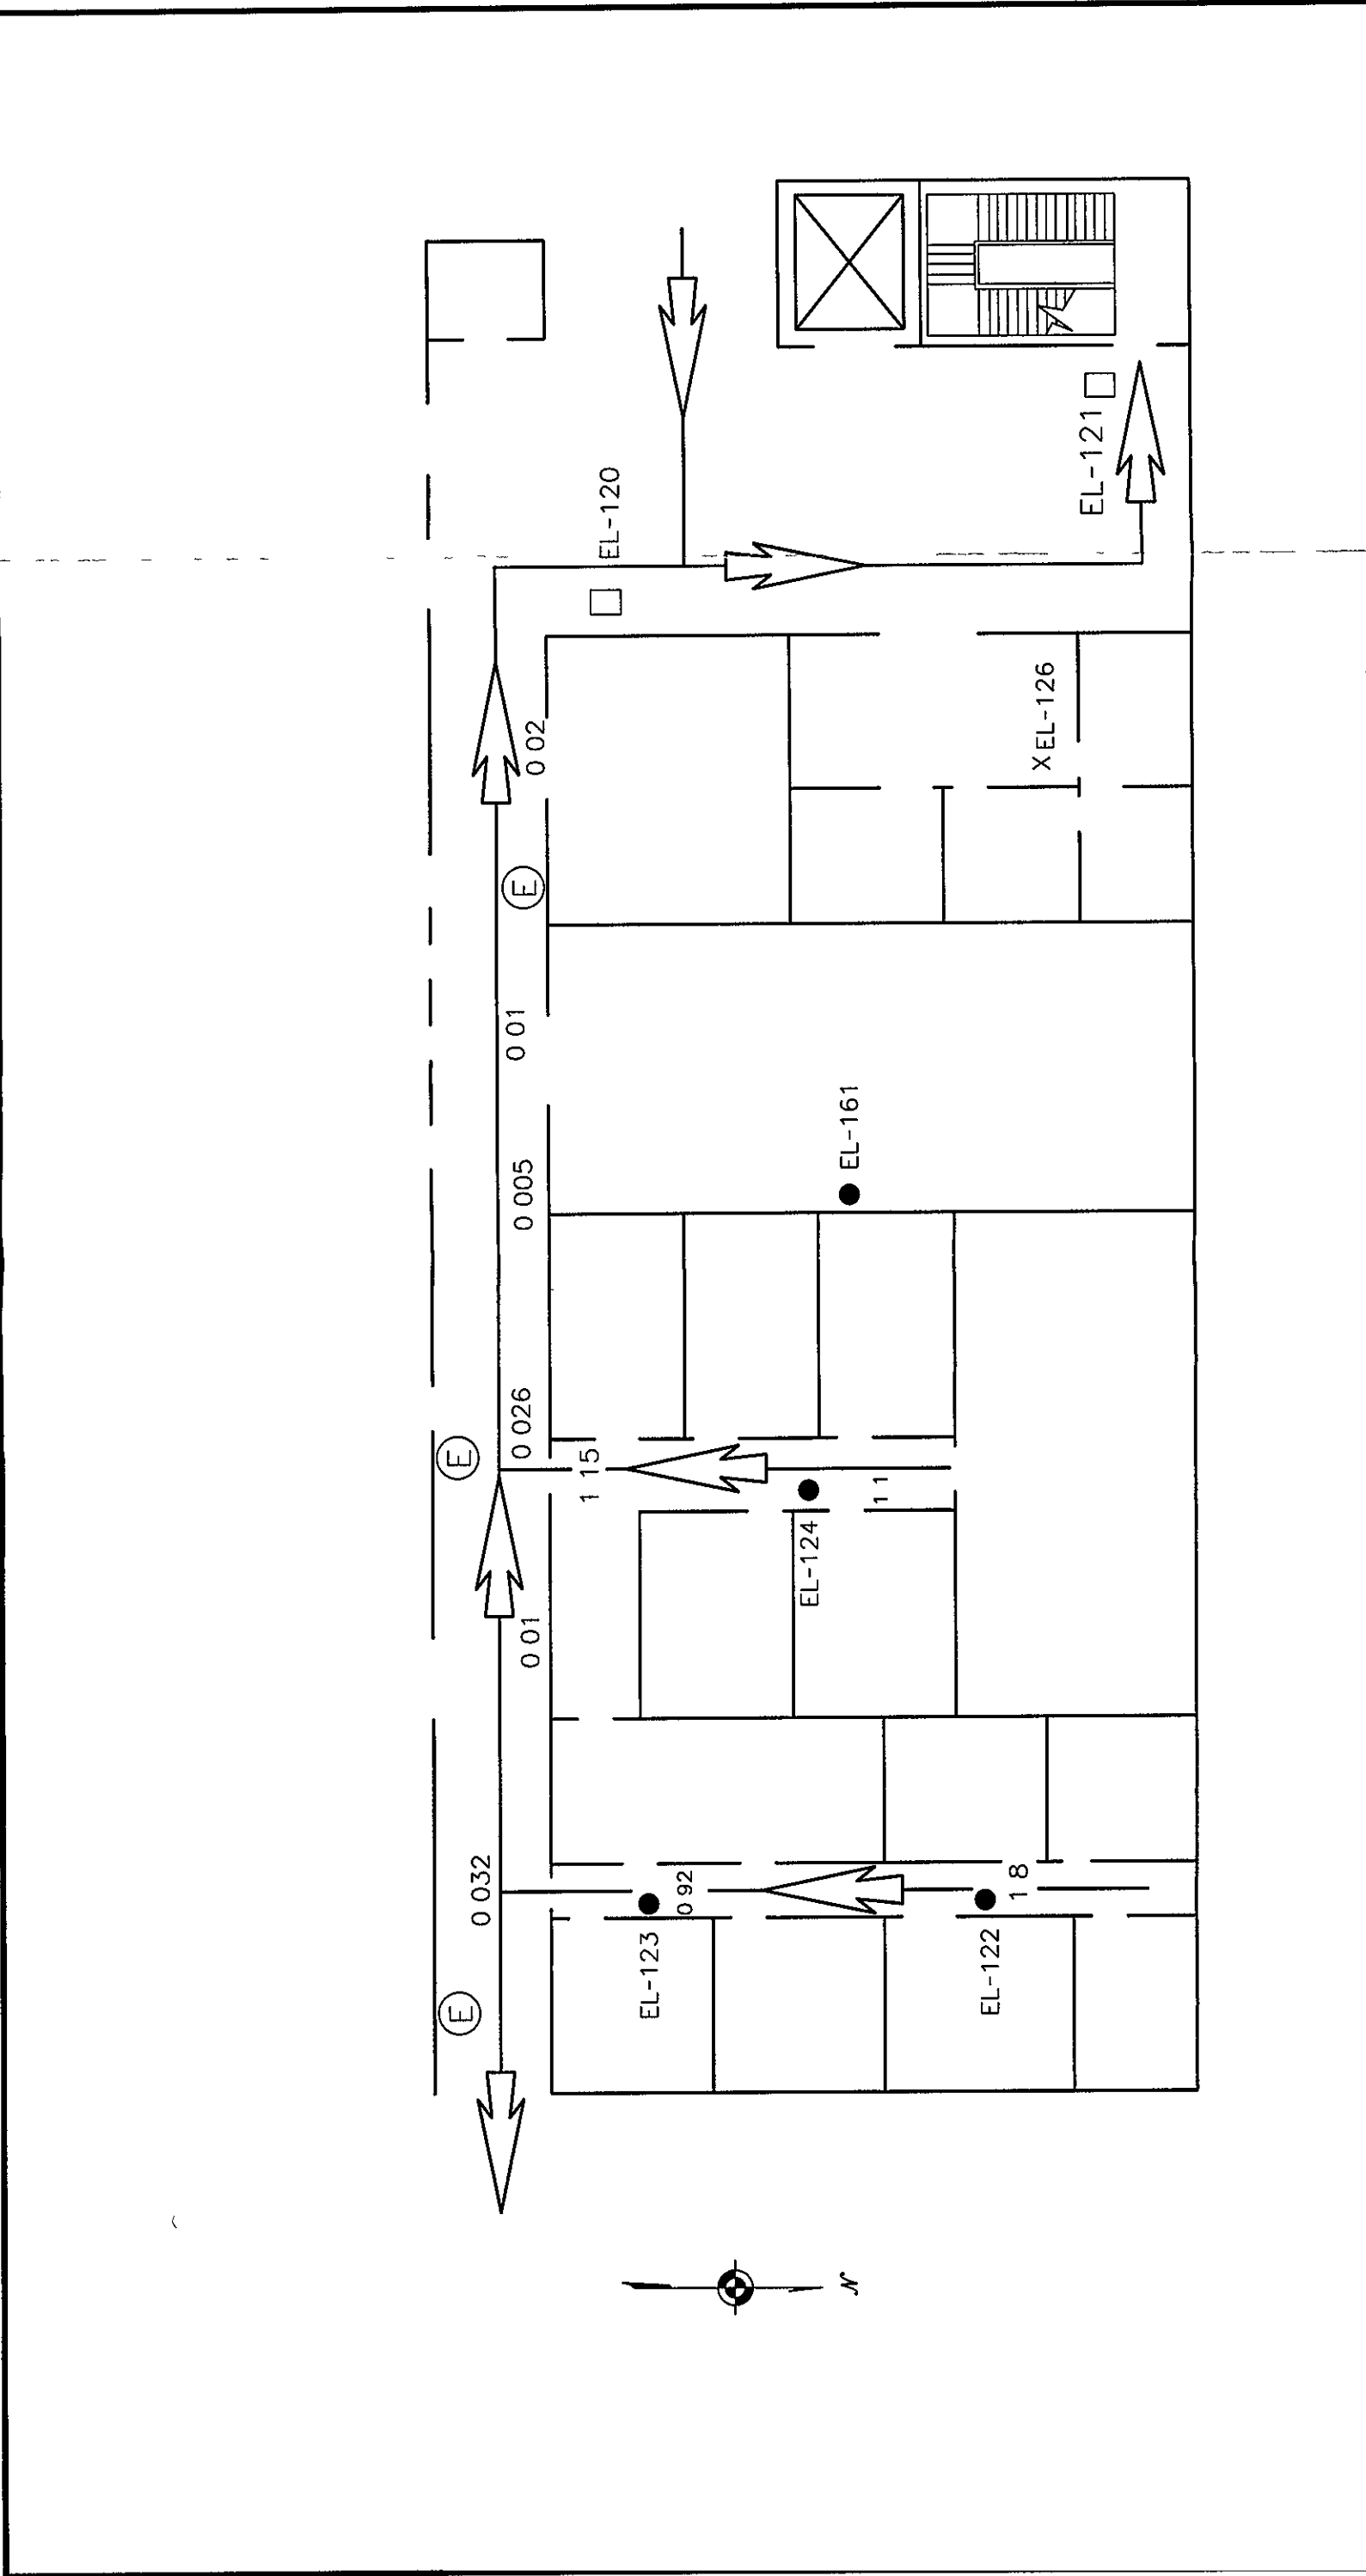
GROUP	H
BUILDING	234-5Z
LOCATION	2nd floor east
PRIORITY	7

- Existing lights which require no changes
 - ⓔ Lights to be added (3)
 - X Lights to be removed (1)
 - Emergency lights with wrong power sources (2)
- Note Numbers along egress routes are light level measurements taken under WP 95-959

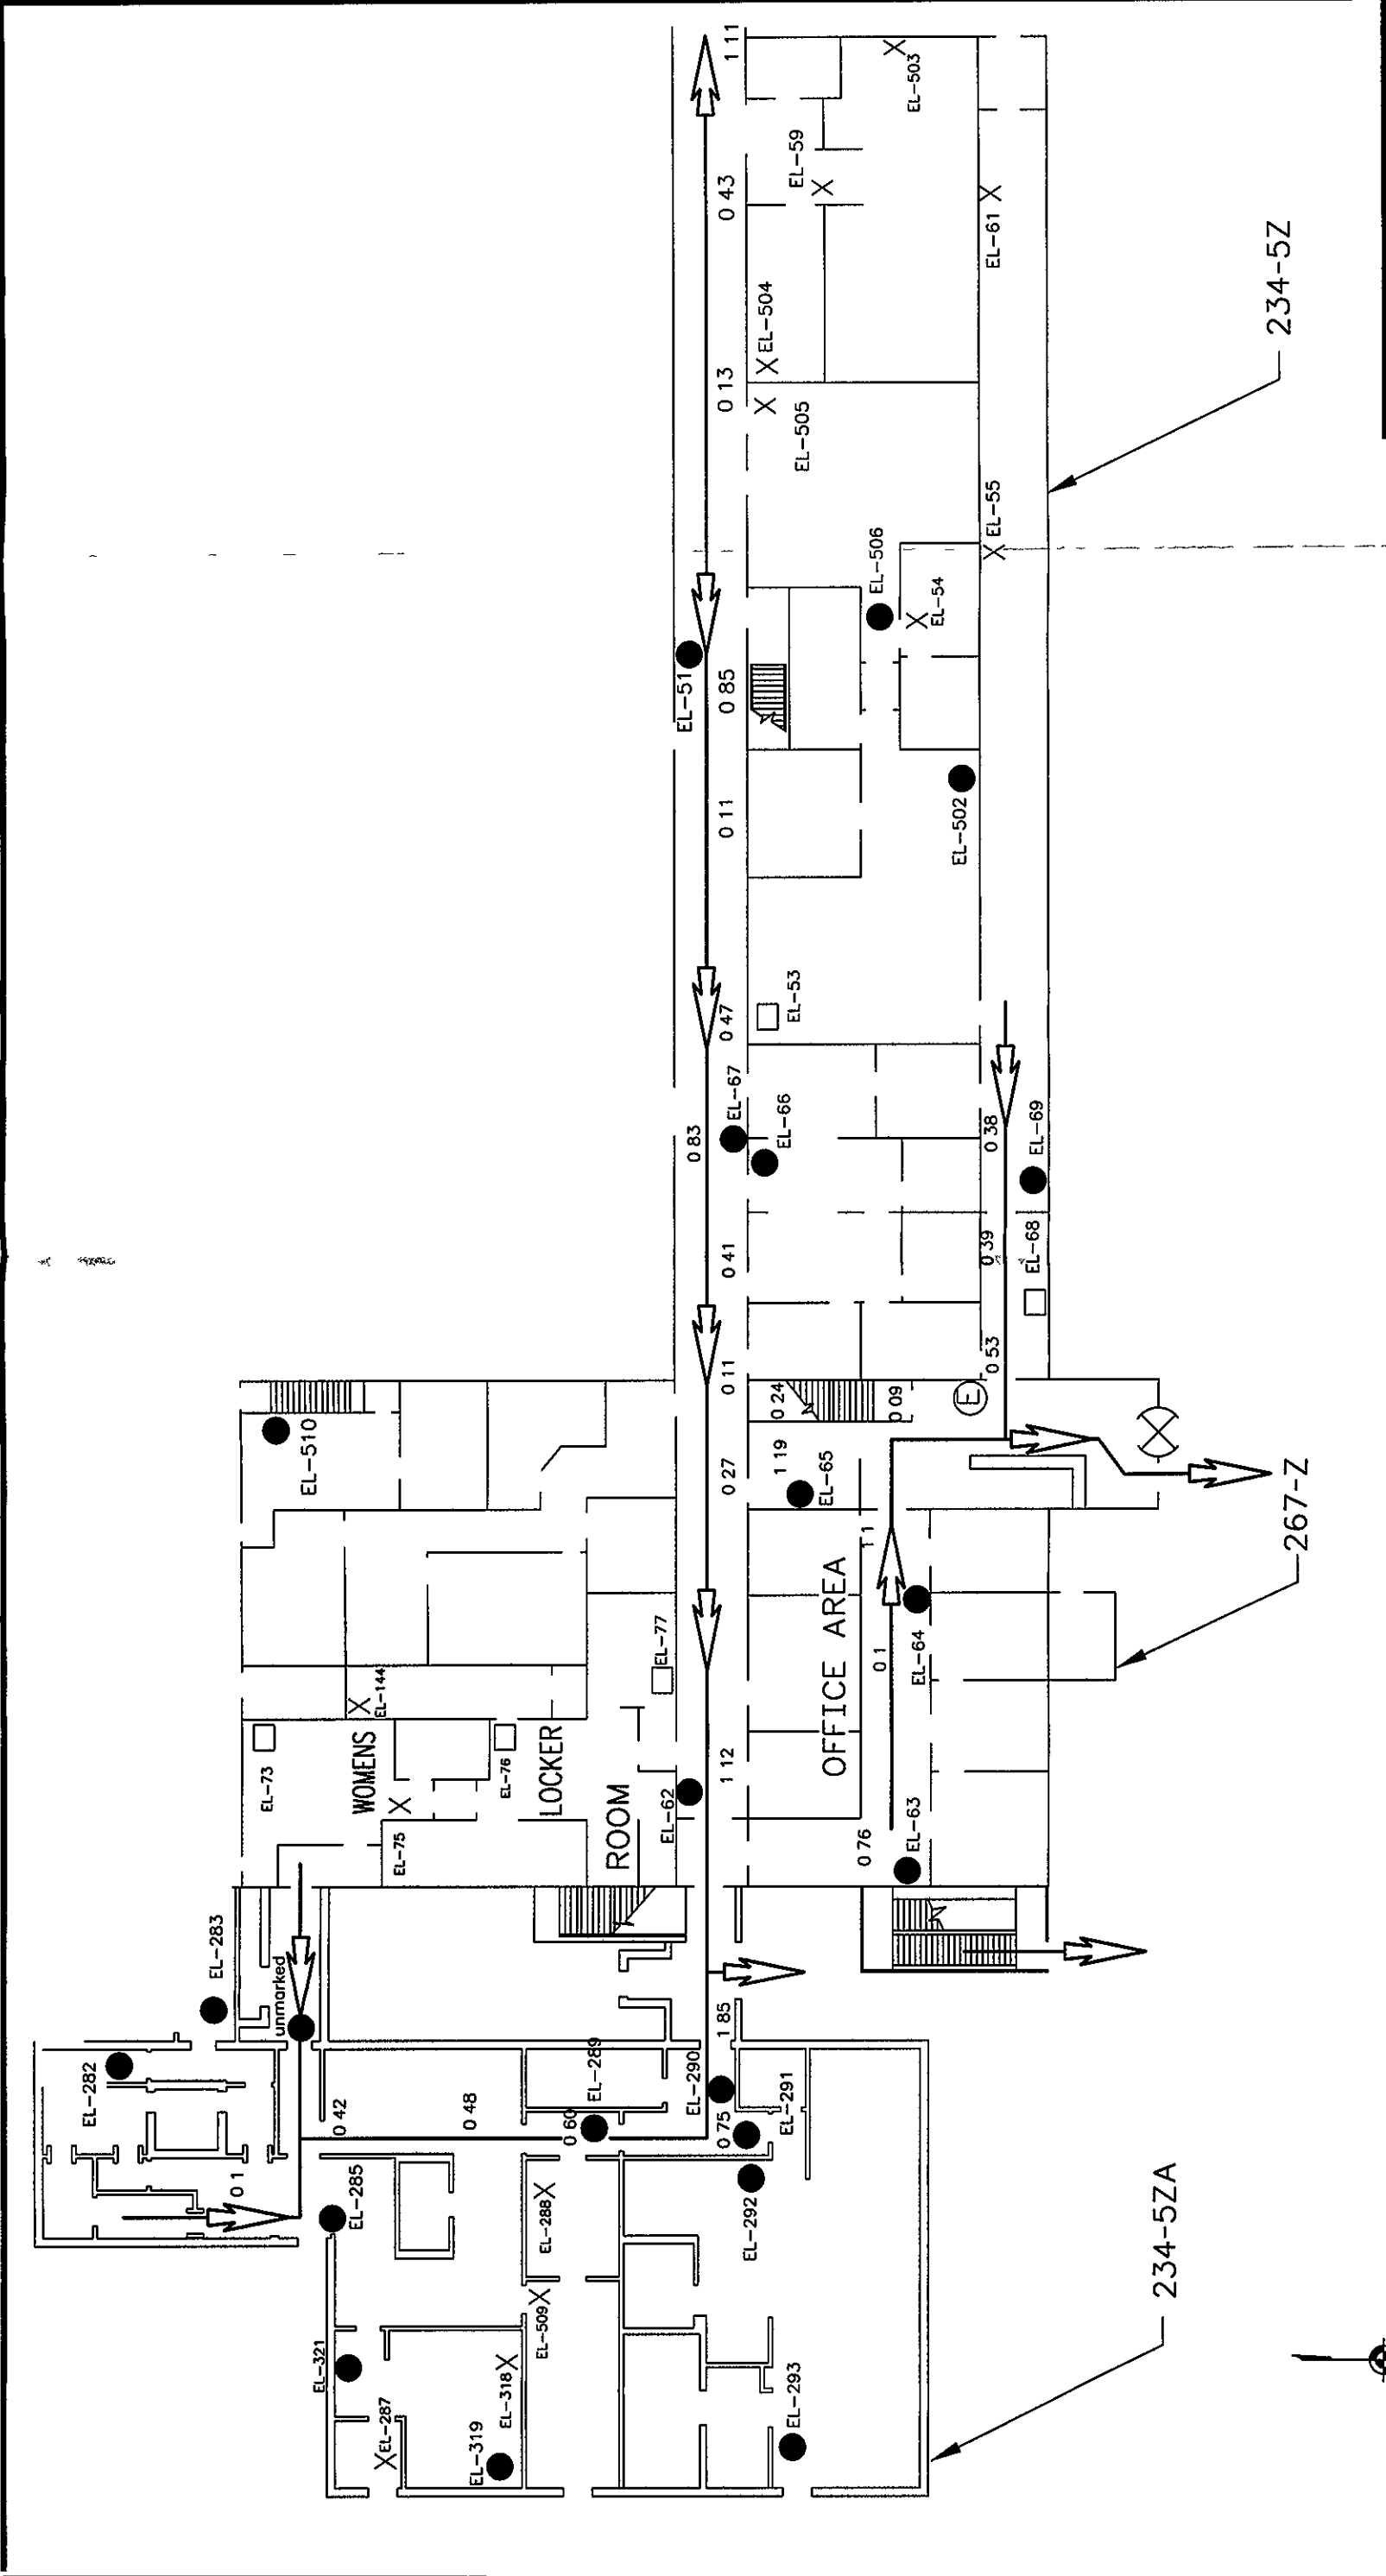
GROUP	A
BUILDING	234-5Z
LOCATION	Front side offices & change room
PRIORITY	8

As in Groups G & H above, only the areas below 0.1 footcandle will be upgraded. This will require one light positioned as shown in Appendix A. Additionally, 13 lights will be removed, 6 lights have incorrect power sources, and 2 lights require relabeling.

- Existing lights which require no changes
 - ⓔ Lights to be added (1)
 - X Lights to be removed (15)
 - Emergency lights with wrong power sources (5)
- Note Numbers along egress routes are light level measurements taken under WP 95-959
