1 ECN 657602

PFP EMERGENCY LIGHTING STUDY

EDT/ECN	657602	UC	506
Org Code	15510	CACN	110793
B&R Code	EW7002000	Total Pages	31

Abstract This engineering study documents PFP's current emergency light configuration and light levels, identifies deficiencies in the emergency lighting system and proposes lighting upgrades to more closely comply with NFPA 101 Section 5.9 requirements

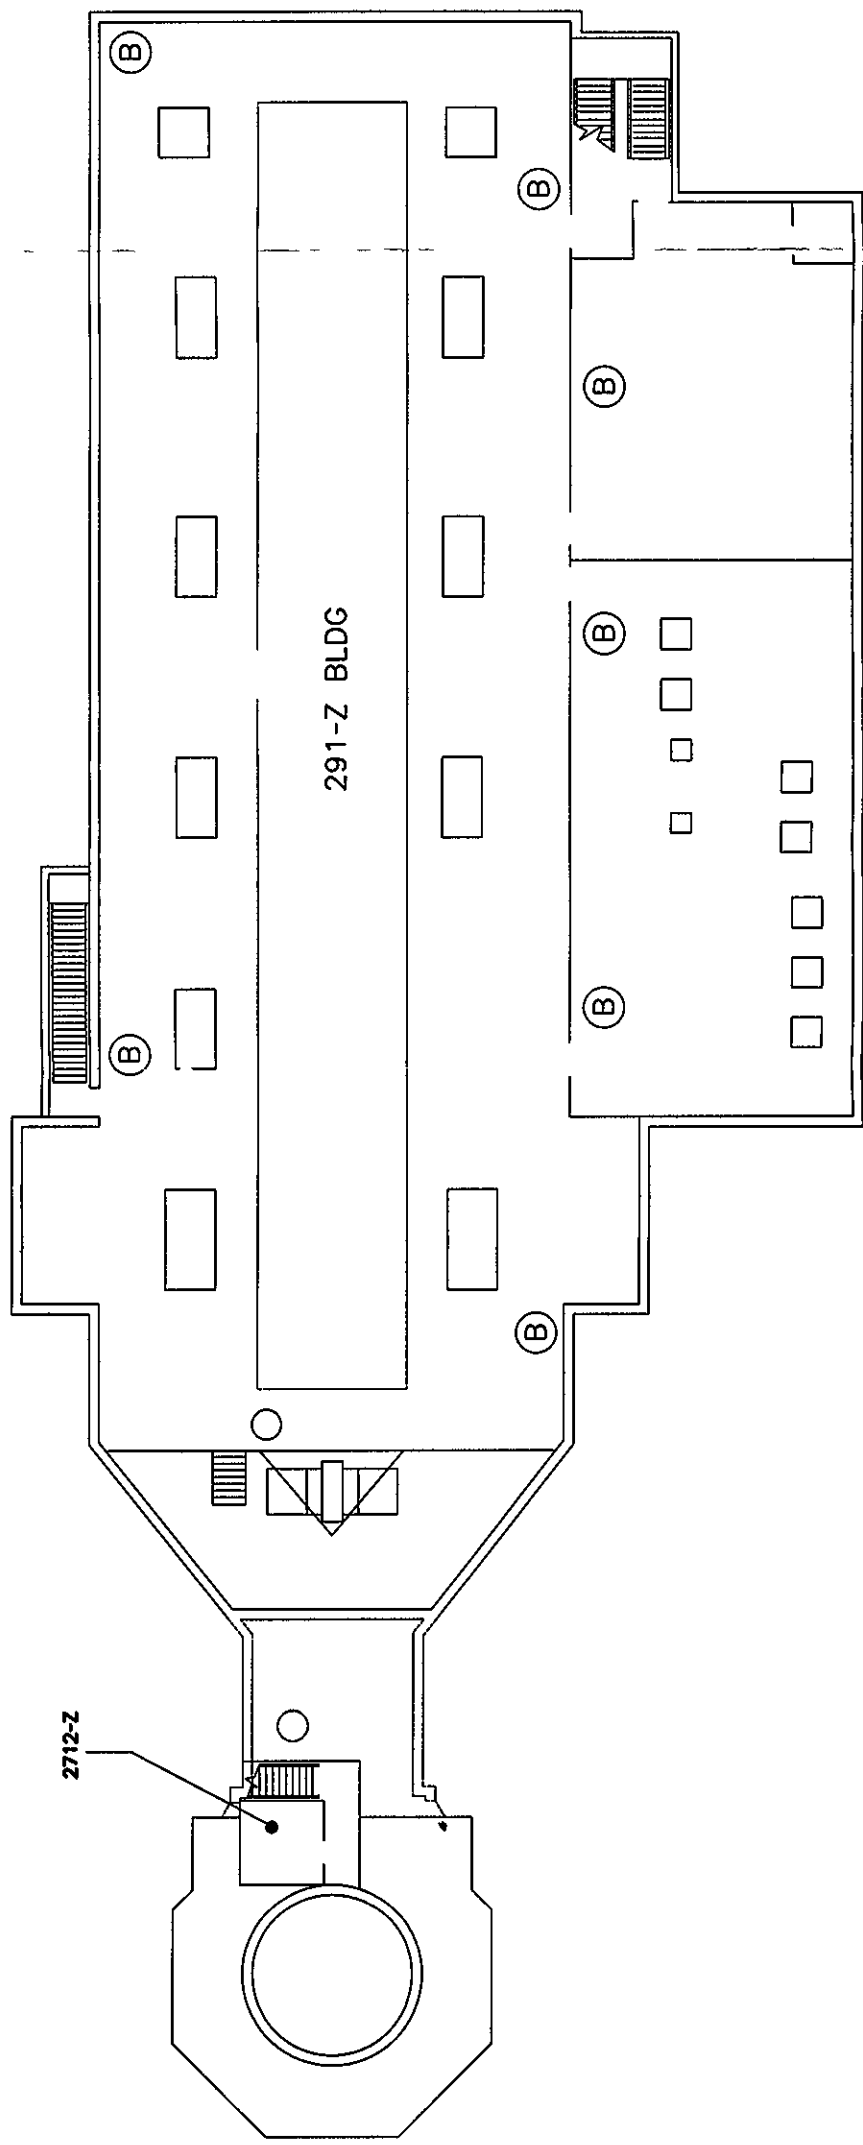
GROUP	N
BUILDING	291-Z
LOCATION	General
PRIORITY	10

Due to the industrial nature of the building and lack of natural light, approximately 7 Backup Lights will be installed as shown in Appendix A. As Backup Lights, they are not required by NFPA, and will be placed on the quarterly maintenance cycle. This is the highest non-egress route priority.

ⓑ Backup Lights to be added (7)

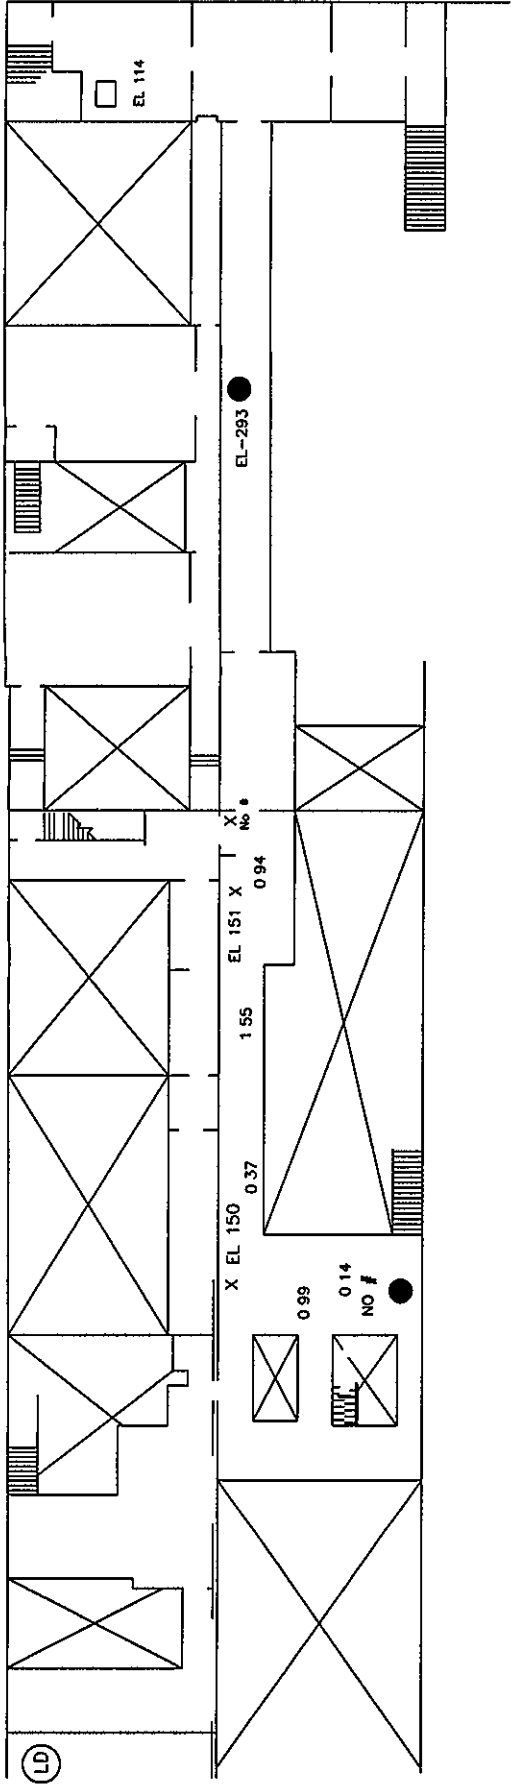
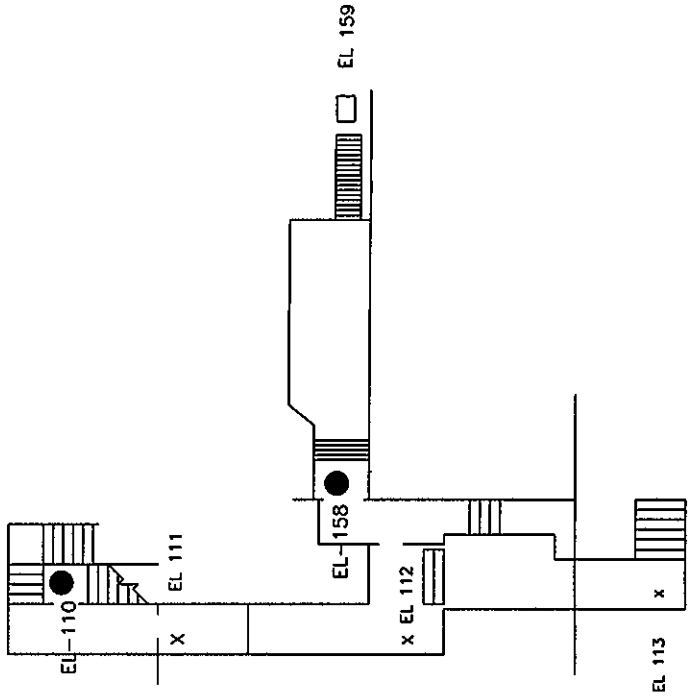
GROUP	R
BUILDING	234-5Z
LOCATION	Mezzanine level
PRIORITY	11

- Existing lights which require no changes
- X Lights to be removed (6)
- Emergency lights with wrong power sources (2)
- Note Light level measurements taken under WP 95-959

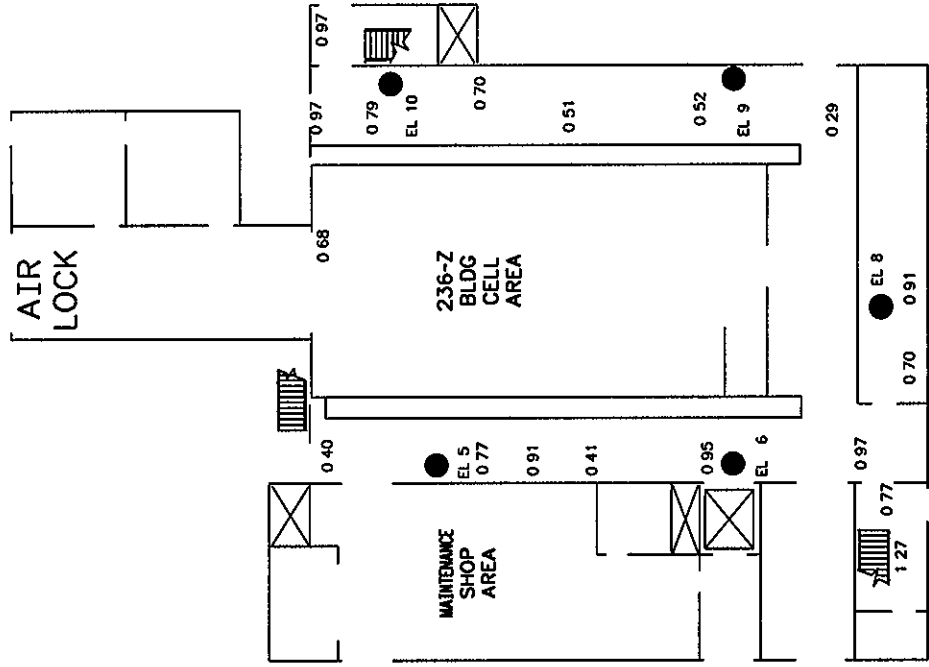
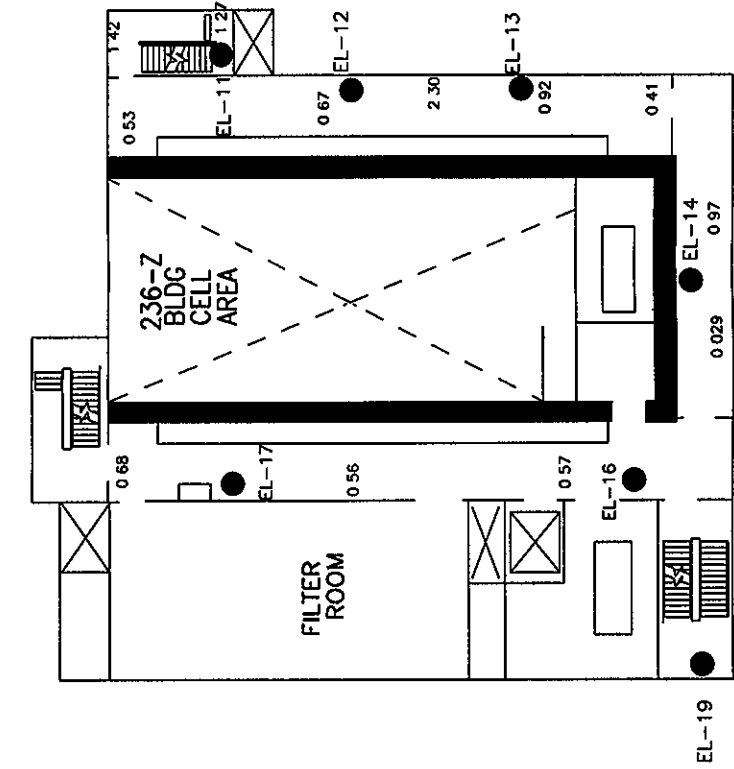
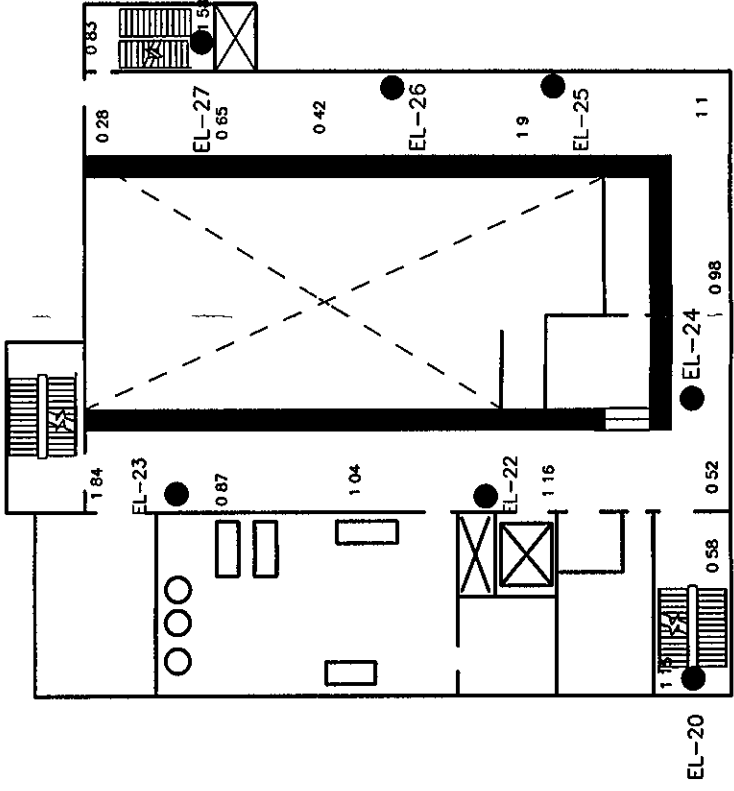
GROUP	K
BUILDING	236-Z
LOCATION	1st 2nd, and 3rd floors
PRIORITY	12

THIS AREA WAS UPGRADED IN 9/99 BY
WORK PKG 98-1759 NO FURTHER ACTION
IS NECESSARY

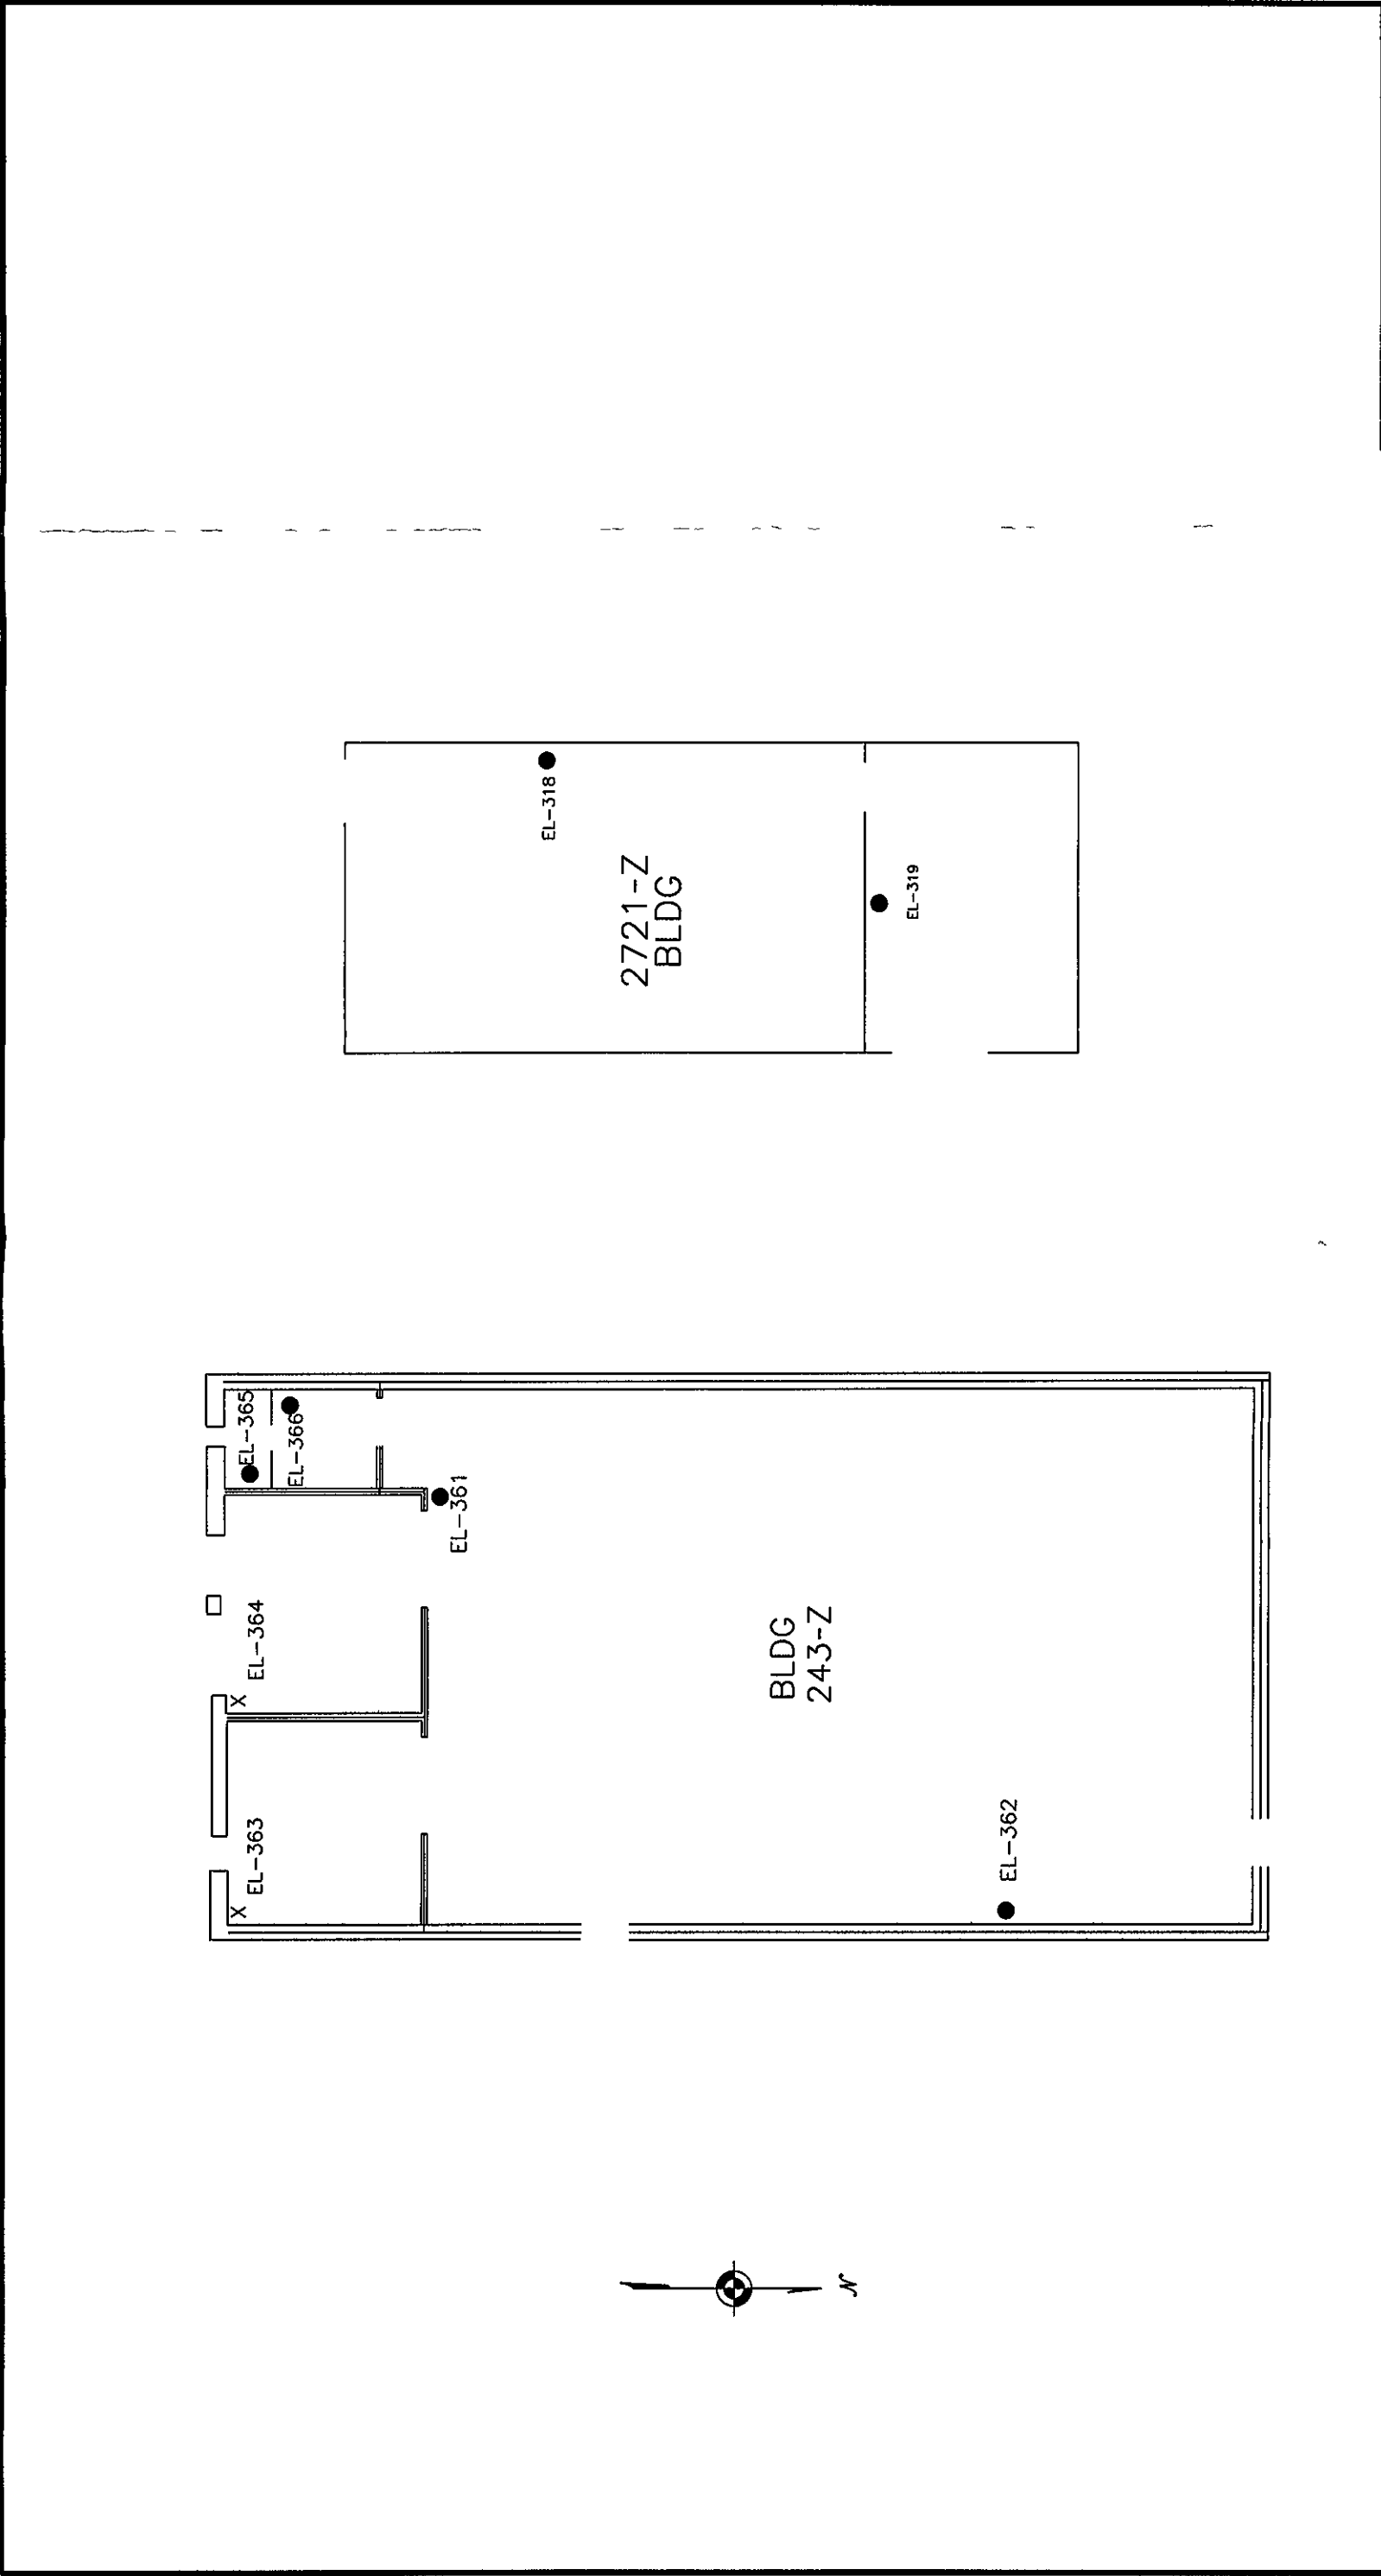
GROUP	M	243-Z, 2721-Z
BUILDING		
LOCATION	All	
PRIORITY	13

X Lights to be removed (2)
