Structural Integrity Program for the 300,000-Gallon Radioactive Liquid Waste Storage Tanks at the Idaho Nuclear Technology and Engineering Center

April 2003

*Idaho National Engineering and Environmental Laboratory
Bechtel BWXT Idaho, LLC*

The conclusion of this report is that the Tank Farm Facility tanks, vaults, and transfer systems that remain in service for storage are structurally adequate, and are expected to remain structurally adequate over the remainder of their planned service life through 2012.

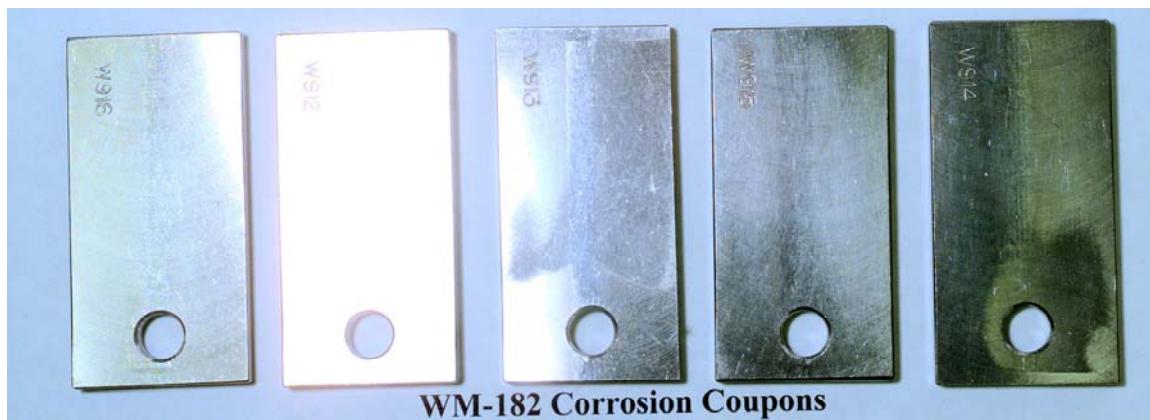
Visual examination of the seamless pipe corrosion coupons from Tank WM-182 under a binocular microscope at 20 \times magnification revealed minor localized corrosion in the form of end-grain attack on the ends of the coupons (i.e., the cut edges). End-grain attack would not normally be seen during tank

Figure C-4. Tank WM-182 coupons at the 0-in. level after 11.4 years of exposure (PD01-0406-17).

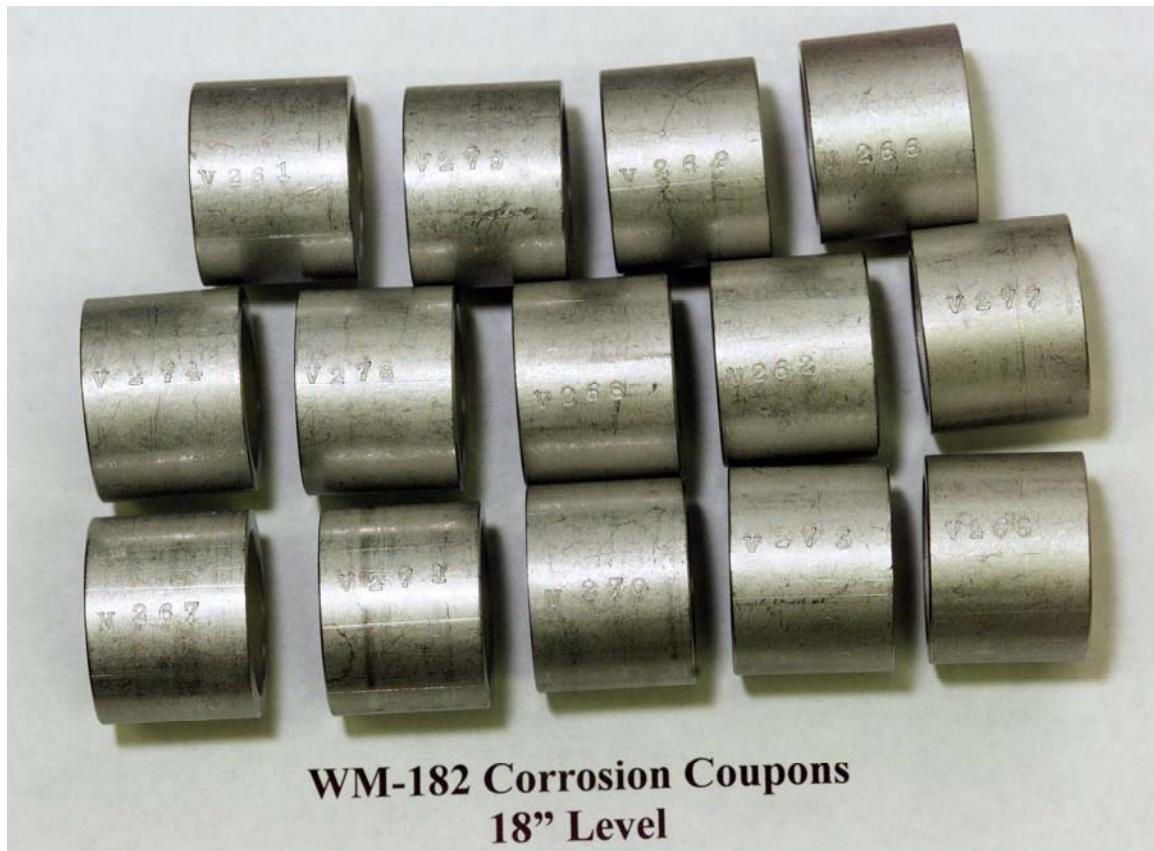
Figure C-5. Tank WM-182 coupons at the 45-cm (18-in.) level after 30.5 years of exposure (PD01-0406-9).

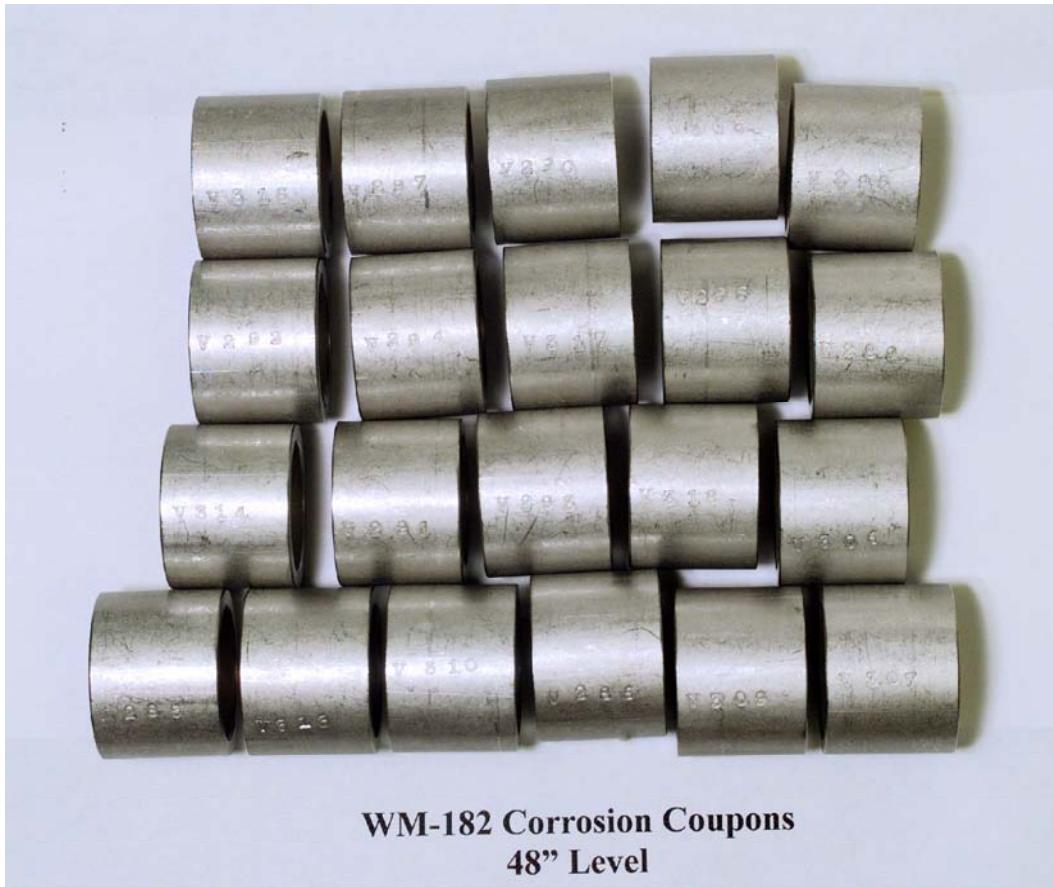
Figure C-6. Tank WM-182 coupons at the 122-cm (48-in.) level after 28.3 years of exposure (PD01-0406-8).

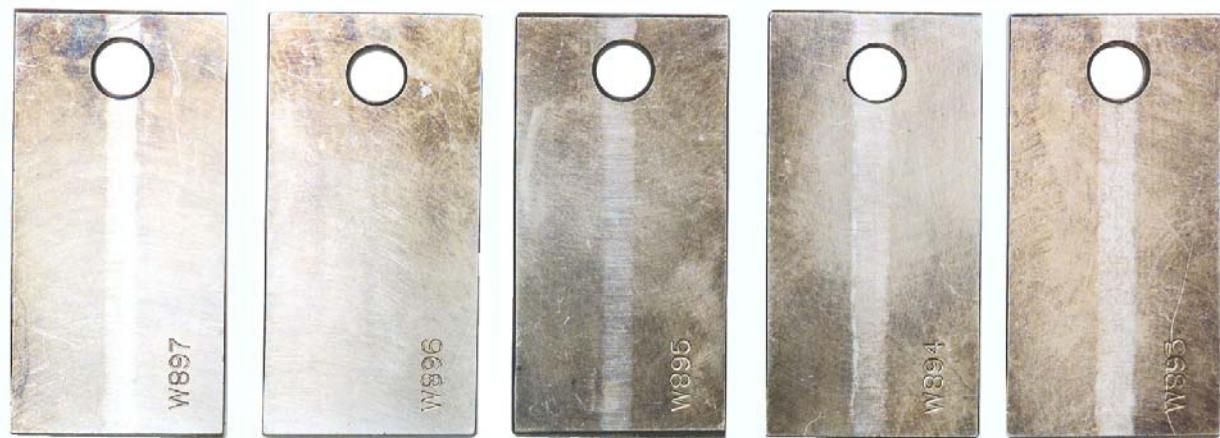
WM-183 (BOTTOMS)
TYPE 304L SS - 11.5 Yr EXPOSURE

Figure C-8. Tank WM-183 coupons at the 0-in. level after 11.5 years of exposure (PD01-0066-25).⁸

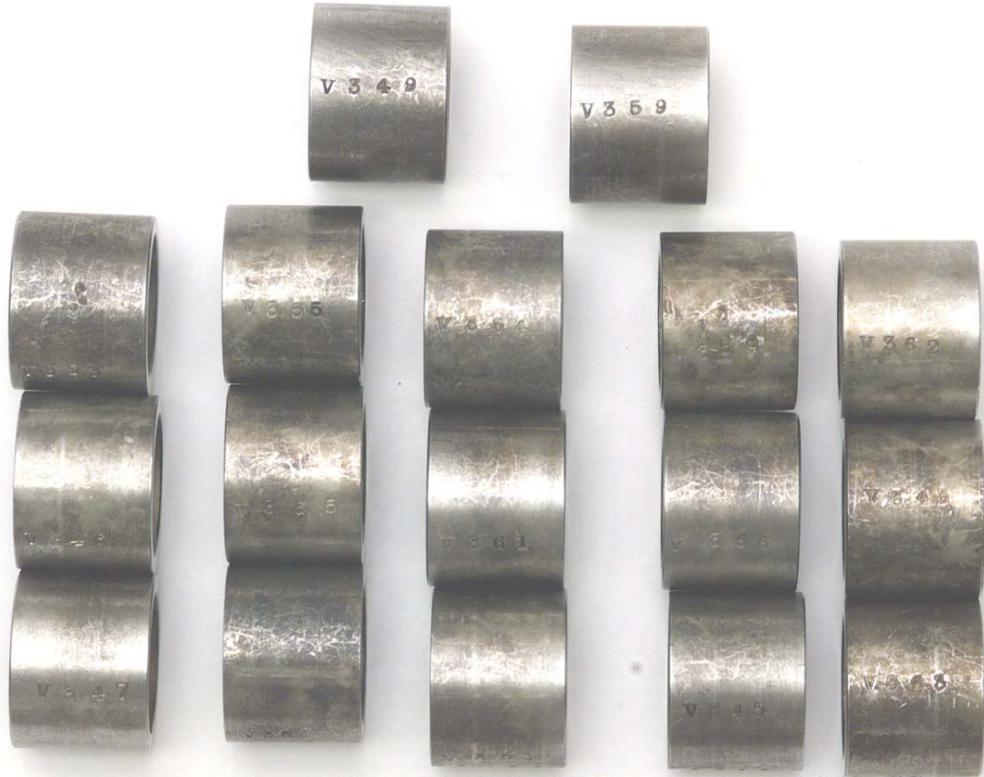
WM-183 (18 IN LEVEL) - TYPE 304L SS
38.5 YEARS EXPOSURE

Figure C-9. Tank WM-183 coupons at the 45-cm (18-in.) level after 38.5 years of exposure (PD01-0066-31).⁸

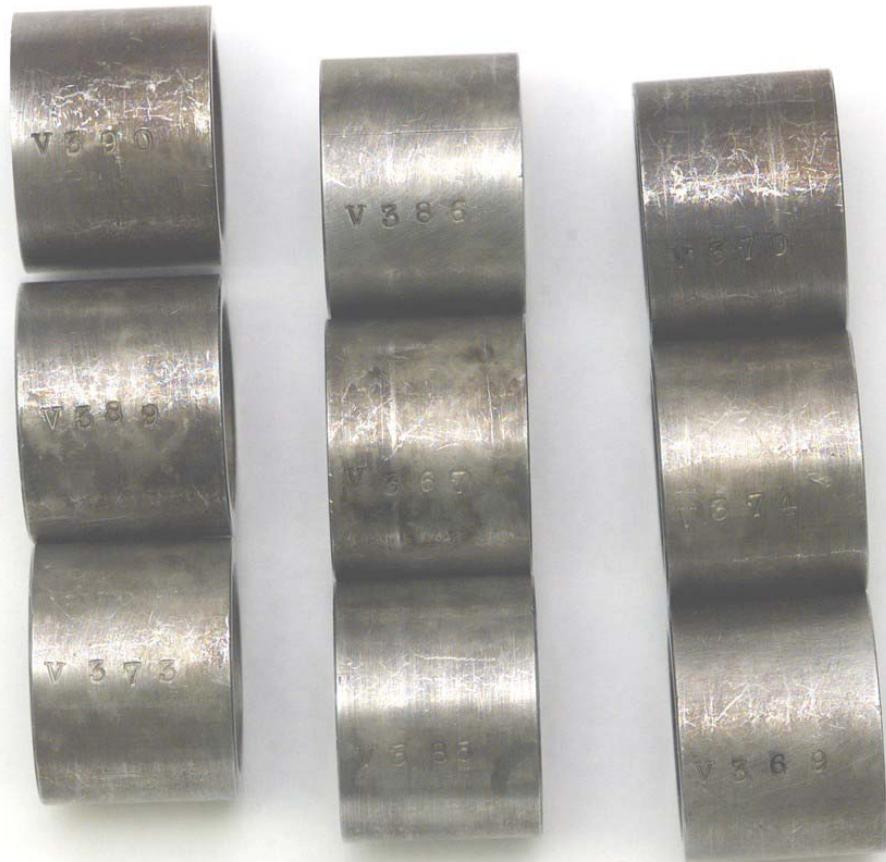
WM-183 (48 IN LEVEL) – TYPE 304L SS 35.2 YEARS EXPOSURE

Figure C-10. Tank WM-183 coupons at the 122-cm (48-in.) level after 35.2 years of exposure (PD01-0066-01).⁸

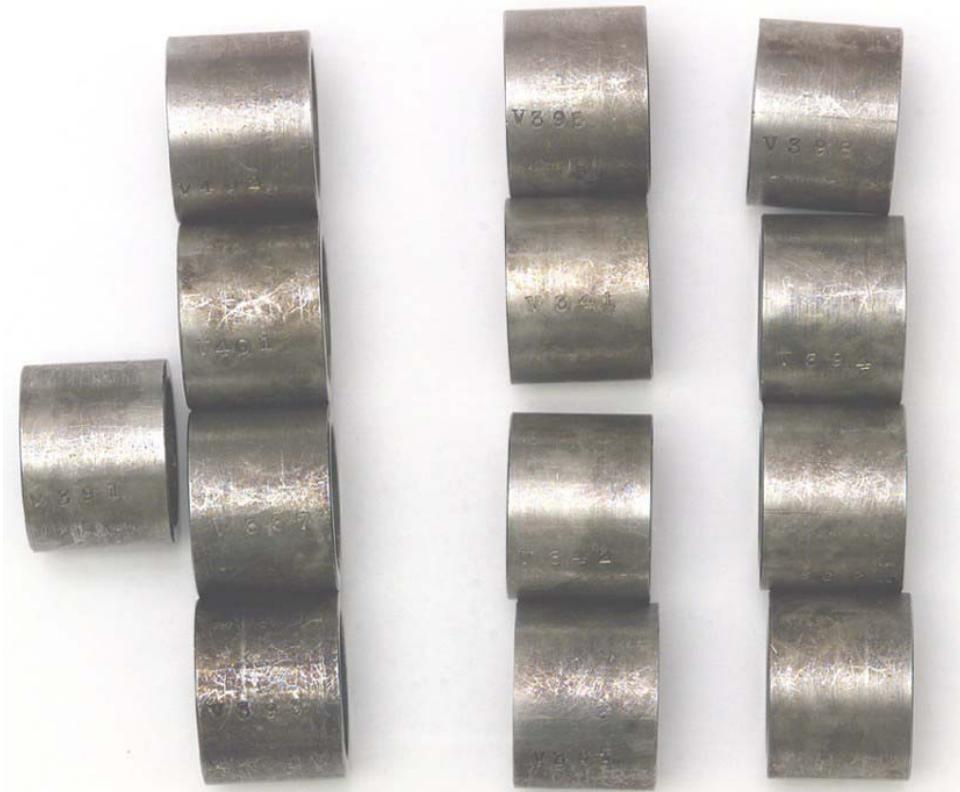
**WM-183 (72 IN LEVEL) – TYPE 304L SS
33.7 YEARS EXPOSURE**

Figure C-11. Tank WM-183 coupons at the 183-cm (72-in.) level after 33.7 years of exposure (PD01-0066-11).⁸

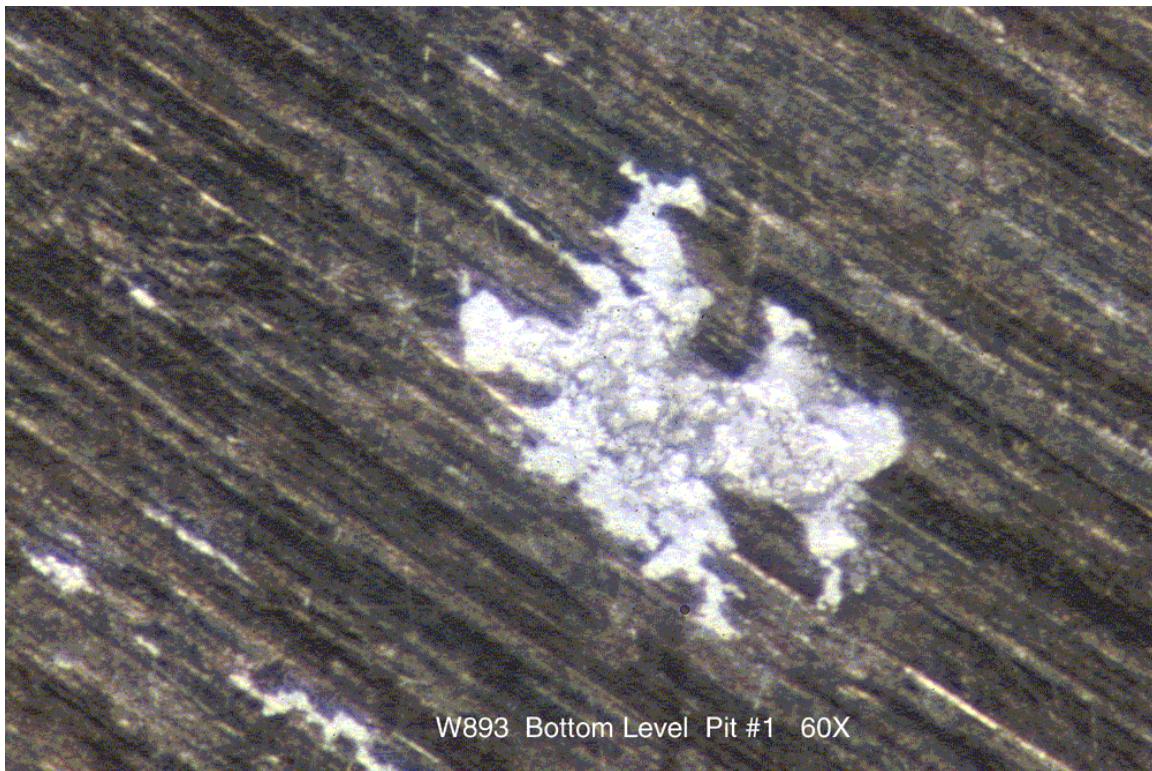
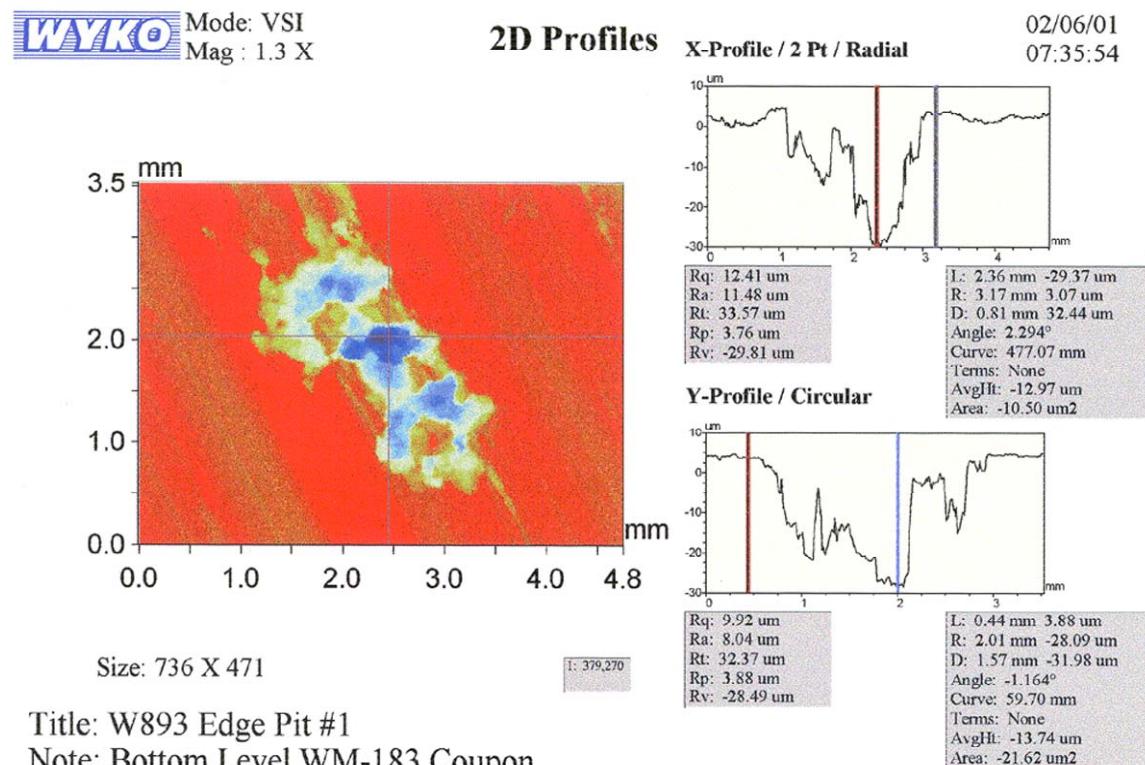
Figure C-12. Magnification and interferometer scan of Pit #1 on Coupon W893 at the 0-in. level in Tank WM-183 (PD01-0066-52 and PD03-0029-15).⁸

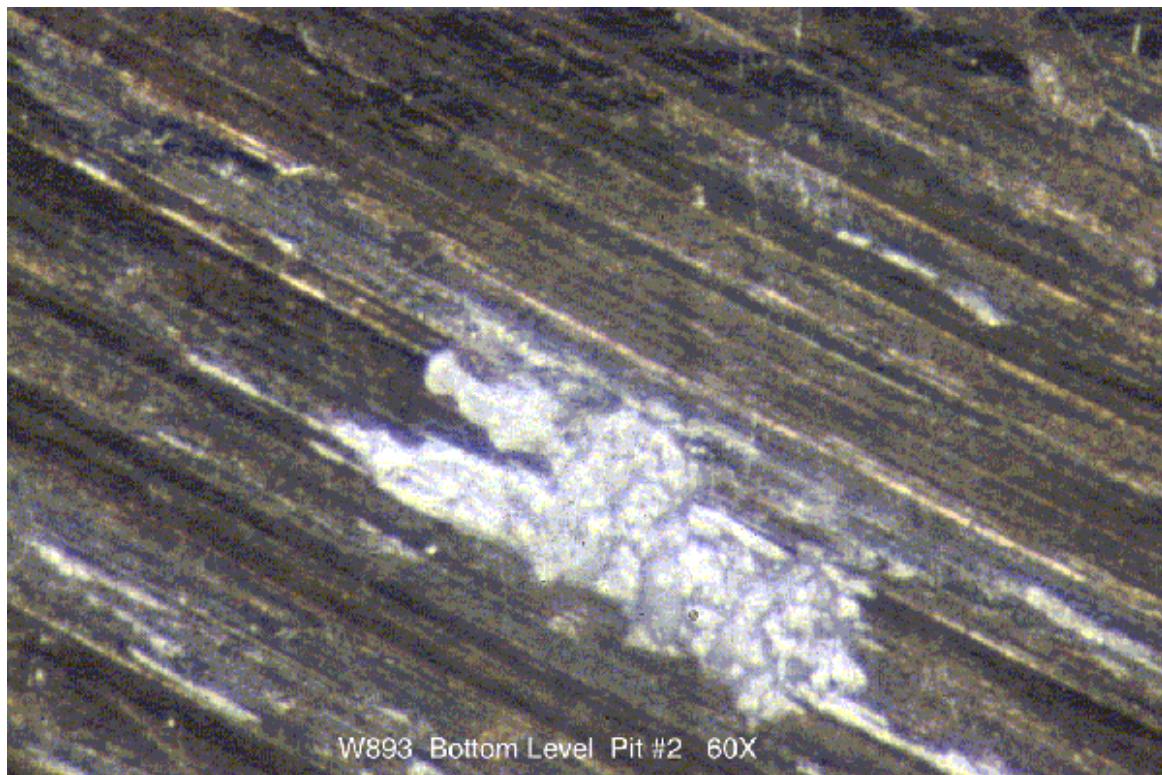
Figure C-13. Magnification and interferometer scan of Pit #2 on Coupon W893 at the 0-in. level in Tank WM-183 (PD01-0066-53 and PD03-0029-16).⁸

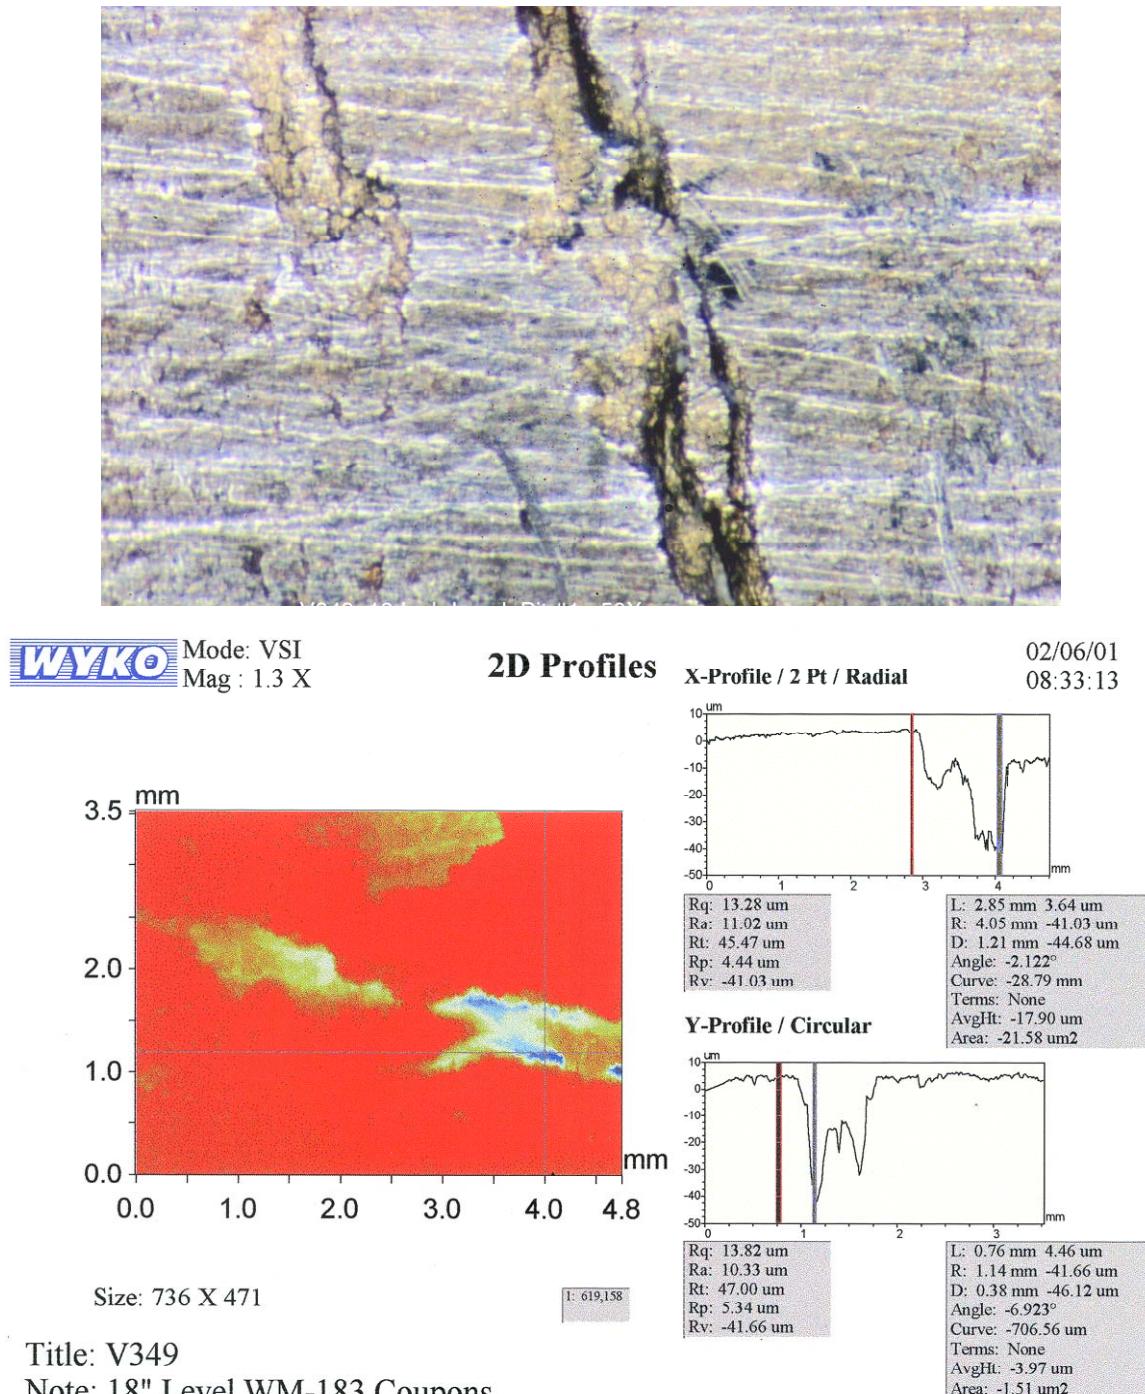
Figure C-14. Magnification (50 \times) and interferometer scan of linear indication on Coupon V349 at the 45-cm (18-in.) level in Tank WM-183 (PD01-0066-55 and PD03-0029-17).⁸

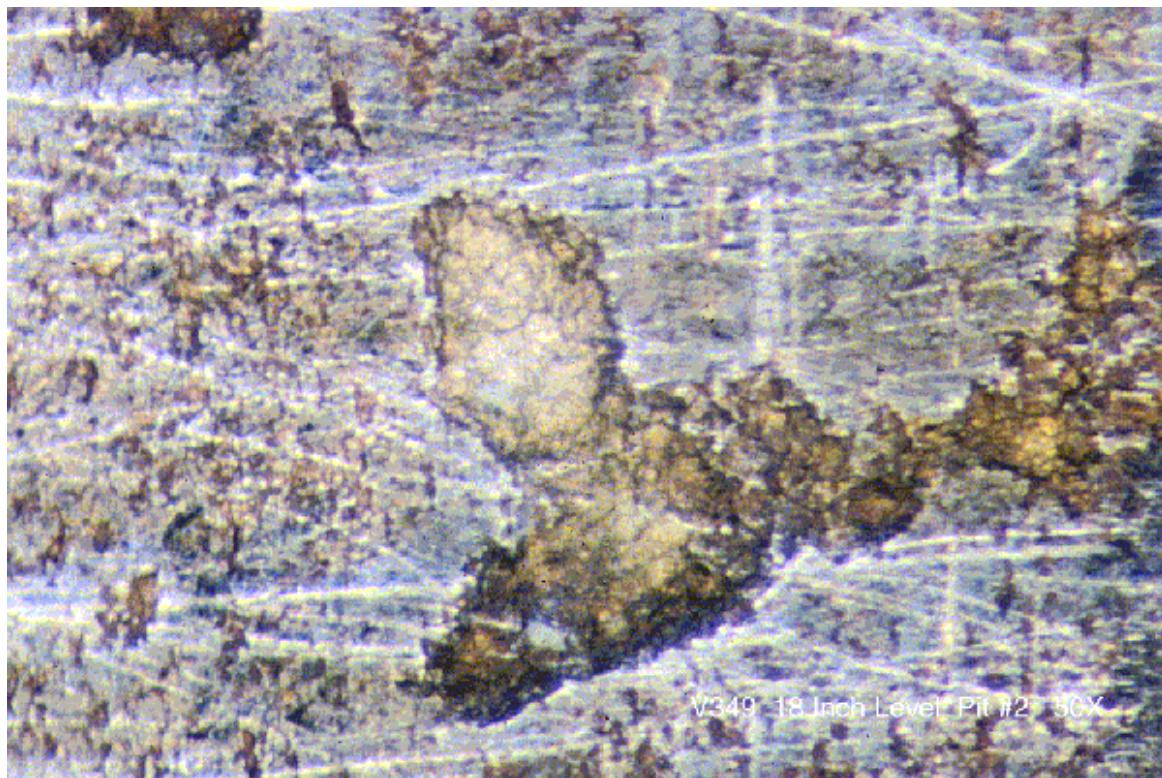
Figure C-15. Interferometer scan of Pit #2 on Coupon V349 at the 45-cm (18-in.) level in Tank WM-183 (PD01-0066-56 and PD03-0029-18).⁸

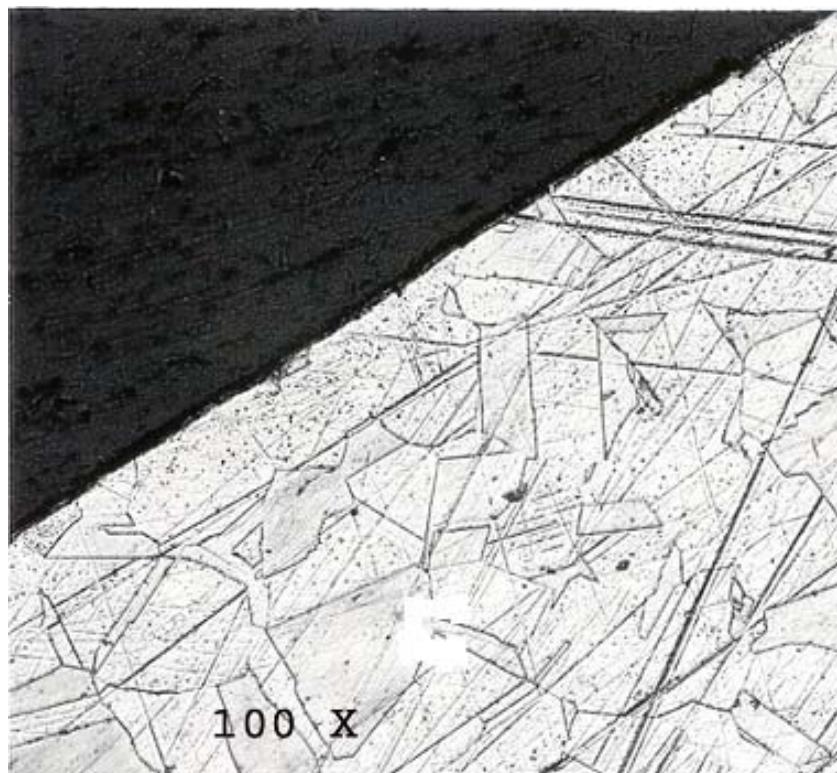
Figure C-16. Magnification (100 \times) of typical surface roughness on Coupon V349 at the 45-cm (18-in.) level in Tank WM-183 (PD03-0029-19).⁸

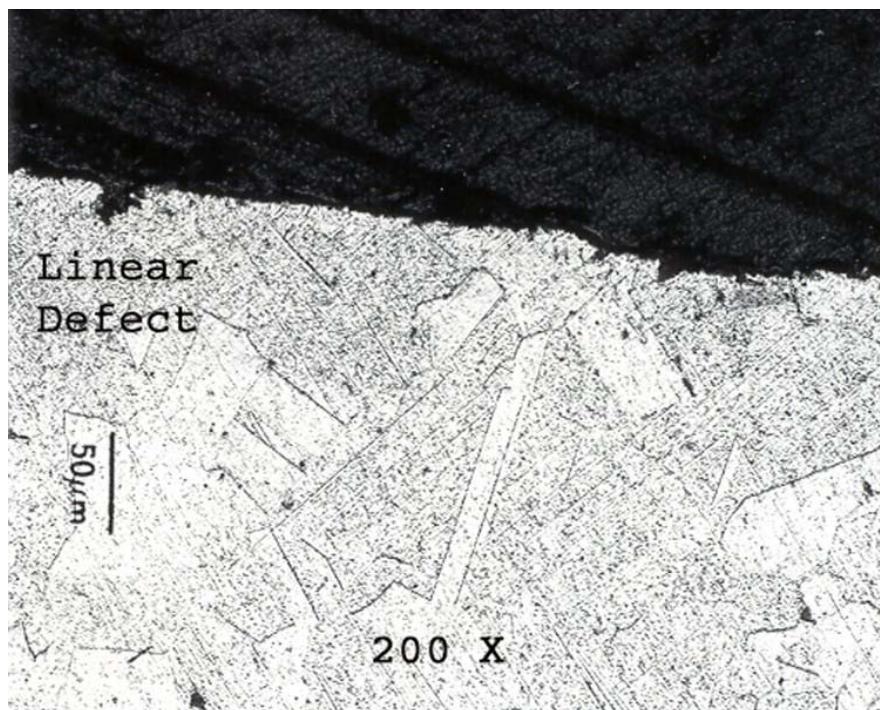
Figure C-17. Magnification (200 \times) of linear indication on Coupon V349 at the 45-cm (18-in.) level in Tank WM-183 (PD03-0029-20).⁸

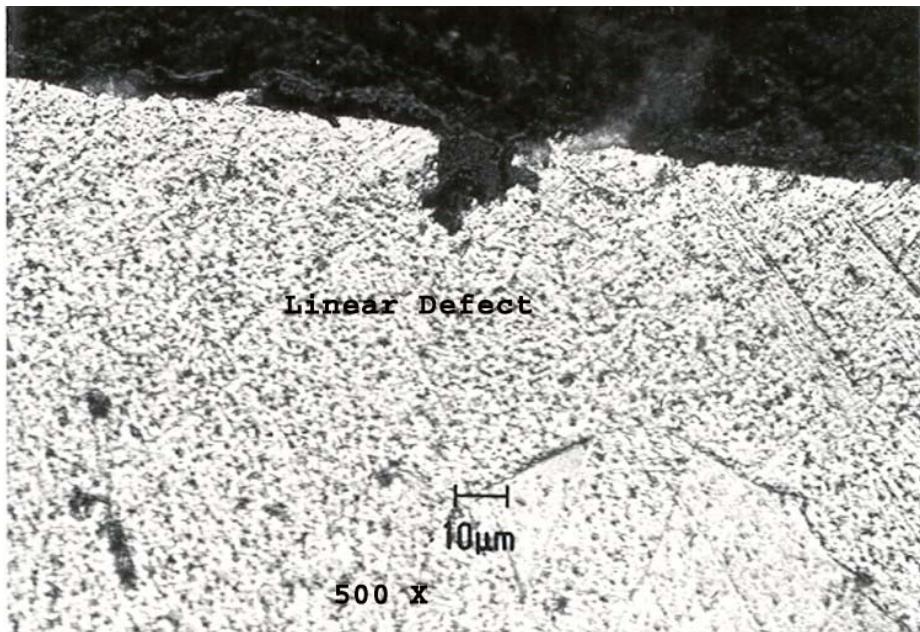
Figure C-18. Magnification (500 \times) of linear indication on Coupon V349 in Tank WM-183 (PD03-0029-21).⁸

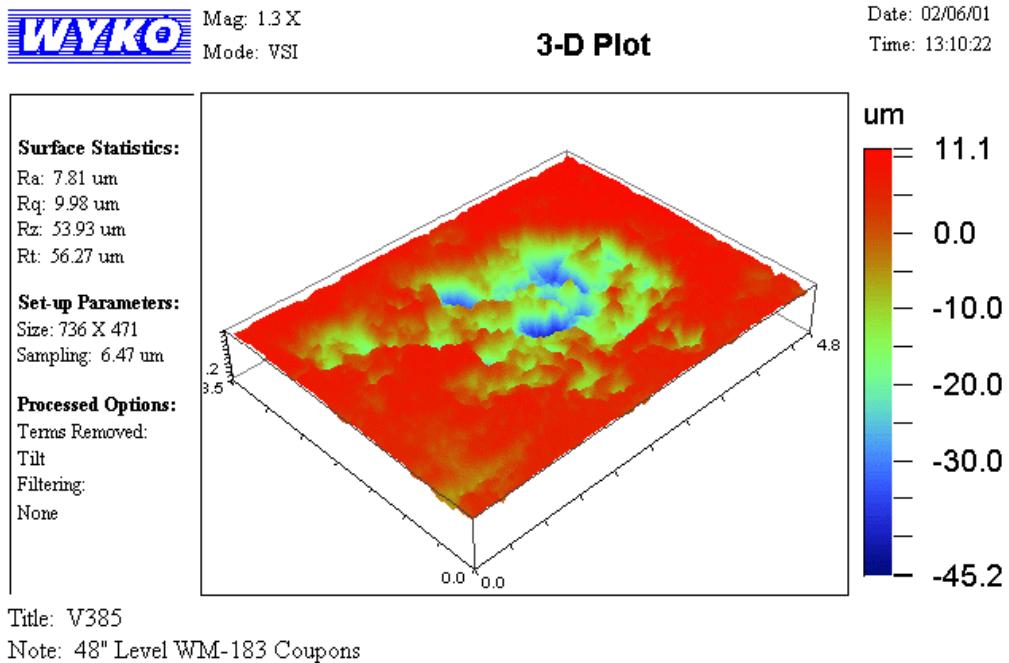
Figure C-19. Interferometer picture of pit on Coupon V385 in Tank WM-183 (PD03-0029-22).⁹

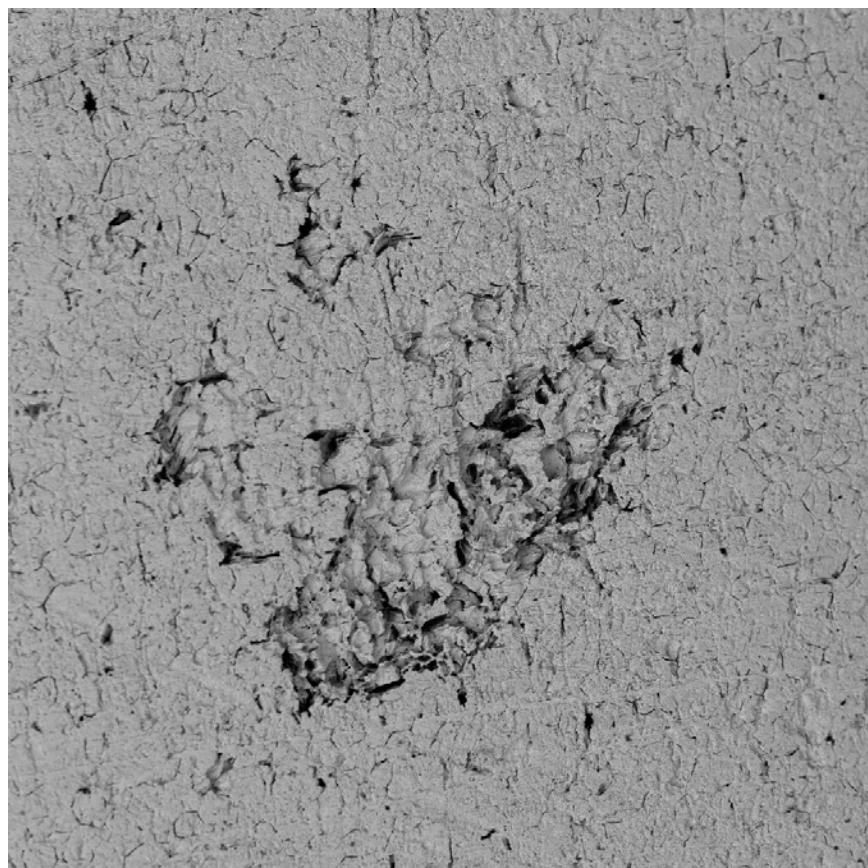
Figure C-20. Scanning electron microscope photograph at 100 \times magnification of pit on Coupon V385 in Tank WM-183 (PD03-0029-23).⁹

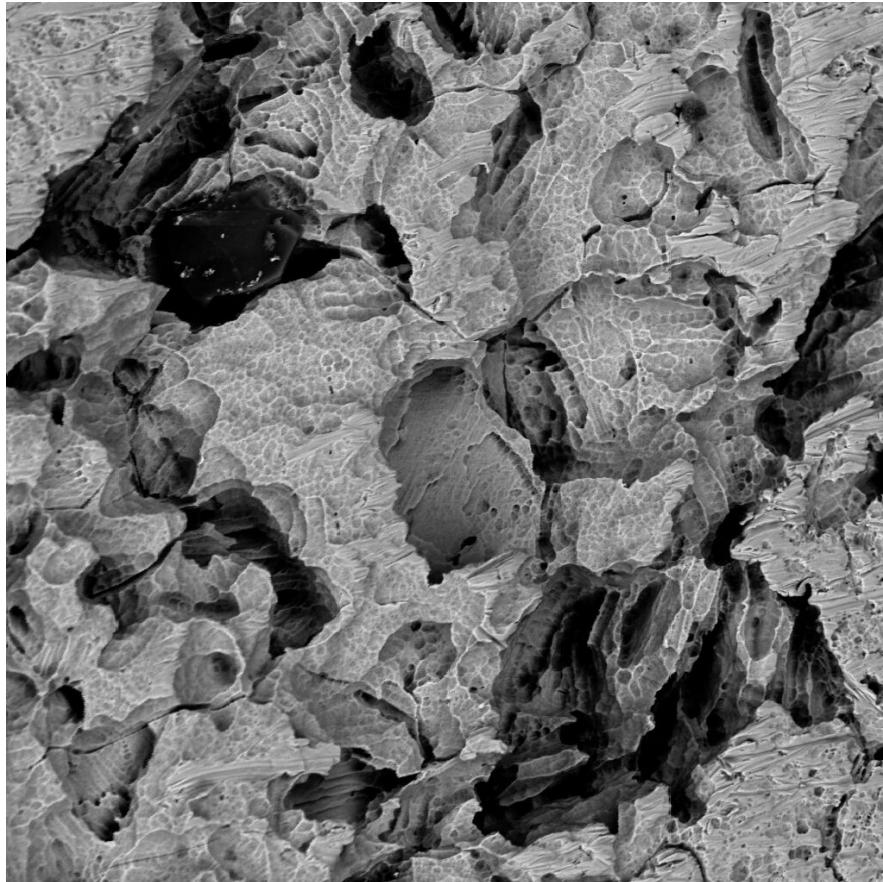
Figure C-21. Scanning electron microscope photograph at 600 \times magnification of the pit shown in Figure C-20 on Coupon V385 in Tank WM-183 (PD03-0029-24).⁹

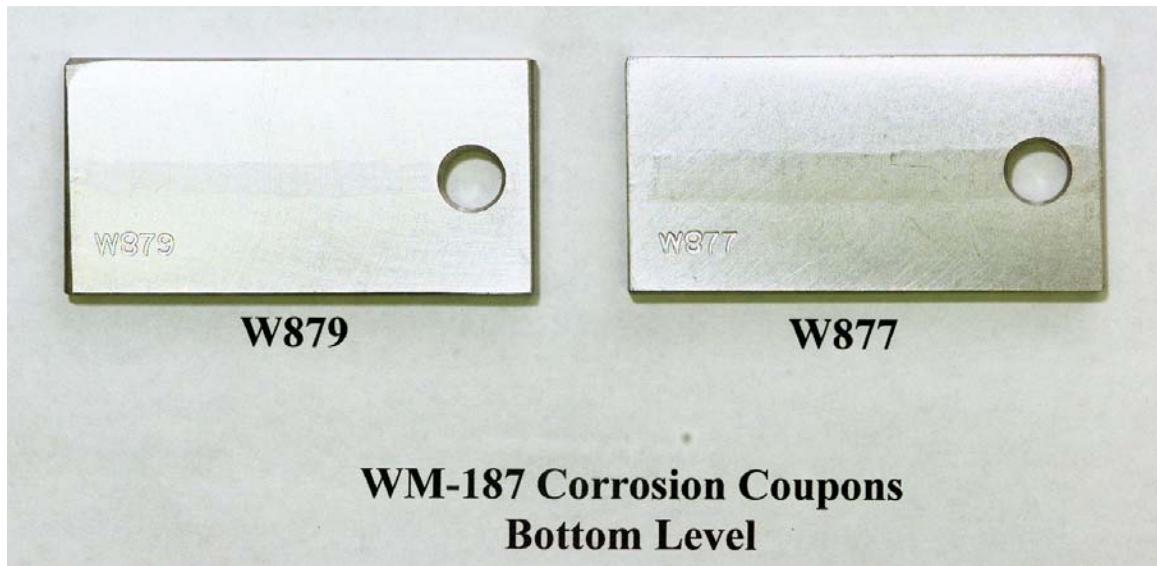
Visual examination of the welded pipe corrosion coupons under a binocular microscope at 10 \times magnification showed pit initiation.⁹ Examination of the two welded tank bottom coupons in Tank WM-187, in place since 1988, revealed no pit initiation. The highest corrosion rate was found on the

Figure C-22. Tank WM-187 coupons at the 0-in. level after 13.4 years of exposure (PD01-0406-14).

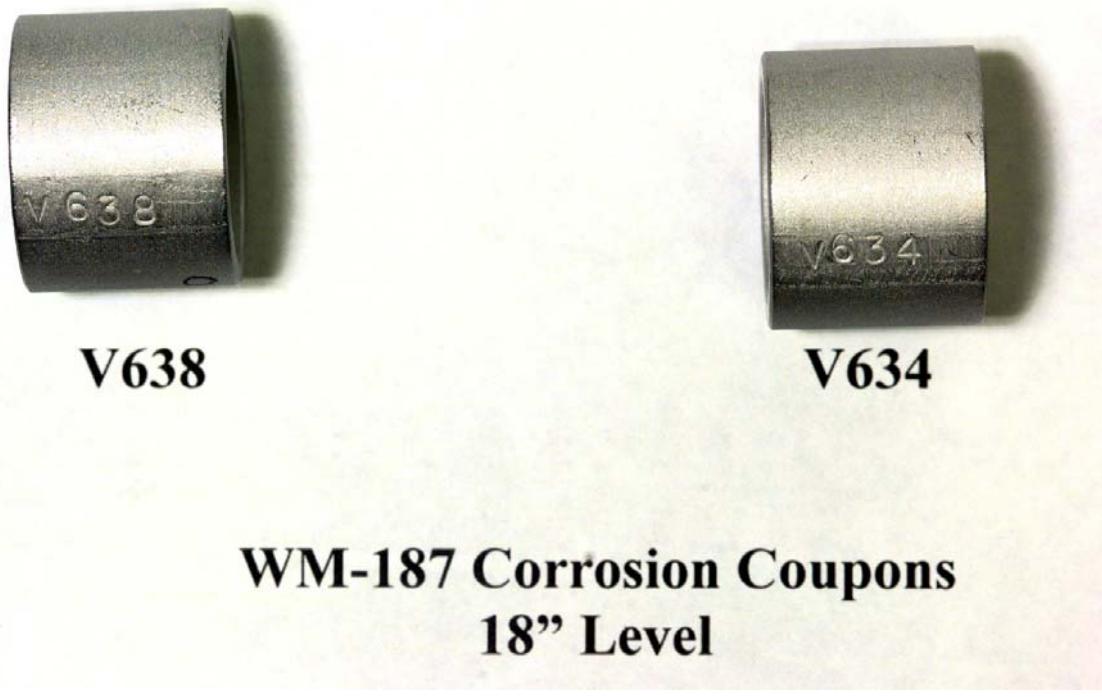
Figure C-23. Tank WM-187 coupons at the 45-cm (18-in.) level after 38.6 years of exposure (PD01-0406-16).

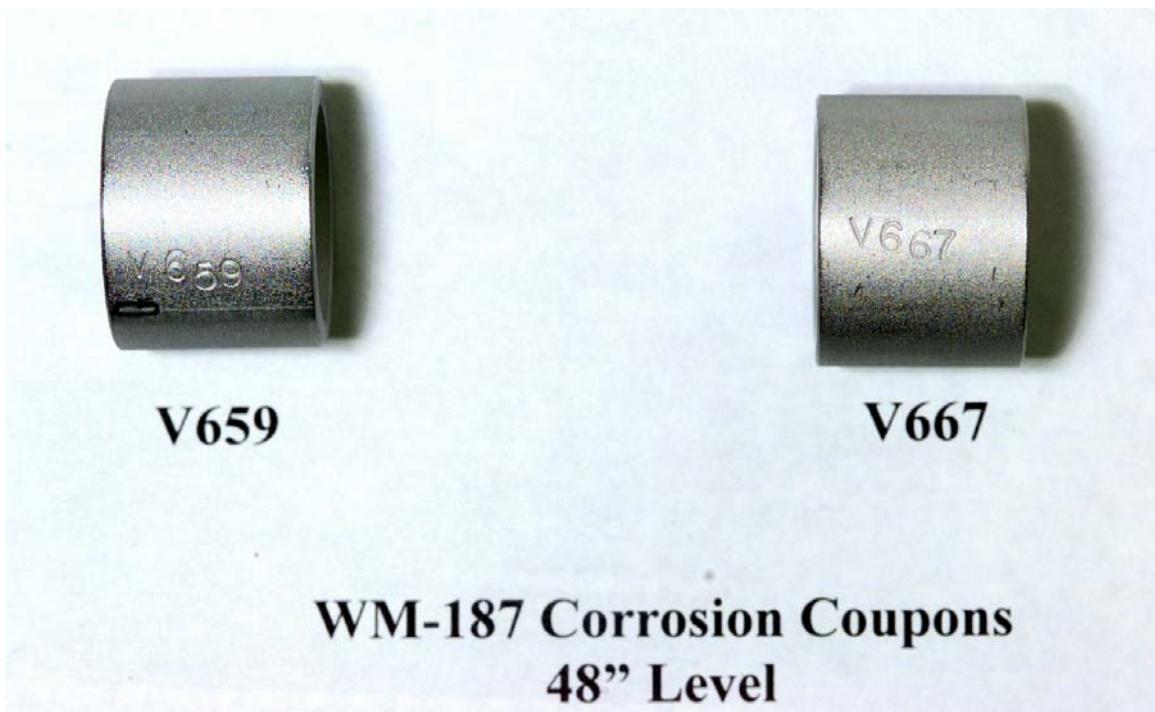
WM-187 Corrosion Coupons 48" Level

Figure C-24. Tank WM-187 coupons at the 122-cm (48-in.) level after 36.7 years of exposure (PD01-0406-15).

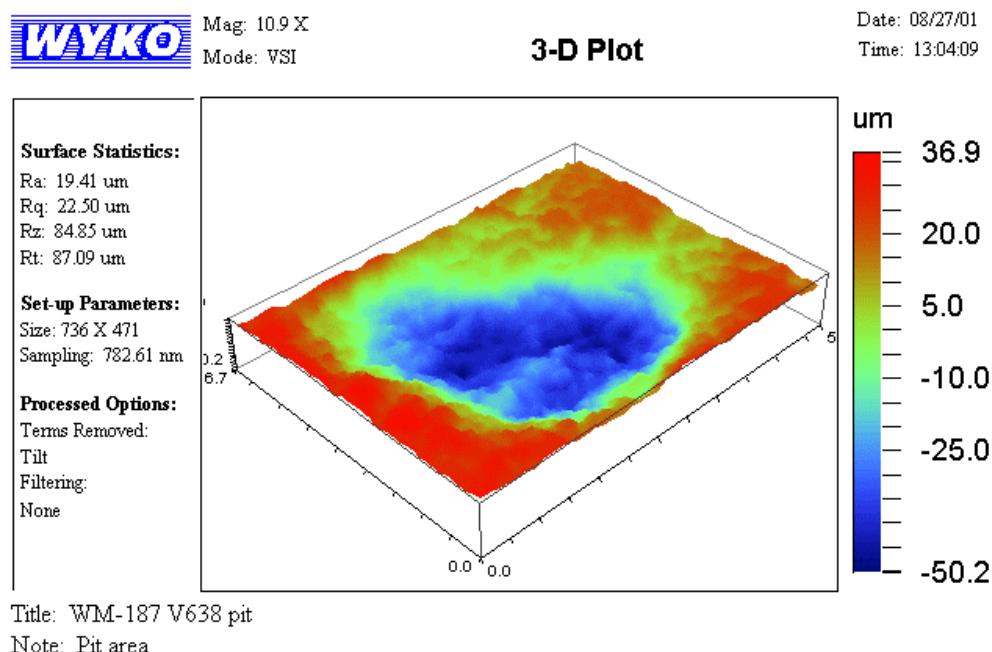
Figure C-26. Interferometer depiction of pit on Coupon V638 in Tank WM-187 (PD03-0029-25).⁹

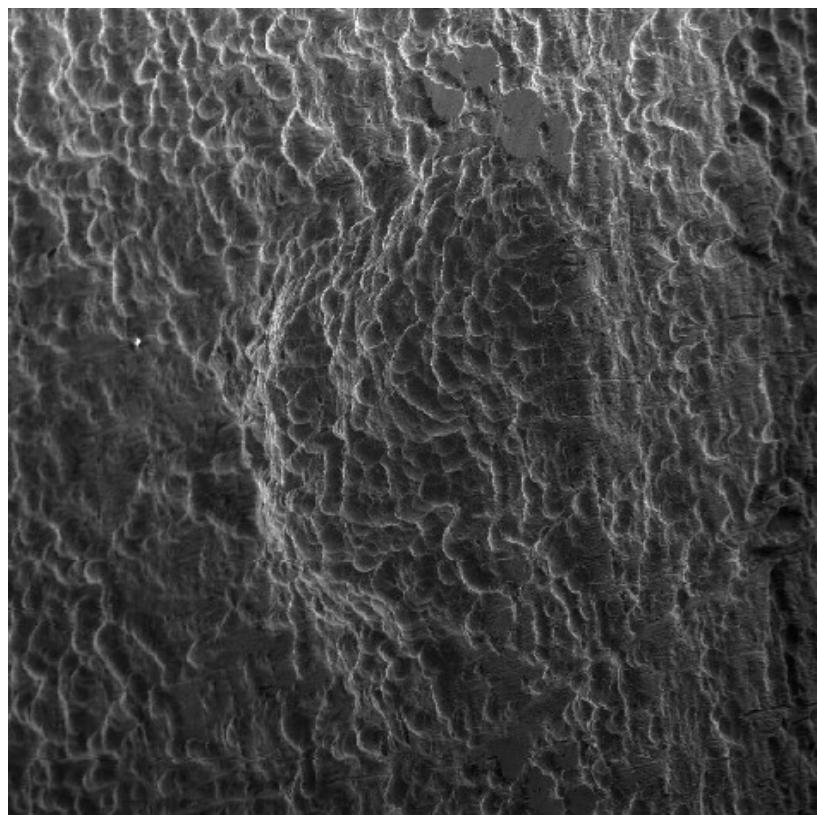
Figure C-27. Scanning electron microscope photograph (150 \times) of pit on Coupon V638 in Tank WM-187 (PD03-0029-26).⁹

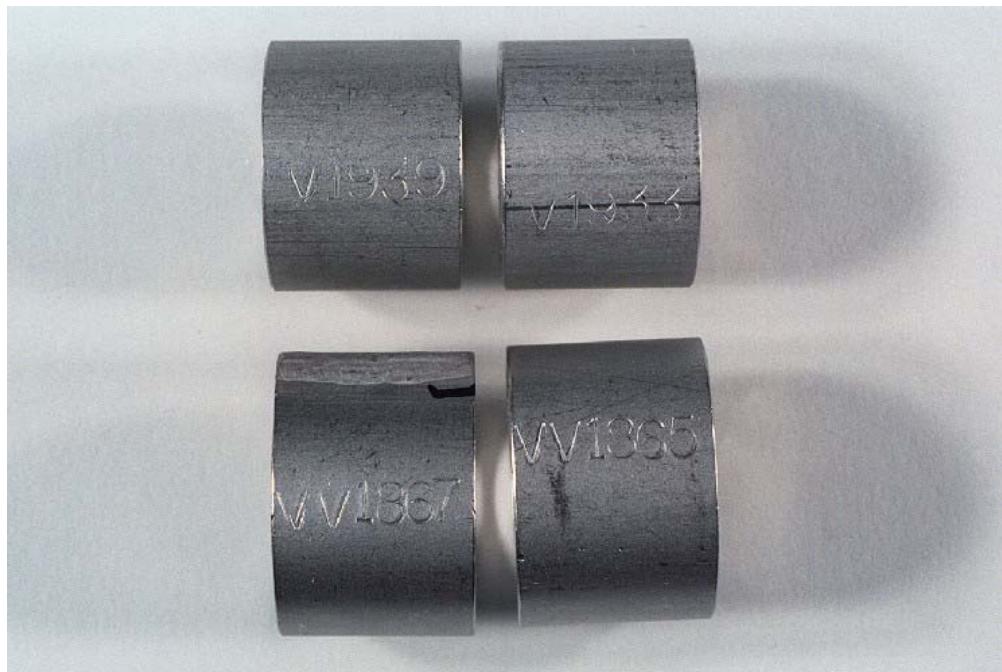
Figure C-28. Tank WM-189 corrosion coupons at the 45-cm (18-in.) level retrieved in 2001 (PN02-0152-1-7).⁹

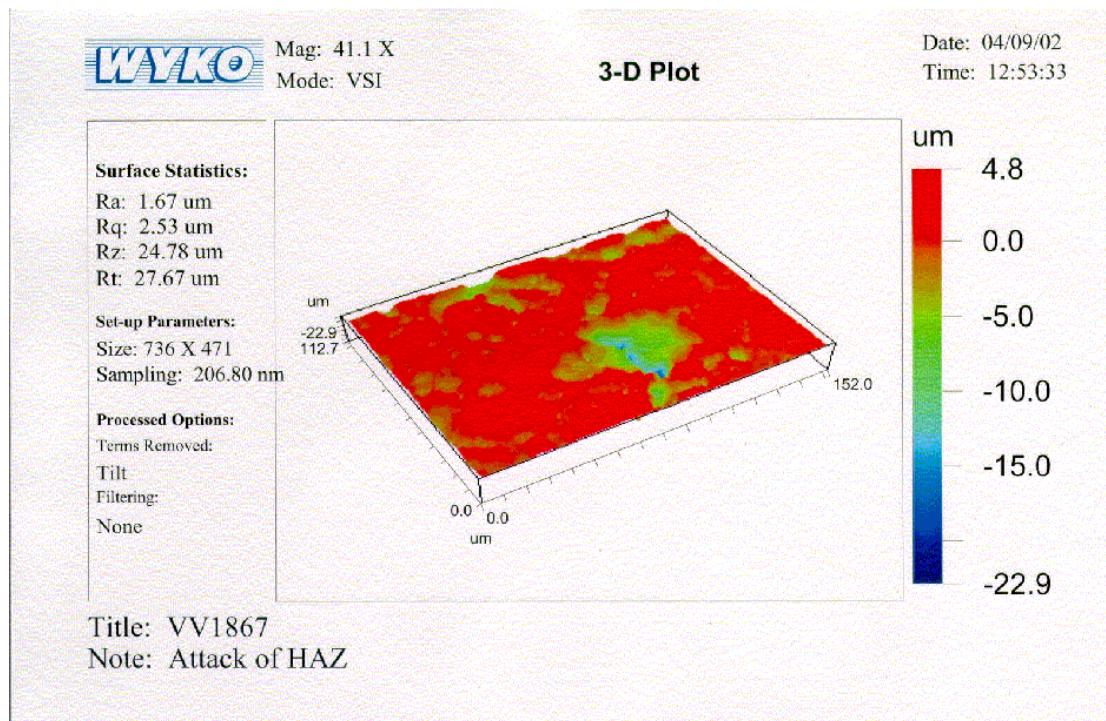
Figure C-29. Interferometer depiction of heat-affected zone attack on Coupon VV1867 in Tank WM-189 (PD03-0029-27).⁹

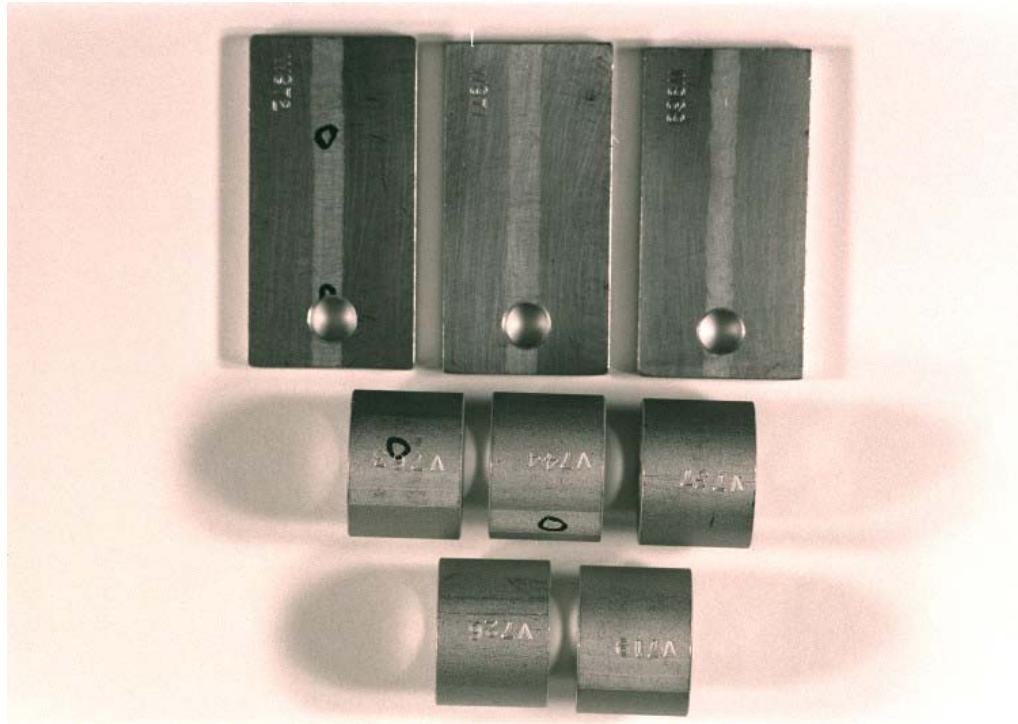
Figure C-31. Tank WM-188 corrosion coupons retrieved in 2002 (PN02-389-1-17).⁹

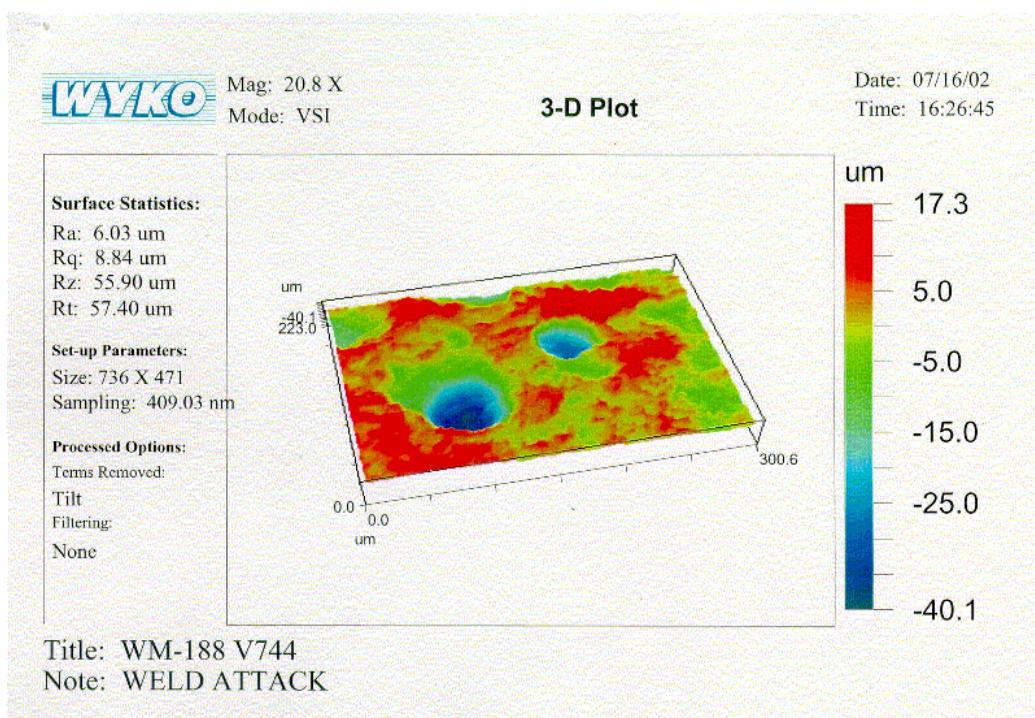
Figure C-32. Interferometer depiction of weld attack on Coupon V744 in Tank WM-188 (PD03-0029-29).⁹

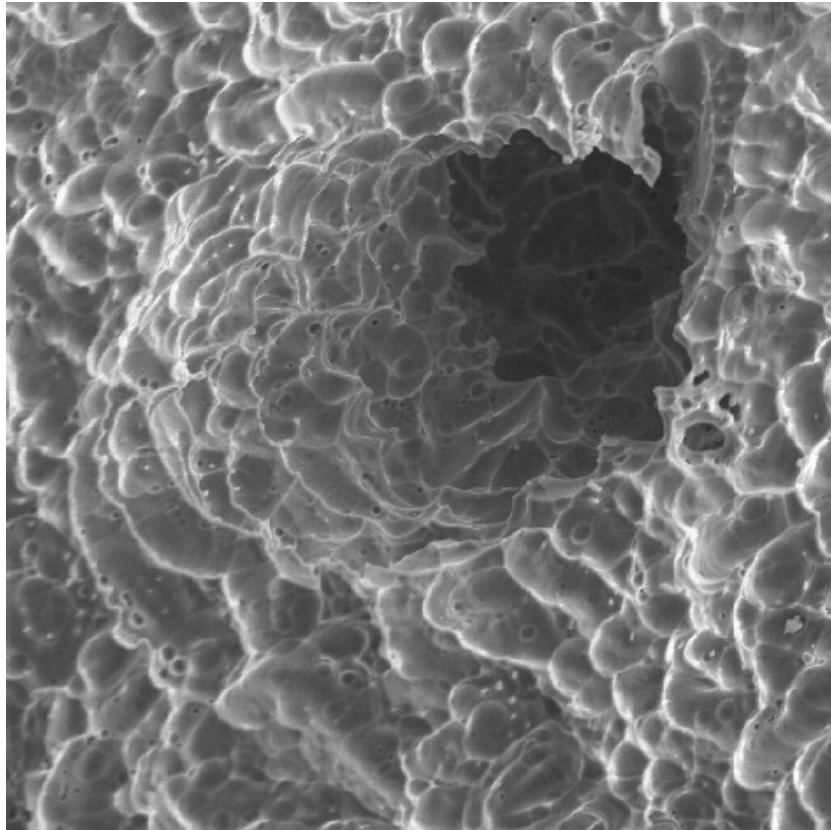
Figure C-33. Scanning electron microscope photograph (800 \times) of weld attack on Coupon V744 in Tank WM-188 (PD03-0029-30).⁹
