Structural Integrity Program for the 300,000-Gallon Radioactive Liquid Waste Storage Tanks at the Idaho Nuclear Technology and Engineering Center

April 2003

*Idaho National Engineering and Environmental Laboratory
Bechtel BWXT Idaho, LLC*

The conclusion of this report is that the Tank Farm Facility tanks, vaults, and transfer systems that remain in service for storage are structurally adequate, and are expected to remain structurally adequate over the remainder of their planned service life through 2012.

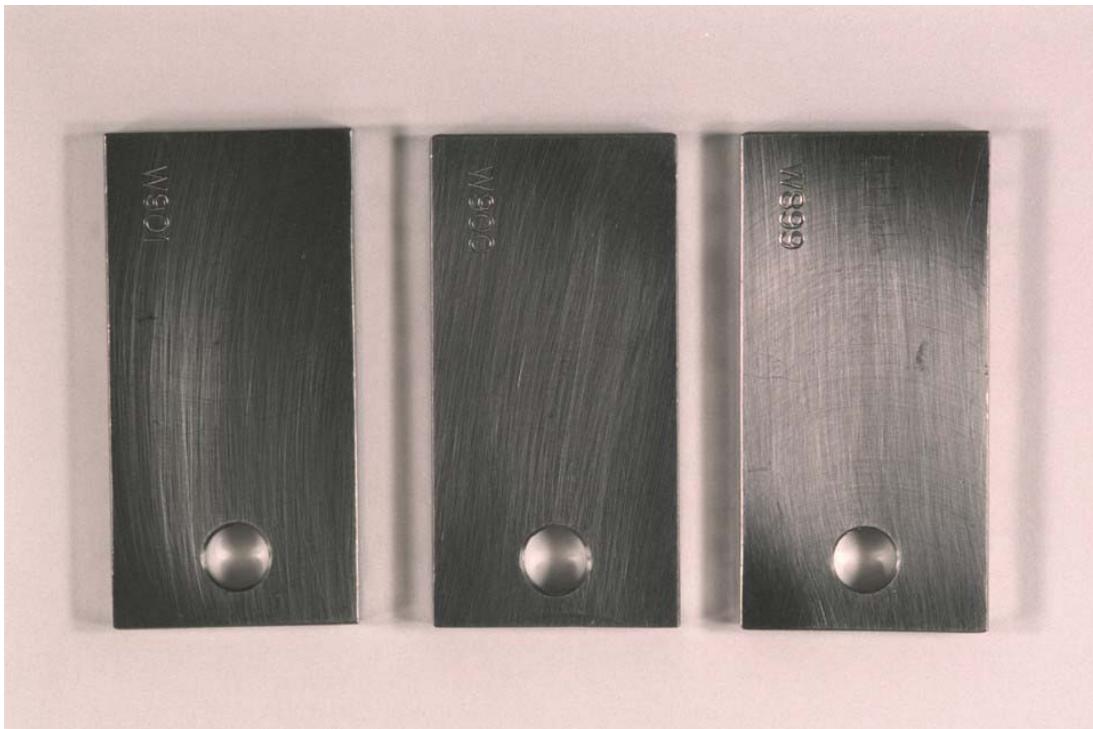
Figure C-34. Tank WM-180 corrosion coupons retrieved in 2002 (PN02-389-1-3).⁹

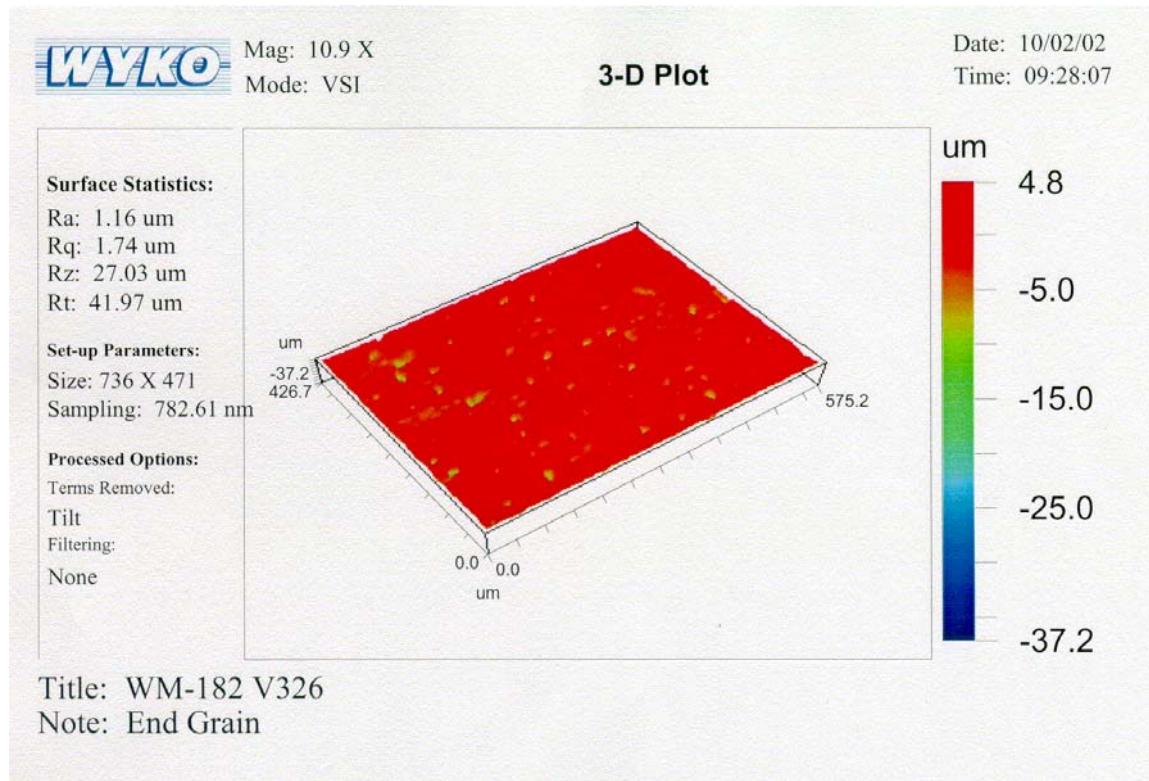
Figure C-36. End-grain corrosion on Coupon V326 in Tank WM-182 (PD03-0029-08).¹⁰

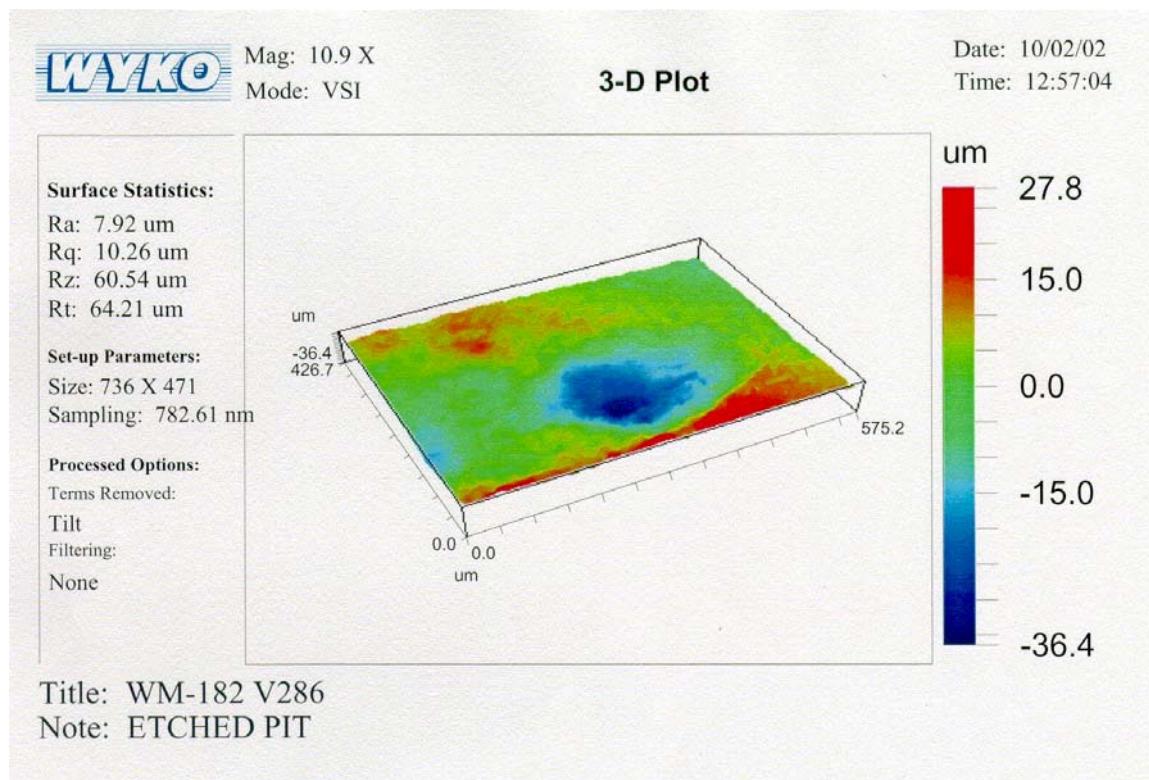
Figure C-37. Etched pit on Coupon V286 in Tank WM-182 (PD03-0029-09).¹⁰

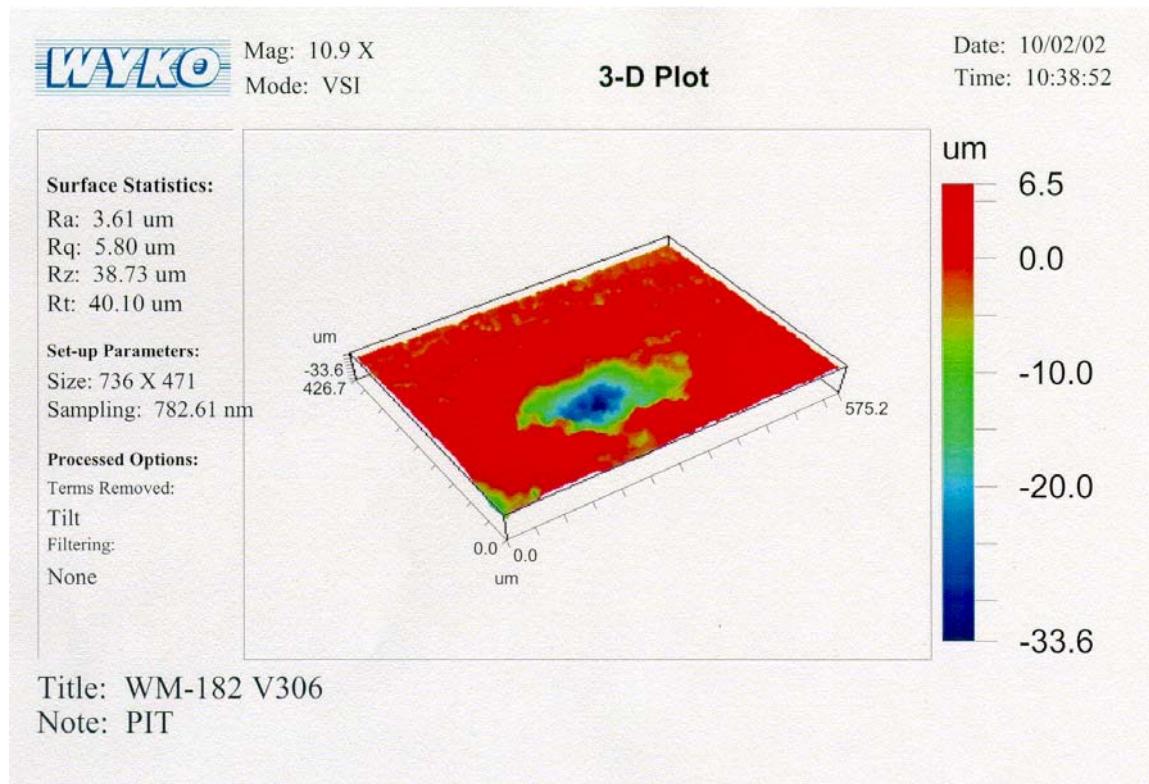
Figure C-38. Pit on Coupon V306 in Tank WM-182 (PD03-0029-10).¹⁰

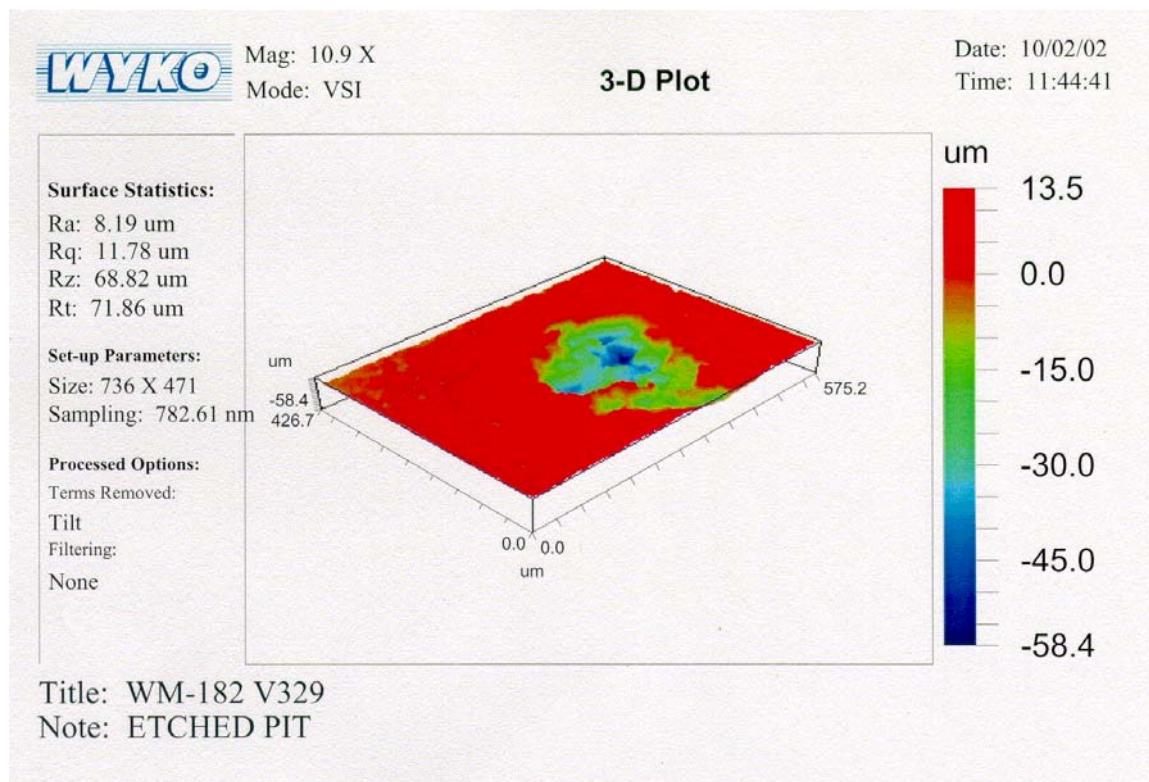
Figure C-39. Etched pit on Coupon V329 in Tank WM-182 (PD03-0029-11).¹⁰

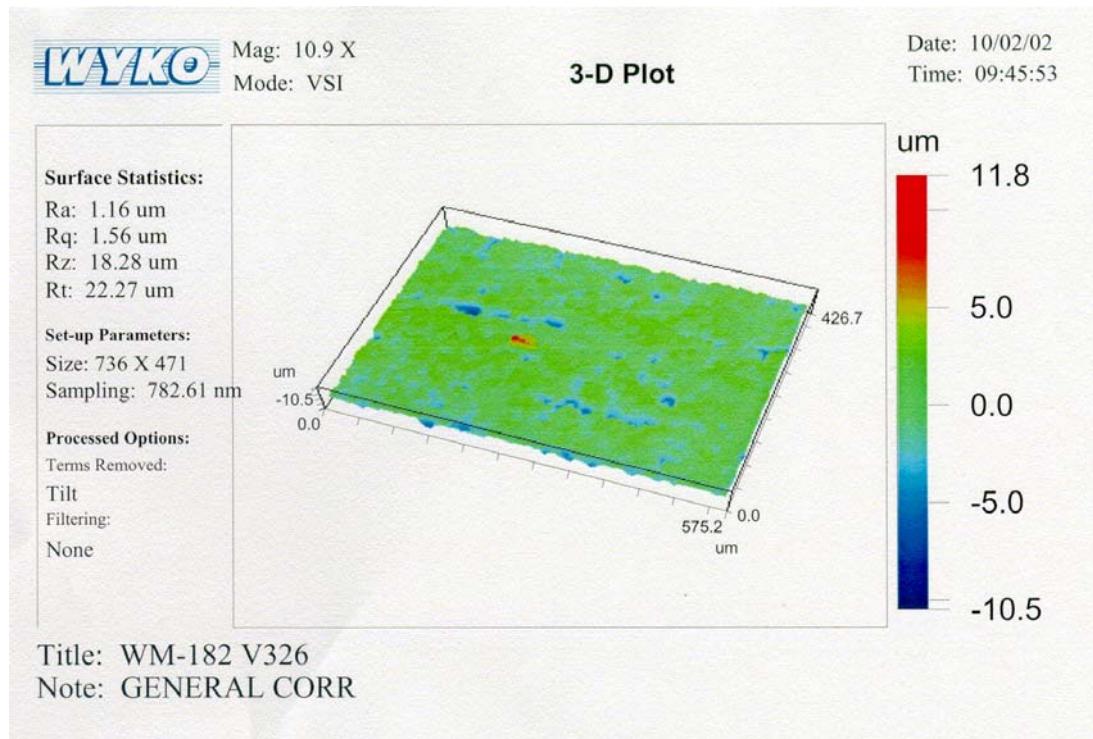
Figure C-40. Interferometer scan showing general corrosion on Coupon V326 in Tank WM-182 (PD03-0029-12).¹⁰

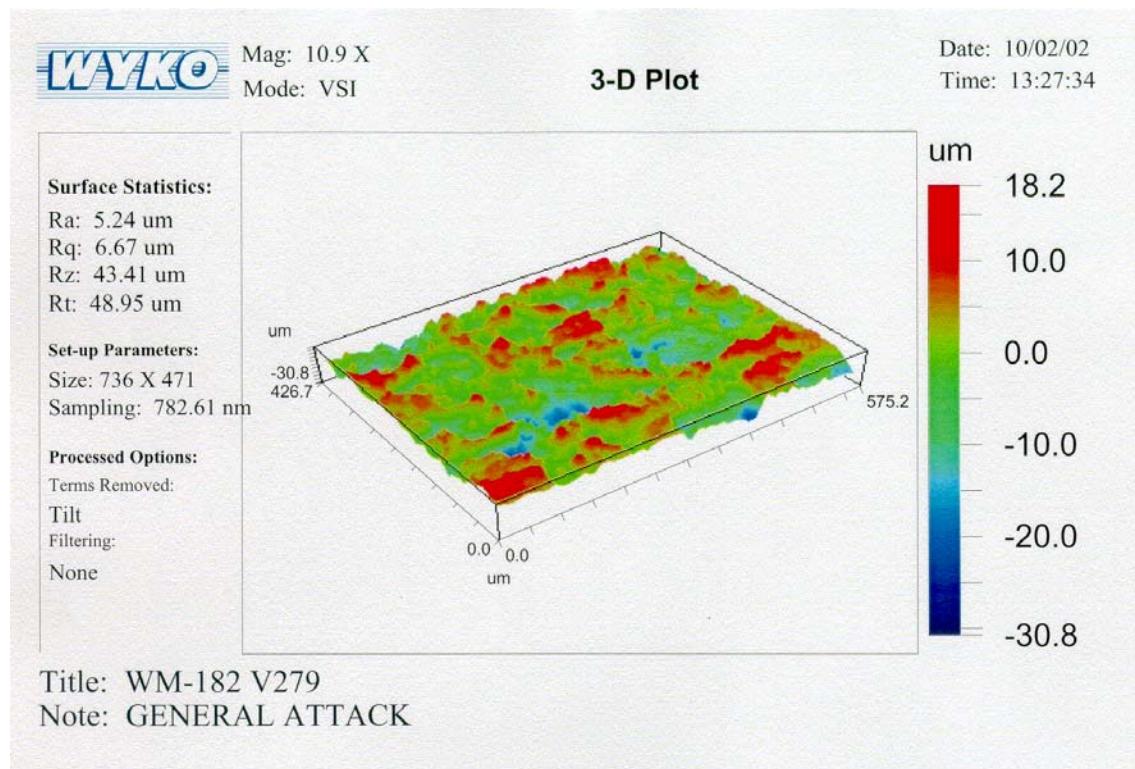
Figure C-41. Interferometer scan showing accelerated general corrosion attack on Coupon V279 in Tank WM-182 (PD03-0029-13).¹⁰

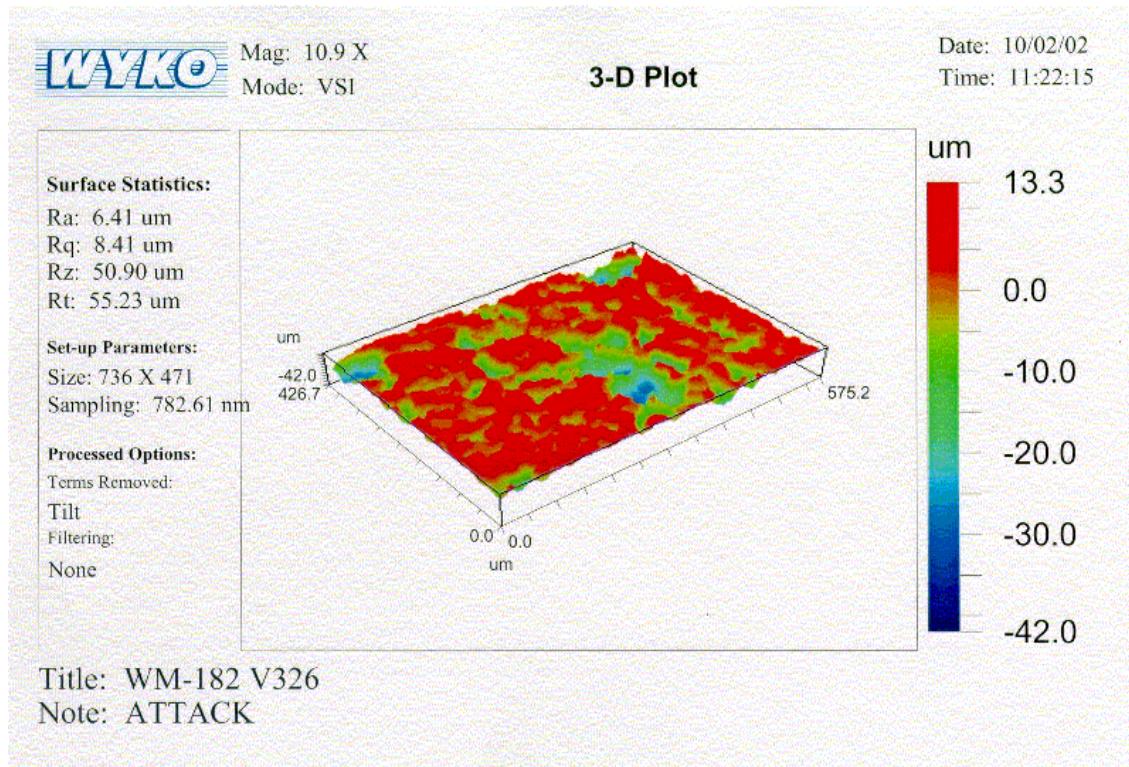
Figure C-42. Accelerated general attack on Coupon V326 in Tank WM-182 (PD03-0029-14).¹⁰

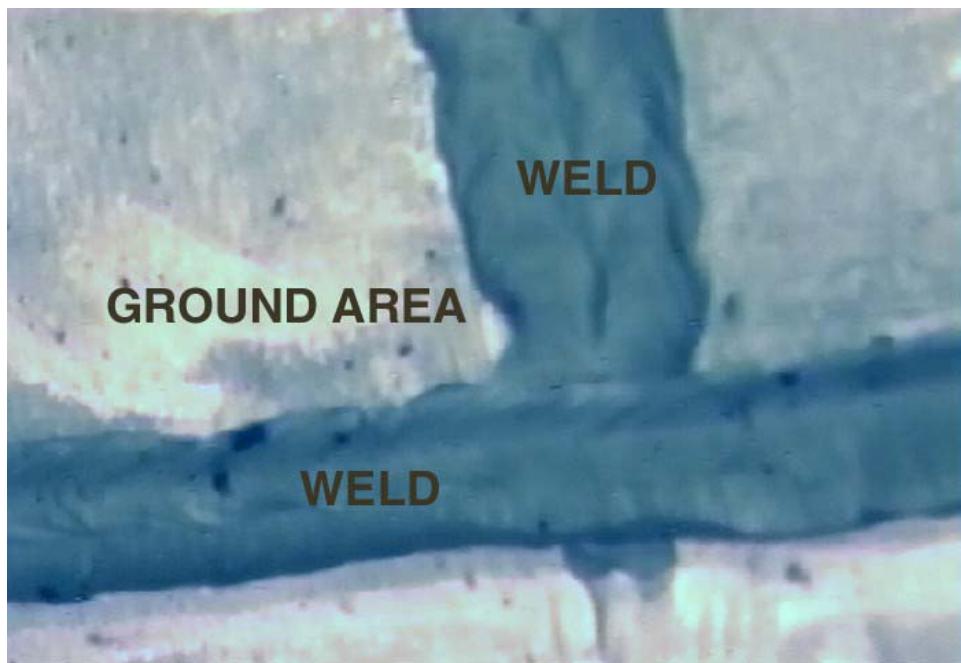
Figure D-4. Weld intersection in Tank WM-188 (PD03-0029-05).⁵

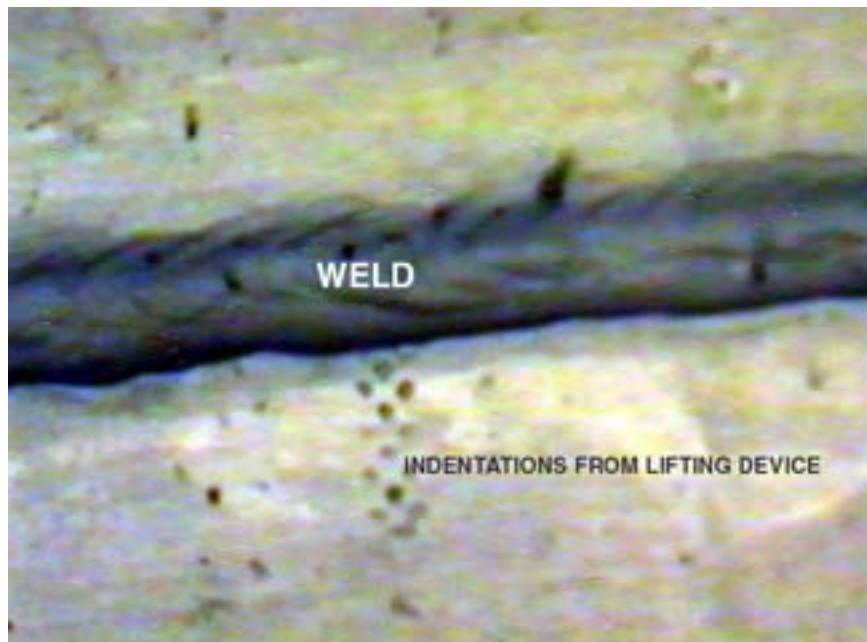
Figure D-5. Areas of mechanical damage from initial tank construction (PD03-0029-06).⁵

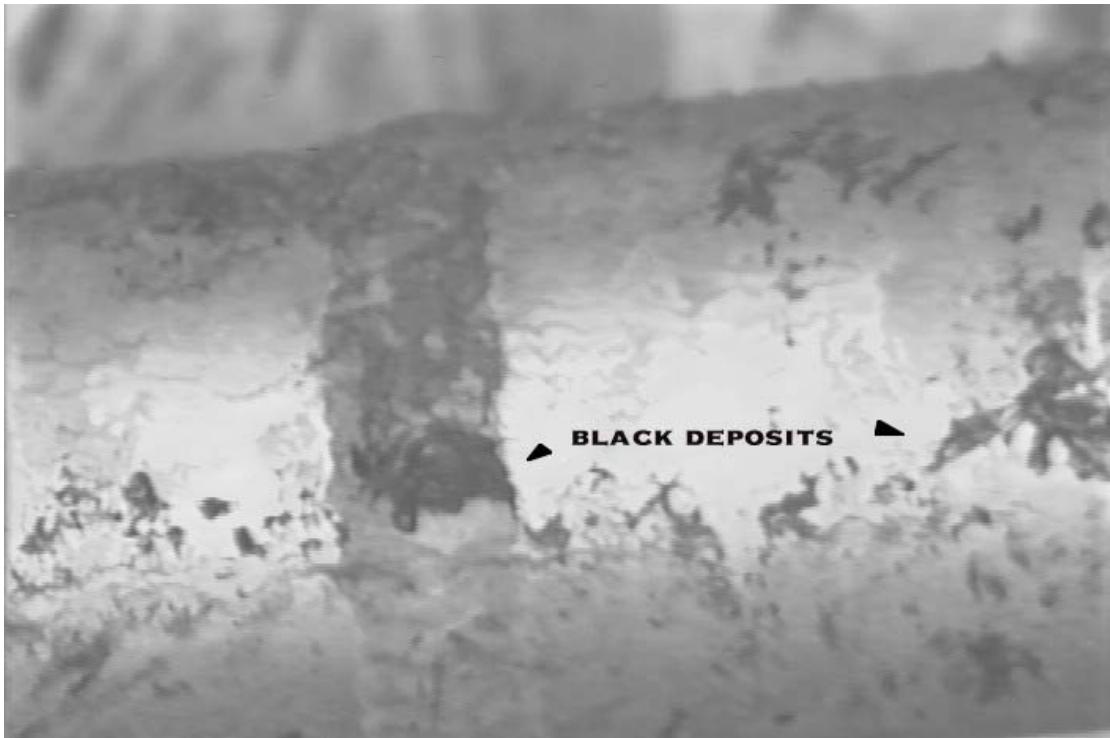
Figure D-7. Cooling coil pipe surface with deposits (PD03-0029-07).⁵
