DOE/NV--898-REV 1

Tonopah Test Range Post-Closure
Inspection Annual Report,
Tonopah Test Range, Nevada
Calendar Year 2002

August 2003

Environmental Restoration
Division

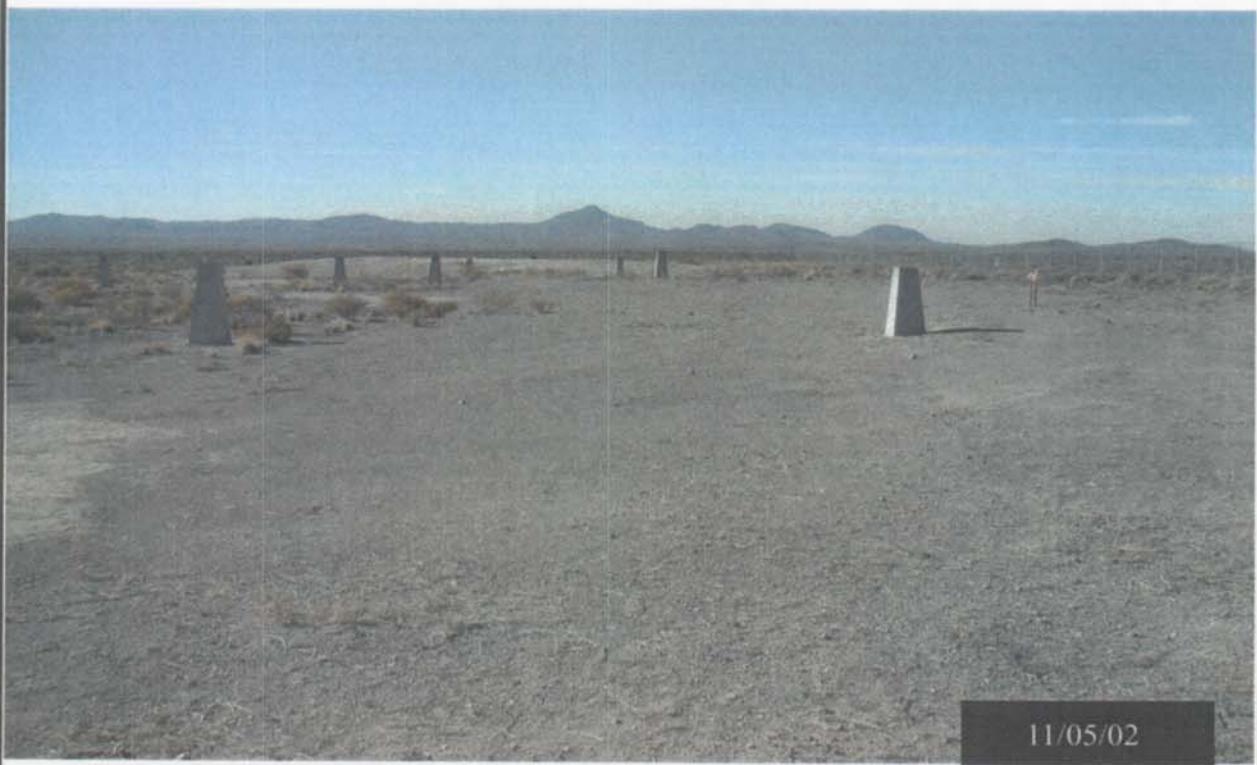
| PHOTO NUMBER | DATE | DESCRIPTION |
|---|---|--|
| 42 | 11/05/2002 | CAU 453 Area 9 UXO Landfill, looking east over repaired landfill cell A9-1. |

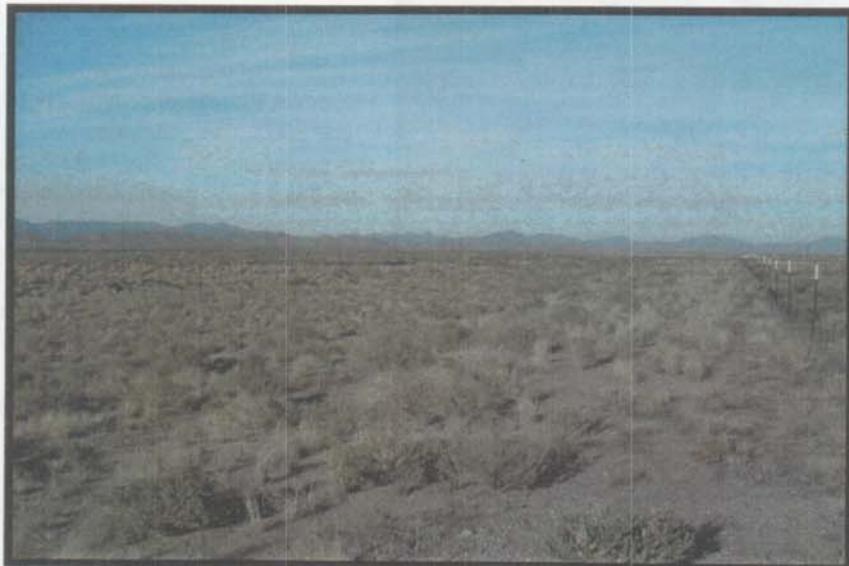
Five Points Landfill photo reference point, June 2002, five growing seasons after revegetation. After five years there is an excellent mix of shrubs and grasses. Slopes on both sides of basin are well vegetated and there are no signs of erosion.

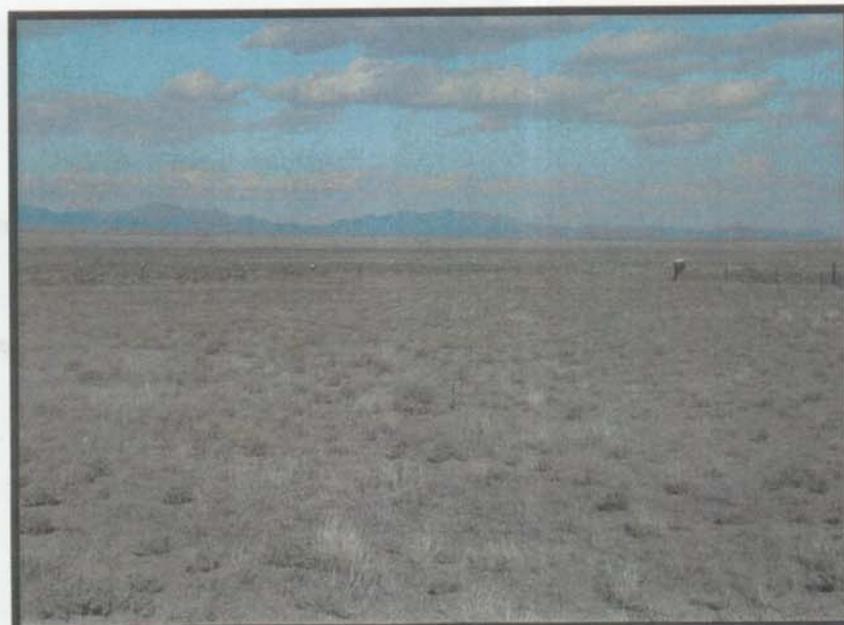
Bomblet Pit reference photo point, June 2002, five years after revegetation. The site looks barren but there is an abundance of native shrubs and grasses. The vegetation at the site is doing relatively well considering the site has received below normal precipitation for the last three years. Of note is the absence of halogeton, a noxious weed common to the site and very abundant on the site prior to revegetation.

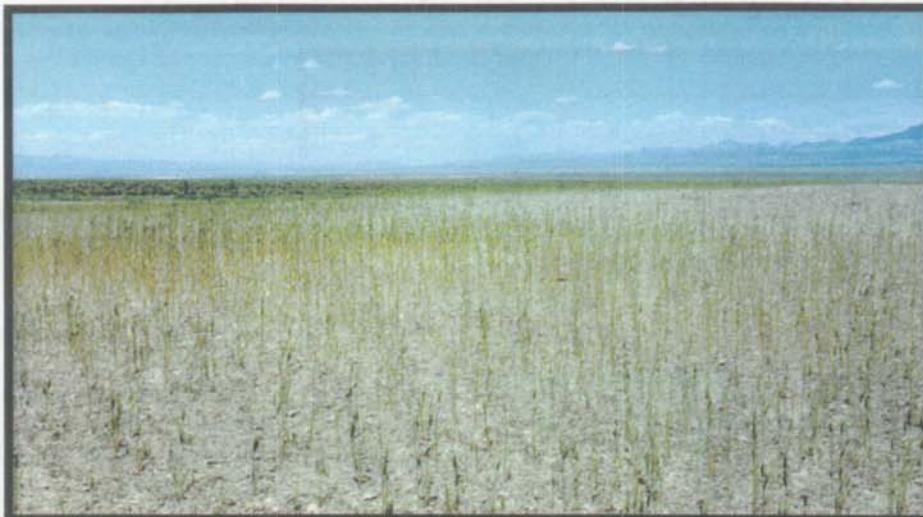
Roller Coaster Sewage Lagoons cover cap photo reference point, June 1998, one year after revegetation. As at other sites wheat dominants much of the site.

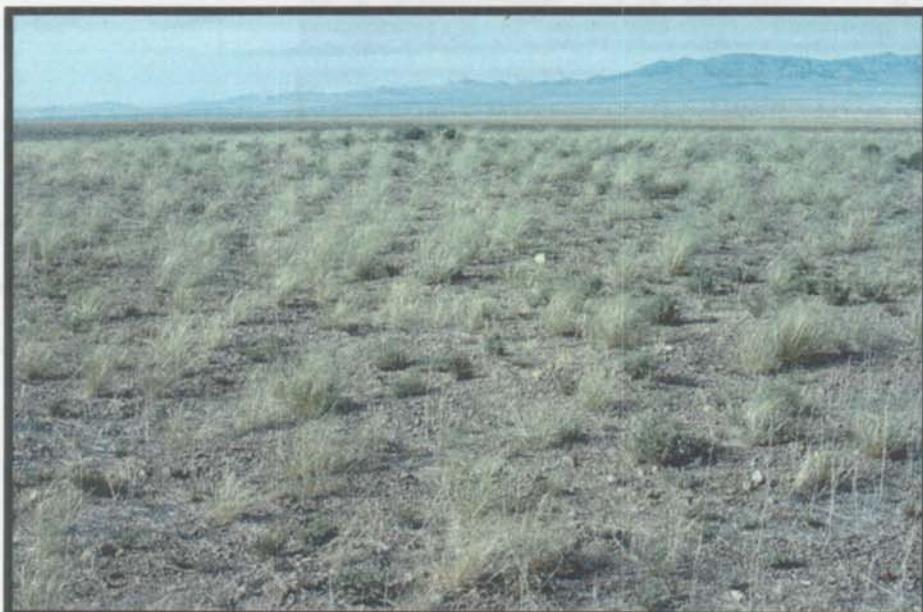
Roller Coaster Sewage Lagoons cover cap photo reference point, June 2000, three years after revegetation. Grasses and shrubs are becoming well established on cover cap. Shrubs are smaller in height and width than those found on the staging area, but shrub vigor is very good.

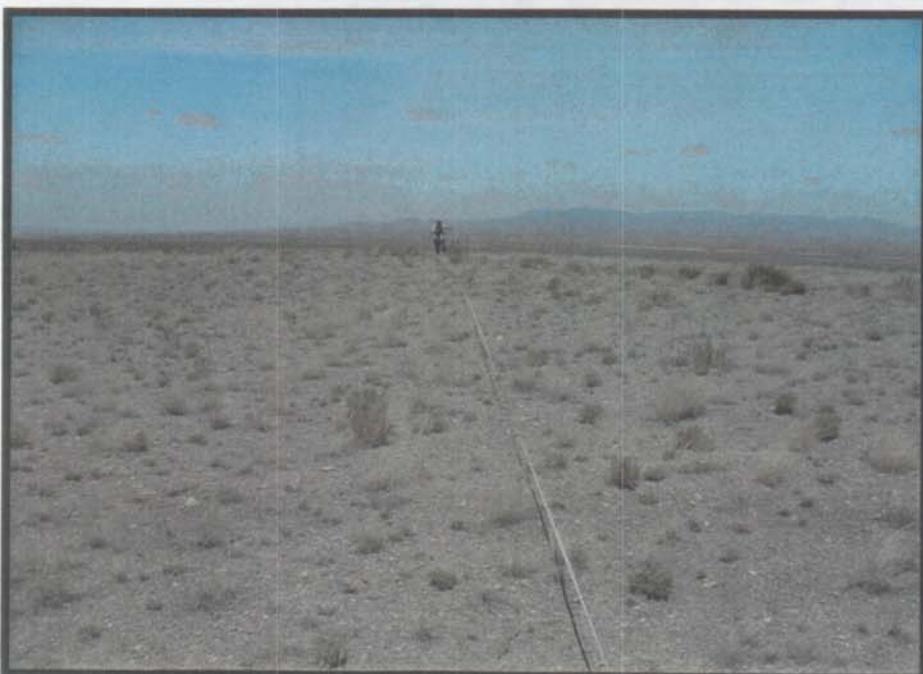
Roller Coaster Sewage Lagoons cover cap photo reference point, June 2002, five years after revegetation. The site does not look as good as it did in 2000, but the density of shrubs and grasses is good. Few plants were able to put on much growth this year and last year because of the dry conditions.

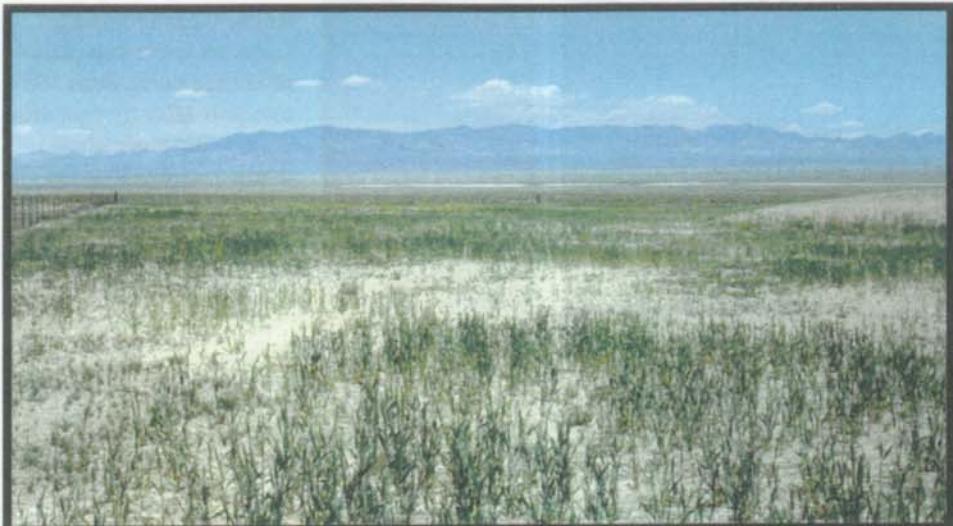
Roller Coaster Sewage Lagoons staging area photo reference point, June 1998, one year after revegetation. Wheat dominants the overall appearance of the site, however, there are numerous seedlings of grasses and shrubs emerging through the layer of straw mulch.

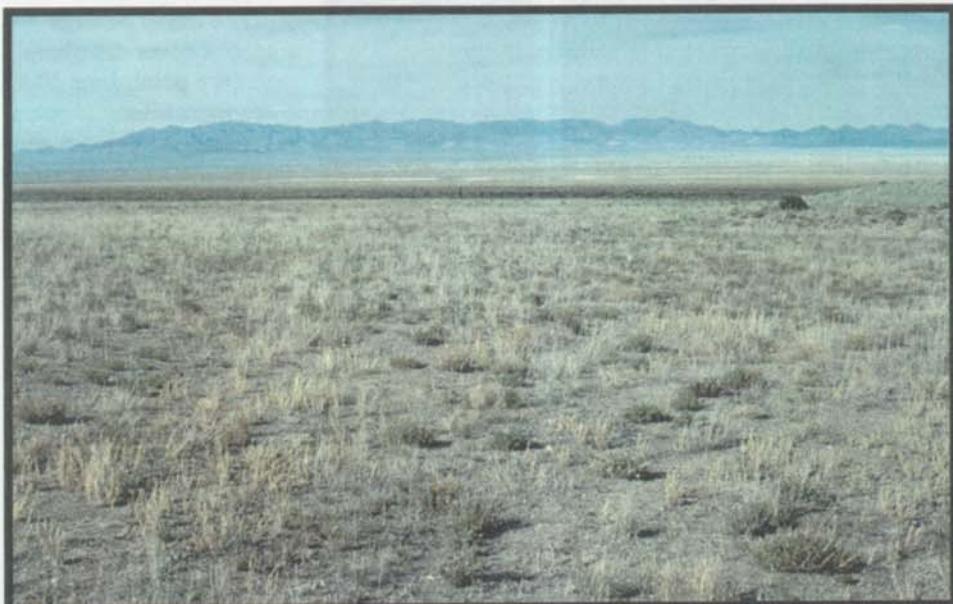
Roller Coaster Sewage Lagoons staging area photo reference point, June 2000, three years after revegetation. Little, if any, wheat is seen on the site. A good mix of shrubs and grasses are establishing. In the foreground several plants of halogeton are seen invading the site. The dominant shrub is shadscale with some fourwing saltbush and budsage.

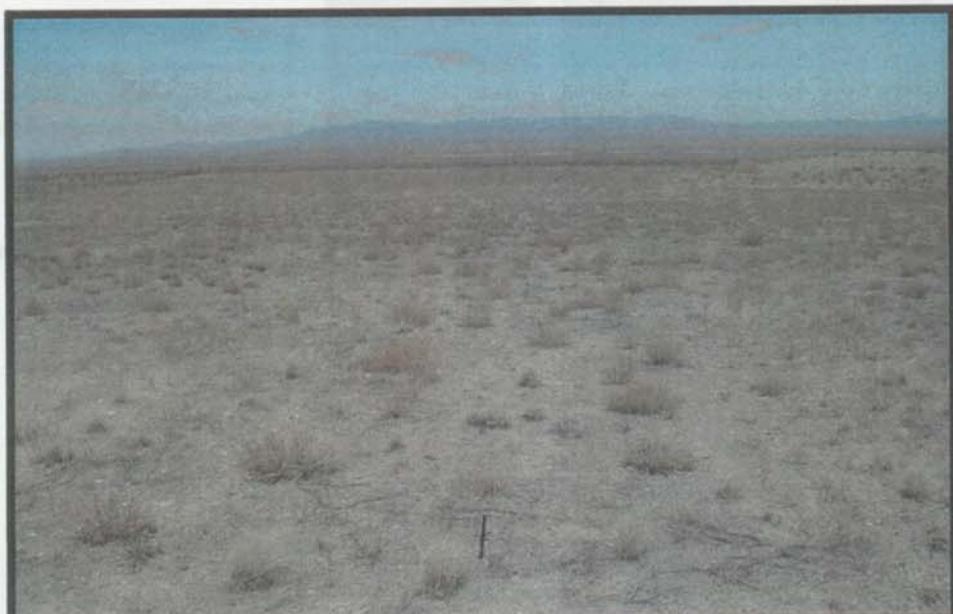
Roller Coaster Sewage Lagoons staging area photo reference point, June 2002, five years after revegetation. Dry conditions over the last couple years have left the site looking barren and brown, but there is a good mix of shrubs and grasses on the site, but they have not shown much growth this year. There was some evidence of die-off of some individuals of shadscale, but this was expected.

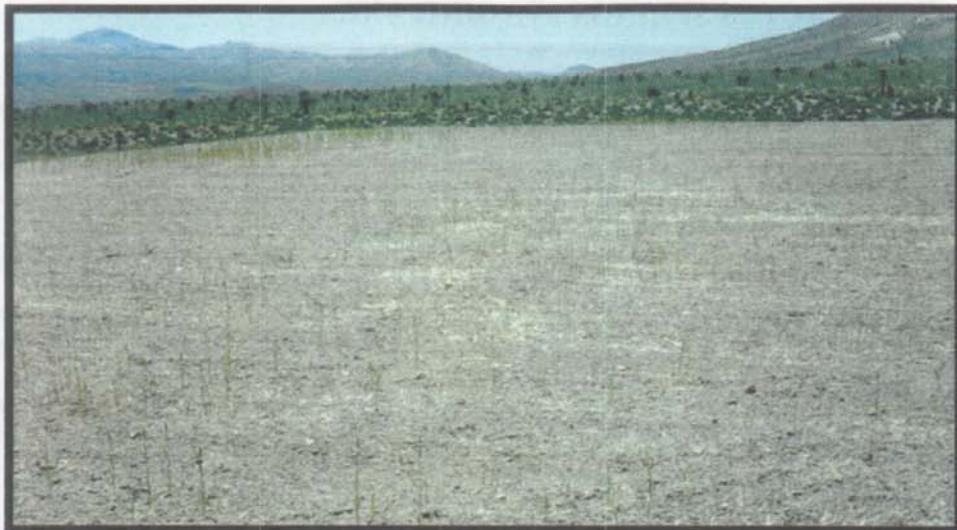
Cactus Springs Waste Trench cover cap photo reference point, June 1998, one year after revegetation. Plant density on the cover cap was low the first year and growth was minimal. A few wheat plants established but were not present by the third year.

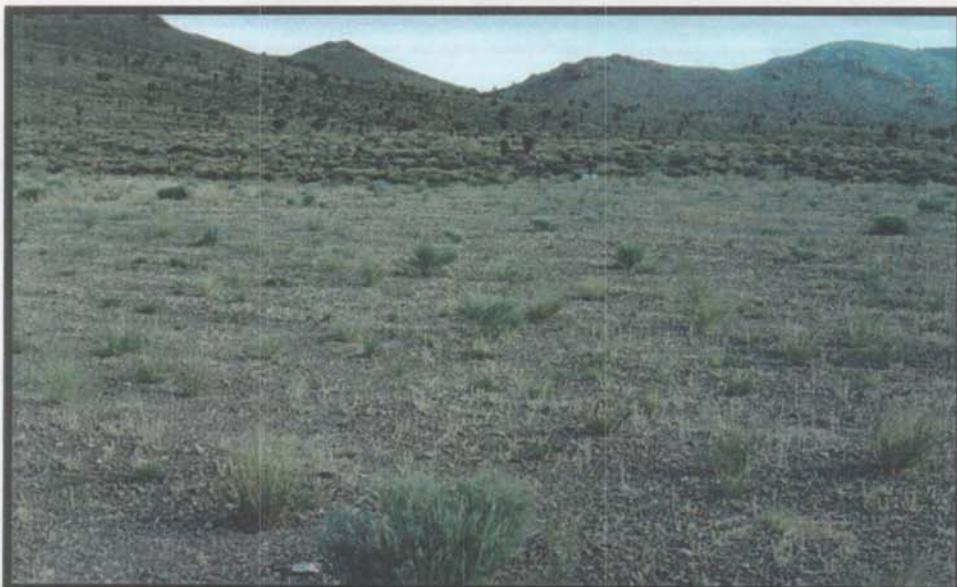
Cactus Springs Waste Trench cover cap photo reference point, June 2000, three years after revegetation. Shrubs are established as well as a several grasses. Grasses were smaller, but density was high.

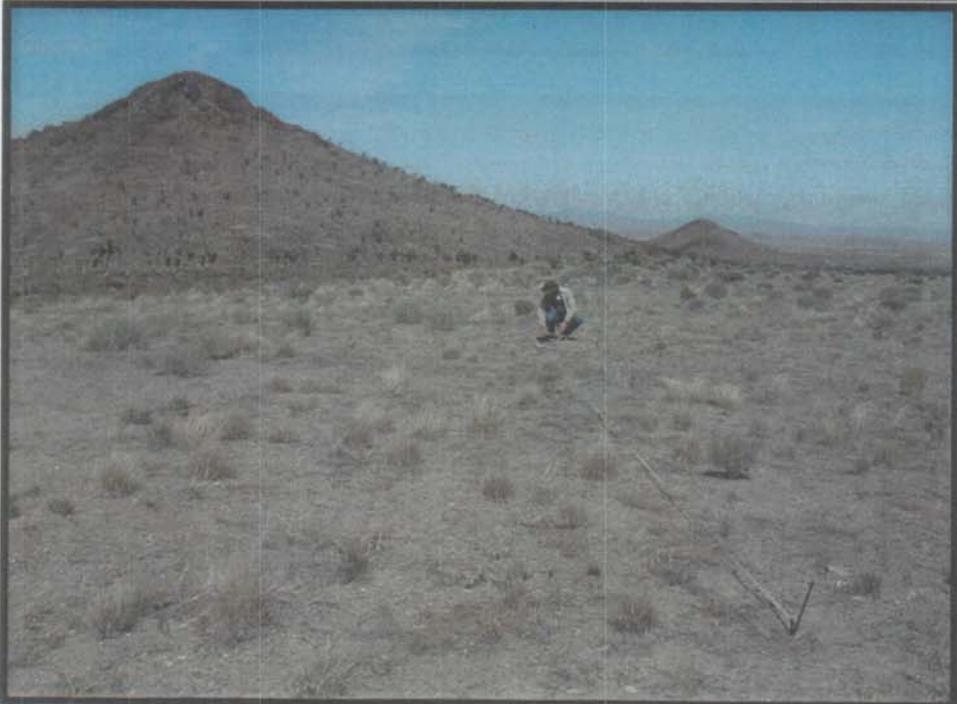
Cactus Springs Waste Trench cover cap photo reference point, June 2002, five years after revegetation. Grasses and shrubs are still present but growth in 2002 was minimal. There is still good density of shrubs and grasses despite the poor showing the first year. Vegetation is becoming established on the cover cap and there are no signs of erosion off the cap. There are numerous signs of rabbits on the site.

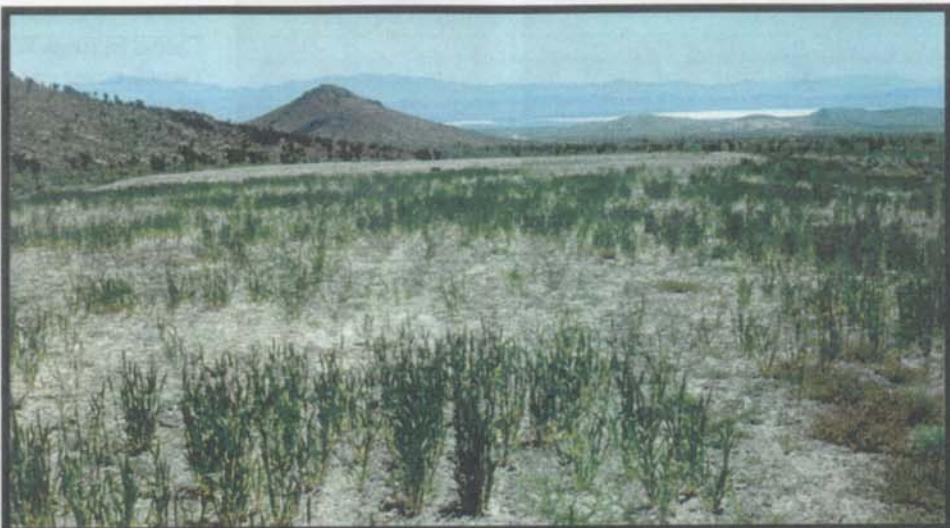
Cactus Springs Waste Trench staging area photo reference point, June 1998, one year after revegetation. As with most sites the first year's vegetation appears dominated by wheat. There is a mix of young shrub and grass seedlings beneath the canopy of wheat stalks.

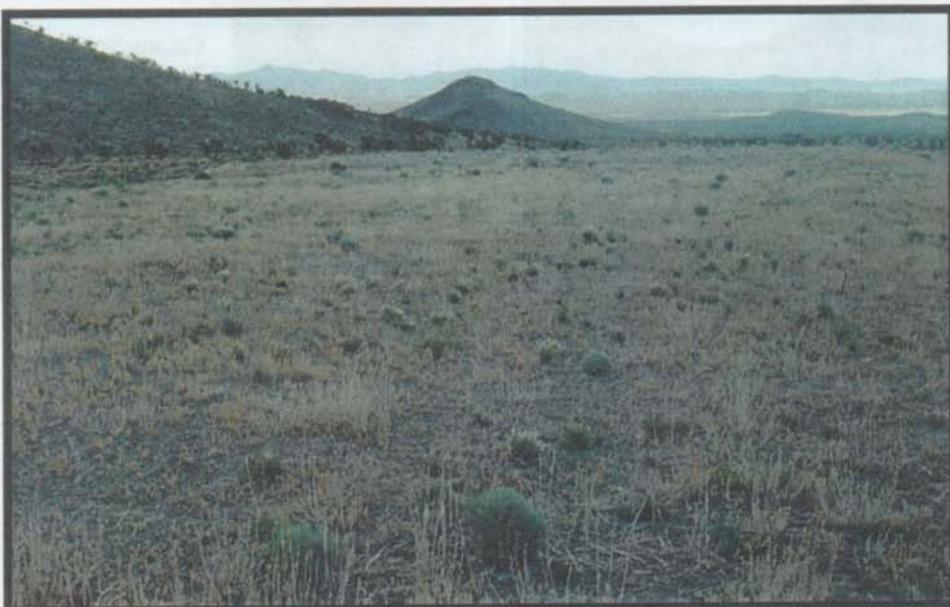
Cactus Springs Waste Trench staging area photo reference point, June 2000, three years after revegetation. As is apparent there are numerous shrubs and grasses becoming established on the site. Because plant density and cover is lower there are barren areas that are quickly invaded by halogeton (foreground, dark tan appearance).

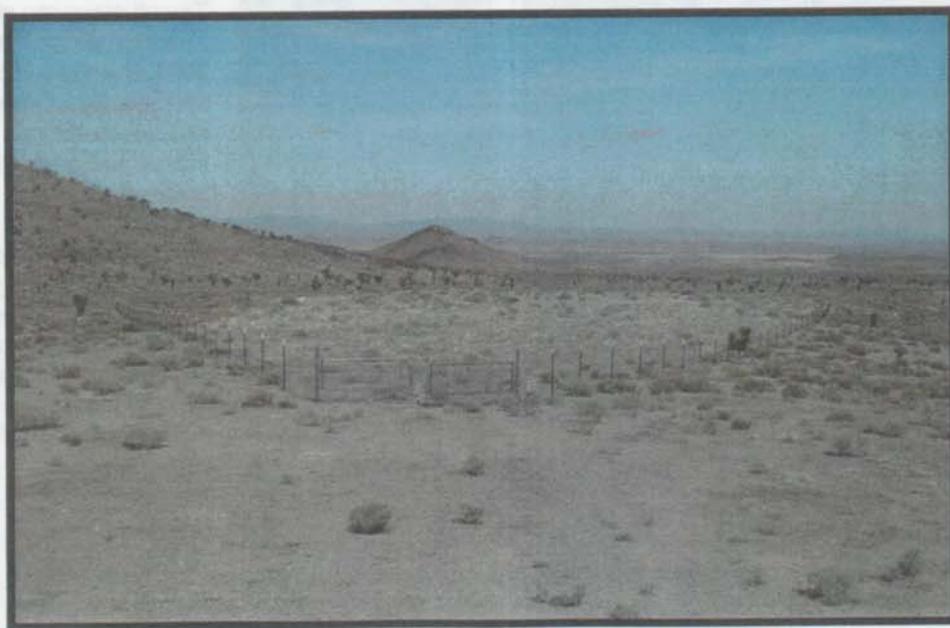
Cactus Springs Waste Trench staging area photo reference point, June 2002, five years after revegetation. Shrubs and grasses are becoming well established on the site. Plant cover and density values are a little lower at this site than at the other closure sites.
