Materials Reliability Program: Environmental Fatigue Testing of Type 304L Stainless Steel U-Bends in Simulated PWR Primary Water (MRP-137)

1008207

Technical Update, December 2004

Framatome ANP GmbH

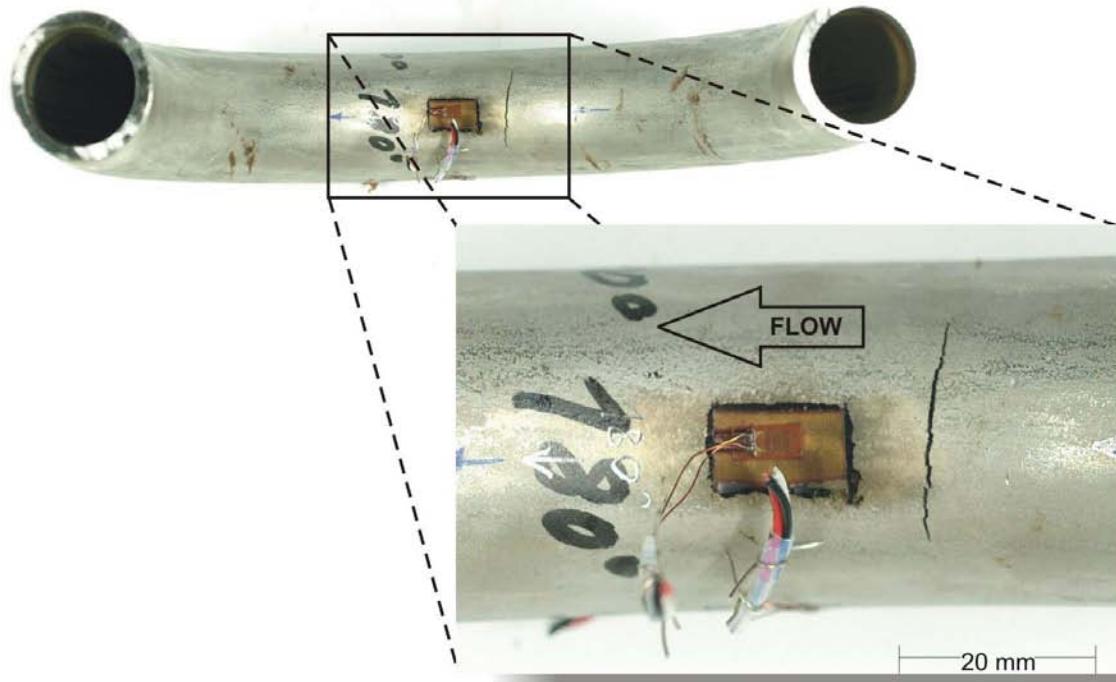
Visual inspection revealed one primary circumferential crack with an approximate length of 20 mm located at the intrados adjacent to the strain gauge. This defect had developed into a through wall crack as displayed in Figure 4-7. No other primary defects visible to the naked eye were found on the external surface during visual inspection.

Figure 4-7
Visual inspection of BLT 2; primary failure in the form of circumferential crack

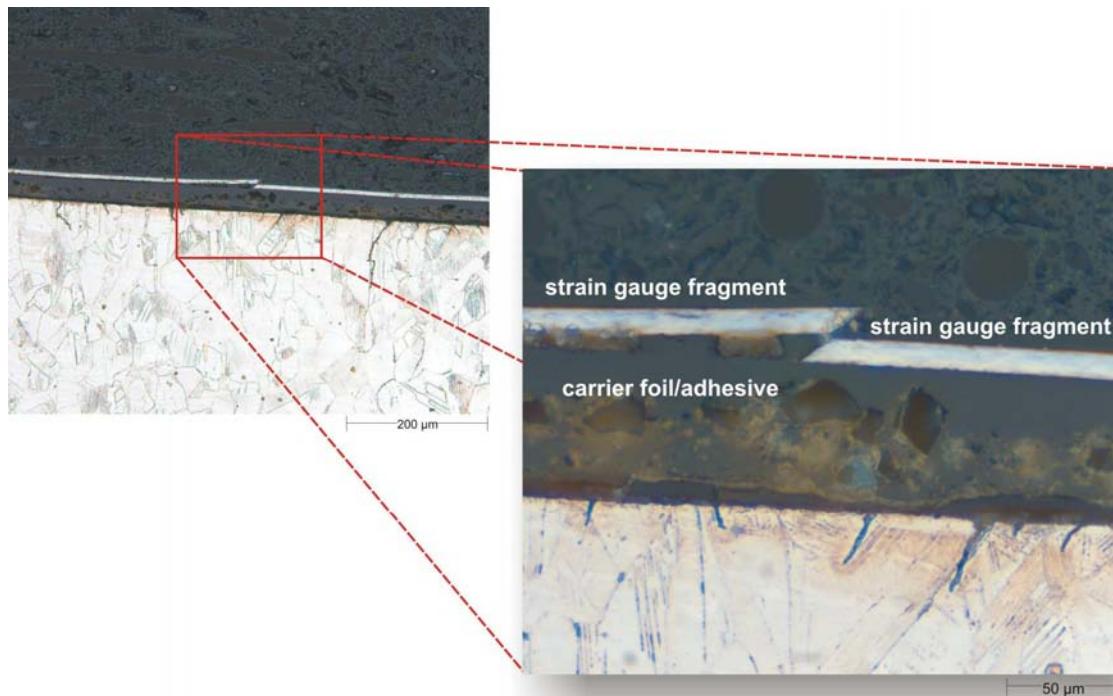
Figure 4-17
Micrograph showing cracked strain gauge; the separation of the strain gauge most likely occurred during sample preparation and is not associated with testing.

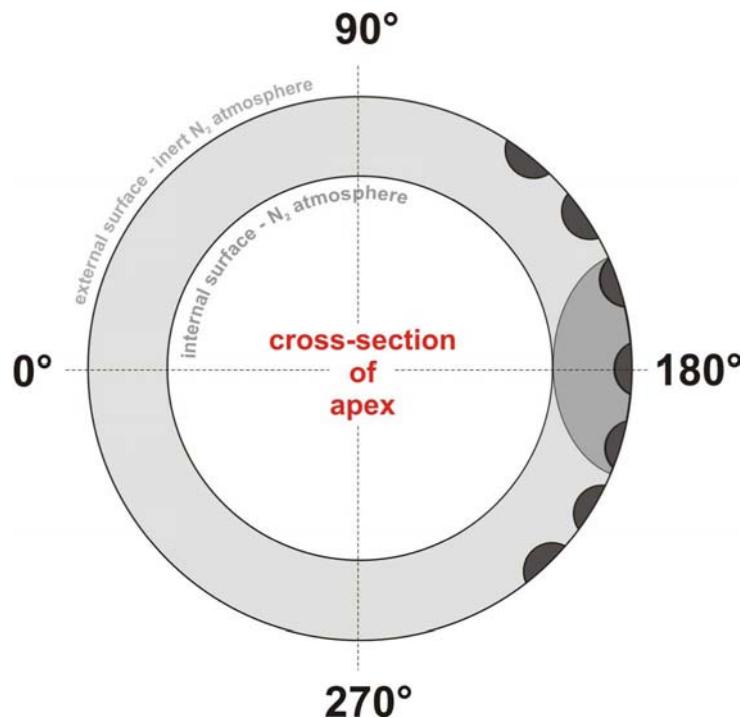
Similar to BLT 1 and BLT 2RT, the U-bend tested during BLT 2 suffered from multiple crack indications on the external surface arranged in an array at the highly strained intrados area. The primary failure occurred due to a circumferential through-wall defect that originated on the external surface of the intrados. The relatively straight crack progression in a transgranular manner and the fracture appearance with striations clearly indicated a mechanical driven fatigue failure. Corresponding to previously tested bends, the microstructure appeared to be sound, since no general microstructural effects negatively affecting the bend's fatigue behavior were observed. With the exception of two readings at the internal and external surfaces, the hardness readings also corresponded with previous results. Figure 4-19 graphically summarizes the results of BLT 2.

Figure 4-19
Schematic graphically summarizing the cracking locations of BLT 2.

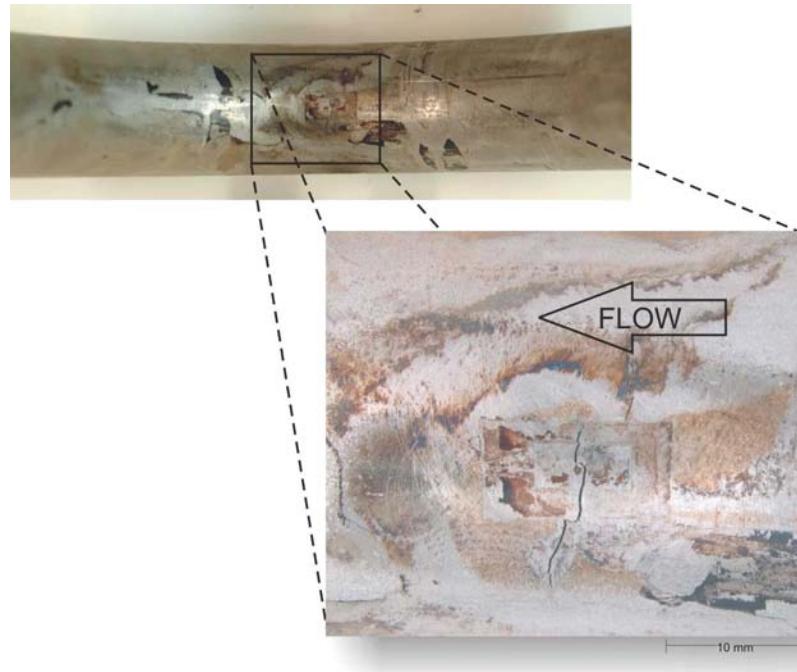
Visual inspection revealed one primary circumferential crack with an approximate length of 15 mm. This defect was located at the intrados immediately underneath the strain gauge. This fracture had developed into a through wall defect causing the loss of most of the primary water environment into the autoclave. No other defects visible to the naked eye were found on the external surface during visual inspection. Figure 5-9 shows the intrados area of the bend with the primary fracture.

Figure 5-9
Visual inspection of U-bend revealing one primary circumferential crack at the intrados.

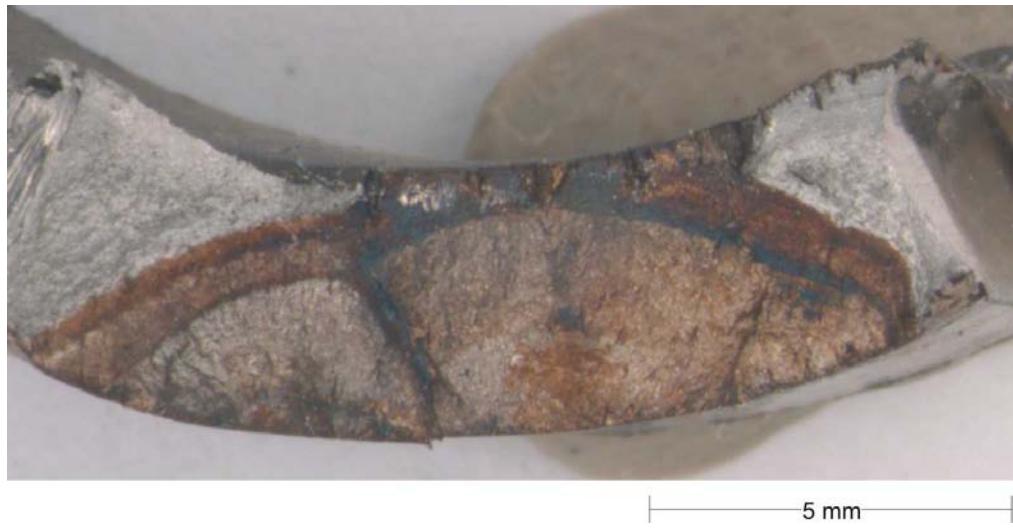
As a next step, the primary circumferential crack at the 180° intrados position was broken open for detailed fractography. Figure 5-17 displays the specimen used during SEM examination.

Figure 5-17
Broken open circumferential crack used for fractography.

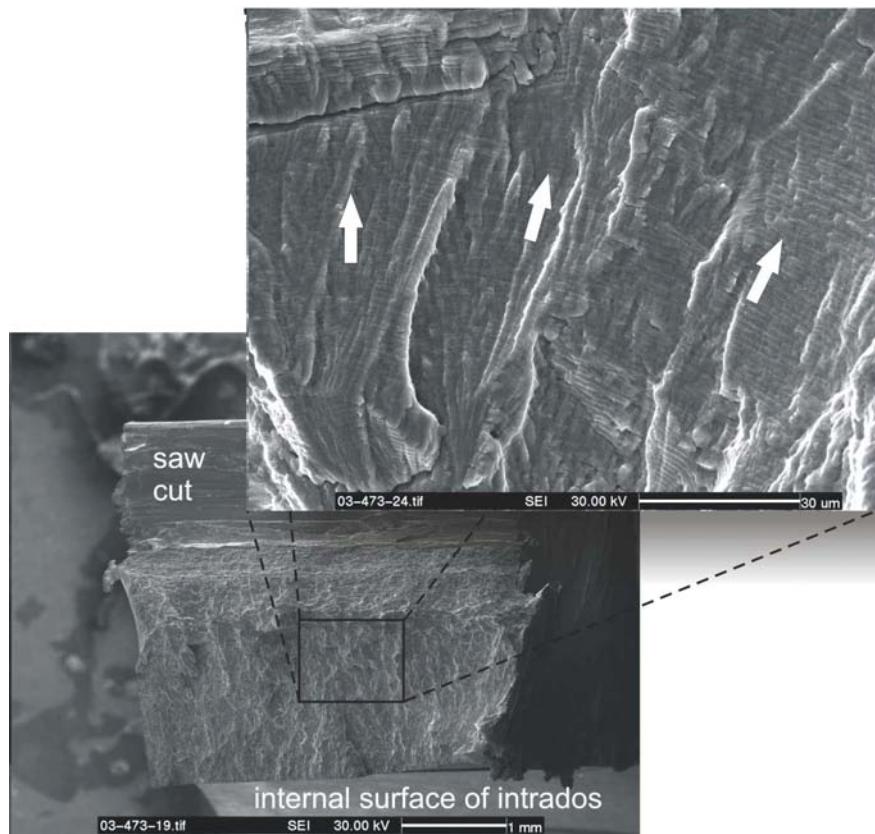
The internal surface of the intrados also disclosed multiple axial fissures as displayed in Figure 5-19. One representative axial fissure was broken open and analyzed with the SEM. The fracture surface also revealed a striation pattern indicating a step-wise crack progression under cyclic loading. However, the spacing was determined as 0.5 μm to 1 μm and thus found to be finer if compared to the primary mechanical driven fracture. The crack progression of this axial fissure occurred from the internal towards the external surface. The fracture surface was partly altered by the HT water during testing, but the morphology still indicated a combined environmental and mechanical effect as to be expected during corrosion fatigue (see Figure 5-20).

Figure 5-20
Broken open axial crack showing evidence of corrosion fatigue with a crack front progressing from the internal towards the external surface.

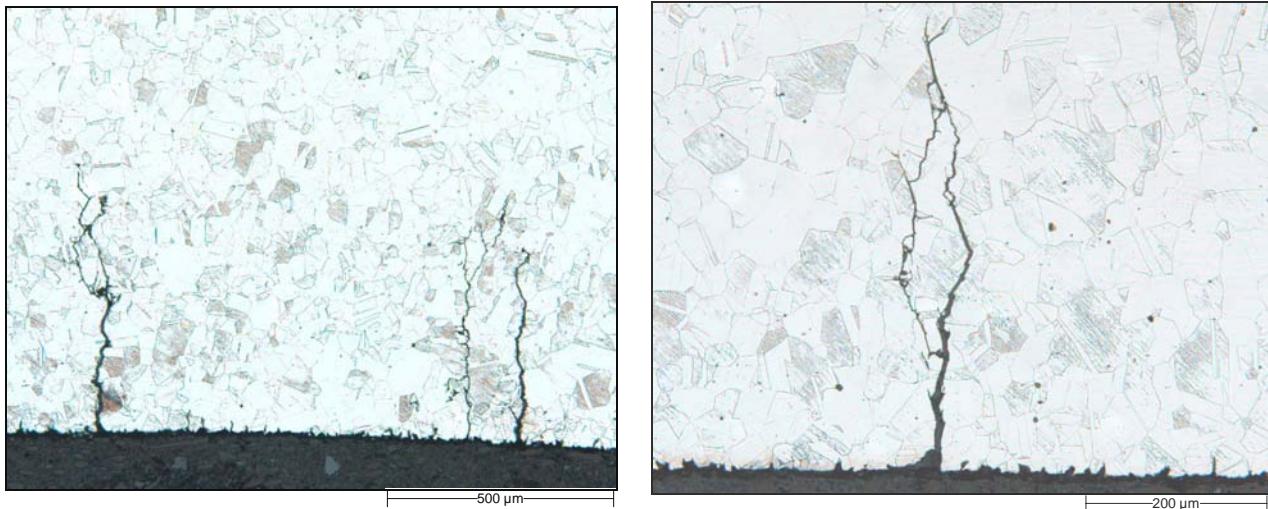
Figure 5-22
Typical views of cross-section in the 270° position (Specimen S1) showing transgranular axial cracking progressing from the internal towards the external surface.

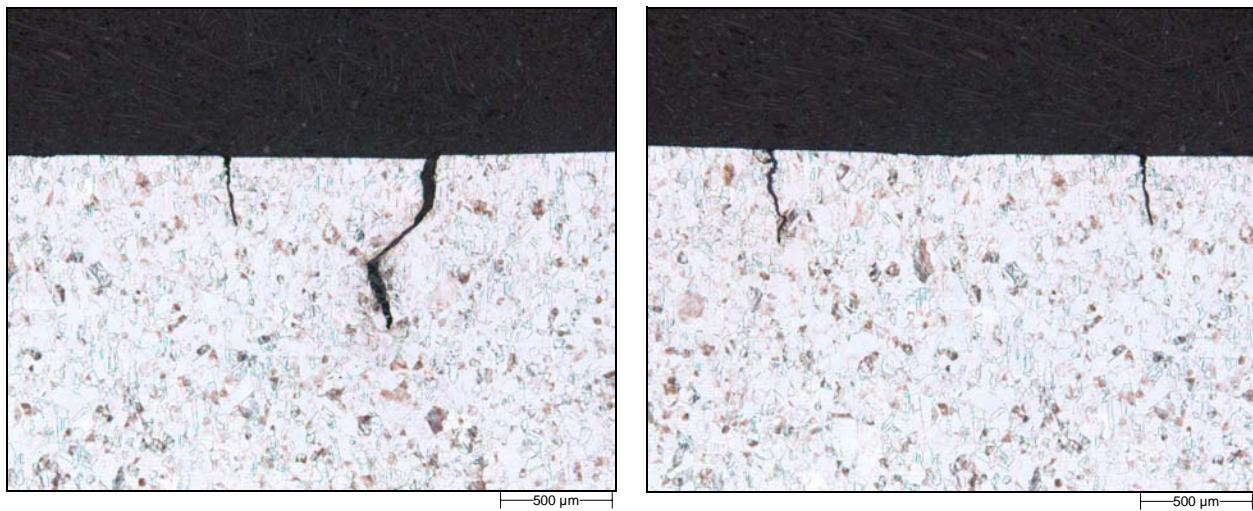
Figure 5-23
Typical views of cross-section in the approximate 200° position (Specimen S2) showing transgranular circumferential cracking progressing from the External towards the internal surface.

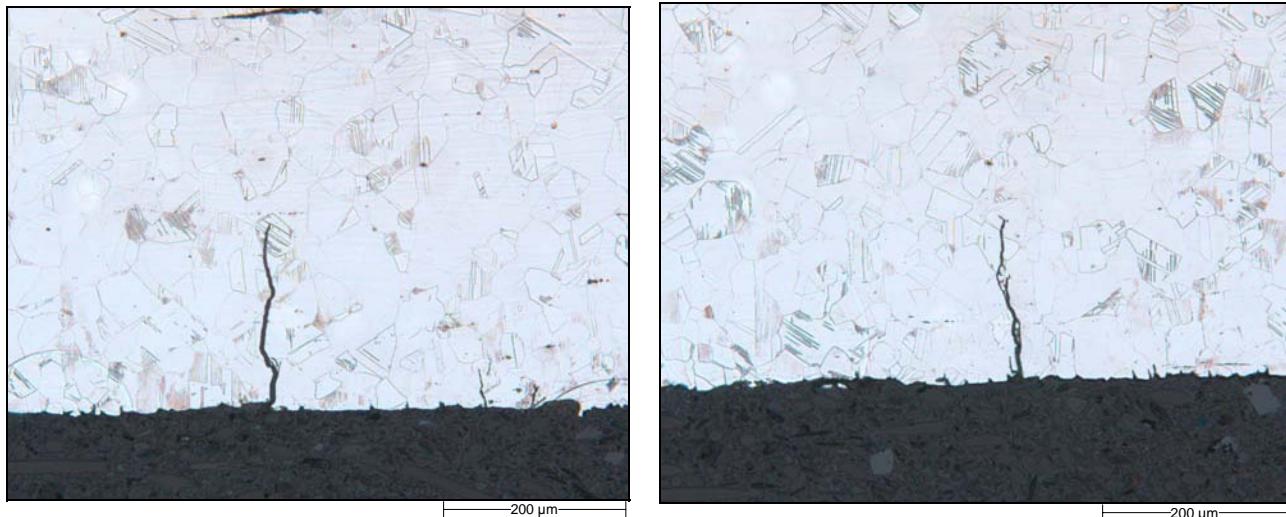
Figure 5-24
Typical views of cross-section in the approximate 110° position (Specimen S3) showing transgranular circumferential cracking progressing from the internal towards the external surface.

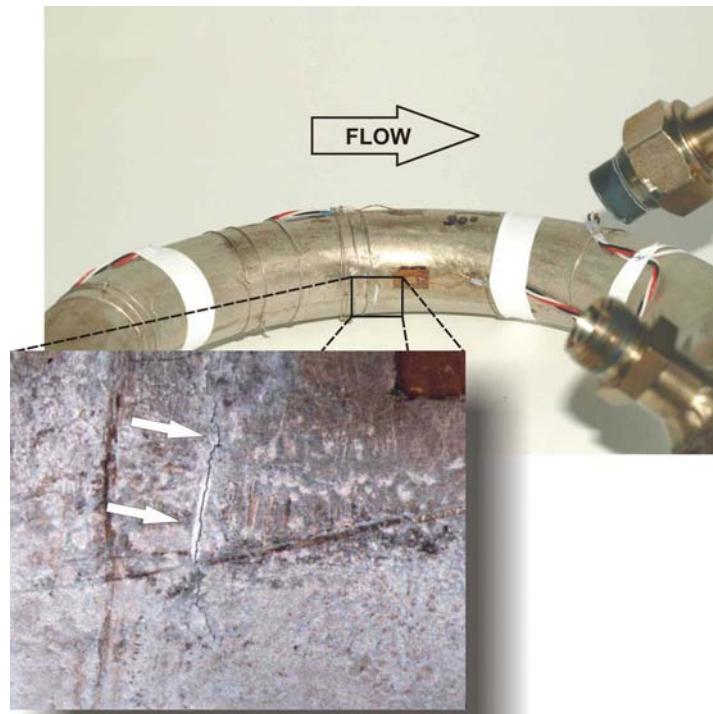
Figure 6-10
Close-up of leakage causing defect located in the intrados area.

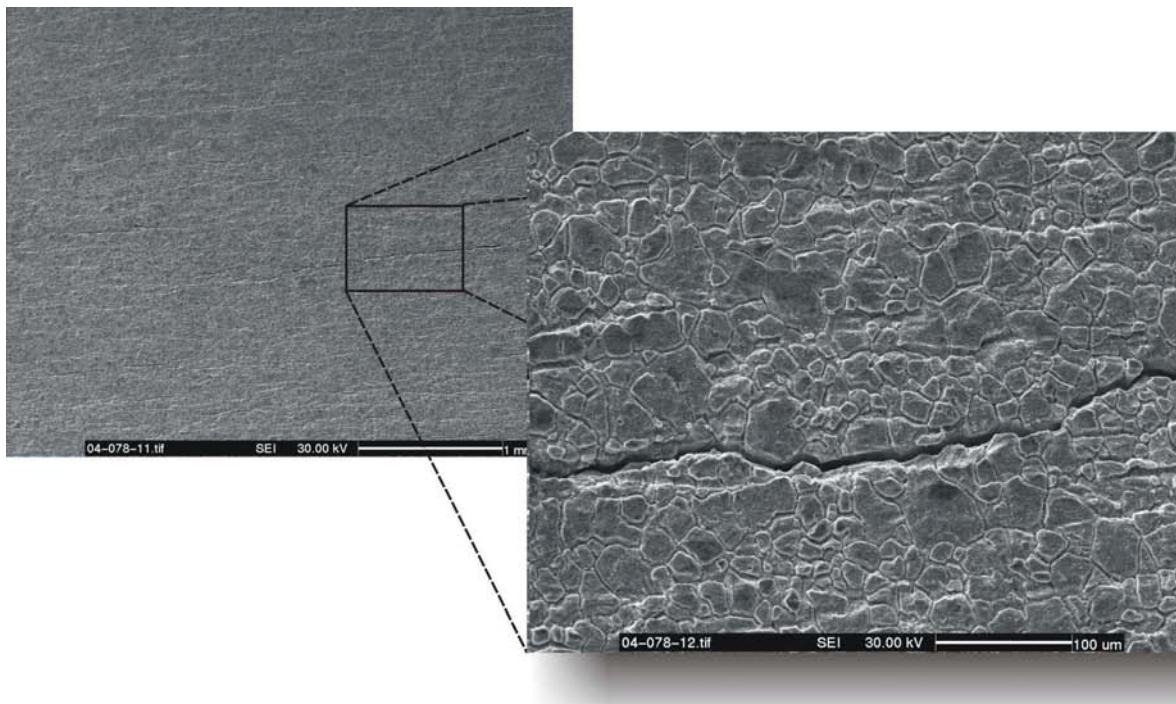
Figure 6-18
Internal surface of intrados showing axial cracking along the texture provided by the pickling attack.

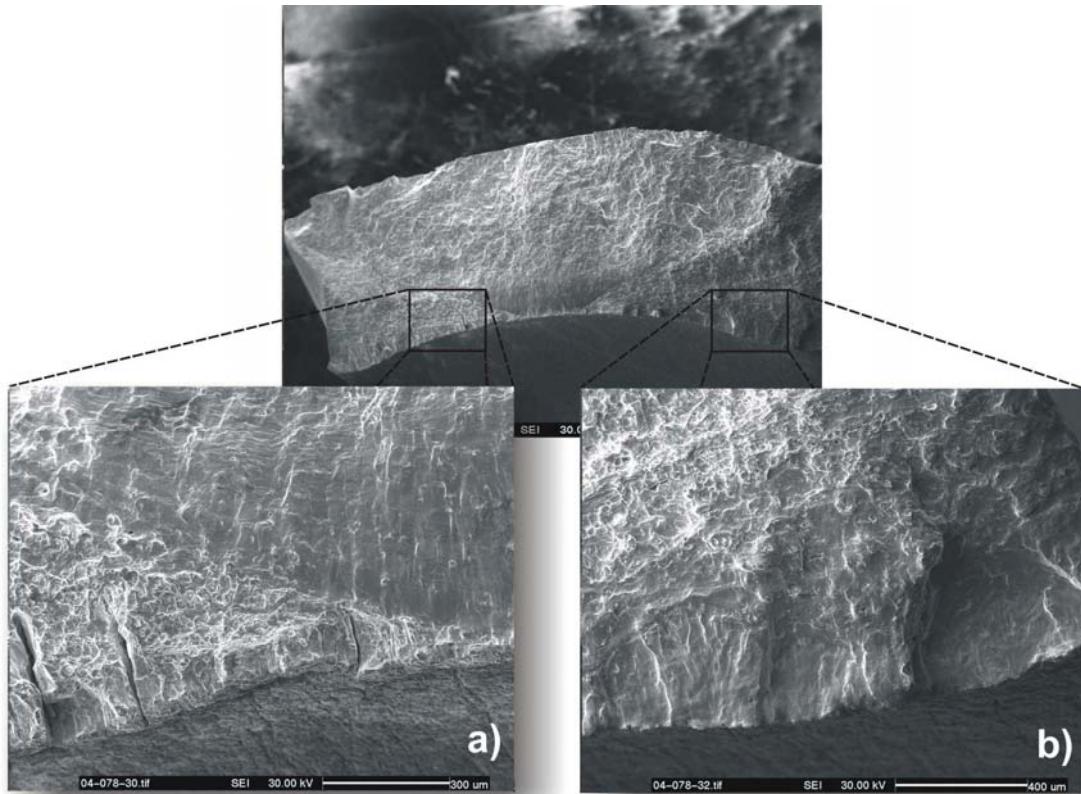
The internal surface exhibited both internally initiated axial and circumferential cracking as shown in Figure 6-22. The striation spacing for both types of cracking was determined to range between $0.5 \mu\text{m}$ to $1 \mu\text{m}$. The morphology of both types of cracks was similar and indicated environmentally assisted crack progression under cyclic loading. Figure 6-23 and Figure 6-24 show typical fracture surfaces of axial and circumferential cracks, respectively.

Figure 6-22
Typical fracture appearance found on the internal surface of the intrados; a) axial cracking initiating from the internal surface; b) circumferential cracking initiating from the internal surface.

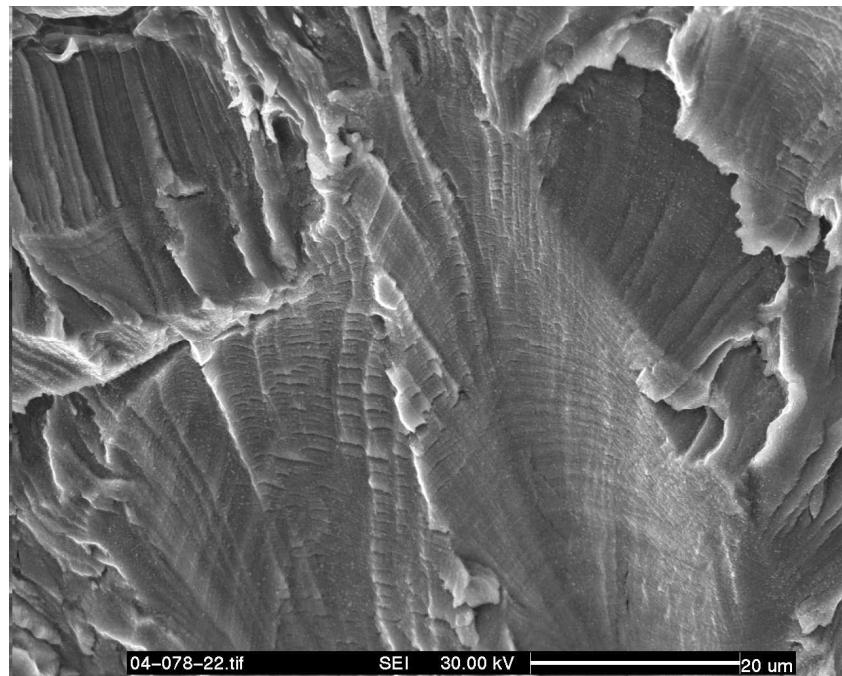
Figure 6-23
Typical crack morphology found on axial cracks that had initiated on internal surface.

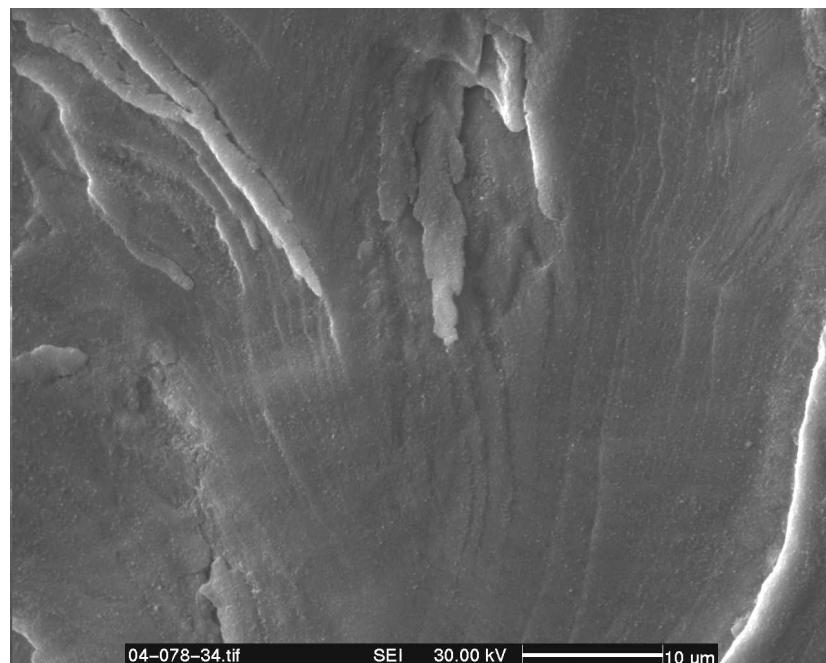
Figure 6-24
Typical crack morphology found on circumferential cracks that had initiated on internal surface.

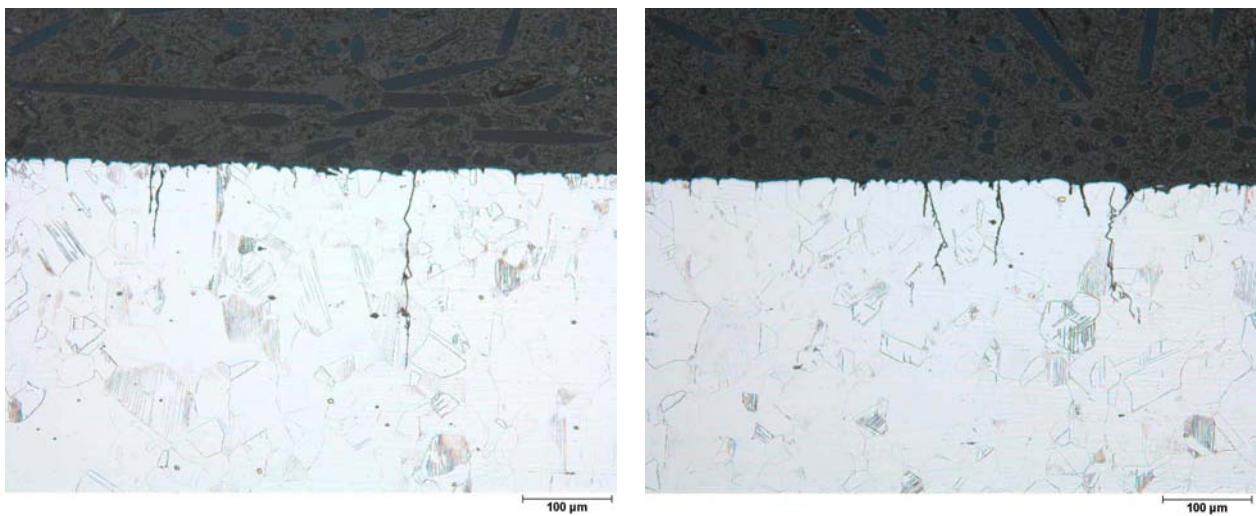
Figure 6-29
Typical views of external 110° position (Specimen S2) showing transgranular crack propagation from the external towards the internal surface; crack initiation appeared to have occurred at attacked grain boundaries from pickling treatment.

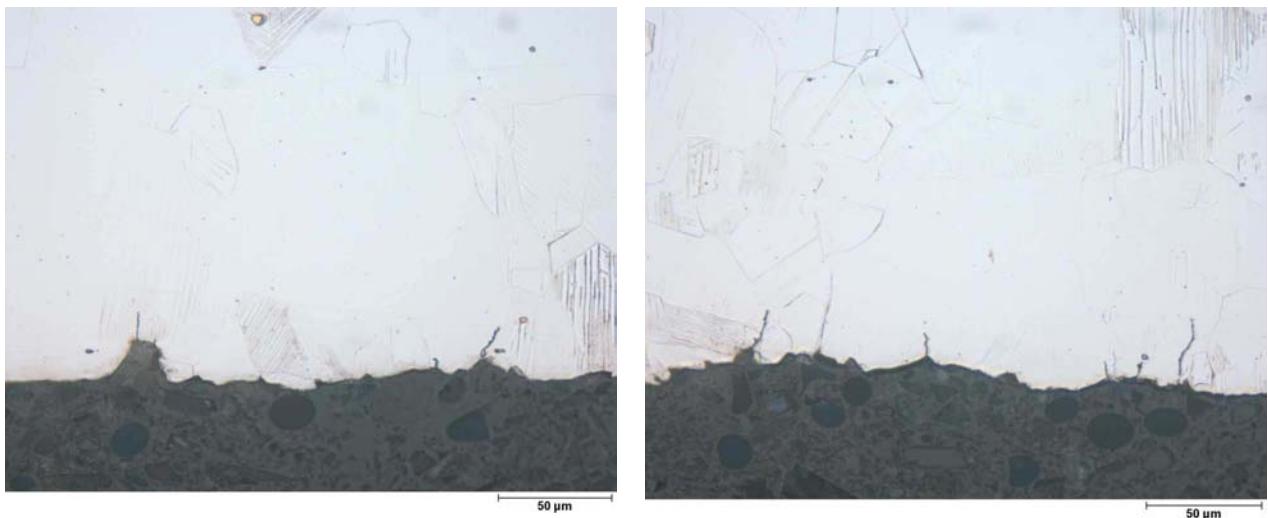
Figure 6-30
Typical views of cross section of the internal 110° position (Specimen S2); environmental, circumferential cracks propagating from the internal towards the external surface in a transgranular manner; crack initiation appeared to have occurred at attacked grain boundaries from pickling treatment.

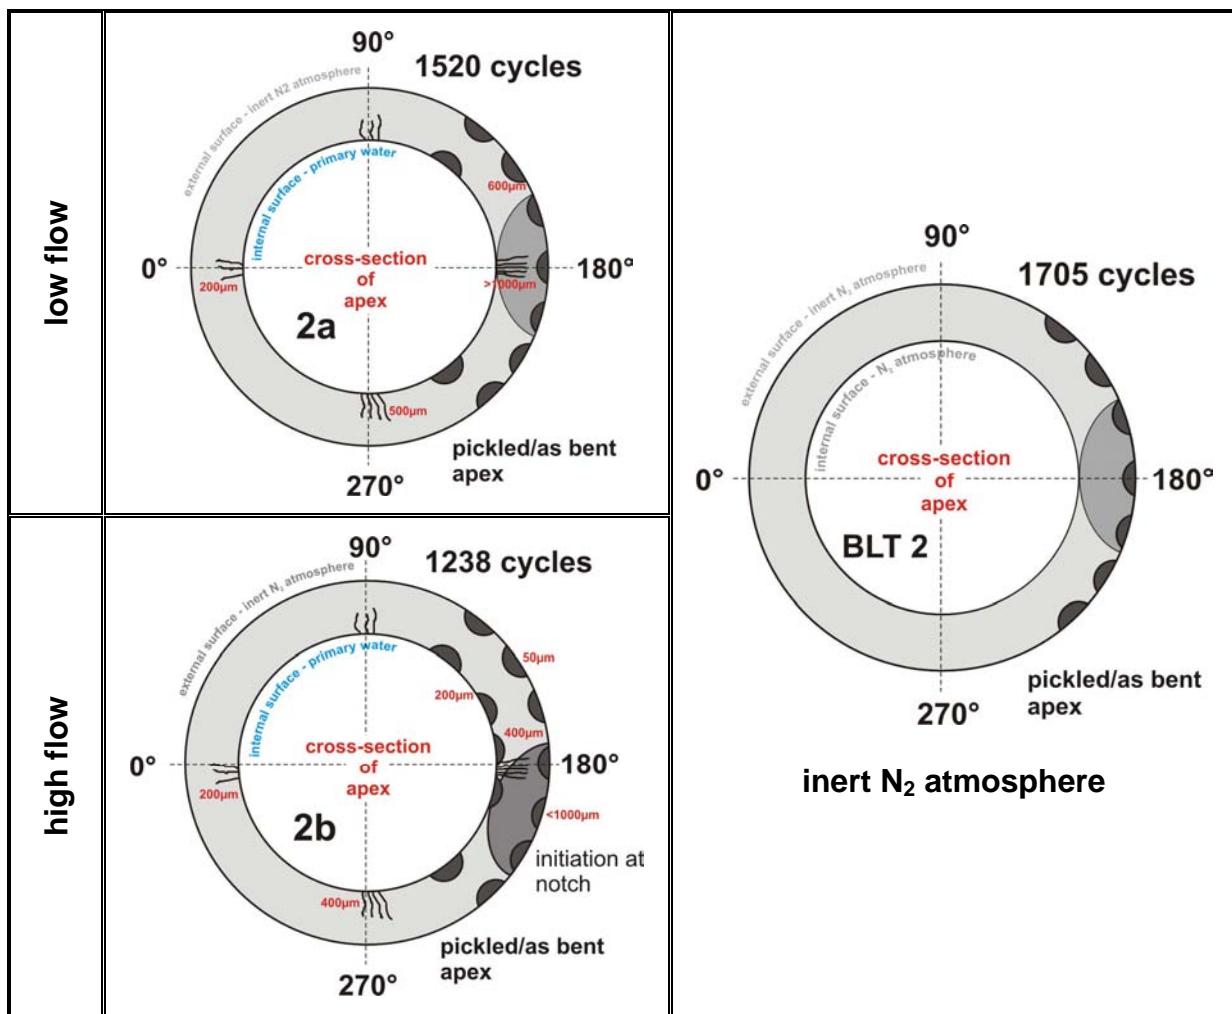
Figure 7-3
Summary of crack locations, depths and achieved cycles.

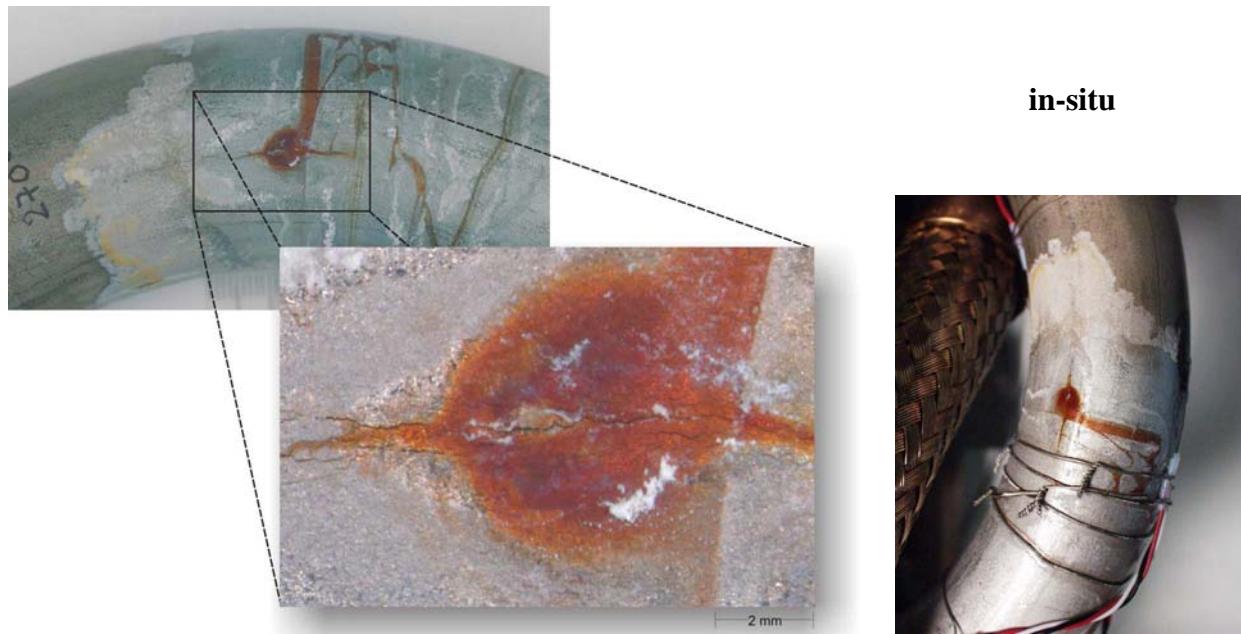
Figure 8-11
Primary leakage causing failure in the 270° position.

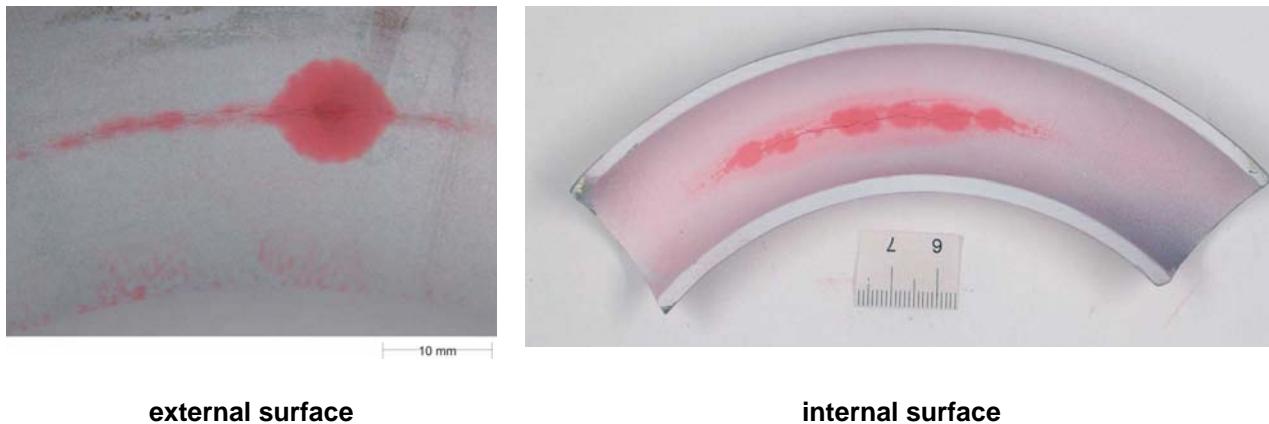
Figure 8-12
DPI surface inspection of 270° position showing multiple axial cracking at both locations.

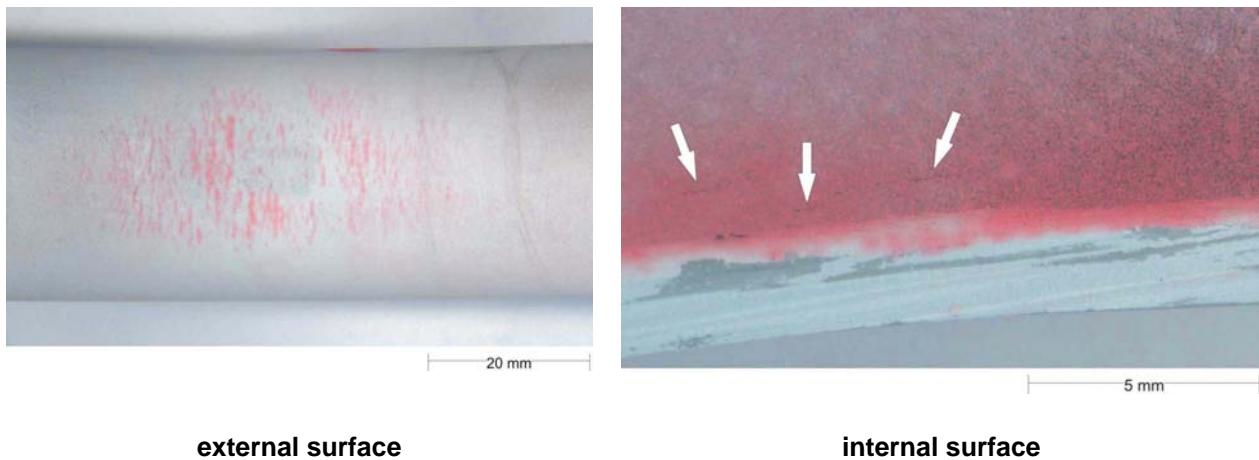
Figure 8-14
180° intrados position showing array of fine circumferential cracking on external surface and fine multiple axial cracking on the internal surface.

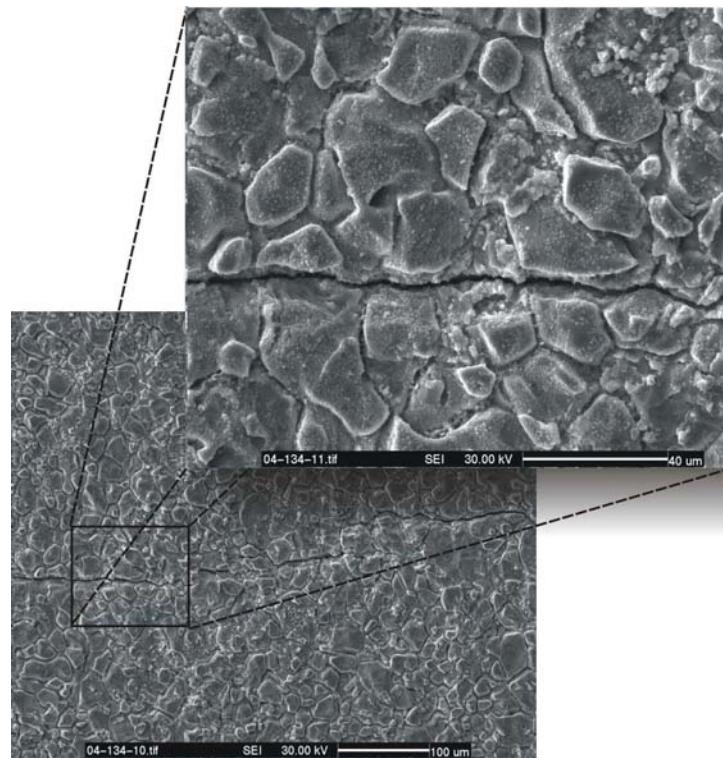
Figure 8-16
Internal surface of 180° intrados position showing axial cracking following attacked grain boundaries from the pickling treatment.

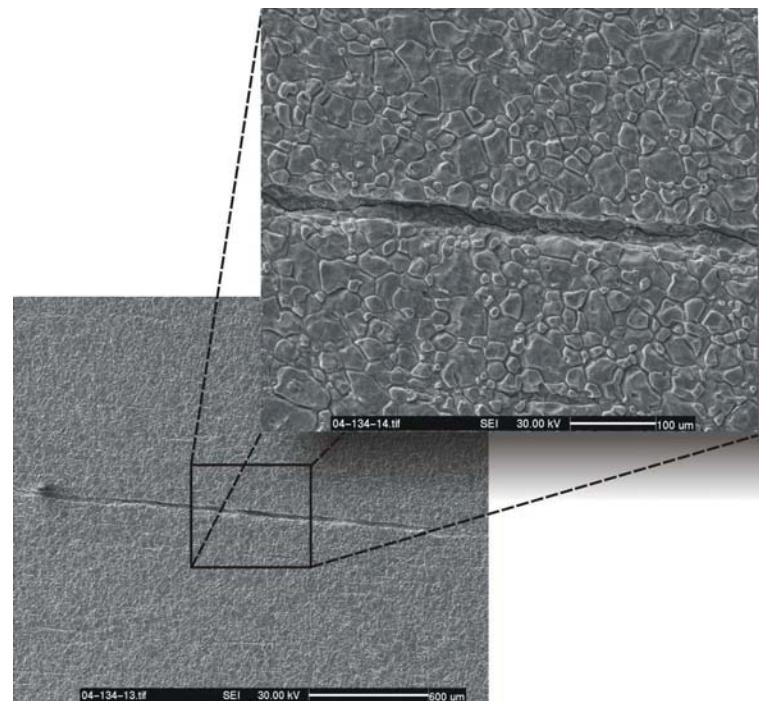
Figure 8-18
Internal surface of 270° position showing defect causing leakage in the form of axial cracking.

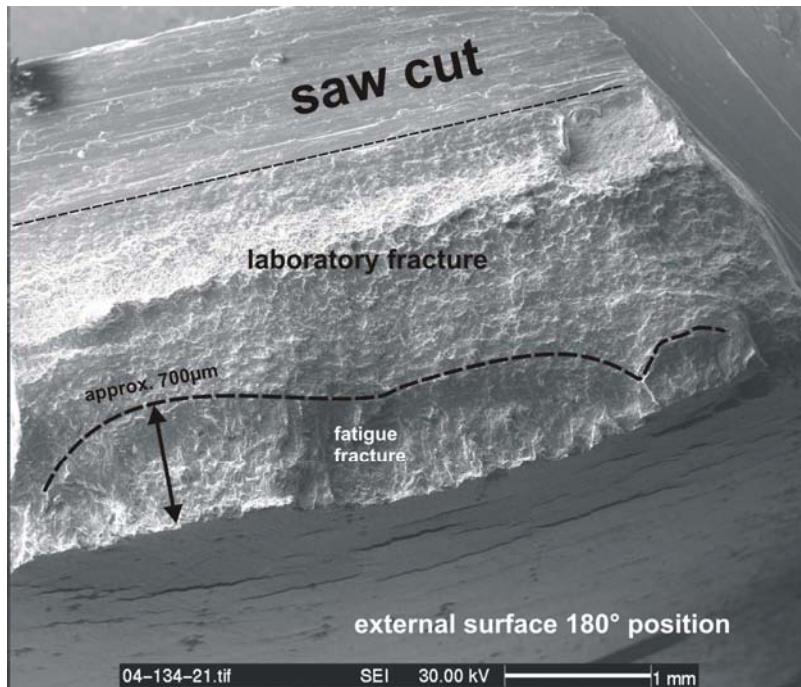
Figure 8-19
Broken open external circumferential crack at 180° intrados position.

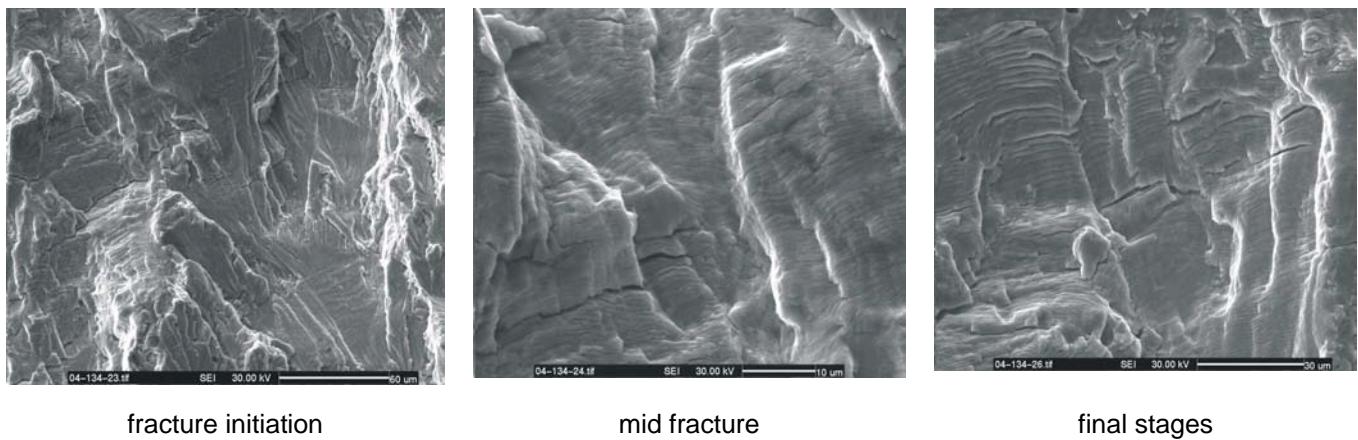
Figure 8-20
Typical views of circumferential crack at 180° intrados position.

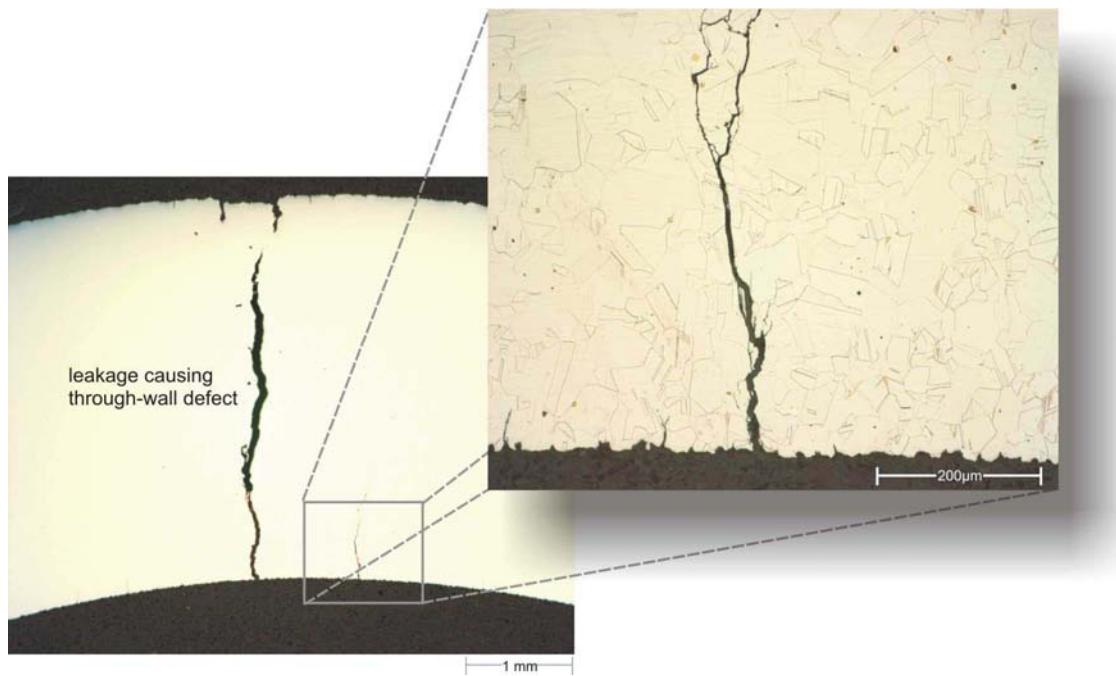
Figure 8-24
Typical view of 270° position showing axial through-wall crack progressing from the internal towards the external surface (Specimen S1).

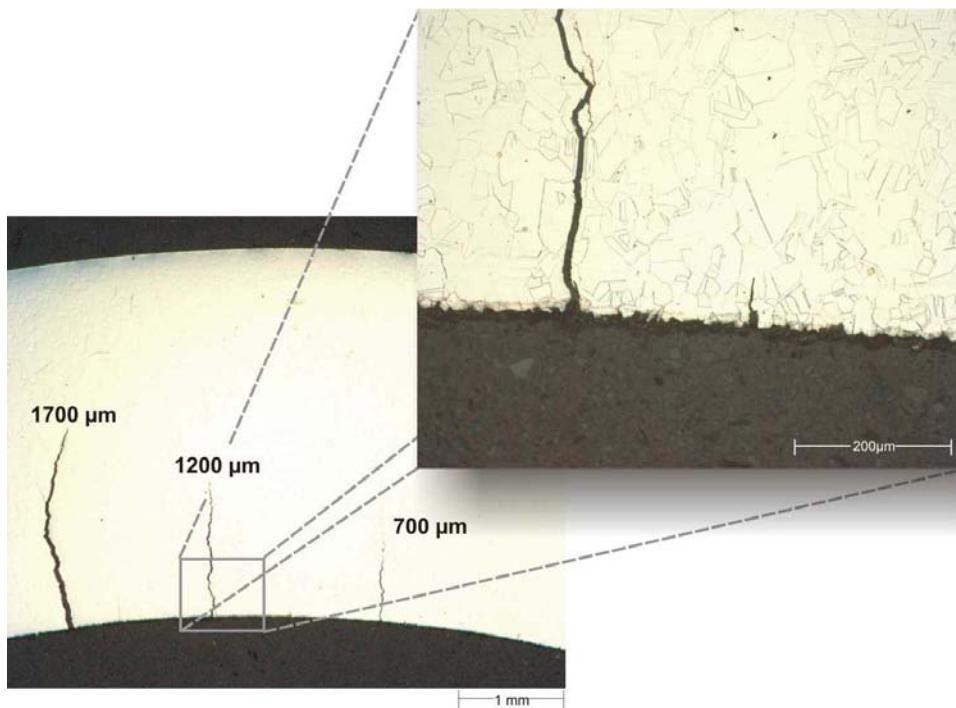
Figure 8-25
Typical view of 90° position showing multiple axial cracking progressing from the internal towards the external surface (Specimen S3); the numbers represent approximate crack depths.

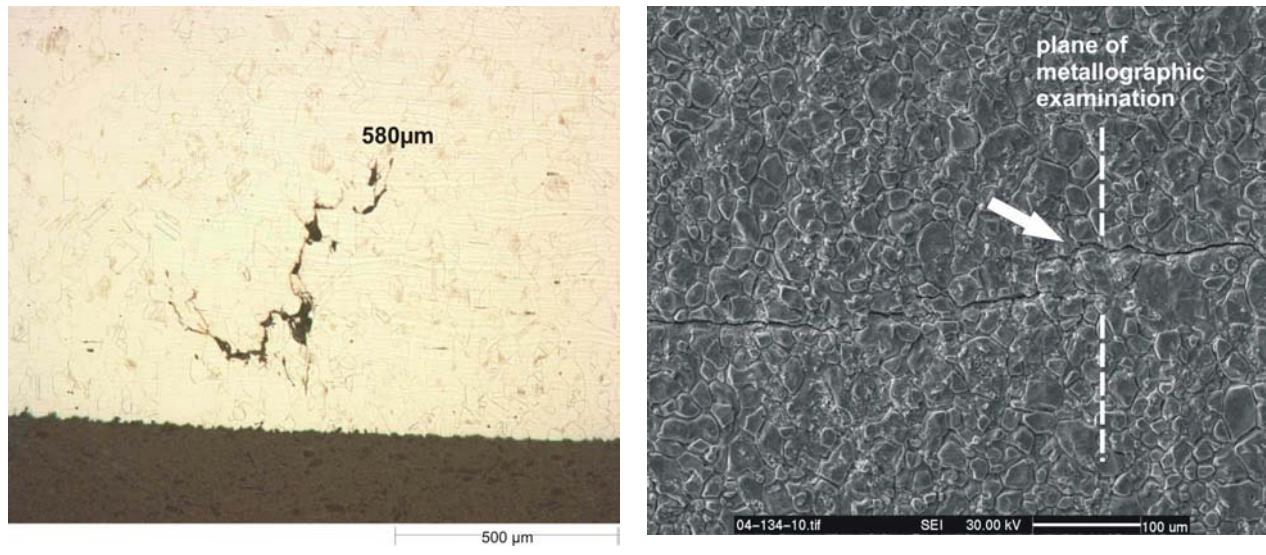
Figure 8-27
Axial cracking found on the internal surface of the 180° intrados position; apparent multidirectional character resulted from forked progression in combination with the plane the specimen was viewed in.

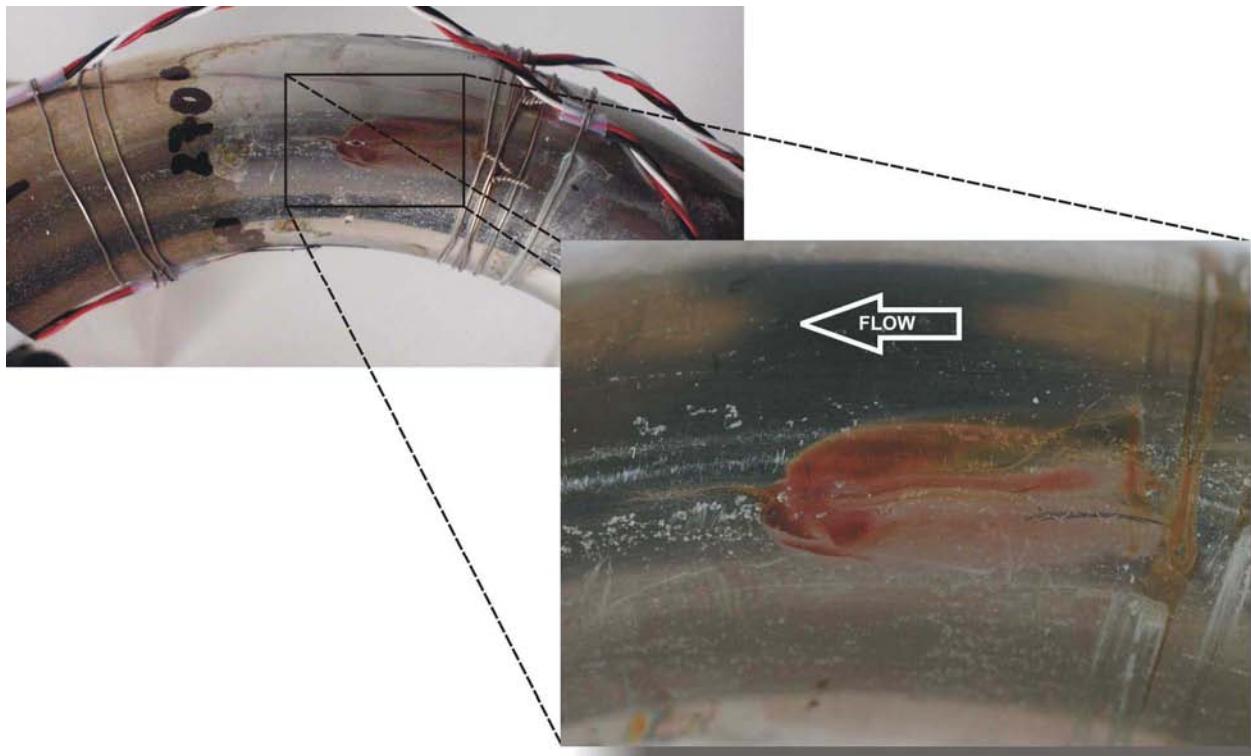
Figure 9-11
Visual inspection revealed leakage in the 270° position.

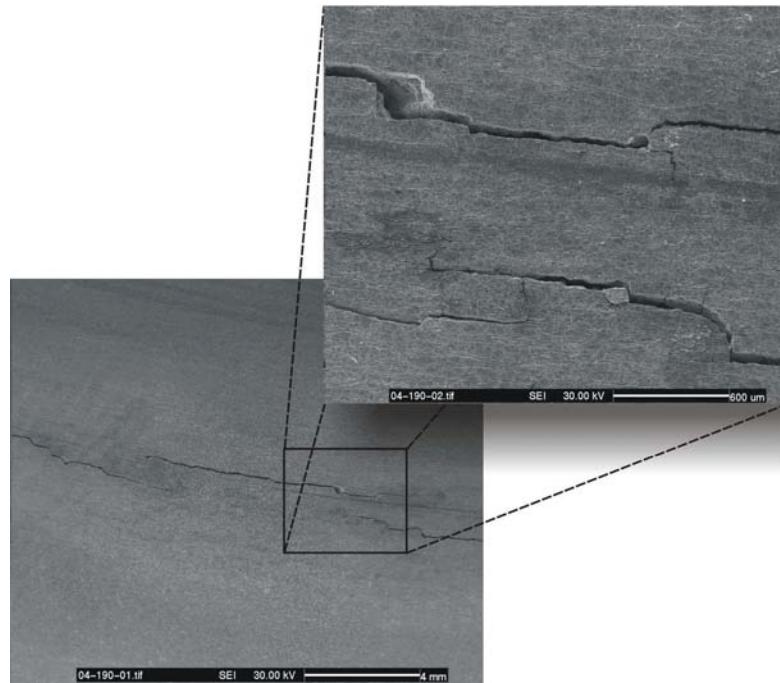
Figure 9-16
Internal surface examination of 270° position showing axial cracking that followed attacked grain boundaries from pickling treatment.

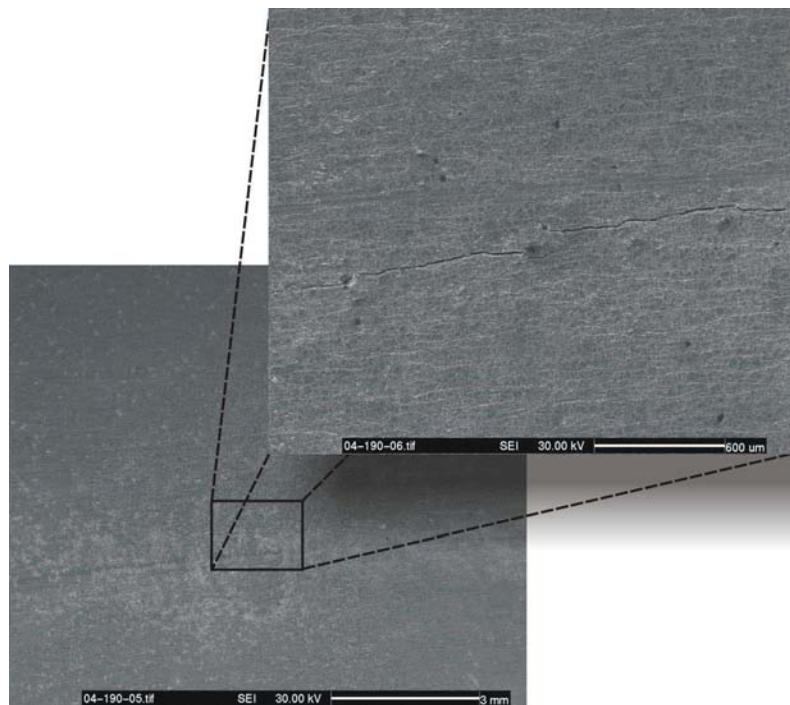
Figure 9-17
Internal surface examination of 90° position showing axial cracking that followed attacked grain boundaries from pickling treatment.

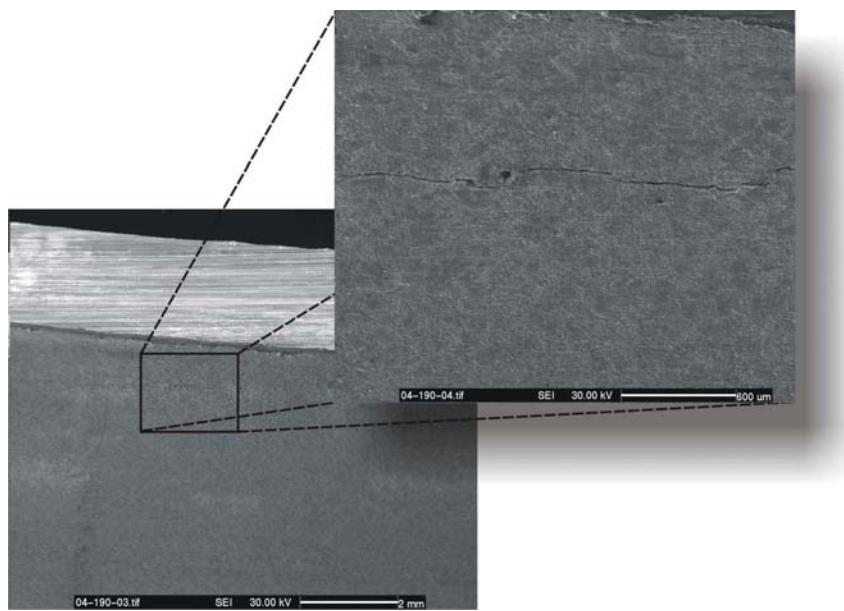
Figure 9-18
Internal surface examination of 180° position showing axial cracking.

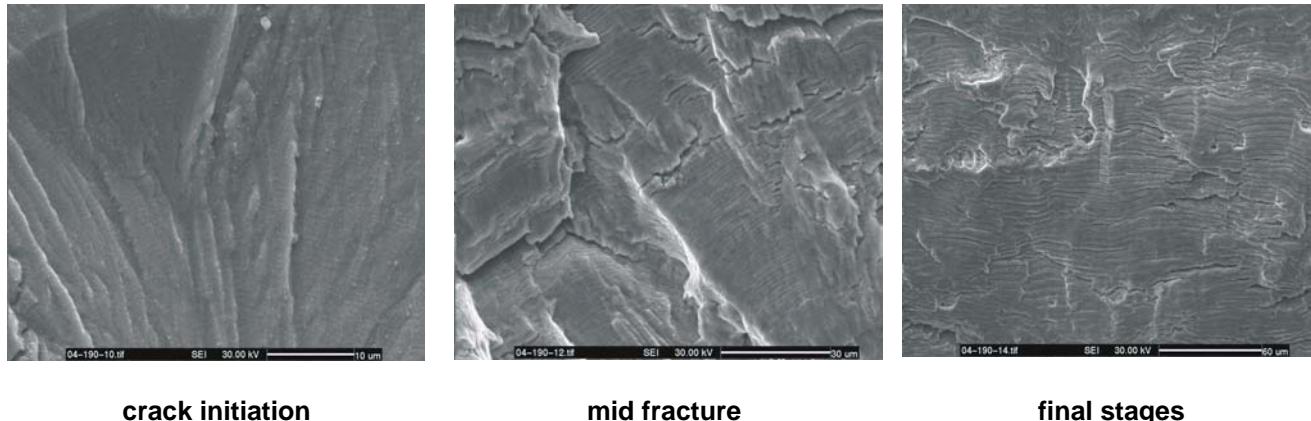
Figure 9-20
Typical views of fracture surface found at the 270° position; the morphology indicates step-wise crack progression under the combined influence of mechanical loading and environment.
