Materials Reliability Program: Environmental Fatigue Testing of Type 304L Stainless Steel U-Bends in Simulated PWR Primary Water (MRP-137)

1008207

Technical Update, December 2004

Framatome ANP GmbH

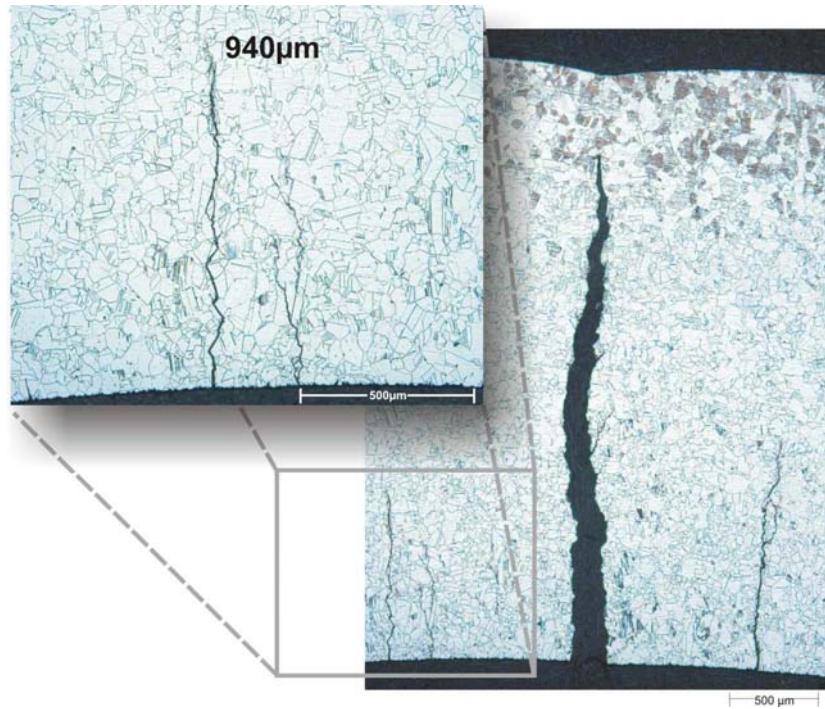
Figure 9-22
Cross sectional view of 270° position showing multiple transgranular cracks propagating from the internal towards the external surface (Specimen S1).

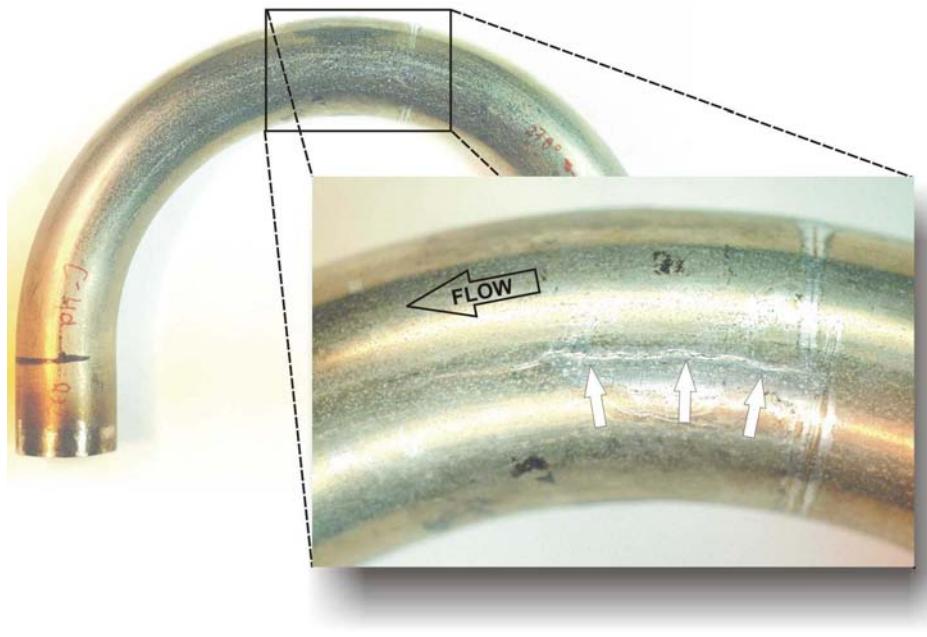
Figure 10-13
Axial through-wall defect in the 270° position.

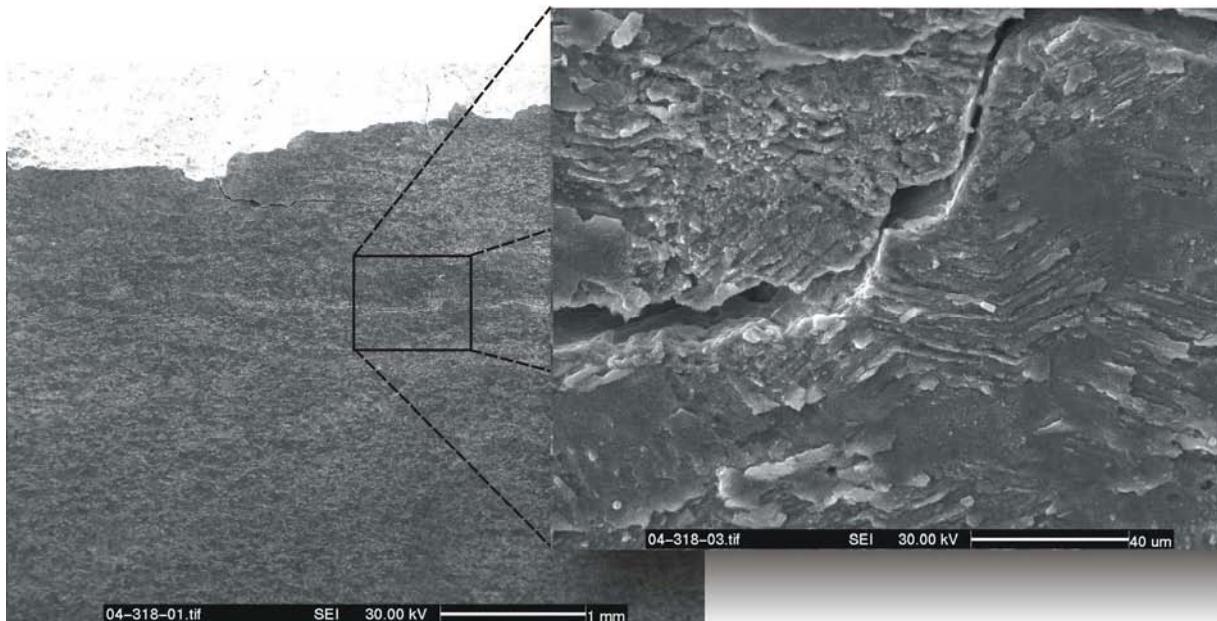
Figure 10-19
Internal surface of 270° position showing axial cracking.

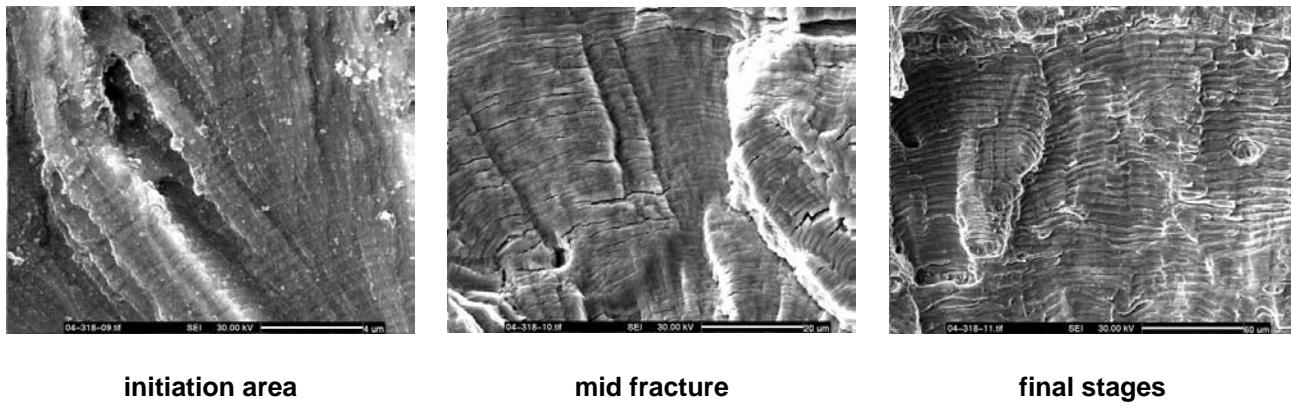
Figure 10-22
Stages of crack progression found at the 270° position; the morphology indicates step-wise crack progression under the combined influence of mechanical loading and environment.

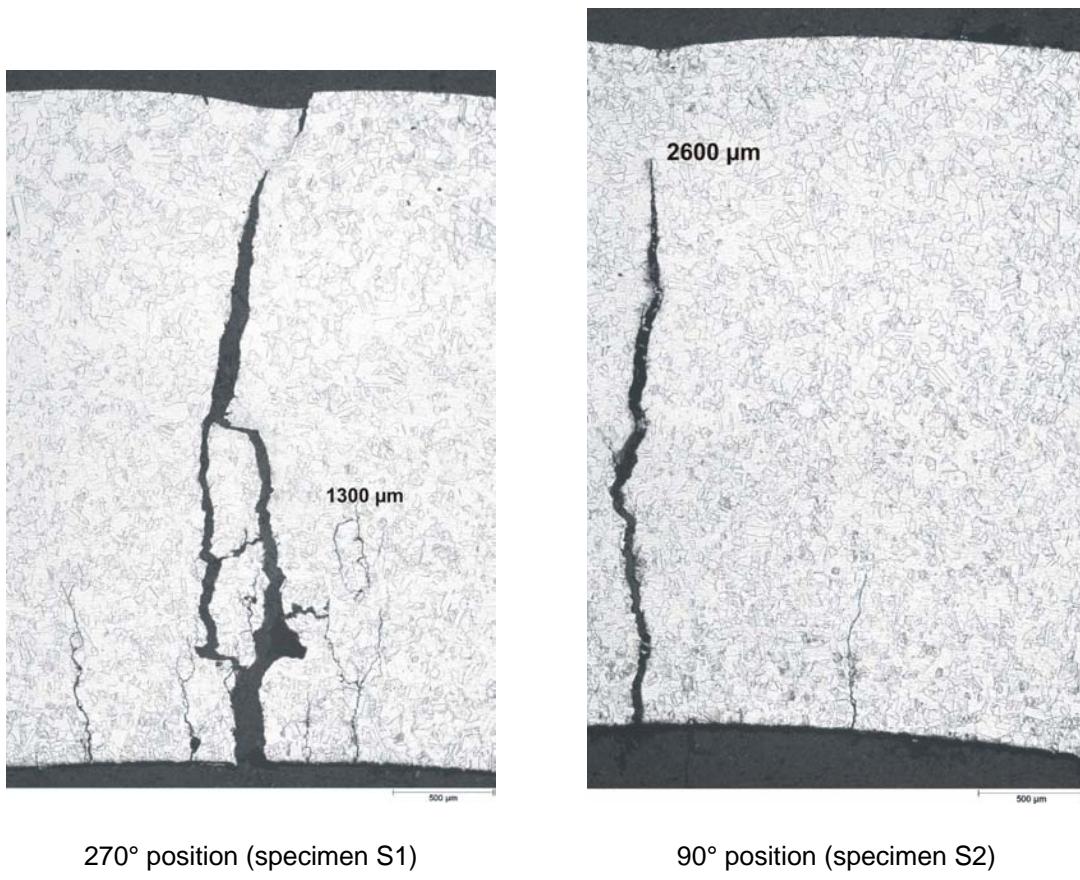
Figure 10-24
Cross-sections of the 270° and 90° position over the entire wall thickness; the numbers represent approximate crack depths.

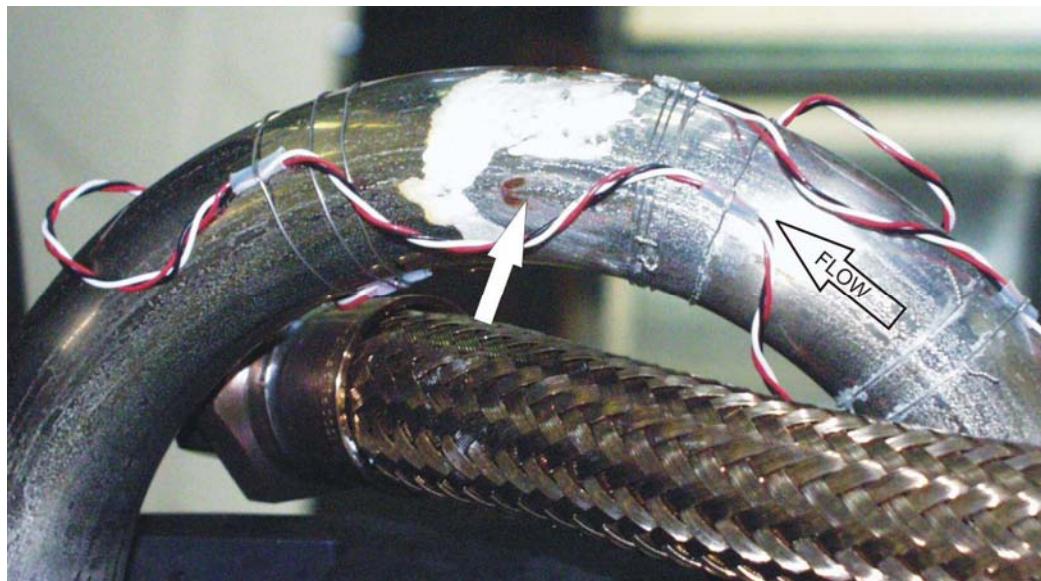
Figure 11-11
270° position (in-situ and rotated ca. 90 degrees) showing leakage indicated by white arrow.

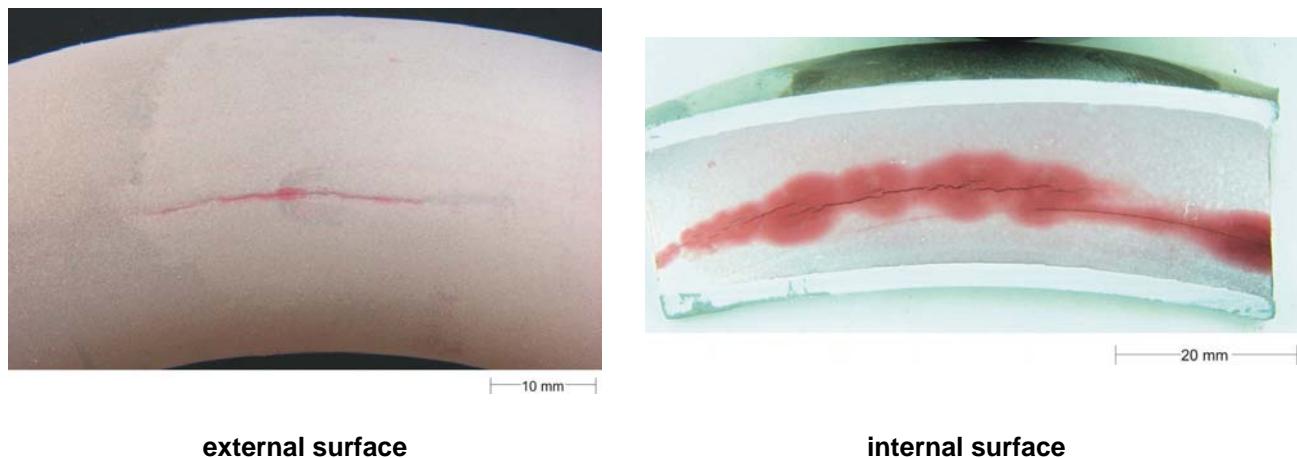
Figure 11-12
DPI at 270° position showing axial cracking on both the internal and external surfaces.

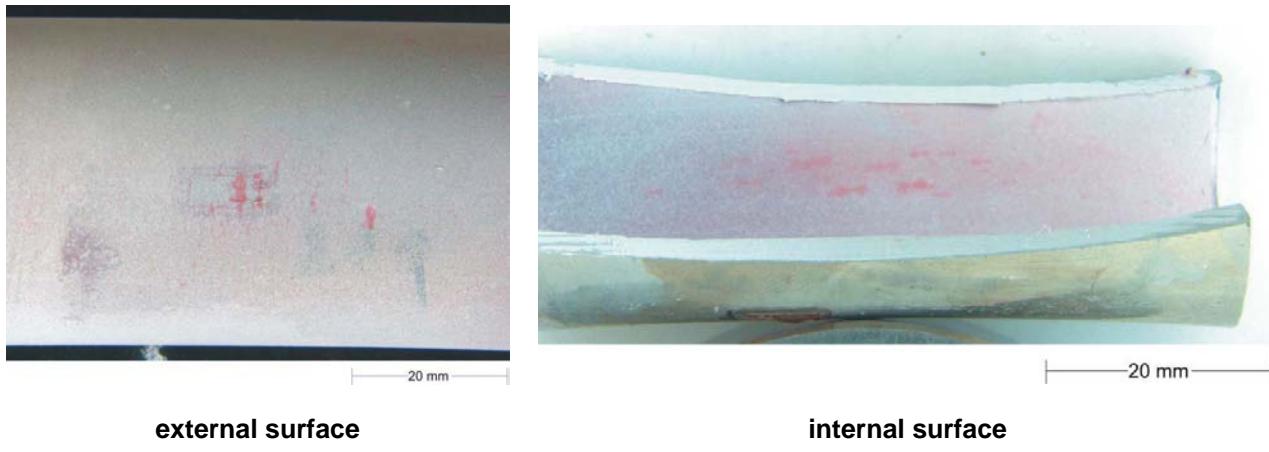
Figure 11-14
DPI at 180° intrados position confirming circumferential cracking on the external and axial cracking on the internal surfaces.

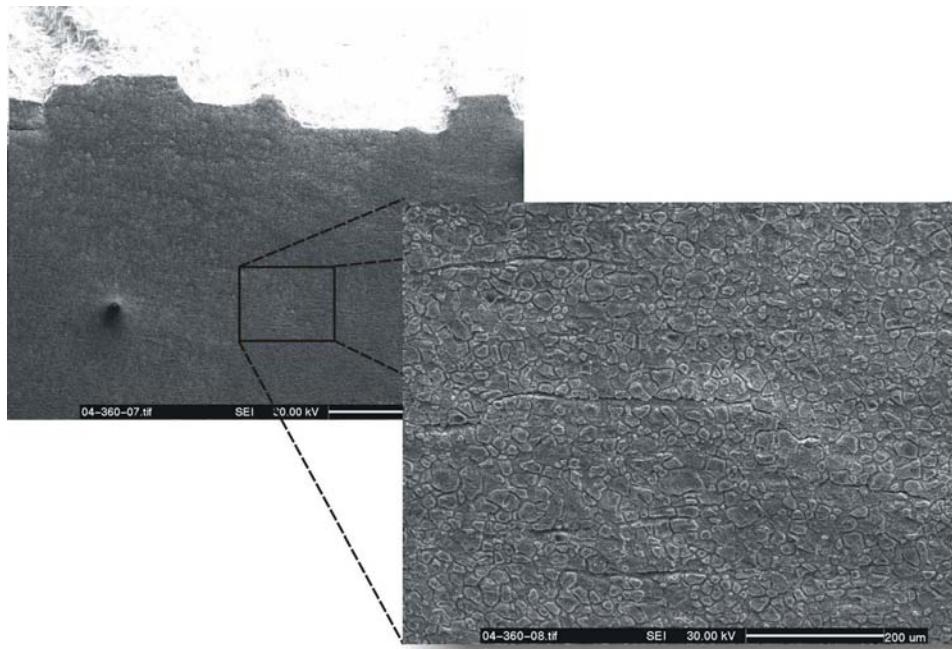
Figure 11-15 SEM surface examination confirming axial cracking that predominantly followed attacked grain boundaries.

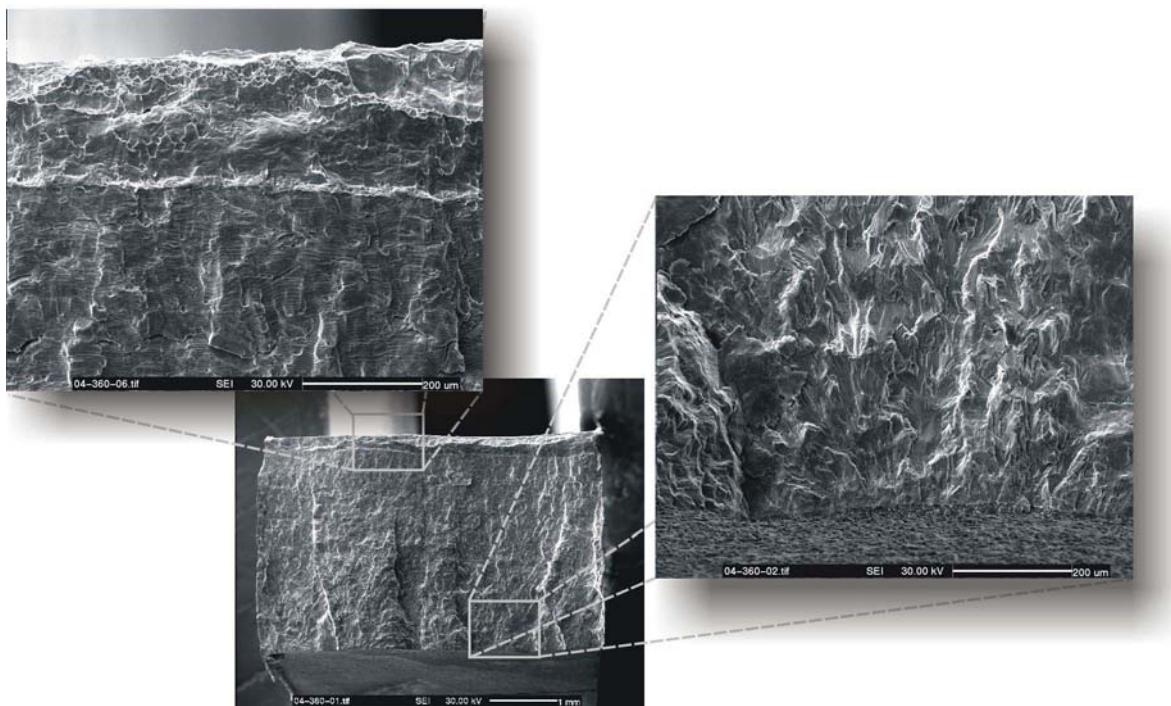
Figure 11-17
Different stages of crack progression confirming corrosion fatigue at 270° position.

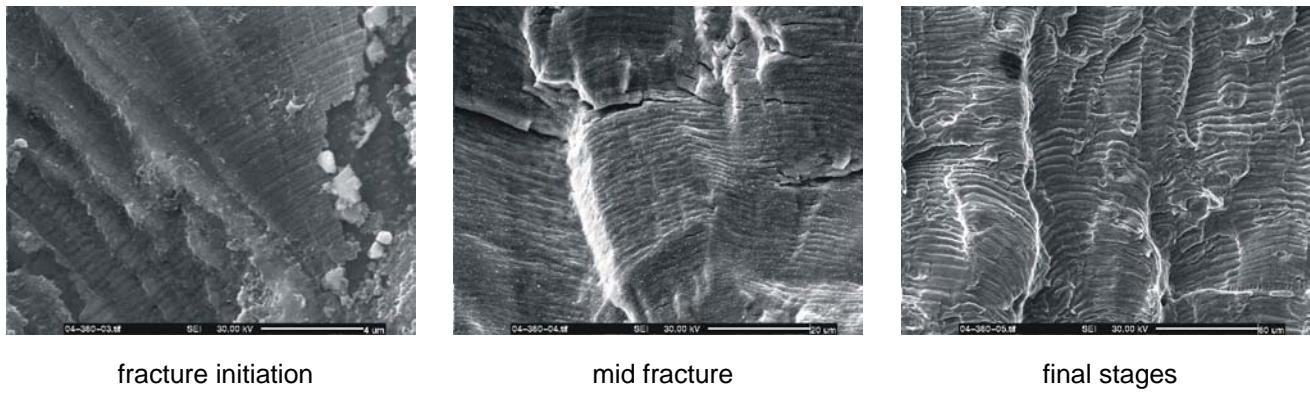
Figure 11-8
Stages of crack progression found at the 270° position; the morphology indicates step-wise crack progression under the combined influence of mechanical loading and environment.

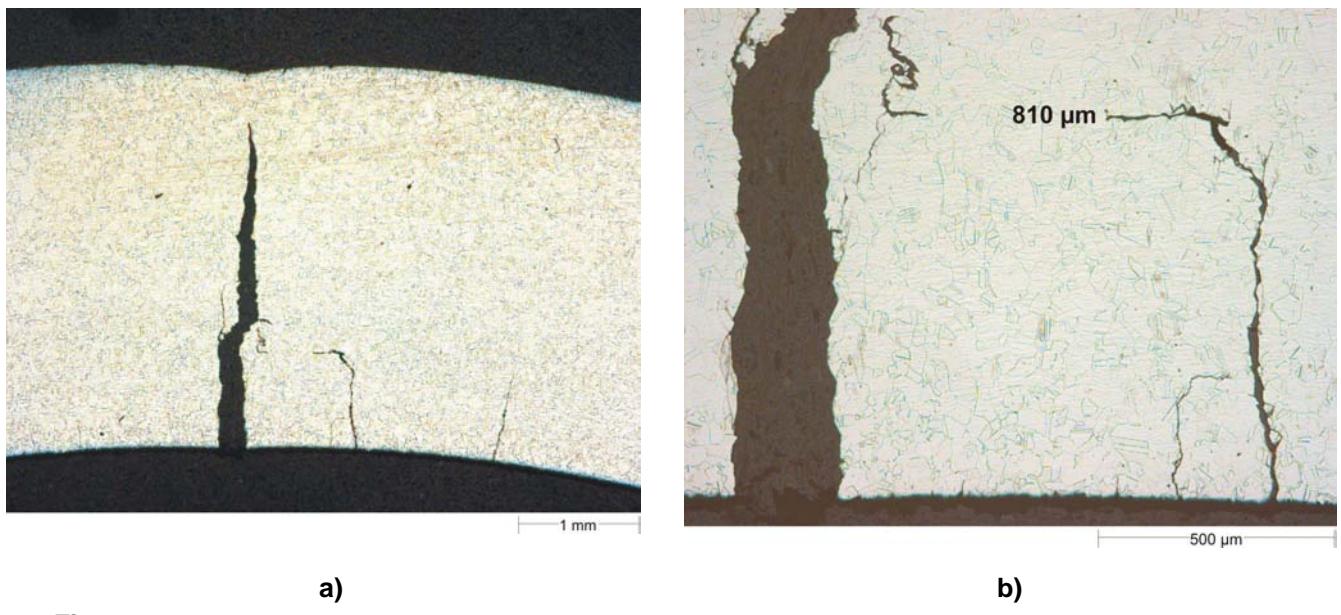
Figure 11-20
Metallography of 270° position (Specimen S1) confirming transgranular corrosion fatigue;
a) overall view; b) close-up of parallel oriented crack.

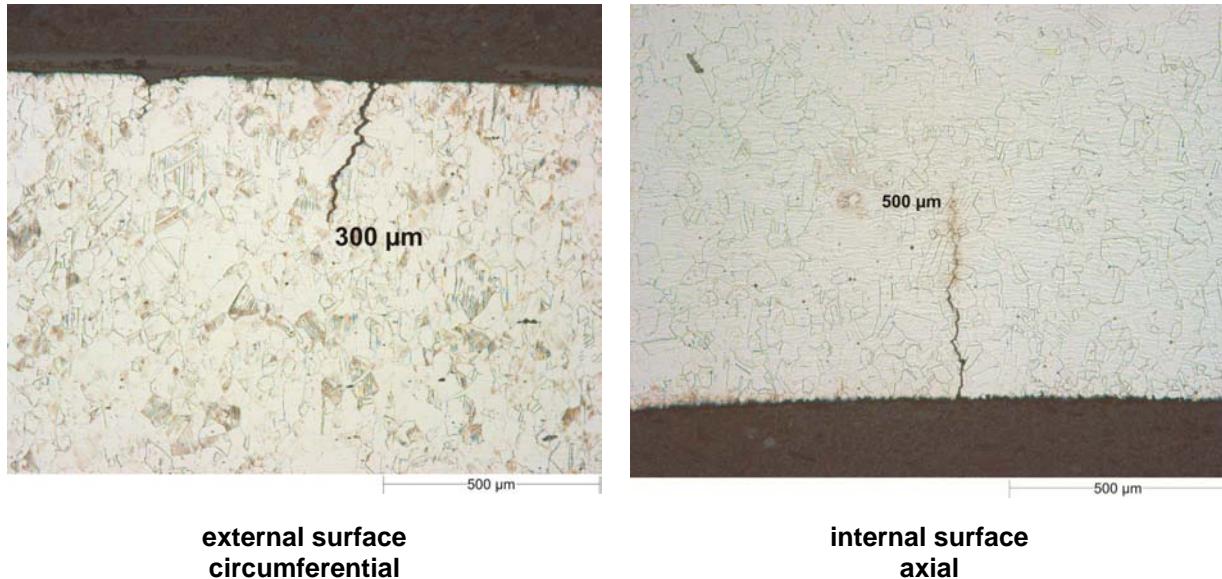
Figure 11-2
Metallography of 180° position confirming external circumferential and internal axial cracking.

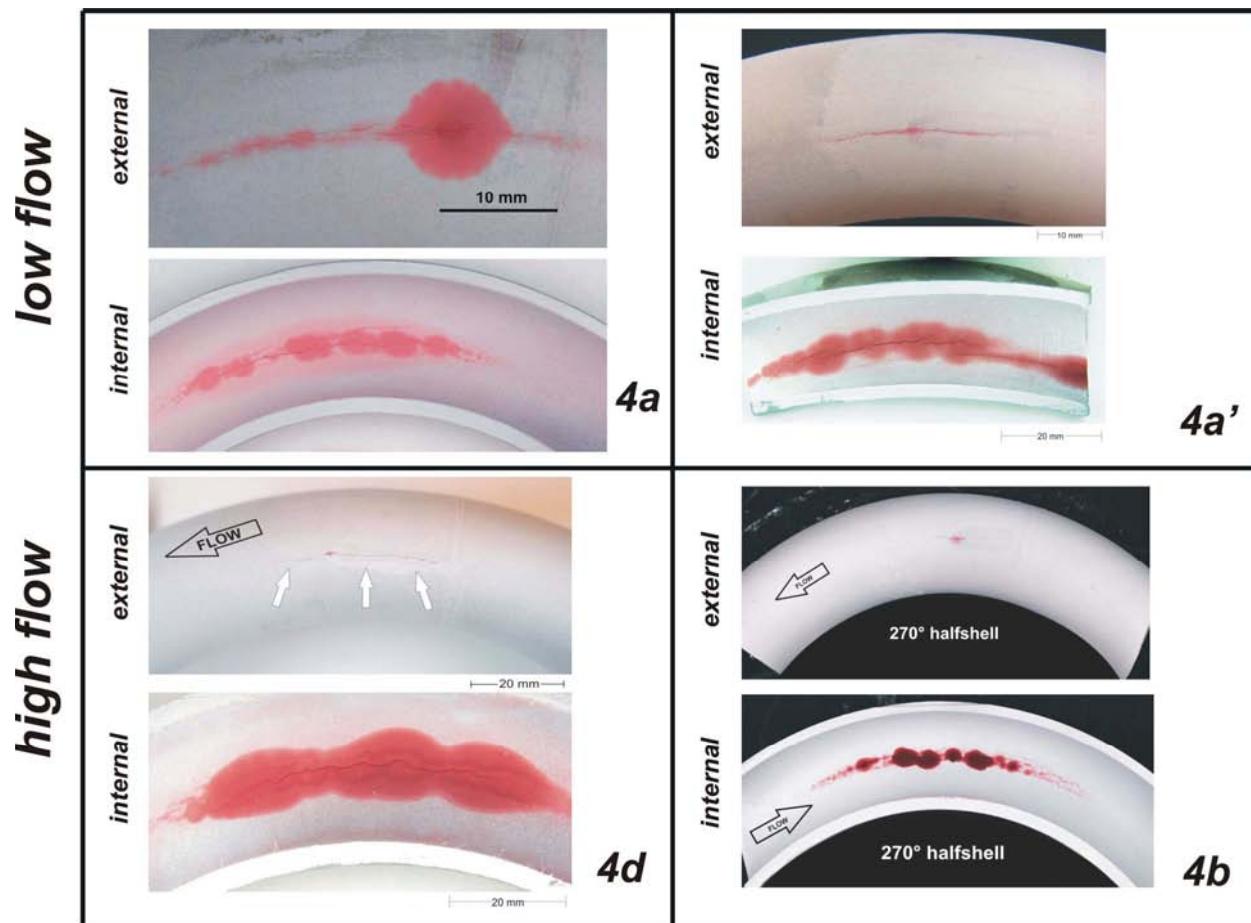
Figure 12-1
Summary of DPI findings during Test Series 4.

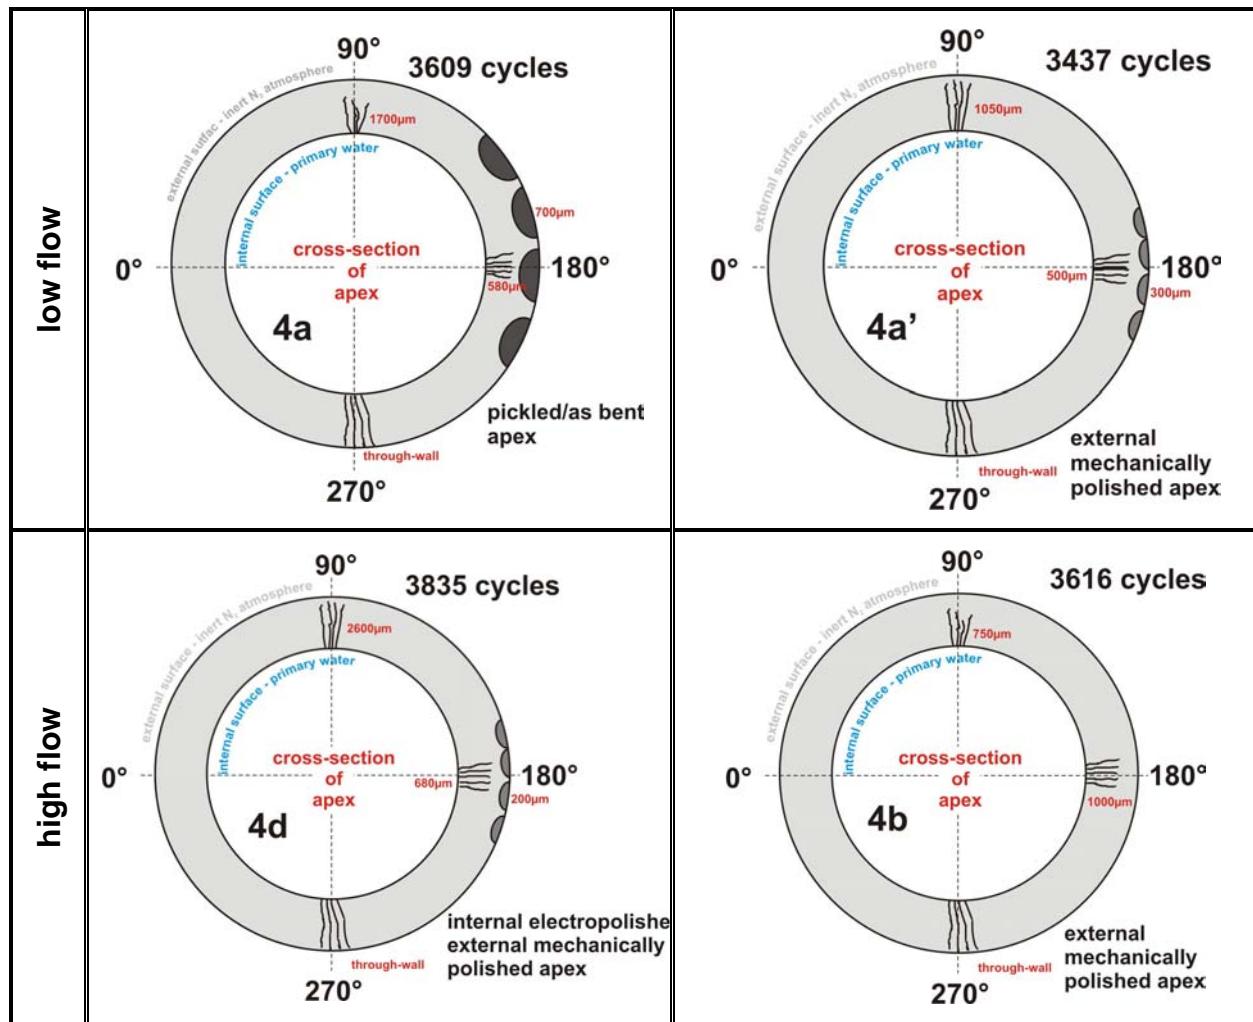
Figure 12-3
Summary of crack locations and depths observed during Test Series 4.
