Nevada
Environmental
Restoration
Project

DOE/NV--1083

Post-Closure Inspection Report
for Corrective Action Unit 90:
Area 2 Bitcutter Containment,
Nevada Test Site, Nevada
For the Period
July 2004 - June 2005

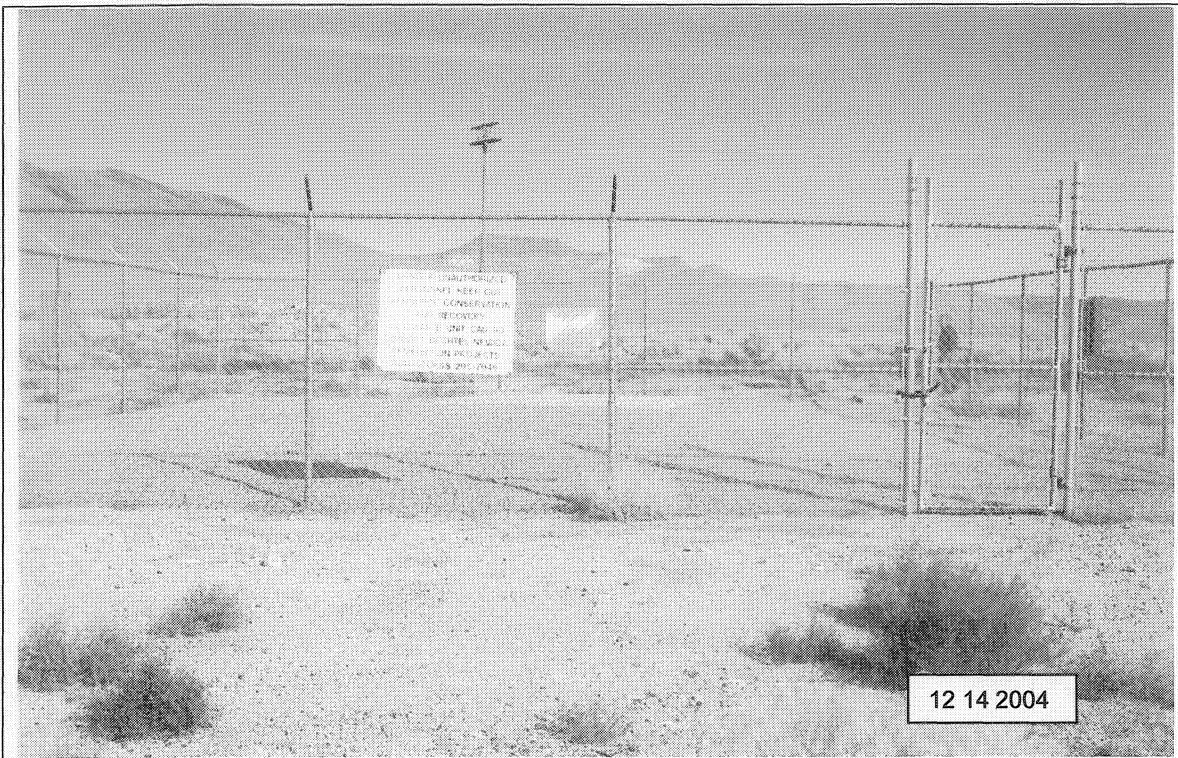
| PHOTOGRAPH NUMBER | DATE | DESCRIPTION |
|---|---|---|
| 1 | 12/14/2004 | View of west unit looking north. |

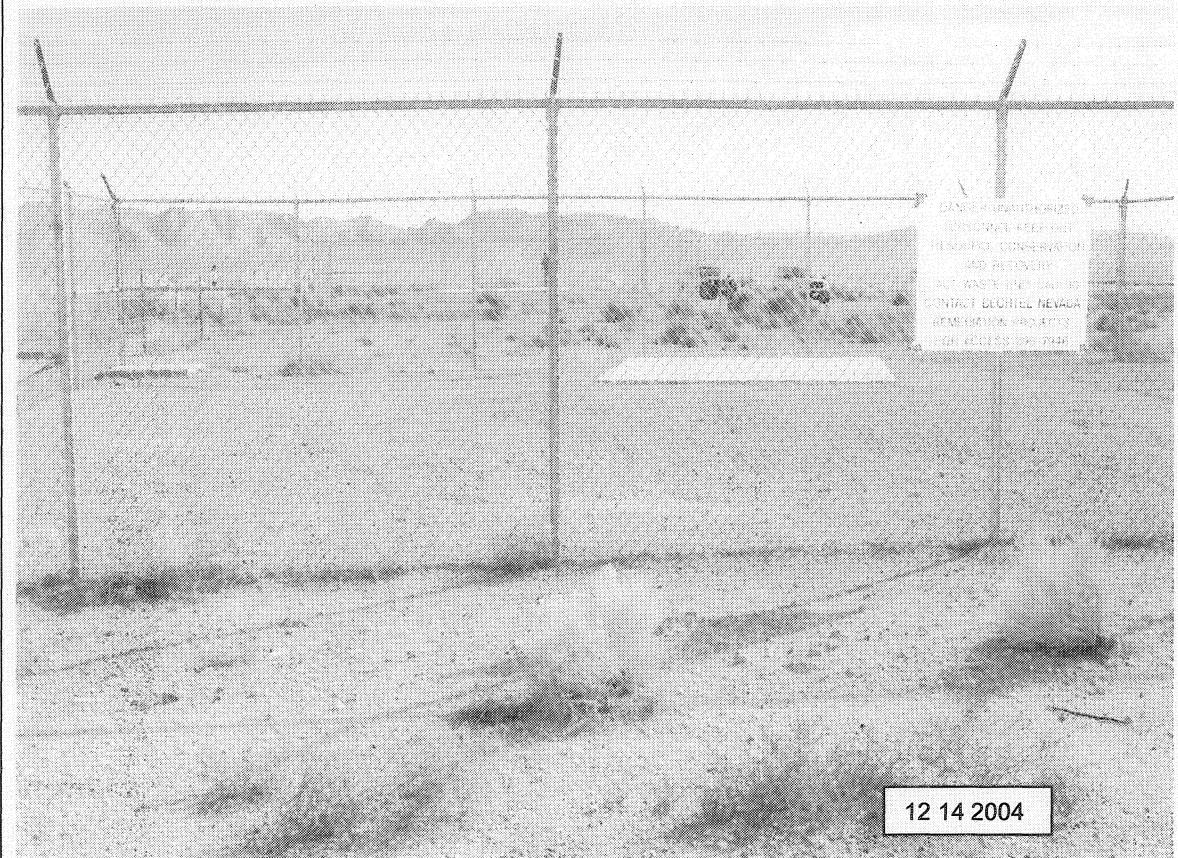
| PHOTOGRAPH NUMBER | DATE | DESCRIPTION |
|---|---|---|
| 2 | 12/14/2004 | View of west unit looking east. |

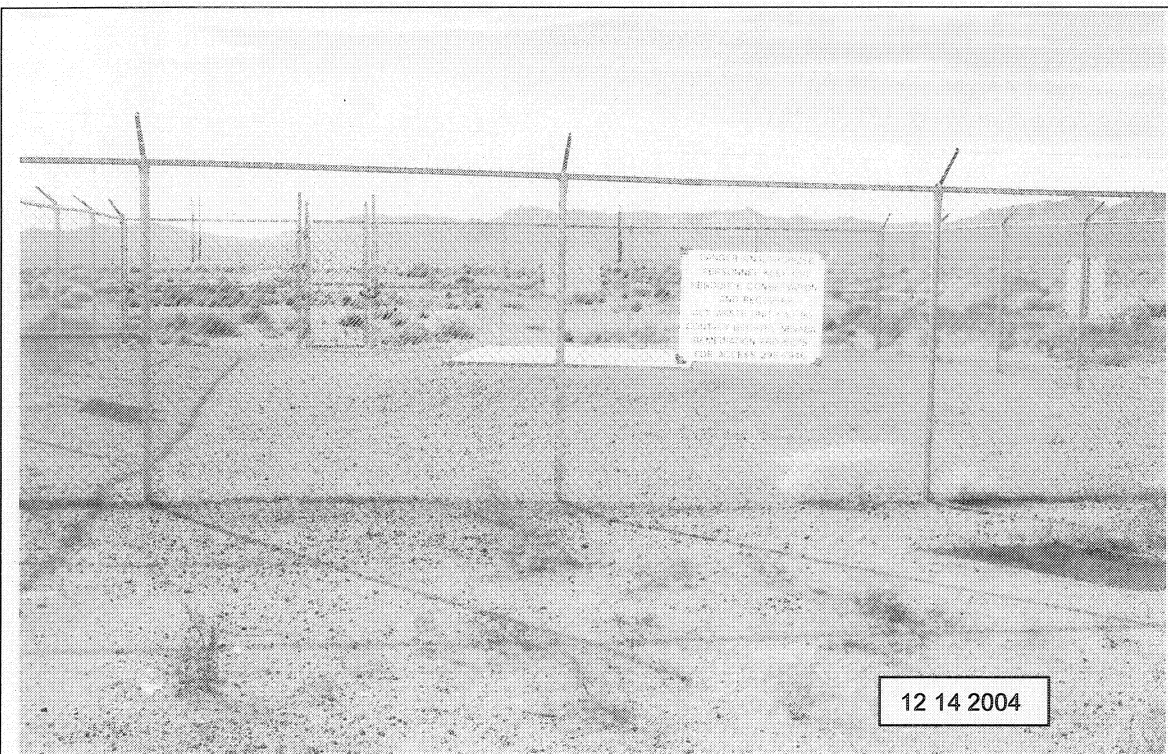
| PHOTOGRAPH NUMBER | DATE | DESCRIPTION |
|---|---|---|
| 3 | 12/14/2004 | View of west unit looking south. |

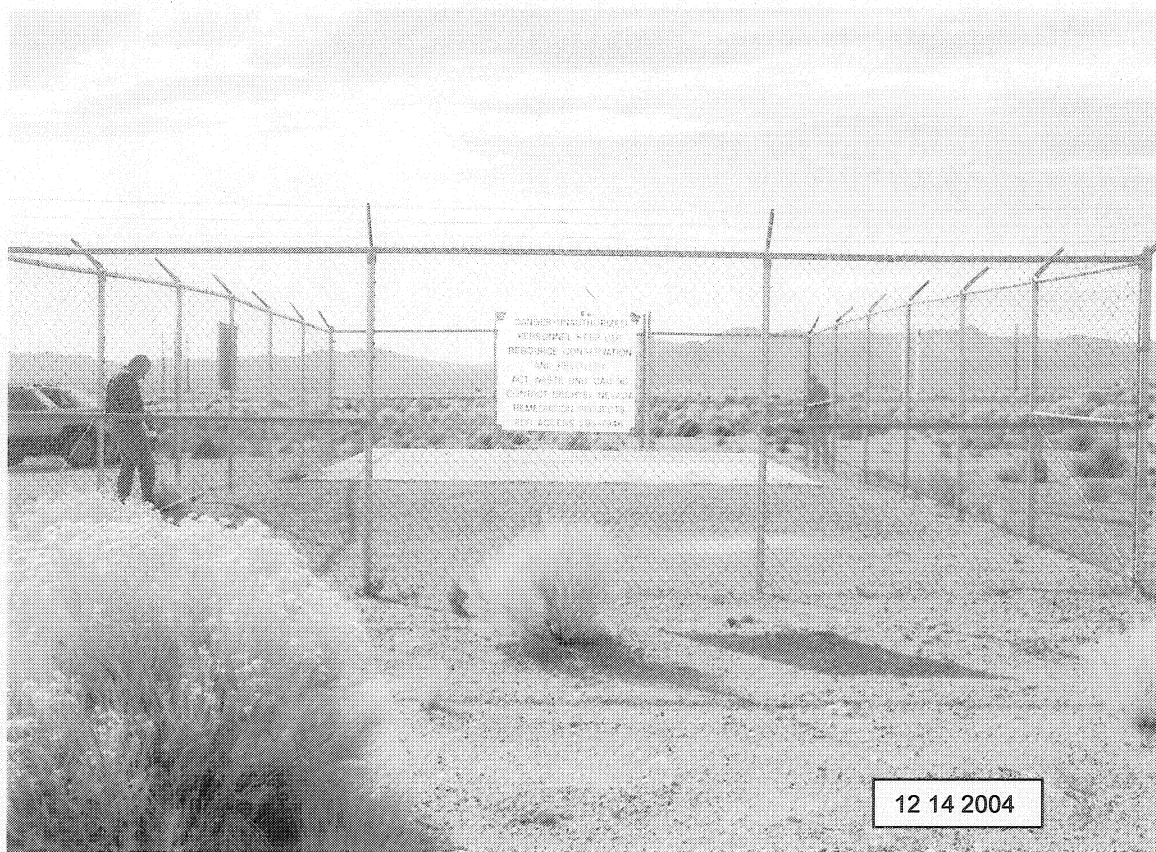
| PHOTOGRAPH NUMBER | DATE | DESCRIPTION |
|---|---|---|
| 4 | 12/14/2004 | View of east unit looking south. |

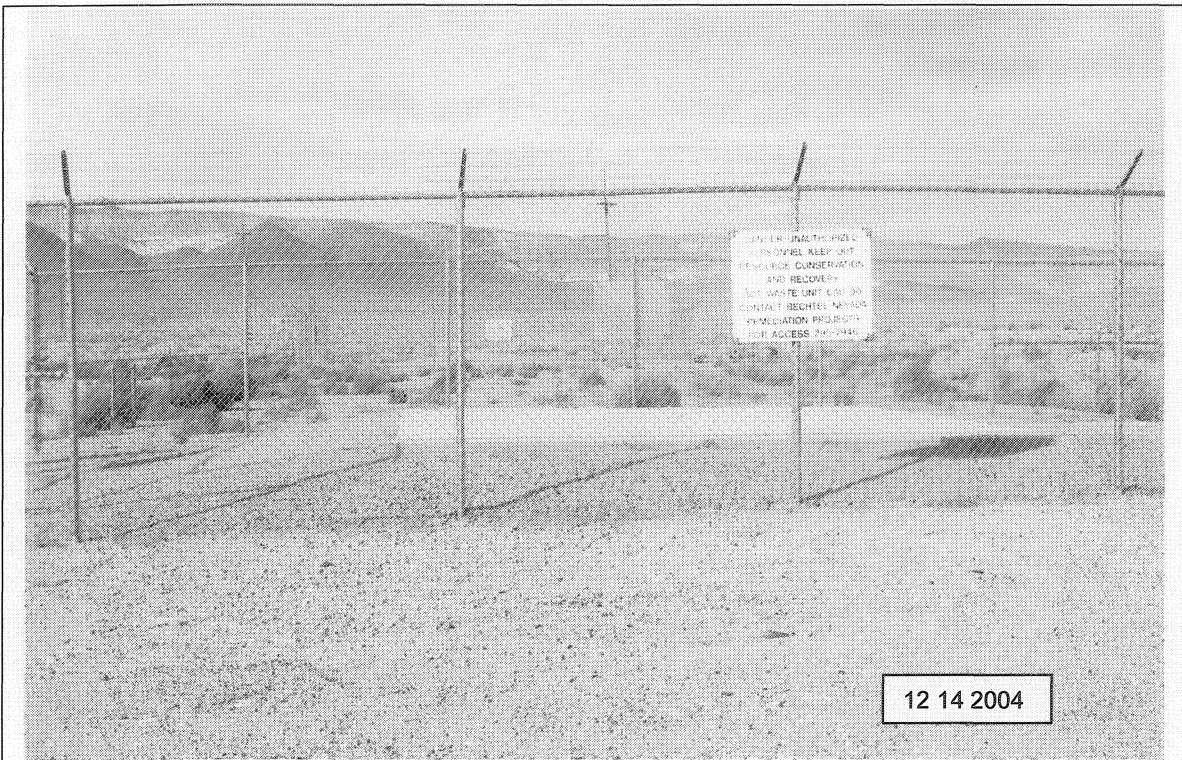
| PHOTOGRAPH NUMBER | DATE | DESCRIPTION |
|---|---|---|
| 5 | 12/14/2004 | View of east unit looking west |

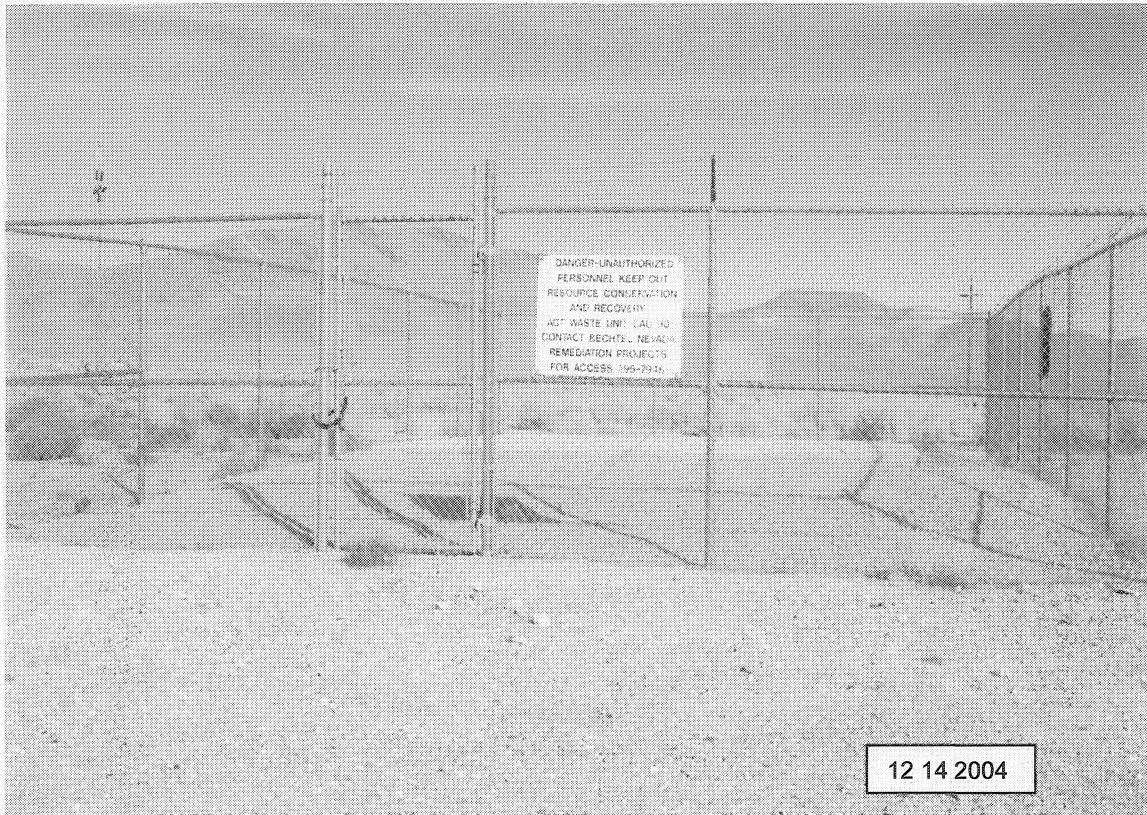
| PHOTOGRAPH NUMBER | DATE | DESCRIPTION |
|---|---|---|
| 6 | 12/14/2004 | View of east unit looking north. |

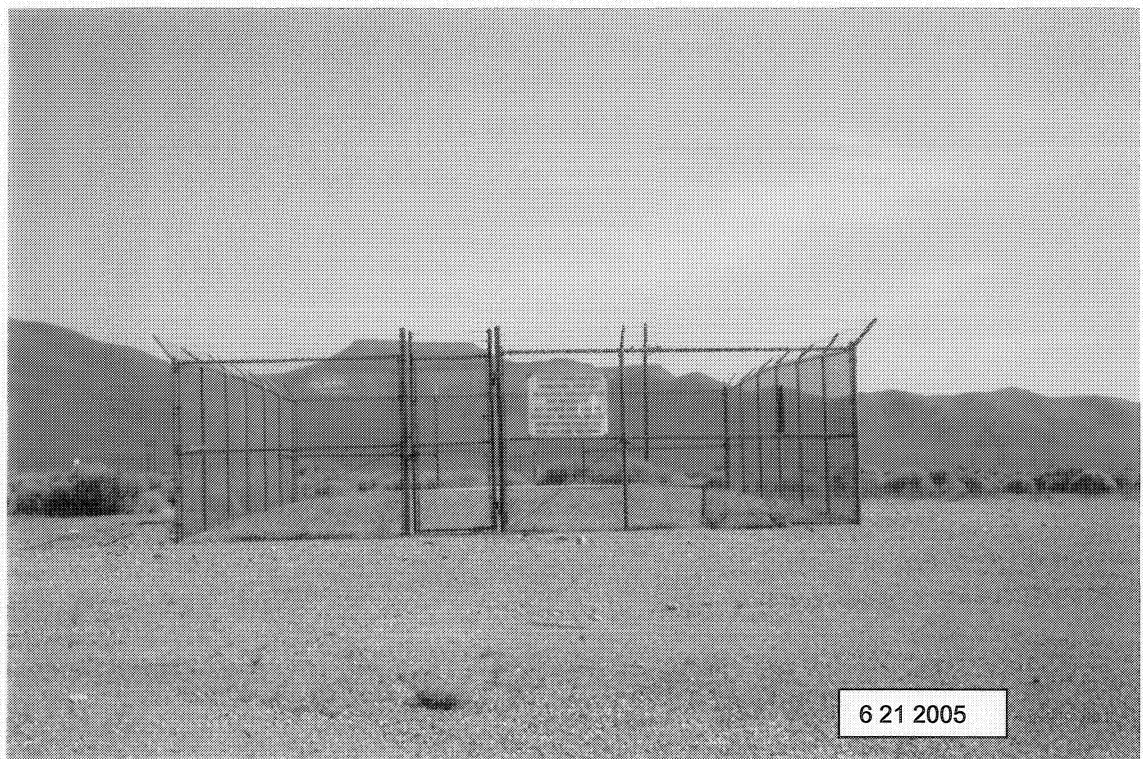
6/21/2005
6

| PHOTOGRAPH NUMBER | DATE | DESCRIPTION |
|---|---|---|
| 6 | 6/21/2005 | View of east unit looking north. |
