SAND95-1361 • UC-610

Printed June 1995

# Aging Assessment for Active Fire Protection Systems

Steven B. Ross, Steven P. Nowlen, Tina Tanaka

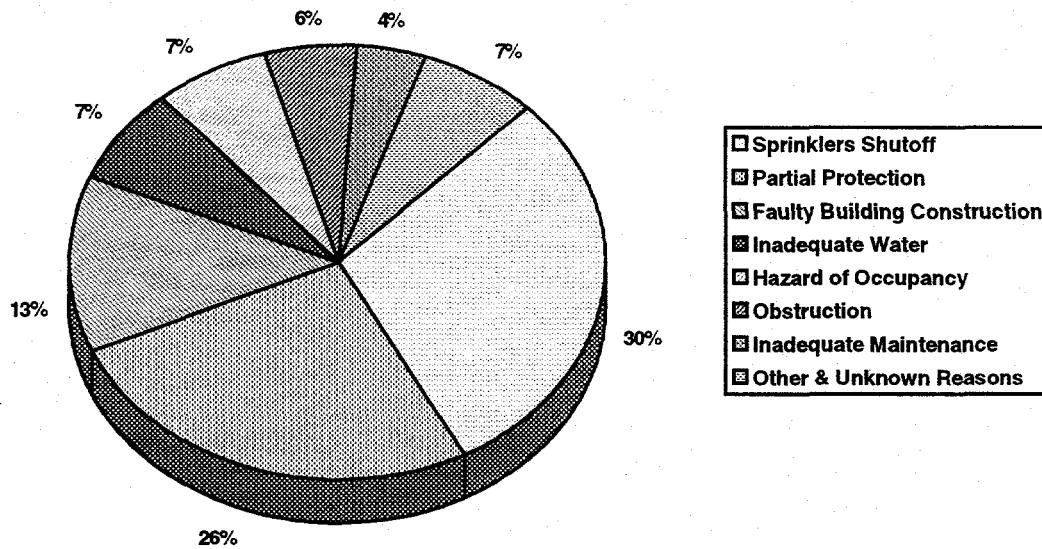
Figure 1 NFPA-Reported Sprinkler Failures (1970 - 1974)

The NFPA has tracked sprinkler system failure in general commercial applications. In this context, NFPA defines failure as the failure to suppress or control a fire, rather than as a failure to actuate. Figure 1 and Table 3 present the failure type and the percentage for that failure.

Inadequate sprinkler coverage caused 26% of the malfunctions; sprinklers shutoff caused 30% of the failures; inadequate water or line obstruction caused 13% of the malfunctions; building construction caused 13%; inadequate system design 7%, inadequate maintenance 4%, and unknown causes account for 7% of the malfunctions. From this list, 83% of the failures could have been prevented with an aggressive test and maintenance program.
