Nevada  
Environmental  
Restoration  
Project

Post-Closure Inspection Report for  
the Tonopah Test Range, Nevada

For Calendar Year 2004

April 2005

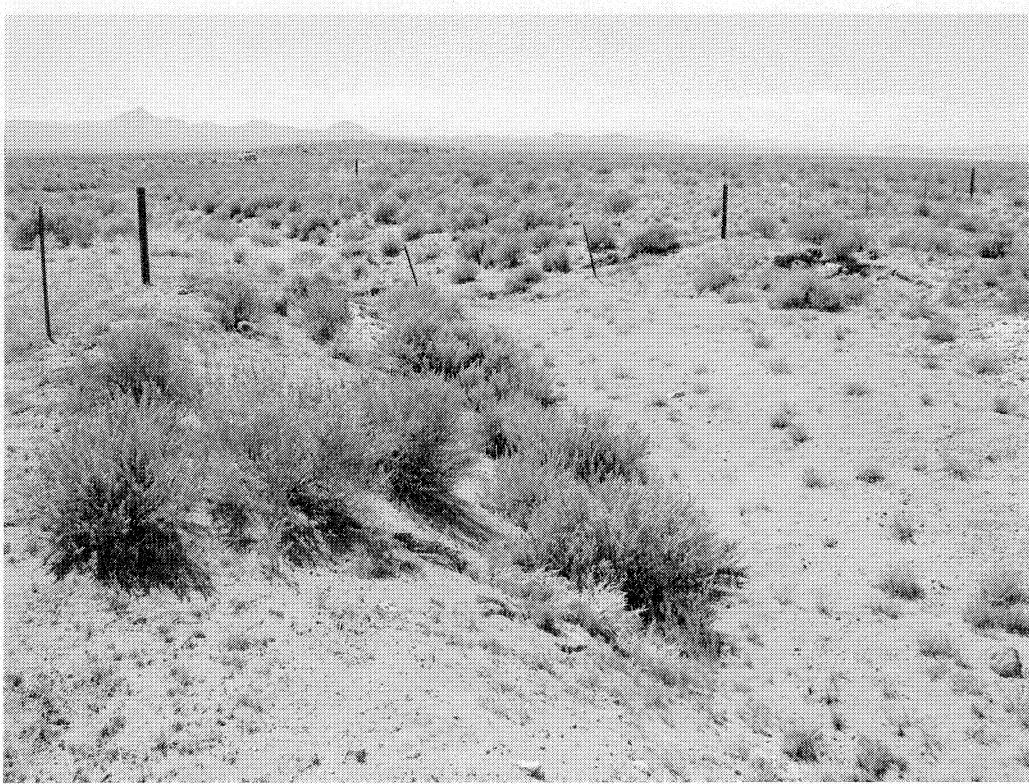
The second inspection was conducted on November 10, 2004. The previously flooded area on the central low-lying portion of the site exhibited evidence of plant mortality. Animal tracks and tire tracks from an unknown vehicle were evident leading from the washed-out portion of the fence onto the site. It was recommended to repair the fence and reseed the site.

Photograph 7: CAU 400 Five Points Landfill, fence damage, looking east, 07/07/2004

Fence damage and flood damage at the Five Points Landfill were first noticed during the July inspection. The central low-lying portion of the site was reseeded on November 16, 2004, with a seed mixture of native shrubs and grasses using a rangeland drill seeder mounted on a Kawasaki Mule towing a chain drag harrow. The reseeding activities are documented in photographs 9-12 in Appendix E. The fence was repaired during the week of November 22, 2004. To slow water flow, catch debris, and protect the fence, ten bales of straw were placed in the wash leading to the landfill and anchored using t-posts on November 30, 2004, and copies of the field notes taken during this activity are included in Appendix D.

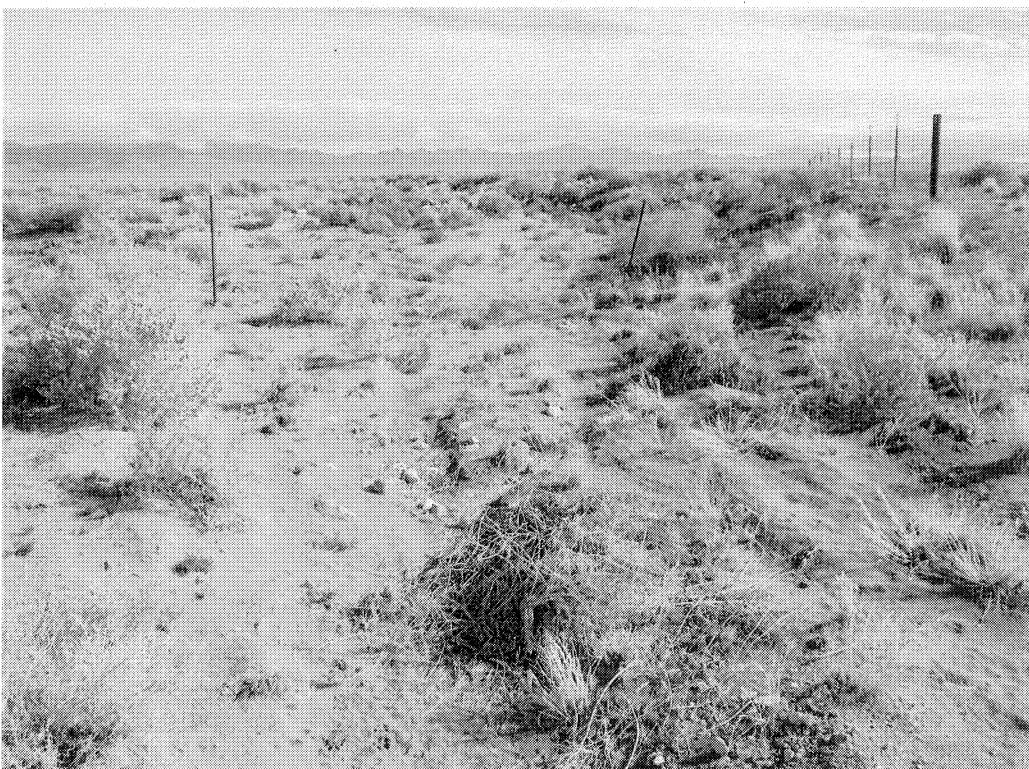
Photograph 8: CAU 400 Five Points Landfill, fence damage, looking east, 11/10/2004

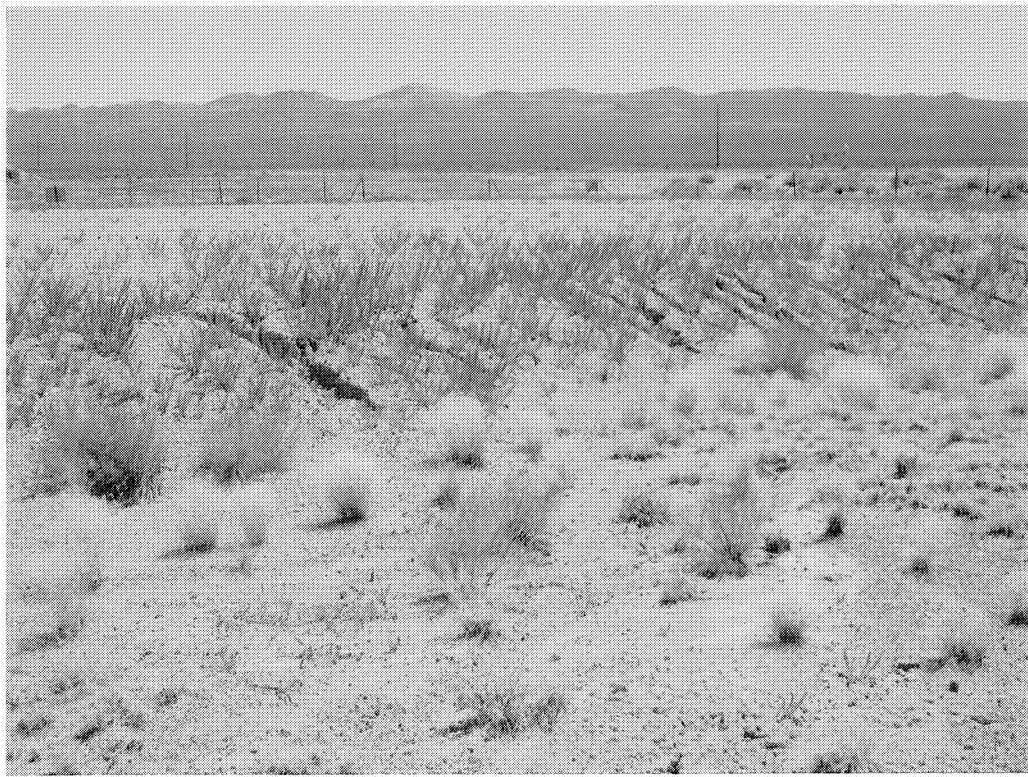
The first inspection was conducted on July 7, 2004. The inspection indicated minor but noticeable erosion rills along the cover margin that were not compromising the integrity of the cover. It was agreed that repairs would be made during the fourth quarter of Calendar Year 2004 (the first quarter of Fiscal Year 2005) when funding resources would be available. Sparse vegetation was present on the cover and had become better established since the last inspection. Some small animal burrows were also present along the edges of the cover. The fence and signs were intact and in good condition.

Photograph 17, CAU 407, Erosion rills on the east side of the cover, 07/07/2004

Maintenance and repairs at CAU 407 included erosion repair, reseeding the cover, and replacing one warning sign. One radiological warning sign was replaced by a radiological control technician on November 29, 2004. The erosion rills were filled with clean native fill on November 30, 2004. The erosion repair is documented in photographs 19 and 20 in Appendix E and in field notes in Appendix D. The cover was reseeded and mulched, and an erosion blanket was placed on December 1, 2004, to facilitate stabilization of the side slopes and mitigate the effects of storm water runoff on the soil cover. The reseeding activities are documented in photographs 21-24 in Appendix E. As recommended by the biologist, to ensure the health of the vegetation and supplement natural precipitation, the site will be irrigated in February, March, and April of 2005.

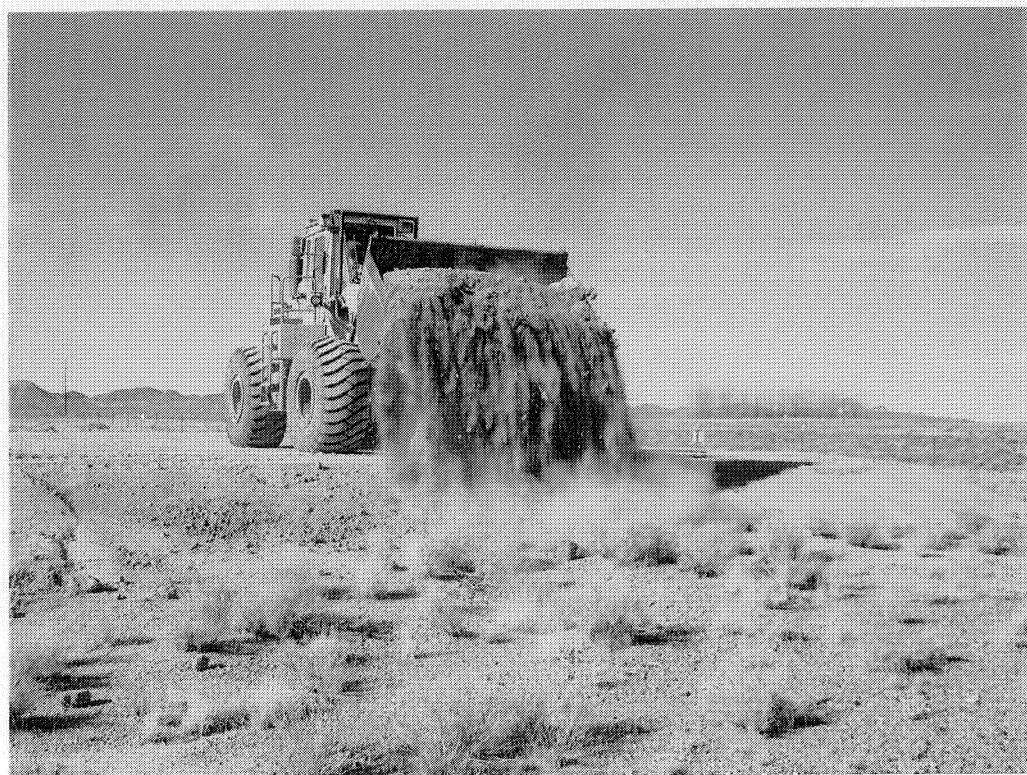
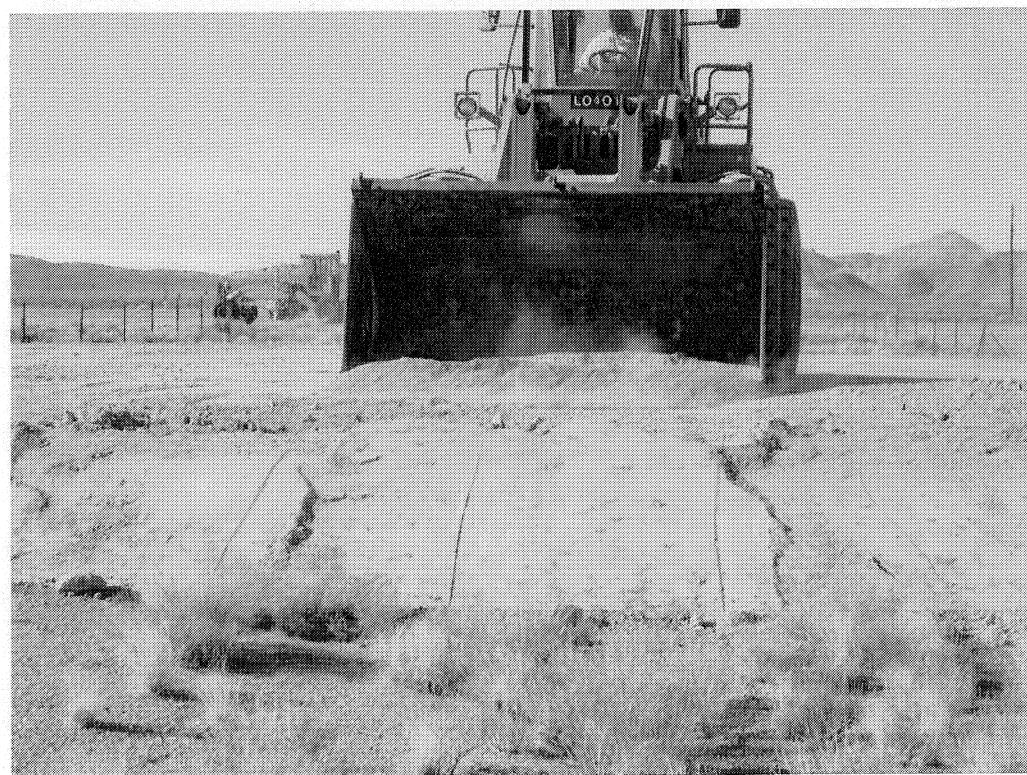
Photograph 19: CAU 407, Erosion Repair, 11/30/2004

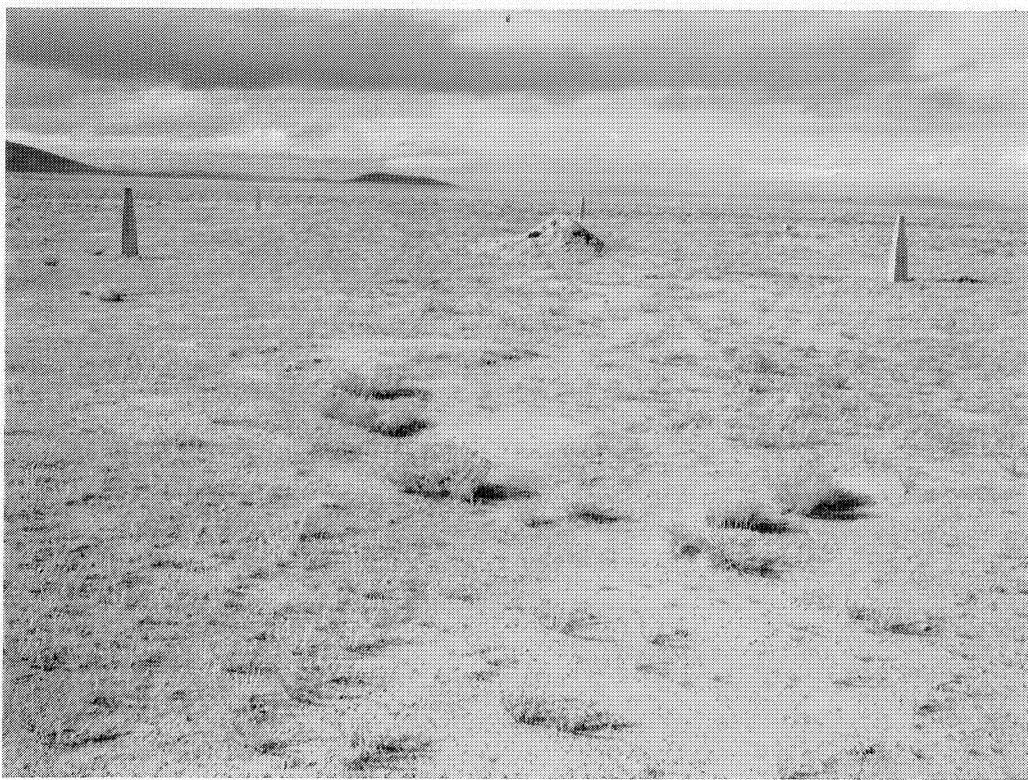
Photograph 51: CAU 487, A-17 anomaly, looking west, 11/10/2004

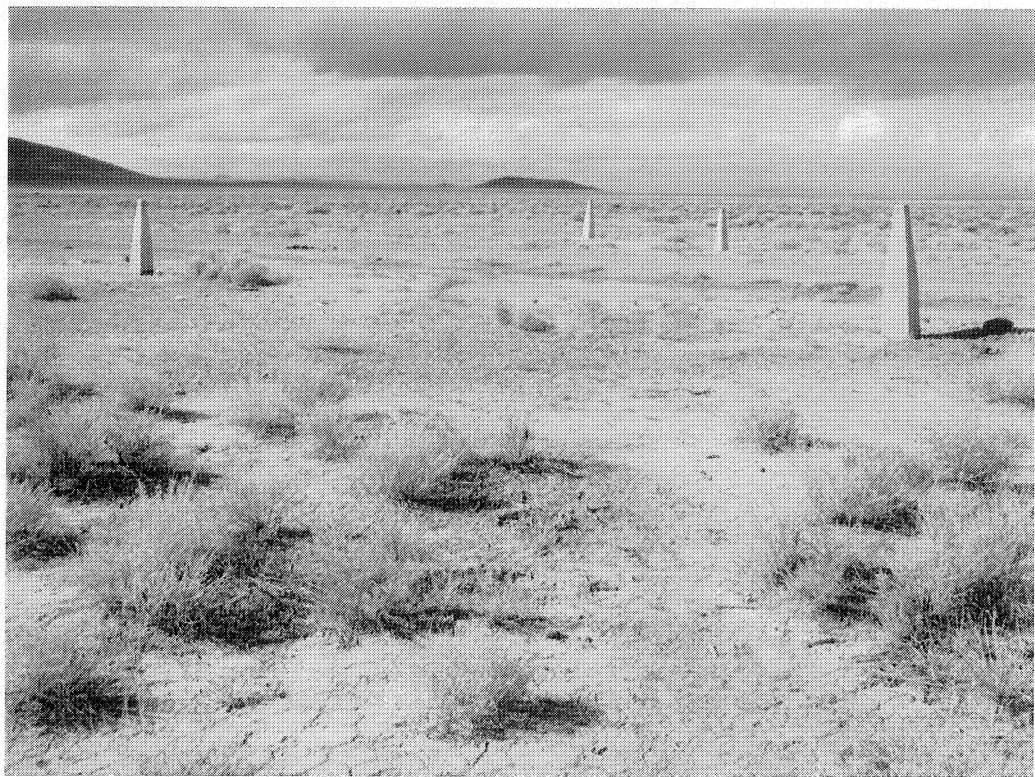
Photograph 52: CAU 487, A-8 anomaly, looking west, 11/10/2004

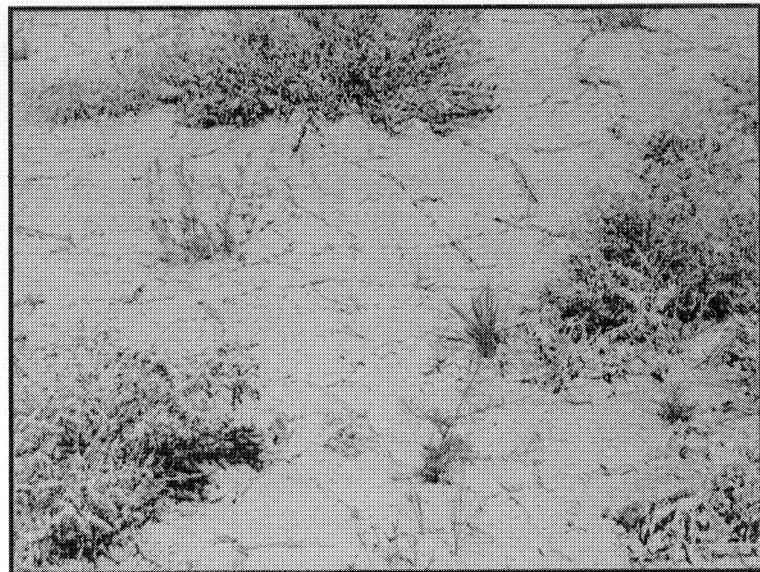
Figure 1. June 3, 2004. Close-up of flash flood damage at CAU 400, Five Points Landfill. Young plants of squirreltail grass and some annual plants are growing through cracks of sediment, while plants of bud sagebrush and fourwing saltbush are covered in mud and dead.

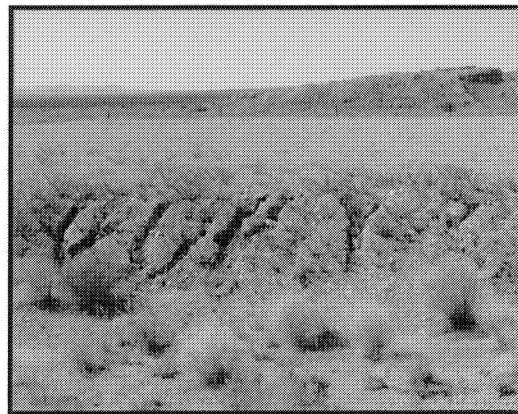
Erosion is the major concern at this site. Numerous small gullies off the slopes of the soil cap were first noted in 2003 (Figure 3). The gullies do not seem to be deeper than last year but are still present. There are also several animal burrows on the edges of the cover.

Figure 3. June 4, 2004. Erosion gullies along northern edge of the soil cap at CAU 407.

CAU 407 still lacks a vegetative cover, and erosion off the pad is severe (Figure 3). Some remedial action might be appropriate at this site. The establishment of vegetation on the cover would reduce the potential for erosion, or diversion channels could be used to direct water flow and possibly reduce the number of gullies that are forming on the cover.
