INL Sitewide Operations and Maintenance Report for CERCLA Response Actions—FY 2005

September 2005

Idaho Cleanup Project

DOE/ID-11249
Revision 0
Project No. 23689

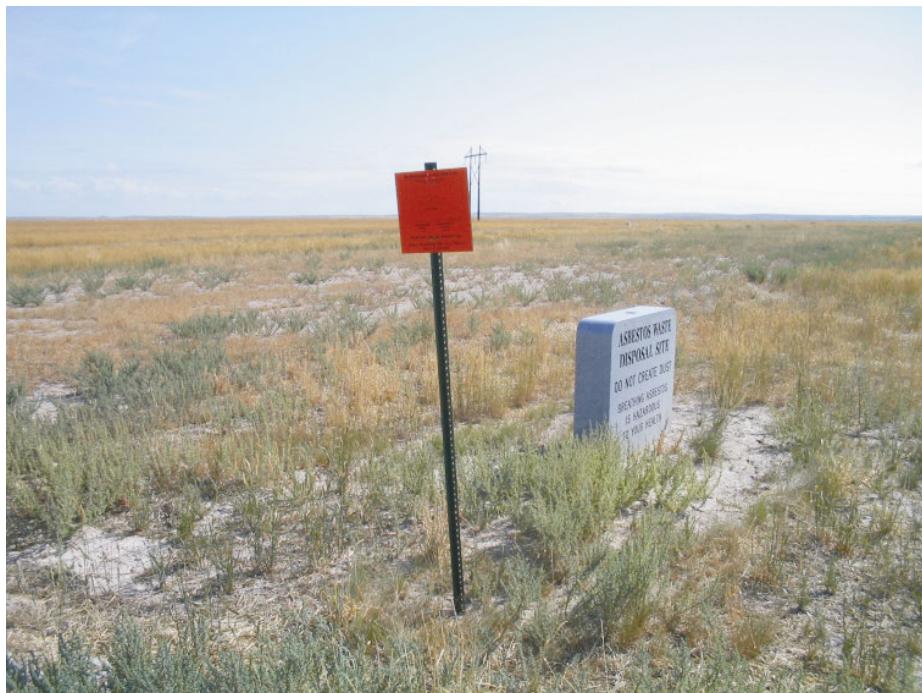
WAG 1 was visited on August 17, 2005, to conduct the annual O&M inspection. The WRRTF-01 site within Operable Unit (OU) 1-10 was assessed for soil-cover erosion, subsidence, and intrusion. During remediation in 2004, Pits II and IV at this site received caps. The caps were vegetated in the fall of 2004, and good growth was observed during the 2005 inspection. No signs of erosion, subsidence, or intrusion were noted. Refer to Figure 2 for the log of the 2005 O&M inspection activity. Refer to Figure 3 for a photograph of the WRRTF-01 cap and monument.

Figure 3. WRRTF-01 cap and monument on August 17, 2005.

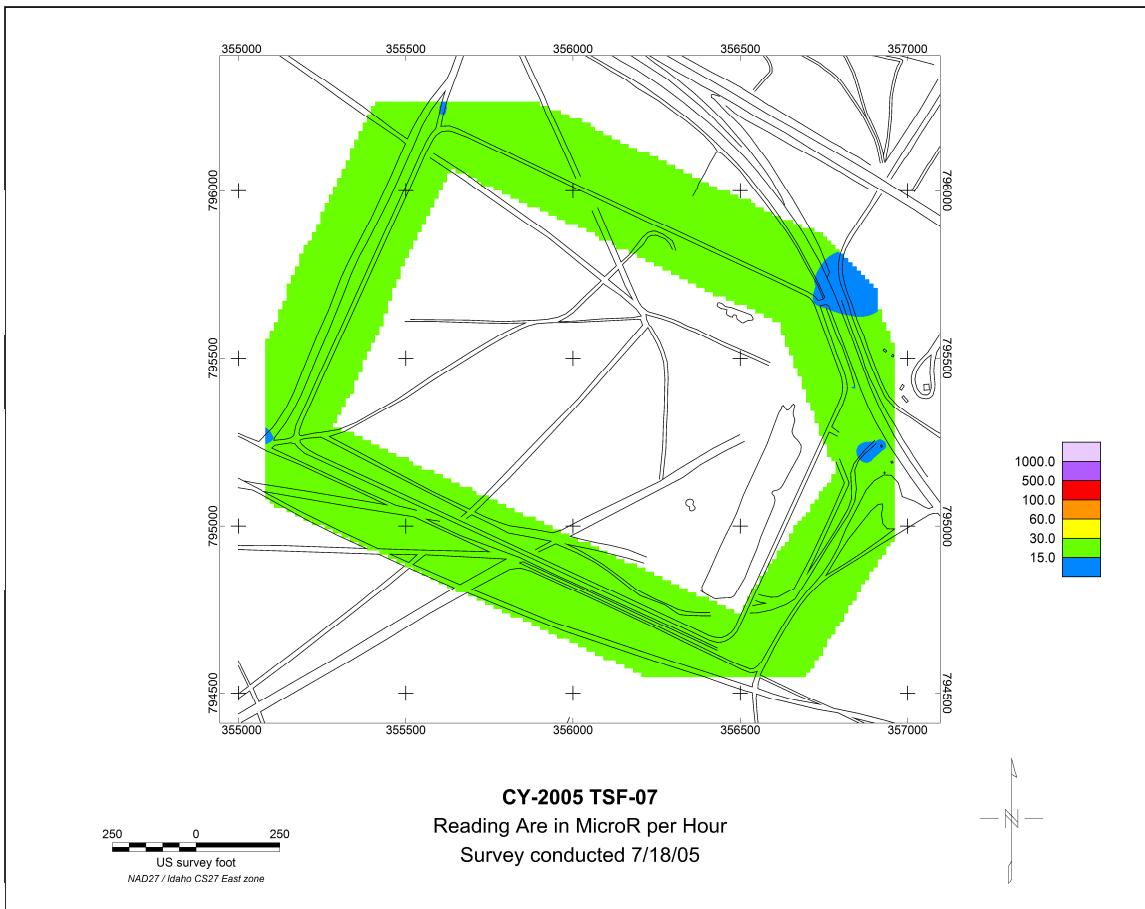
Environmental monitoring of windblown contamination at the TSF-07 site was performed using the vehicle-based (Humvee) global positioning radiometric scanner (GPRS). Results of the 2005 radiation survey are presented in Figure 4. Refer to Table 1 for a comparison of radiological surveys at TSF-07 over the past five years. Note that the detector configuration changed in November 2003. The count rate from 2004 to 2005 is statistically the same. No migration of contamination was detected at TSF-07.

Figure 4. Results of radiological survey using the GPRS at TSF-07 in 2005.

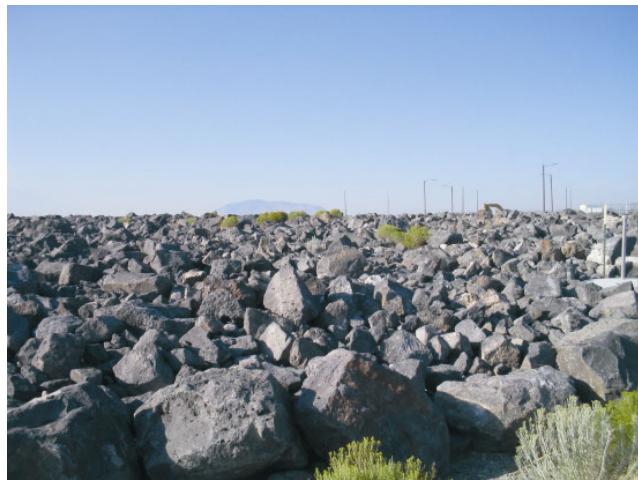
Figure 6. TRA-03 warm waste pond. (P-2660-03.JPG)

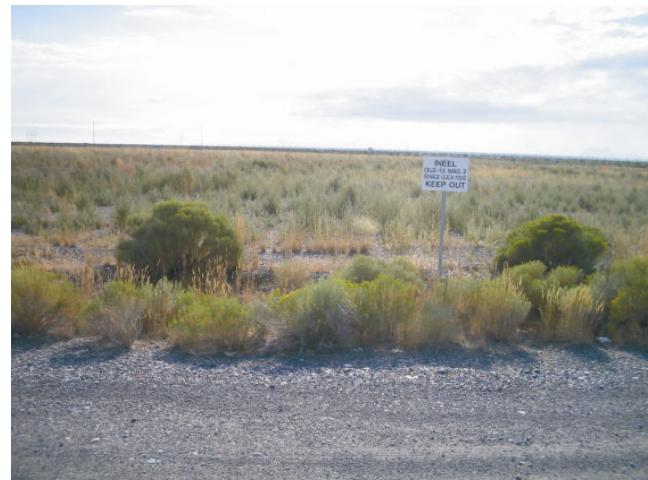
Figure 7. TRA-13 sewage leach pond cover. (P-2660-01.JPG)

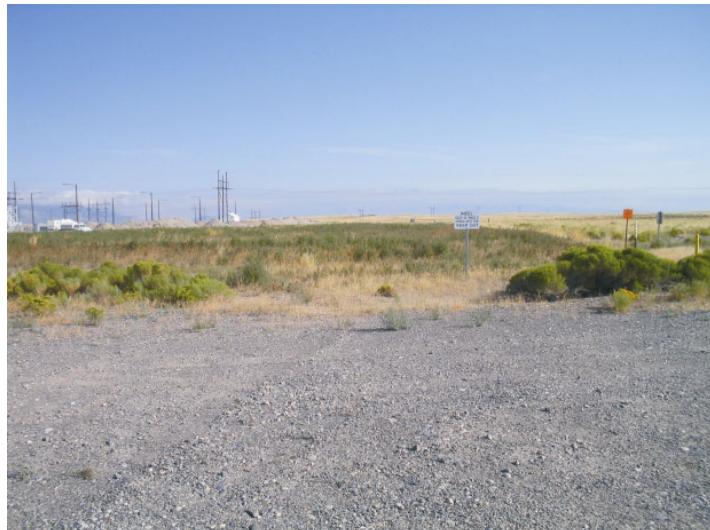
Figure 8. TRA-06 chemical waste pond. (P-2660-08.JPG)

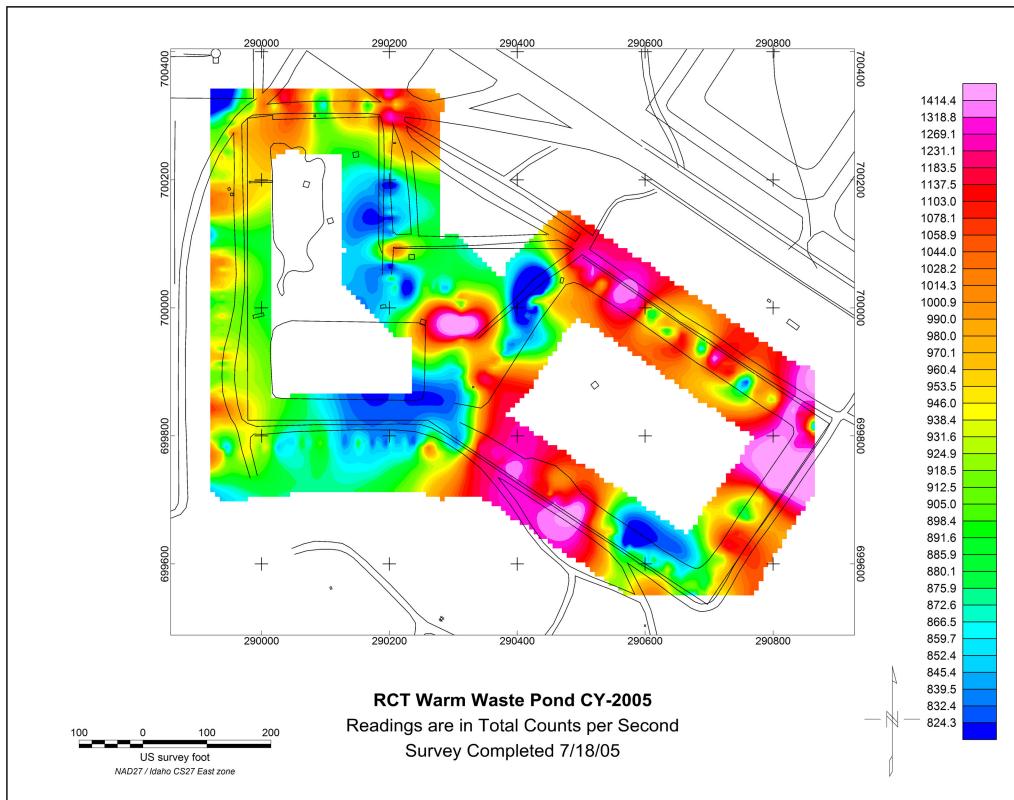
On July 18, 2005, the GPRS (Humvee) radiological surveys were performed around the perimeter at TRA-03 and the TRA-13 SCA and on the cover of TRA-13 SCA. The radiological survey indicated that no change has occurred from previous years. Refer to Figure 9 for results of the radiological survey at TRA-03 and TRA-06. Refer to Figure 10 for the results of the Humvee drive-over at TRA-13 and the TRA-13 SCA.

Figure 9. Humvee perimeter survey at the TRA-03 warm waste pond in 2005.

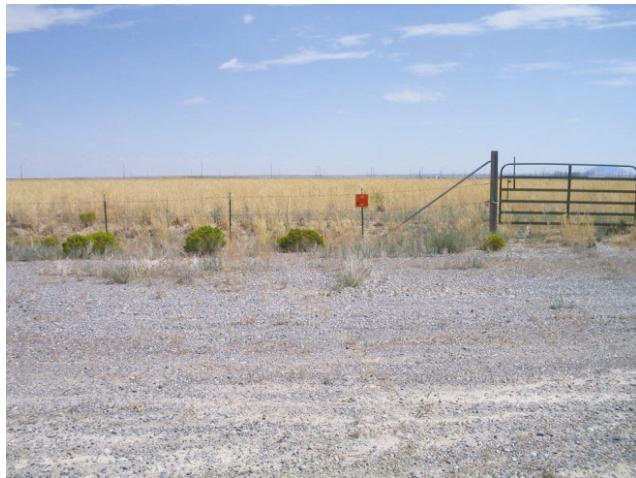
Figure 12. CFA Landfill I. (P-2660-14.JPG)

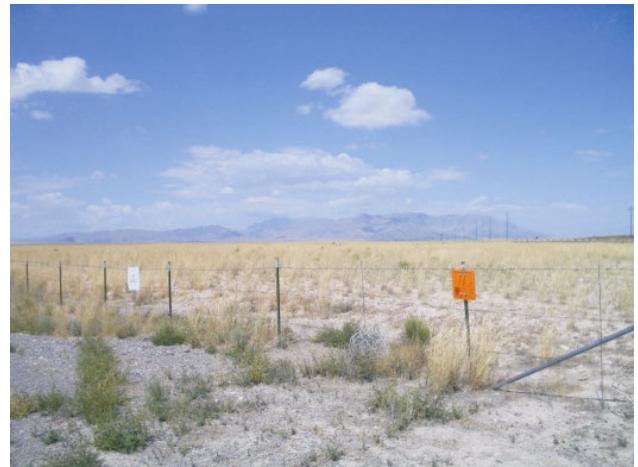
Figure 13. CFA Landfill II. (P-2660-13.JPG)

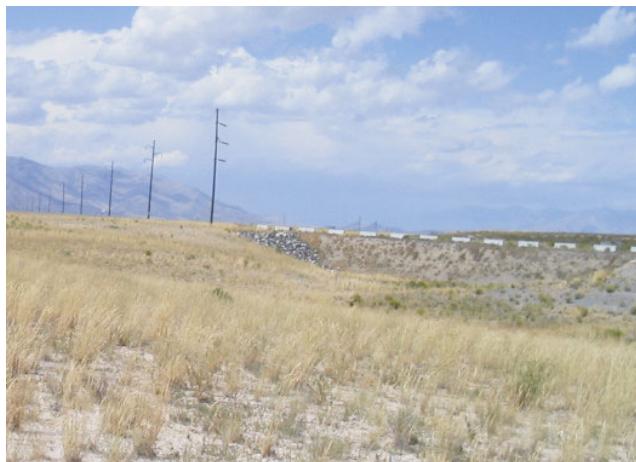
Figure 14. Riprap at CFA Landfill II. (P-2660-18.JPG)

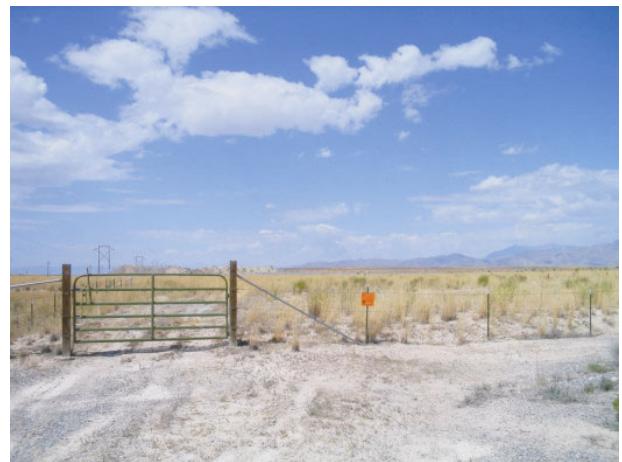
Figure 15. CFA Landfill III. (P-2660-15.JPG)

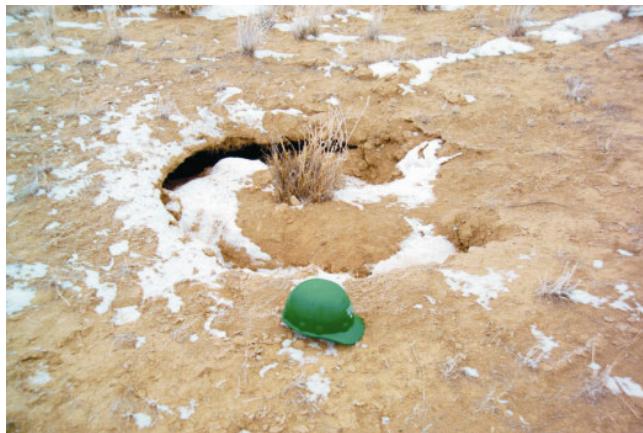
On August 17, 2005, O&M sites at WAG 4 were inspected: CFA-01, CFA-02, CFA-03, and CFA-08. These sites are inspected annually for erosion, animal intrusion, subsidence, and the condition of the soil covers and vegetative cover. Additionally, CFA-08 is inspected for the condition of the monuments, and the three landfill sites are inspected for the condition of monitoring equipment and rock armor as applicable. The 2005 O&M inspection showed no evidence of subsidence, erosion, or intrusion. Vegetation is in good condition on the Central Facilities Area (CFA) landfills, and the subsidence area reported in 2004 at CFA Landfill III has been repaired.

Figure 16. Subsidence in CFA Landfill III. (P-1216-06.JPG)

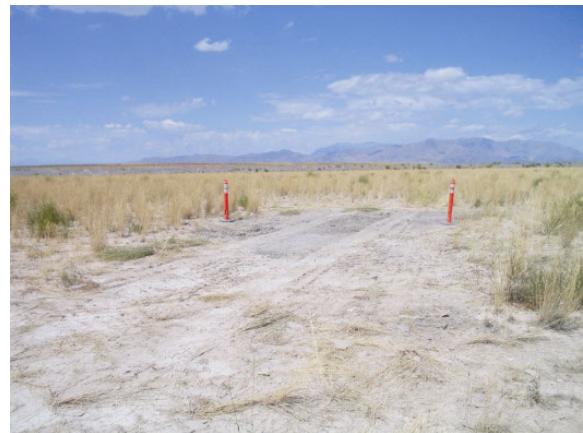
Figure 17. CFA Landfill III repair. (P-2660-16.JPG)

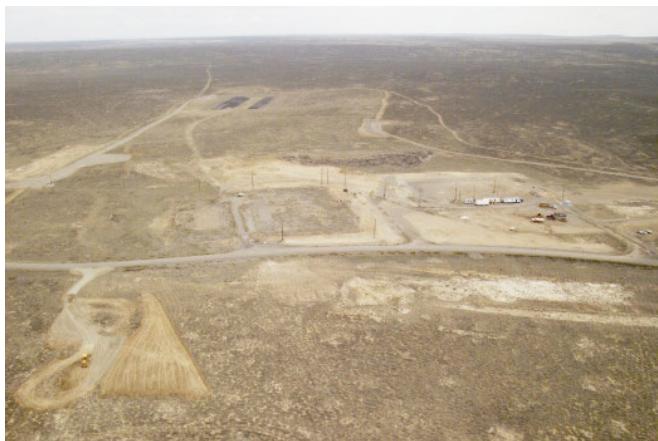
Figure 20. WAG 5 area.

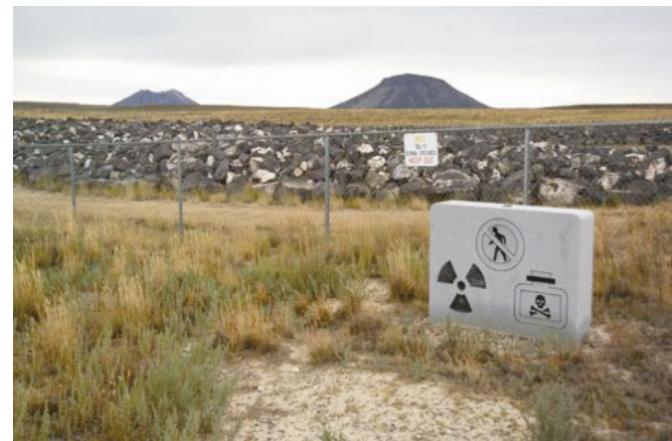
Figure 20. WAG 5 area. (PD040079-130.jpg) Figure 21. SL-1 monument.

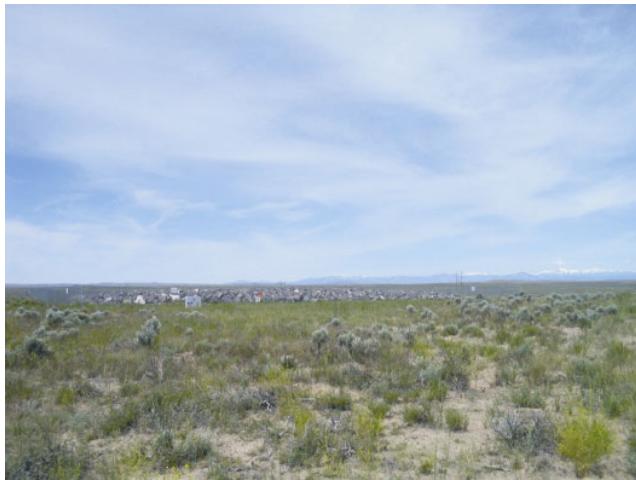
The Boiling Water Reactor Experiment (BORAX) I burial ground, i.e., the BORAX-02 site, was inspected on June 14, 2005. The perimeter radiological survey was performed at BORAX-02 on August 11, 2005. No subsidence or erosion was noted, and the radiological results were consistent with previous years. Refer to Figure 22 for the 2005 site inspection log. Refer to Figure 23 for the results of the radiological survey. Refer to Figure 24 for a photograph of BORAX-02.

Figure 24. BORAX-02.
