DOE/NV--1207

Post-Closure Inspection Report for the Tonopah Test Range, Nevada

For Calendar Year 2006

U.S. Department of Energy
National Nuclear Security Administration
Nevada Site Office

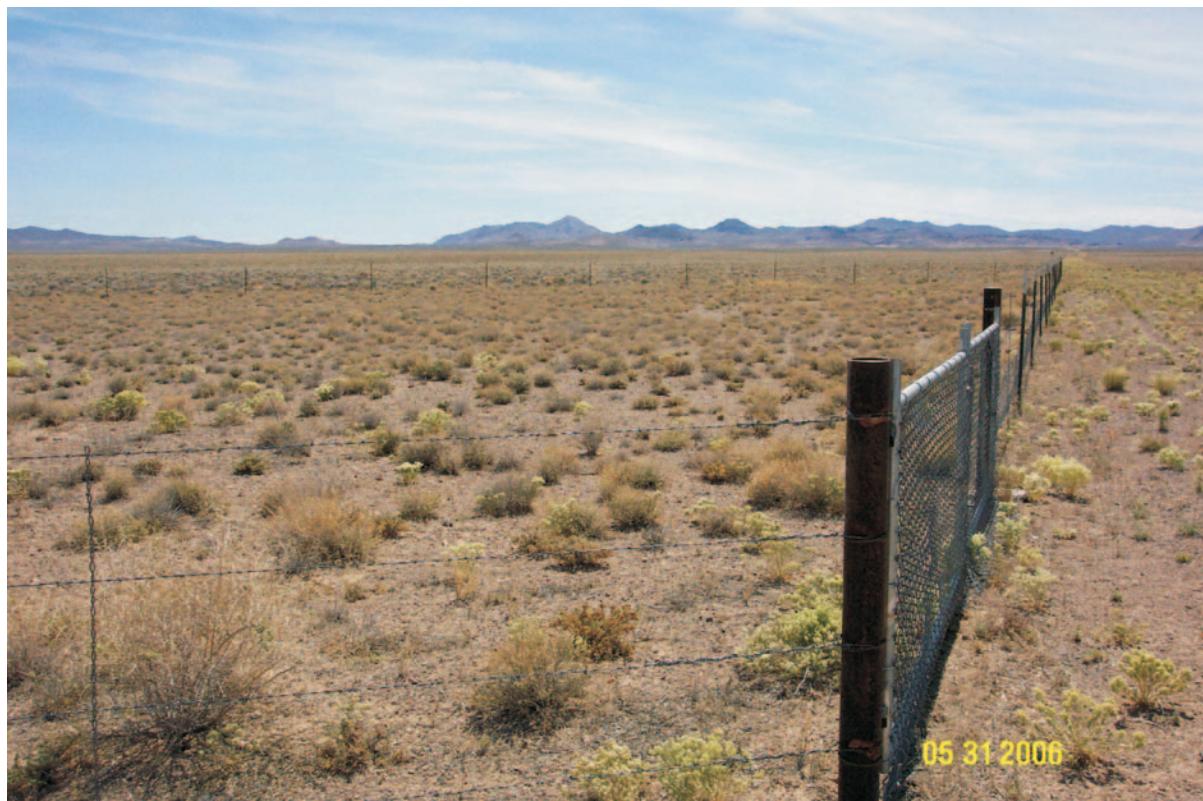
The Bomblet Pit is presented in Figure 2 of Attachment A. The first inspection was conducted on May 31, 2006. The cover vegetation was healthy, well established, and similar to the surrounding area outside the fence. The fence, site signs, and cover were in good condition, but the east and west sections of chickenwire fencing beyond the standard fencing were damaged, necessitating repair. Additionally, a bomblet with a suspected fuse was discovered at the conclusion of the inspection. The area was marked with orange flagging, and a Westinghouse safety representative was notified of the bomblet location.

Photograph 1: CAU 400 Bomblet Pit, looking west, 05/31/2006

Repairs were made to the chicken wire fence at the CAU 400 Bomblet Pit, CAS TA-55-001-TAB2, in June 2006. No repairs were required at the Five Points Landfill.

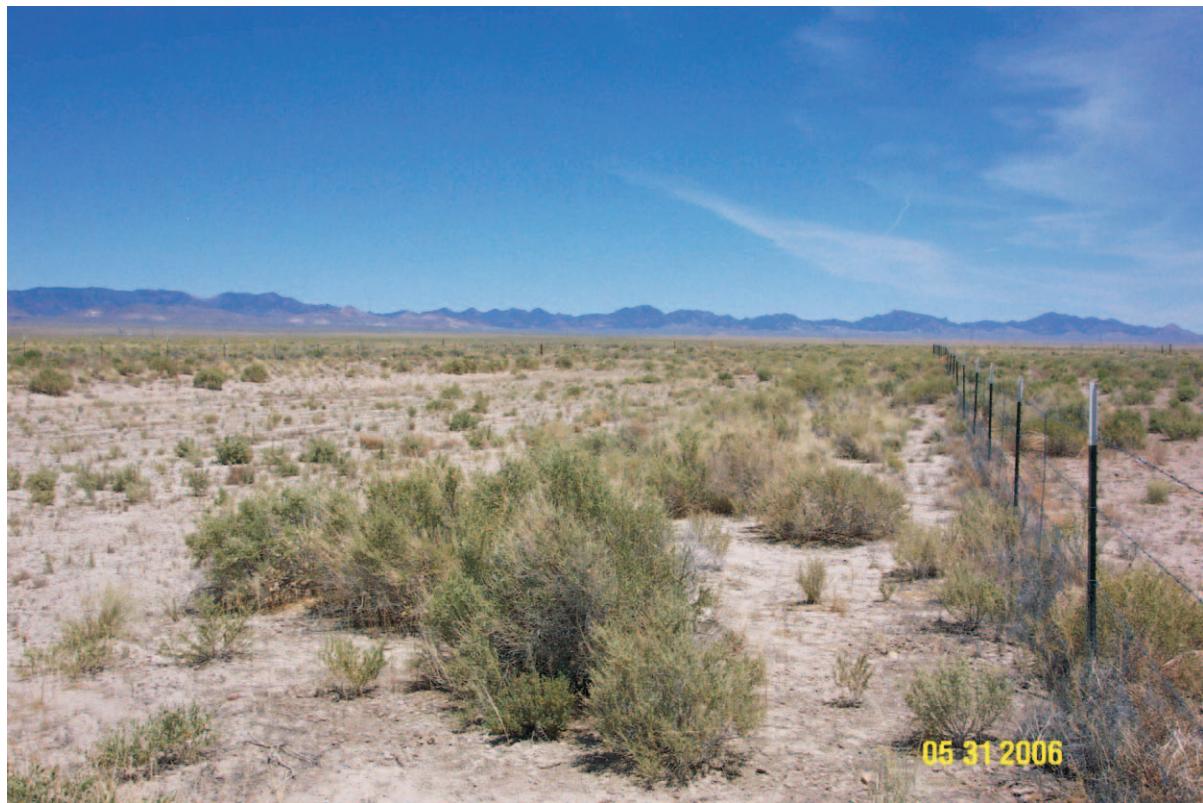
The Five Points Landfill is presented in Figure 3 of Attachment A. The first inspection was conducted on May 31, 2006. The inspection indicated some minor animal burrows within and outside of the fence at the northeast corner of the site. All signs and fencing were in good condition. The cover vegetation appeared normal, with the continuance of nominal growth after reseeding in 2004.

Photograph 5: CAU 400 Five Points Landfill, looking east, 05/31/2006

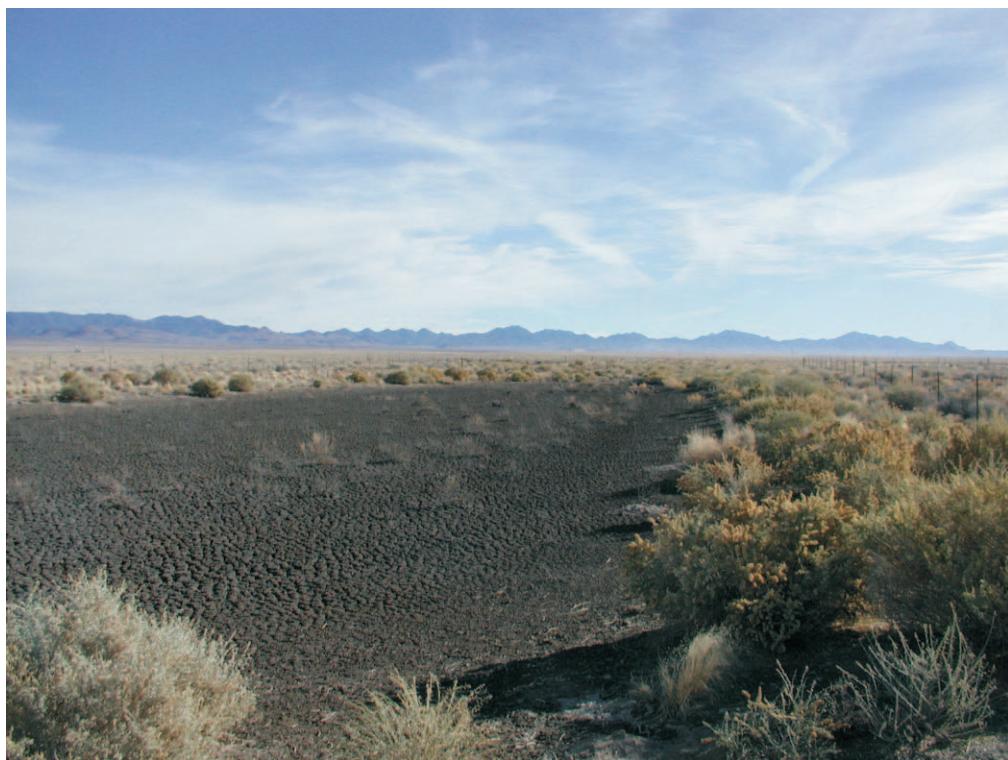
The second inspection was conducted on November 15, 2006. All signs and fencing were in good condition. Evidence of animal burrows was observed near the front fence. However, due to apparent flooding in the area, no living vegetation remained in the low-lying areas of the cover. (See Attachment E, Photographs 5 and 6.) An ecological specialist will evaluate the site in 2007 for new vegetation growth, and options will be considered depending upon the site conditions at that time. Because of the loss of vegetation, the recommendation of the U.S. Department of Energy, National Nuclear Security Administration Nevada Site Office (NNSA/NSO) and Nevada Division of Environmental Protection (NDEP) to remove the fence following the 2006 inspection, contingent upon healthy vegetation, was not implemented. No maintenance or repairs were recommended as a result of this site inspection.

While the Bomblet Pit site was in excellent condition, the Five Points Landfill experienced a significant loss of vegetation. As stated in the revegetation plan (DOE/NV, 1997), the sites are to be fenced for a minimum of 5 years in order to give the vegetation sufficient time to become established. Based on the results of the 2006 inspections and the Post-Closure Vegetation Monitoring Report (Attachment F), it has been determined that the vegetation is not currently sufficiently established to remove the fences. Until it is determined that the vegetation has matured to the same extent as the surrounding undisturbed areas, both sites will remain fenced and semiannual site inspections will continue.

Photograph 6: CAU 400 Five Points Landfill, looking east, 11/15/2006

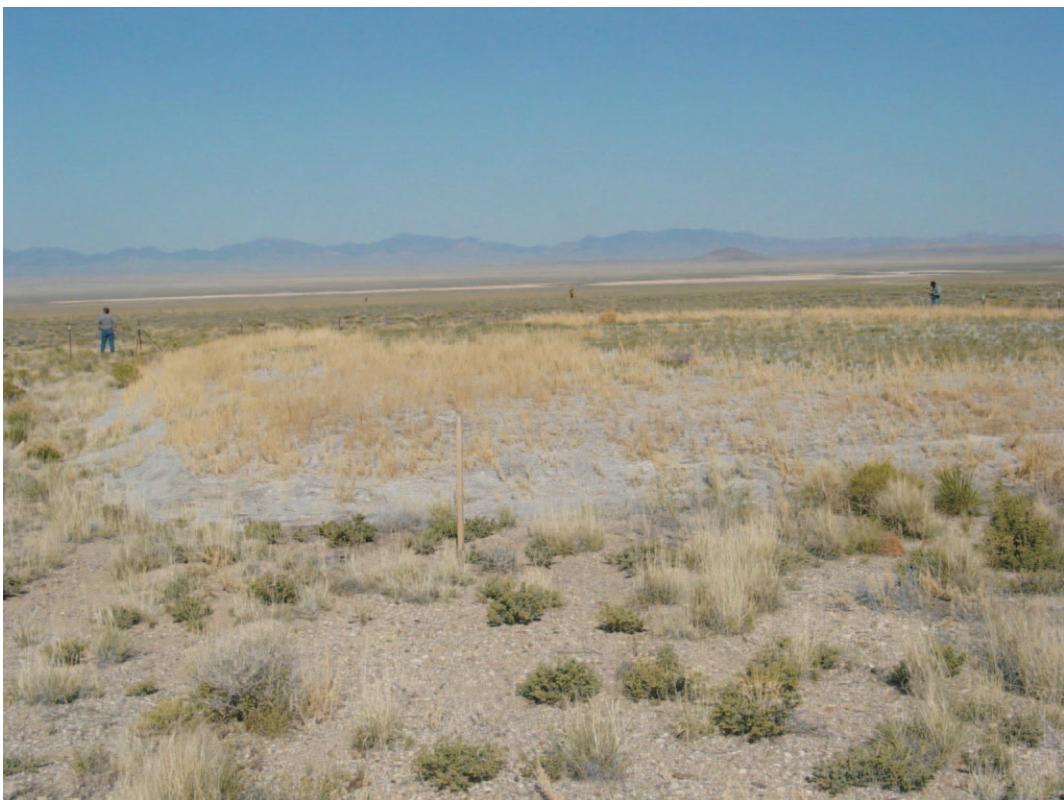
The first inspection was conducted on May 9, 2006. The inspection indicated the cover was in good condition, and local grasses were becoming established on the cover. Many small animal burrows were present along the southern edge of the fencing, and options for mitigating burrowing were considered. Additionally, the southeast corner fence post required reinforcing, and one warning sign required reattachment. Otherwise, the fence and warning signs were intact and in good condition.

Photograph 11: CAU 407, looking east, 05/09/2006

A loose radiological warning sign was reattached, and the southeast corner fence post was reinforced in June 2006.

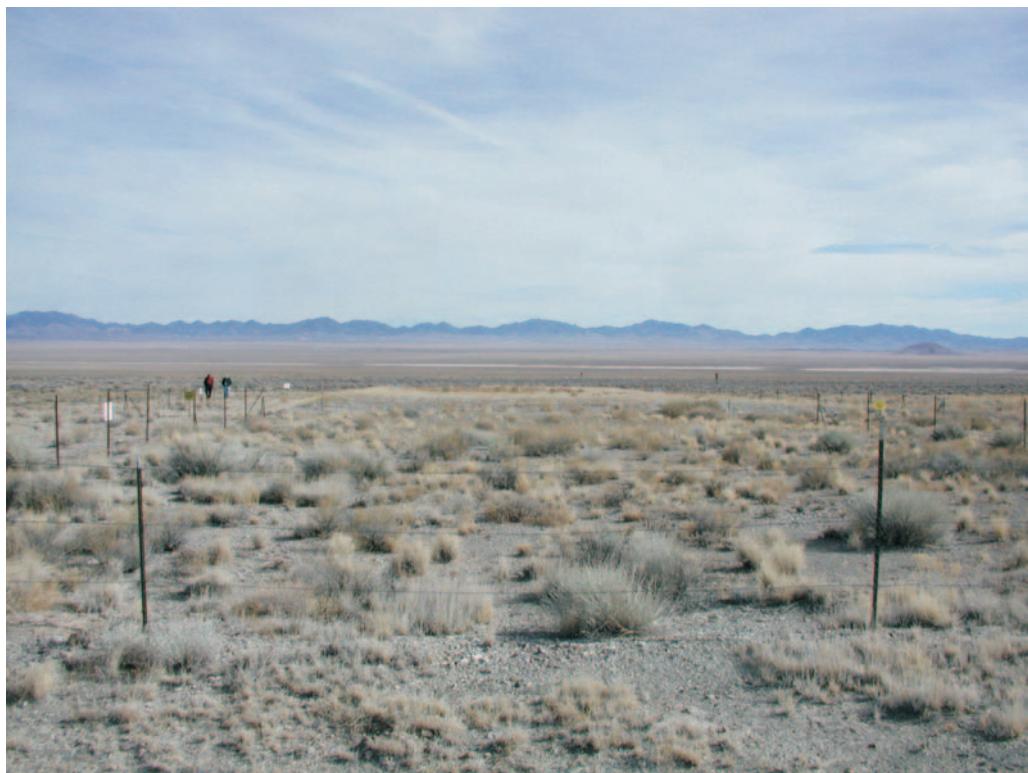
The second inspection was conducted on November 15, 2006. Repairs made to the fencing and signs in June 2006 were in good condition. No animal burrows were observed inside the fence, and no erosion cracks or subsidence of the cover was observed during the inspection. The fencing, signage, and cover were in good condition. No maintenance or repairs were recommended.

Photograph 12: CAU 407, looking east, 11/15/2006

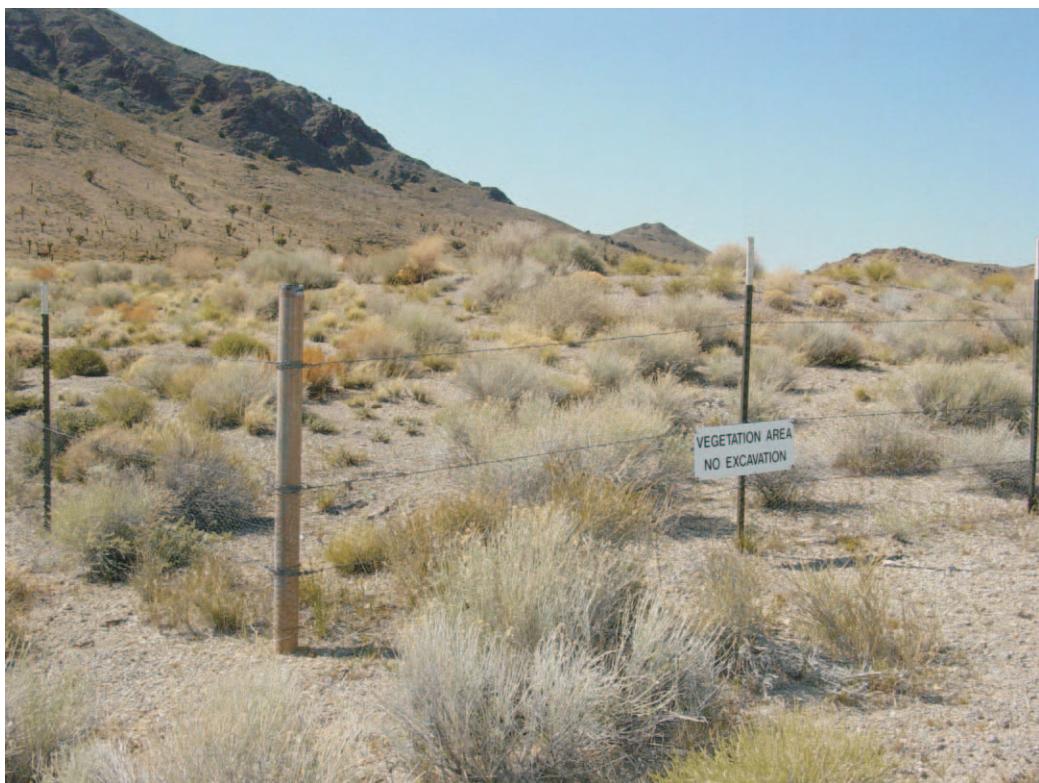
The first inspection was conducted on May 9, 2006. The fence perimeter was walked, and the site was found to be in excellent condition. While some tightening to the perimeter fencing was advised, there was no damage to the perimeter fence or signs, which were intact and legible. No erosion, subsidence, or evidence of unauthorized use was observed. Vegetation was well established and healthy throughout the site. No site maintenance or repairs are needed; however, it was recommended to tighten the fence as a best management practice.

Photograph 33: CAU 426, looking north, 05/09/2006

The perimeter fencing adjacent to the gate at CAU 426 was tightened in June 2006. No additional maintenance or repairs were performed during 2006.

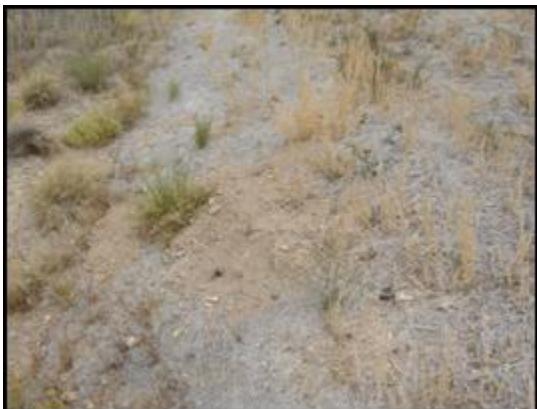
Figure 1. Small mammal burrows along the edge of the cover at CAU 407

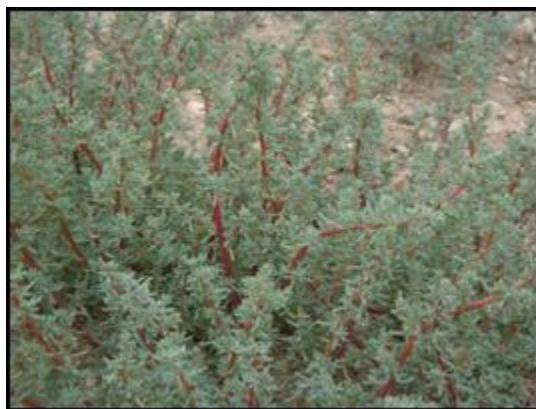
There is an abundance of old, dead stalks of halogeton (Figure 2) from the abundant rainfall in 2005. Halogeton is very common along roadsides and almost any place that has been disturbed, and is characterized by succulent, fleshy leaves and a central reddish stem. The number of plants has decreased by approximately 50 percent from 2005 to 2006. A similar trend has been observed at other revegetated sites, where halogeton becomes less abundant as native plants become established.

Figure 2. Halogeton (*Halopeplis glomerata*)
