FINAL TECHNICAL REPORT
MATERIALS FOR INDUSTRIAL HEAT RECOVERY SYSTEMS

MATERIALS FOR HEAT RECOVERY IN BLACK LIQUOR RECOVERY BOILERS

DOE Award Number
DE-FC36-04GO14035

December 31, 2007

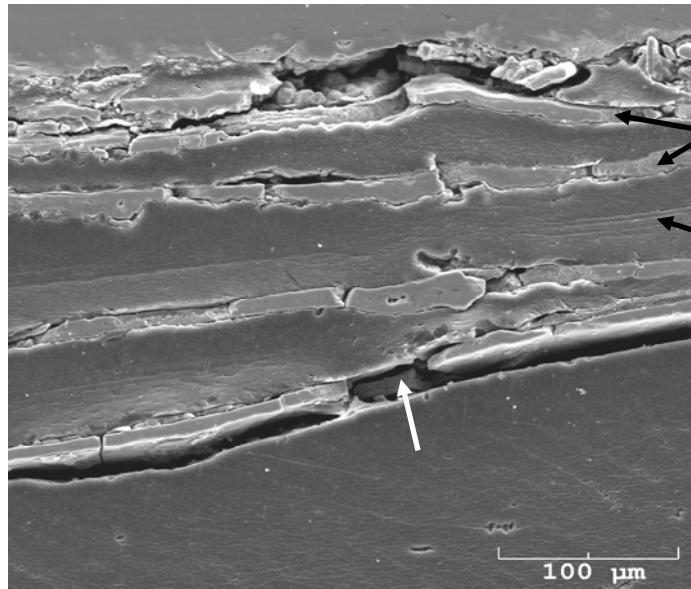
Figure 13. SEM micrograph showing cross-sectional view of laminated scale after Test # 1 exposure. Note alternating oxide/sulfide scale corresponding to each cycle, and the extensive cracking evident in sulfide scale. Oxide scale is relatively continuous and free from cracking.

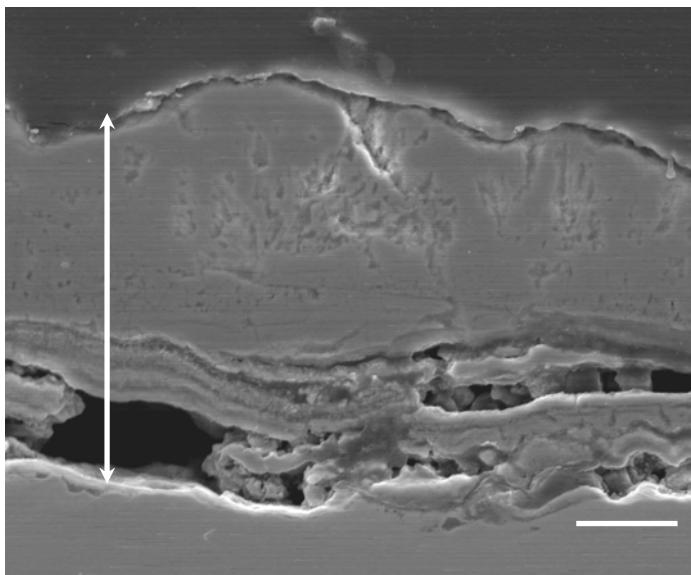
Figure 14. SEM micrographs showing cross-sectional view of laminated scale after Test # 2 exposure. The laminated structure due to cycling of gaseous atmospheres between an oxidizing and sulfidizing environment is evident.

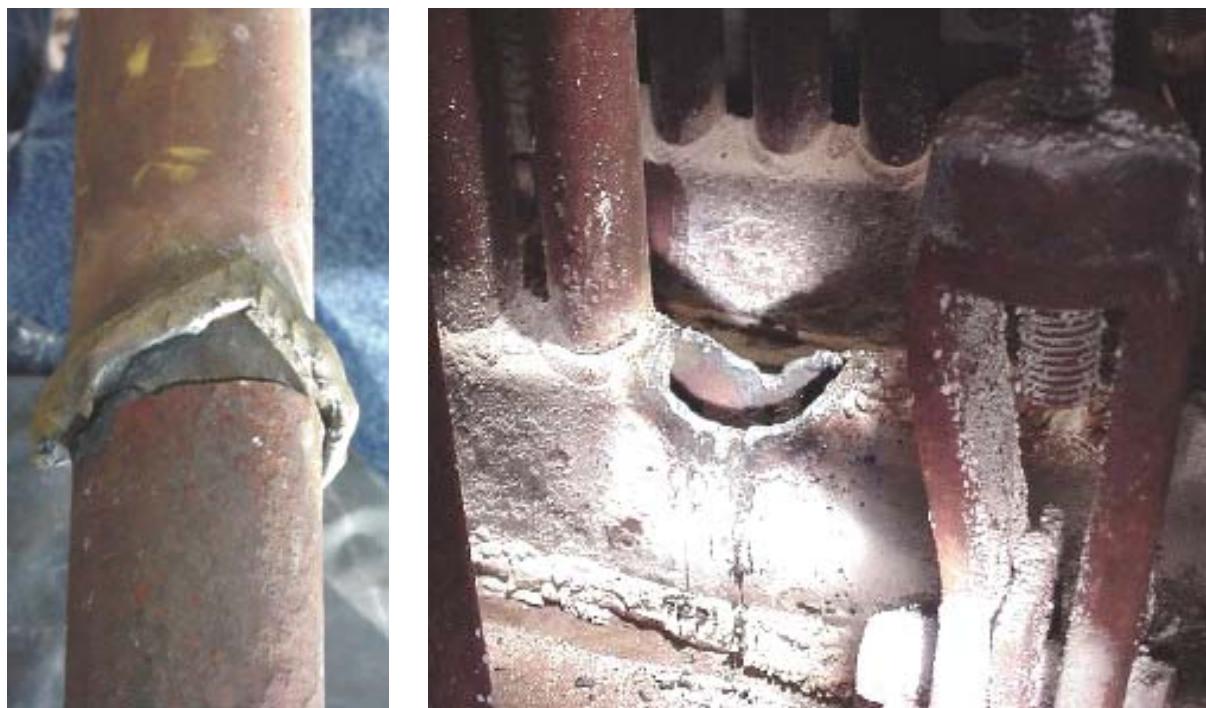
Figure 17. The photo on the left shows the two sections of the failed superheater tube that were examined, and the photo on the right shows the position in the high crown seal from which the tube was removed.

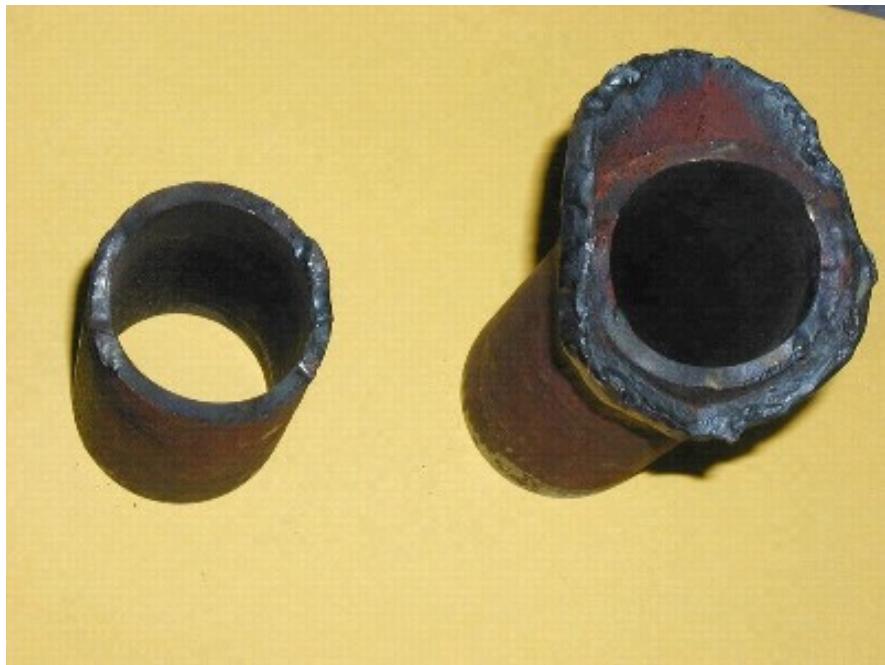
Figure 18. Photo showing the fracture surfaces of the superheater tube shown in the previous figure. Note the smooth surface at the 3 and 9 o'clock positions resulting from damage during removal of the tube.

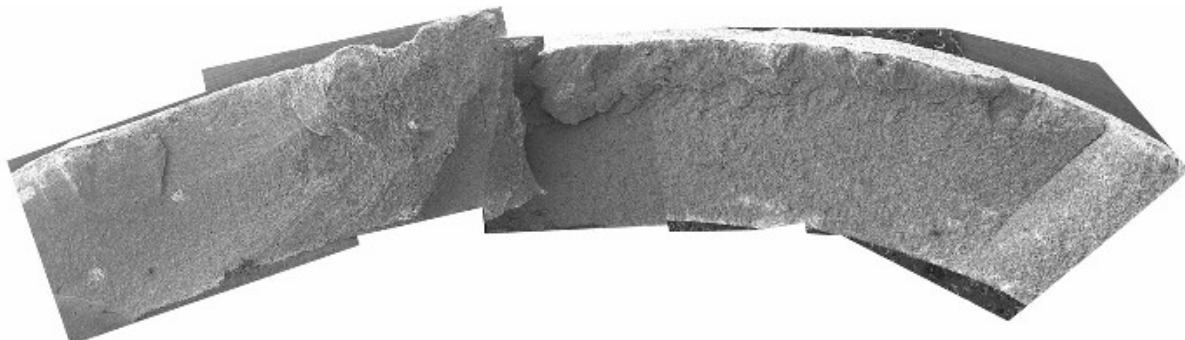
Figure 20. SEM micrographs showing structure of the fracture surface between areas 1 and 4 in the previous figure.

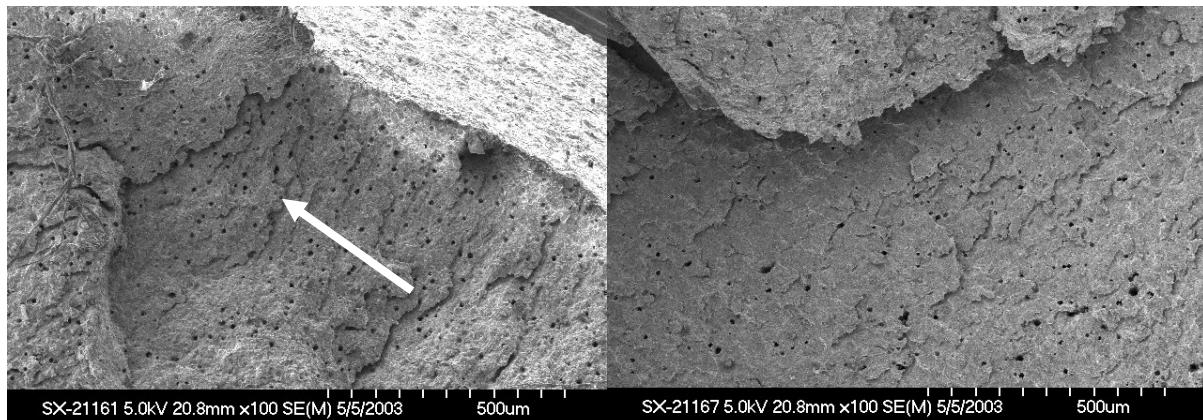
Figure 22. SEM micrographs showing areas to the right and right center in Fig. 20. Both micrographs appear to have secondary cracks advancing into the fracture surface. This type of cracking can be an indicator of fatigue. The arrow indicates the likely direction of crack advance.

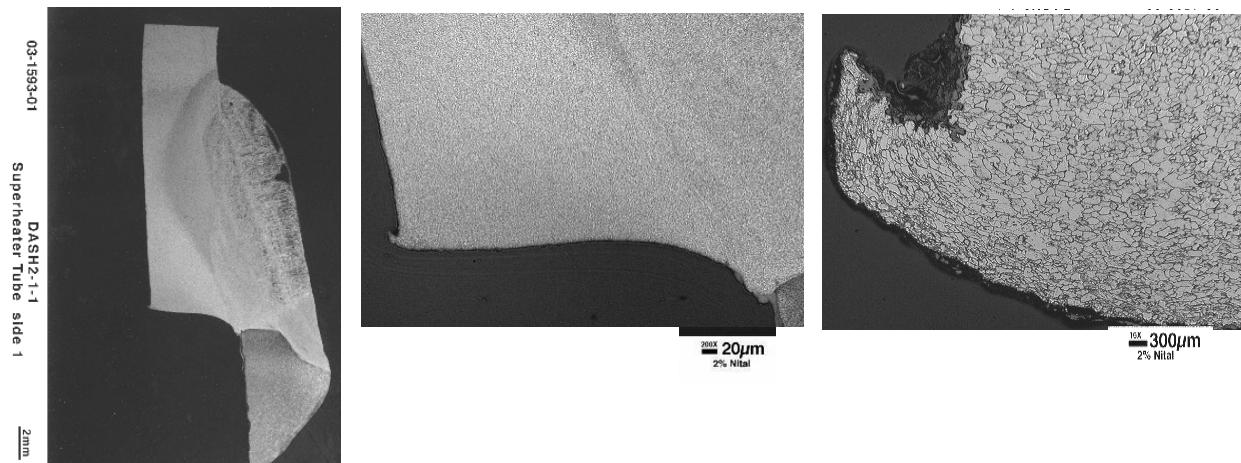
Figure 23. A series of micrographs showing (left) the cross section of the failed tube at the 3 or 9 o'clock position. The center picture shows an enlargement of the lower left corner of the tube, and the right picture shows a further enlargement of the inside edge of the tube. Note the lip indicating a ductile failure on this surface.

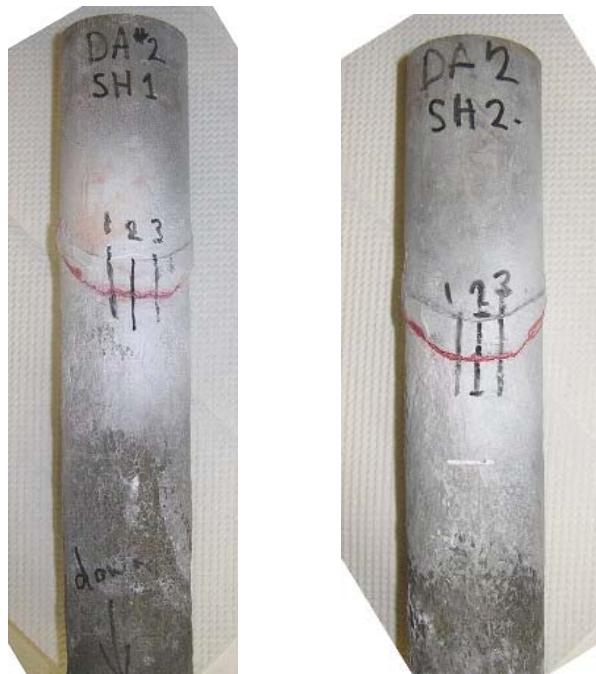
Figure 25. Cracked superheater tubes after dye penetrant examination. Both tubes showed a crack that followed the weld line along the bottom of the tube to high crown seal weld. The vertical lines and the numbers indicate locations from which metallographic samples were cut.

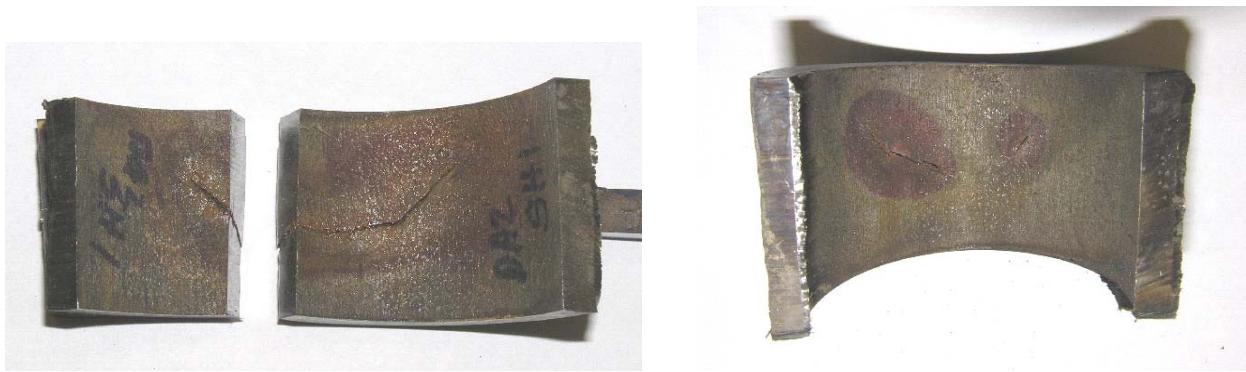
Figure 26. Photos of the inside surfaces of the two tubes shown in the previous figure. Both tubes have cracks that have penetrated through the wall. The crack pattern appears to mimic the directionality of the tube to high crown seal weld.

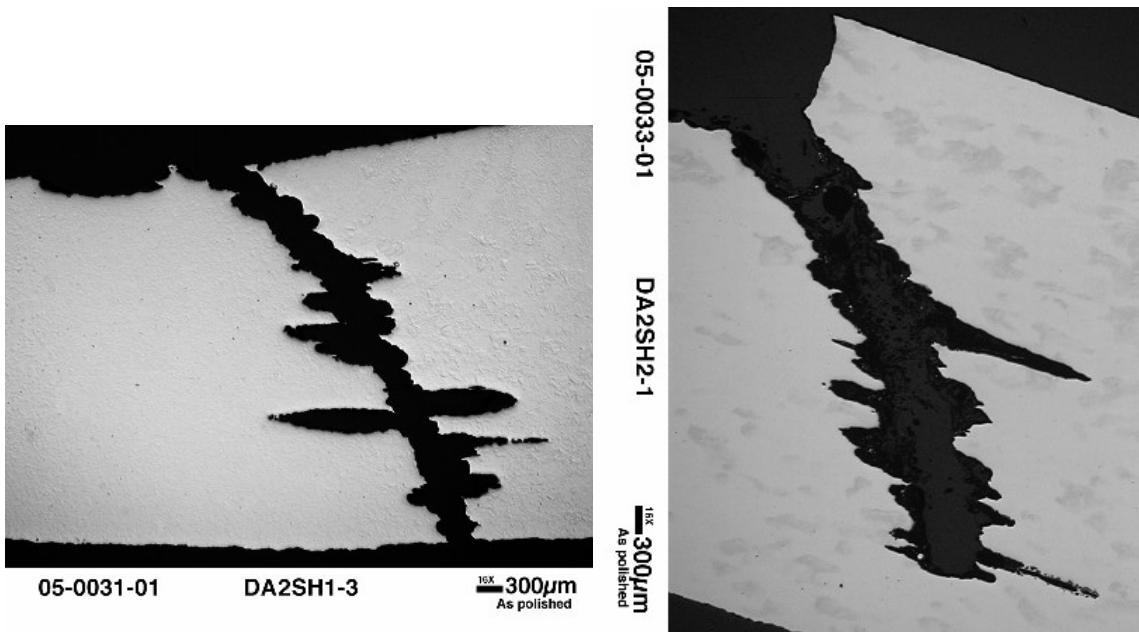
Figure 27. Micrographs of cross sections of the two cracked superheater tubes showing the primary cracks and the areas of secondary attack.

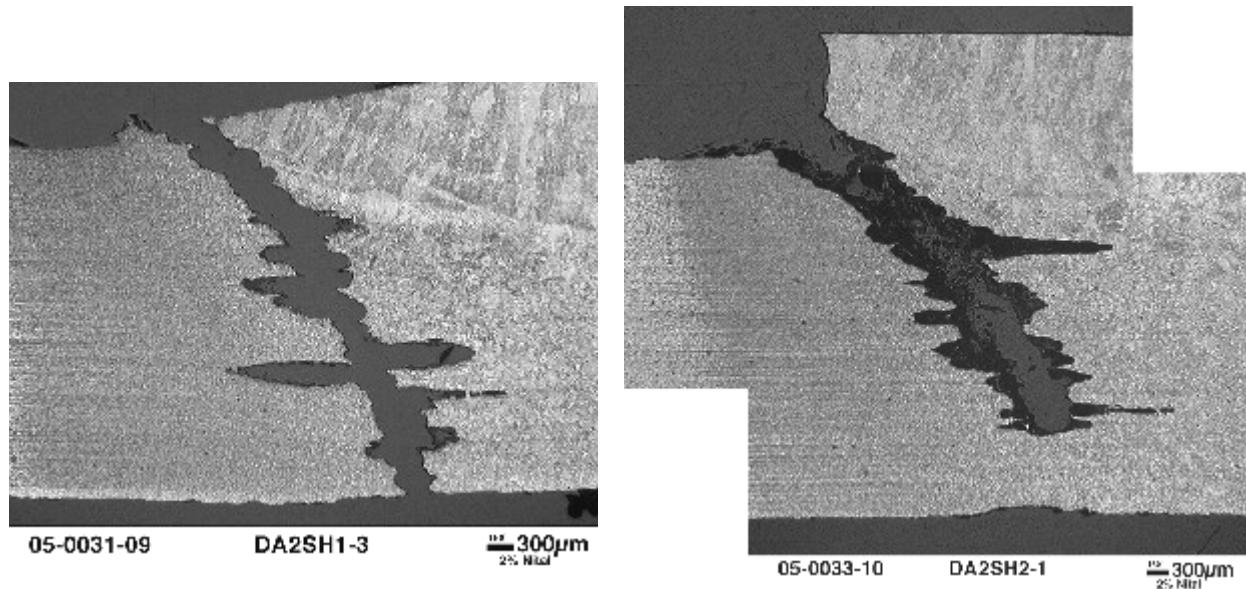
Figure 28. Micrographs of the etched cross sections of the two superheater tubes shown in the previous figure. Cracks are in the heat affected zone next to the weld metal.

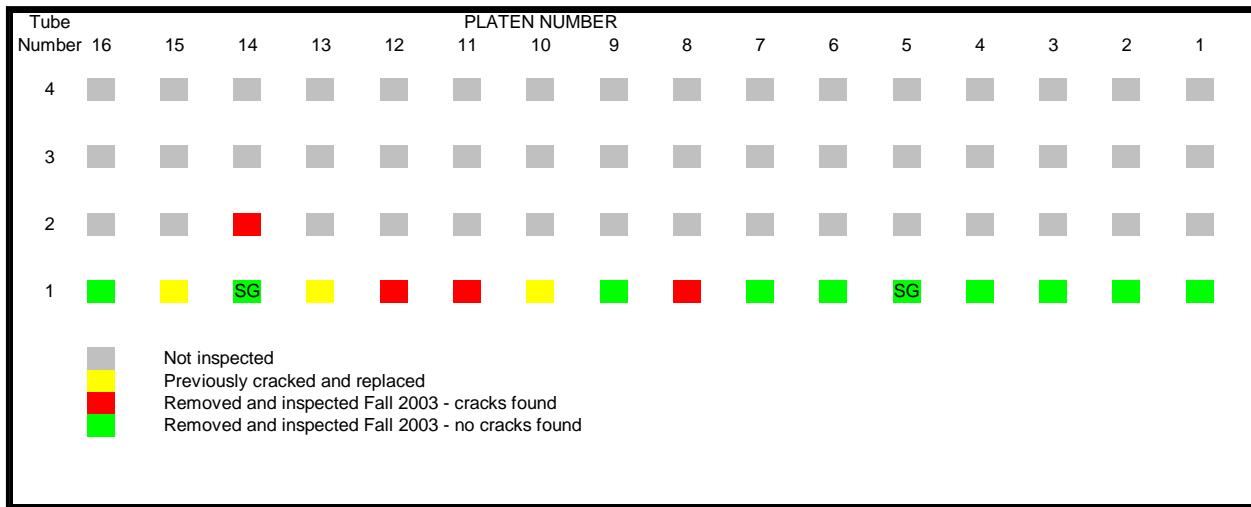
Figure 29. Sketch showing arrangement of superheater tubes in the area where the study was being conducted. As shown by the color coding, three tubes were replaced because of cracking around the time this study began, and four of the tubes removed in Fall 2003 were found to have cracks.

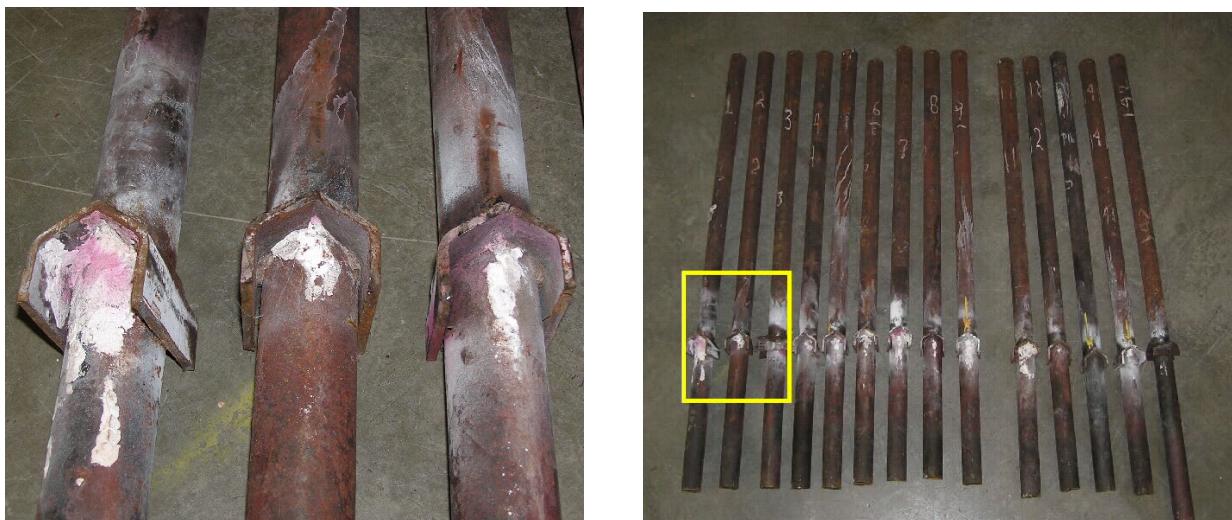
Figure 30. Fourteen unfailed superheater tubes removed from the intermediate superheater for inspection to determine if any cracking has occurred.

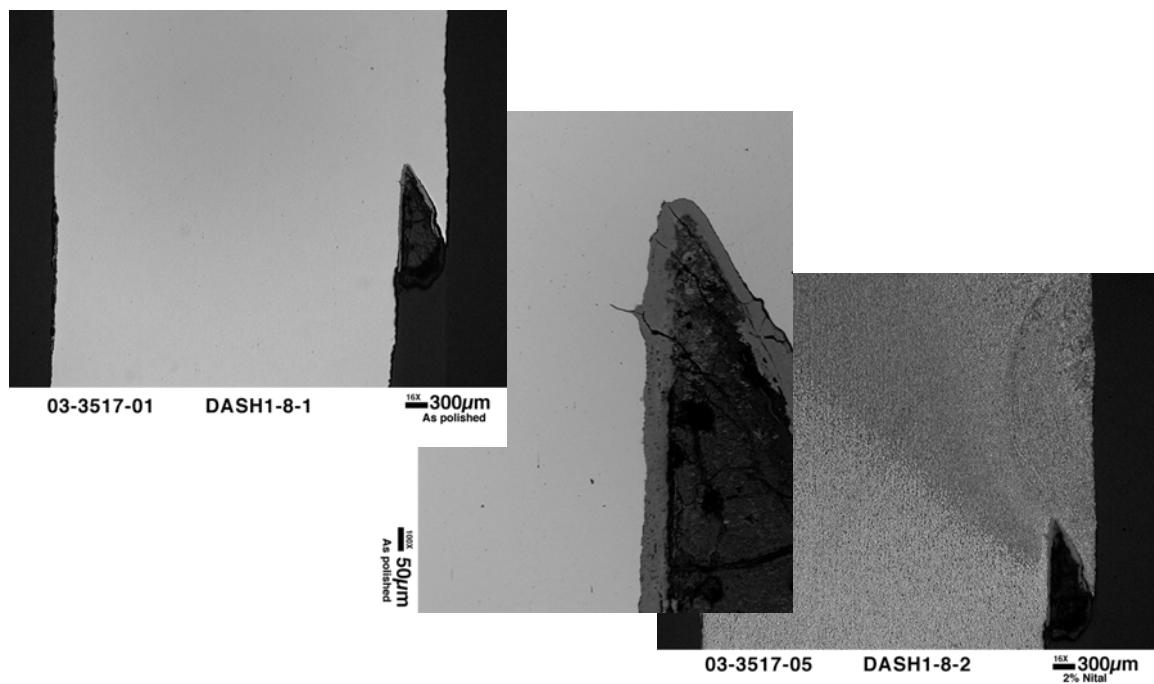
Figure 31. Micrographs showing the cracking on one side of the first tube from platen 8.

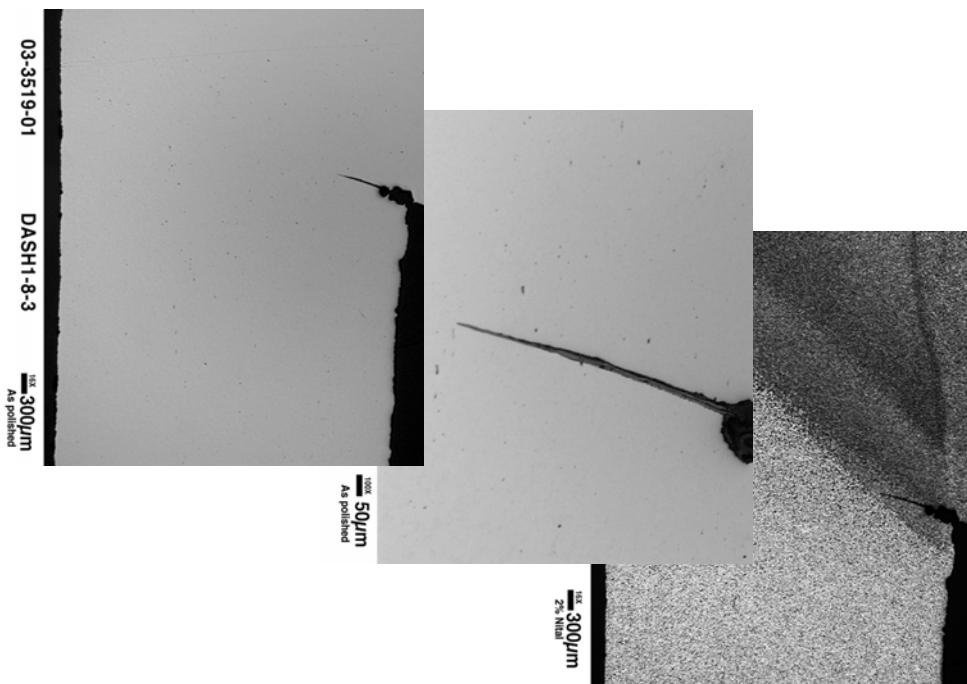
Figure 32. Micrographs showing the cracking on the other side of the first tube from platen 8.

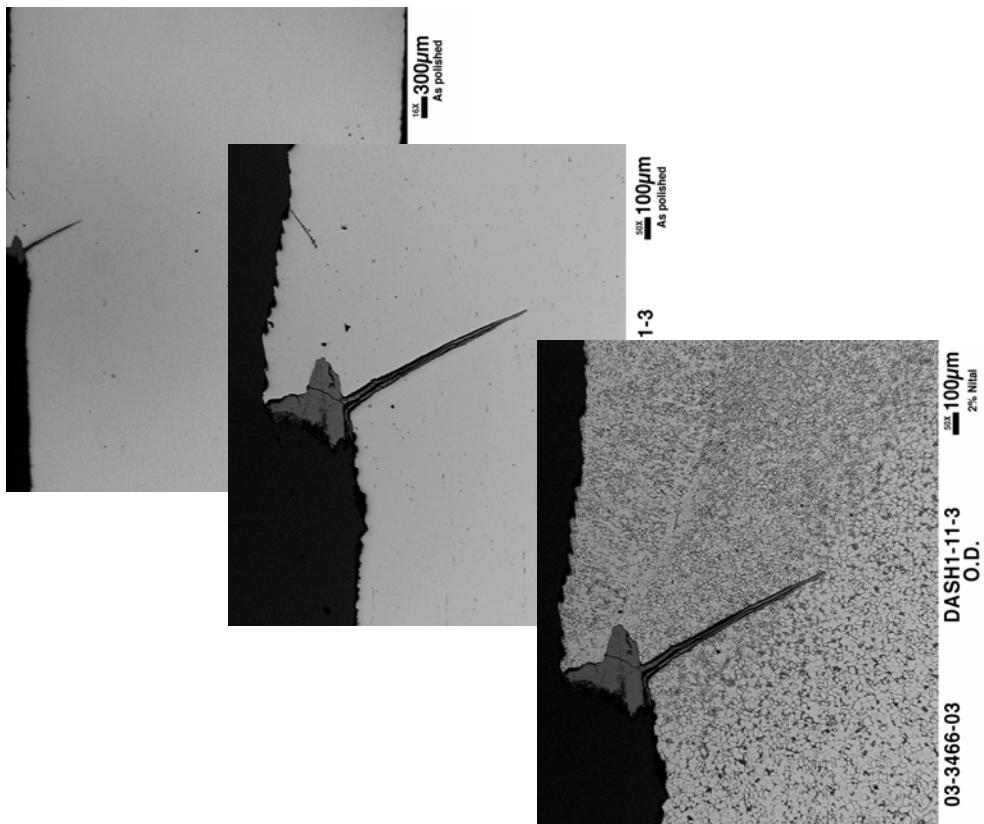
Figure 33. Series of micrographs showing the cracking in the first tube in platen 11.

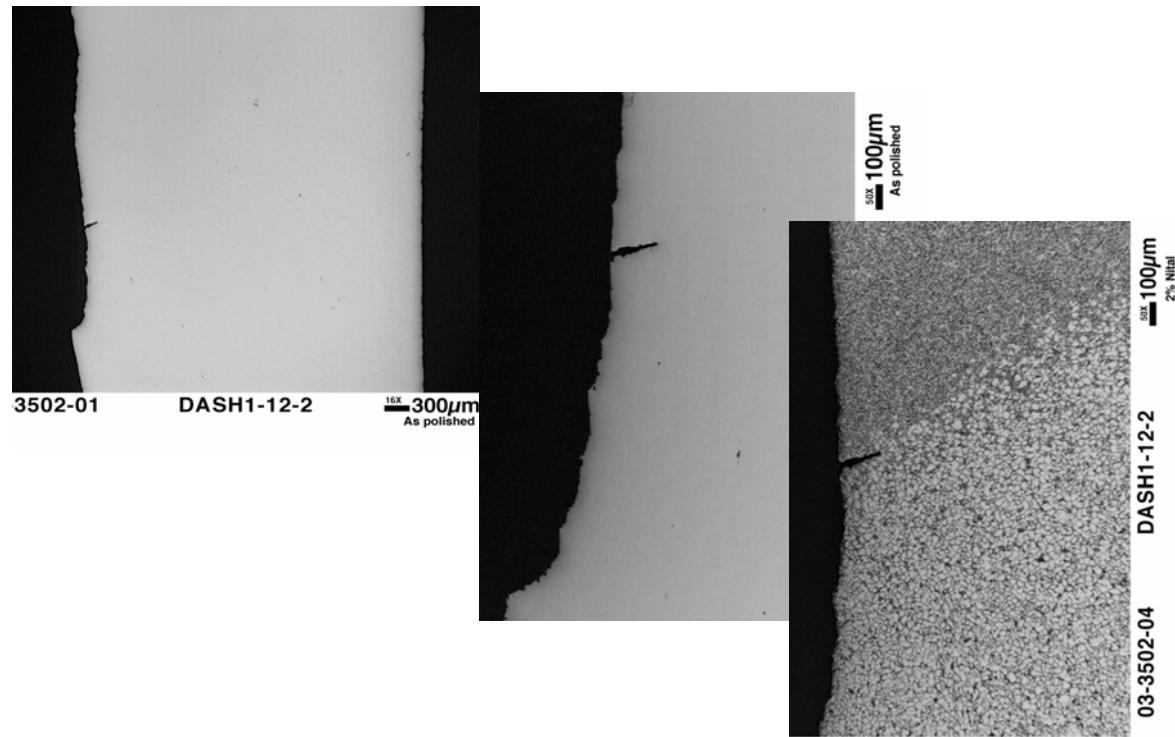
Figure 34. Series of micrographs showing the cracking in the first tube in platen 12.

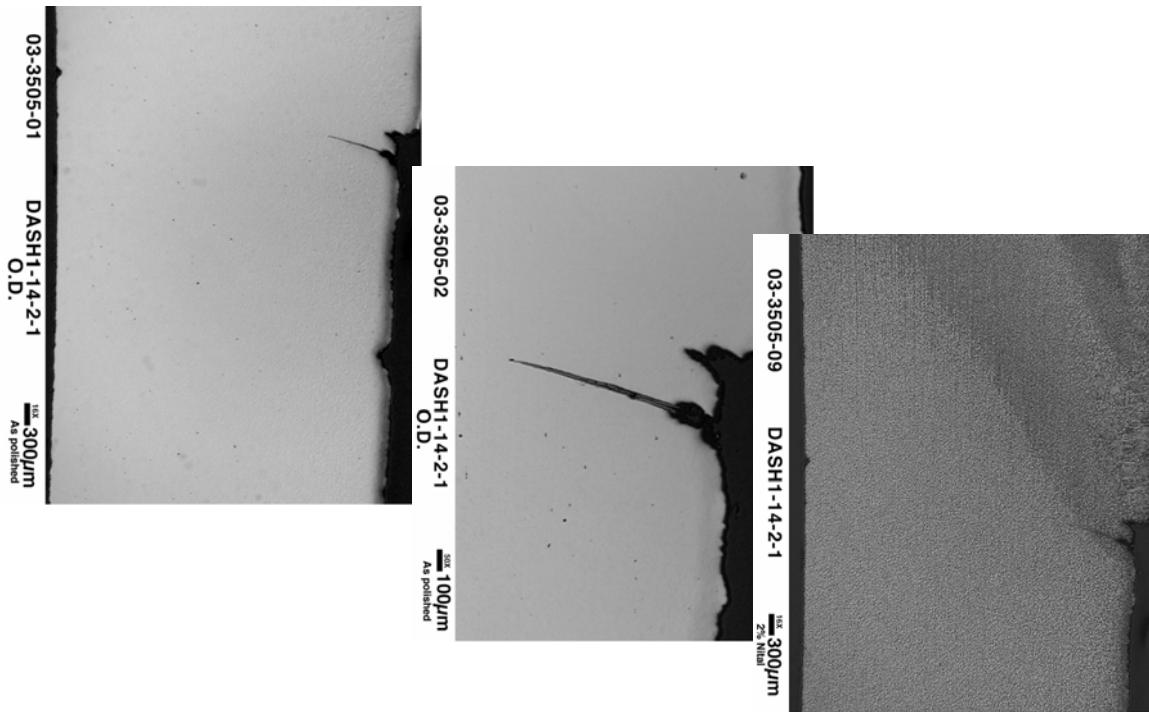
Figure 35. Series of micrographs showing cracking in the second tube from platen 14.

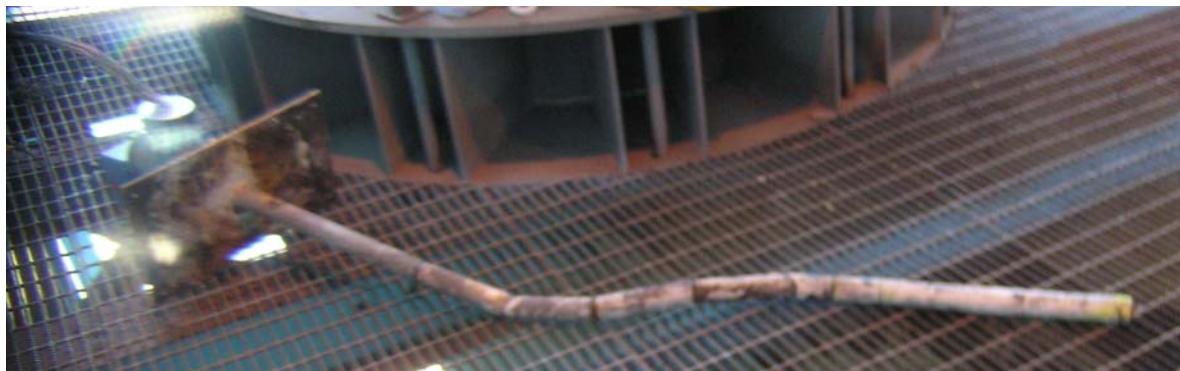
Figure 60. Corrosion probe after removal from recovery boiler.
considered to have been exposed at temperatures above the FMT for the majority of the
