Nevada
Environmental
Restoration
Project

DOE/NV-974

Tonopah Test Range Post-Closure
Inspection Annual Report, Tonopah
Test Range, Nevada
Calendar Year 2003

April 2004

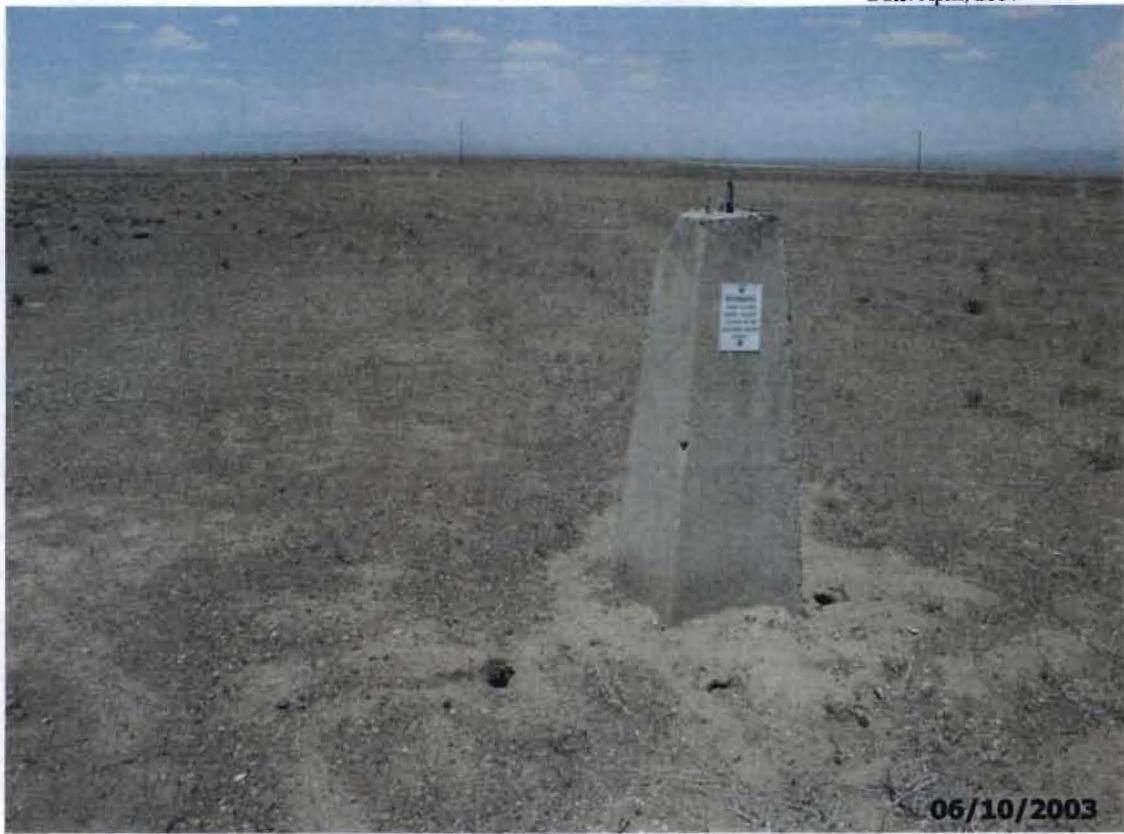
The cover remains in good condition although minor erosion continues to develop on the side slopes due to precipitation run-off and the sparseness of vegetation on the cover. A detailed plant census at CAU 407 was conducted in September of 2003, and the results are included in Attachment E. The fencing and signage were in good condition. No indications of subsidence appeared on the cover. No other repairs to the cover or changes in the frequency of site inspections are recommended at this time.

10. CAU 407 Roller Coaster RadSafe Area, looking north showing erosion on cover

Repairing areas of erosion on the cover, and seeding and mulching of the cover is proposed. Establishing vegetation on the cover will facilitate stabilization of the side slopes and will mitigate the effects of stormwater runoff on the soil cover at the site. Substantial storm events may continue to degrade the cover conditions even with the addition of vegetation.

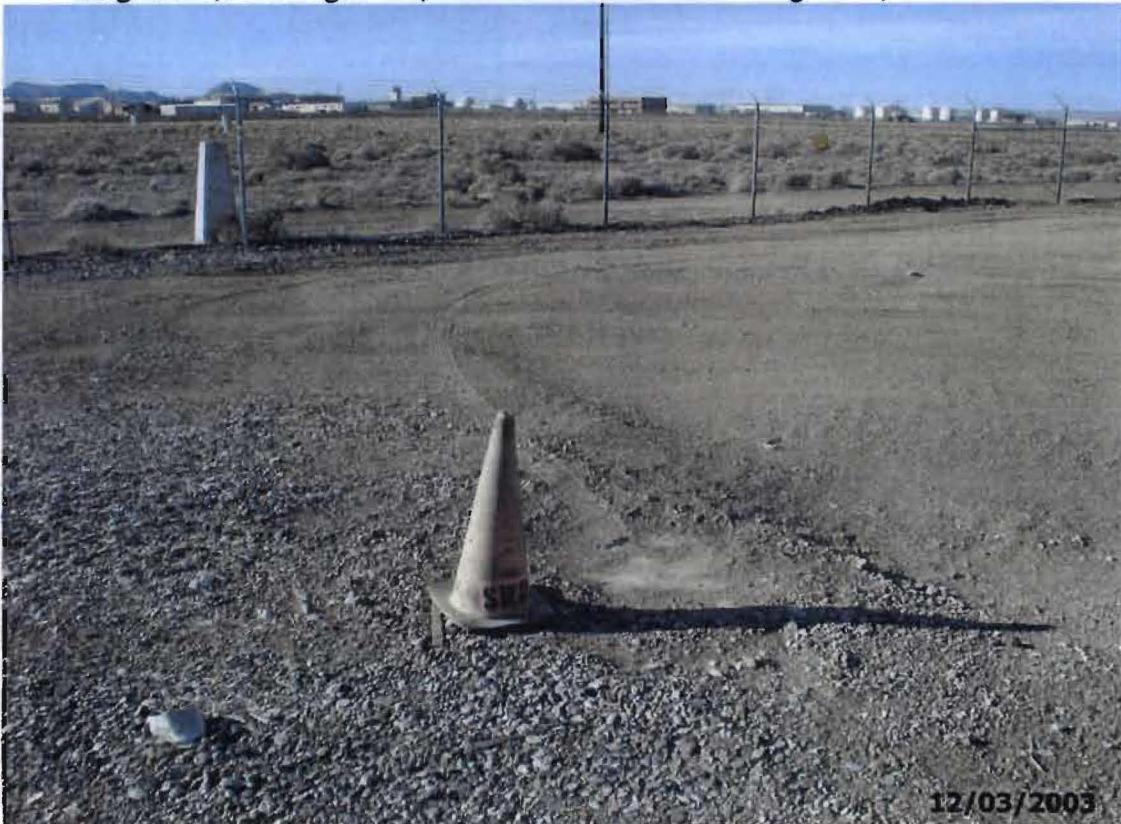
17. CAU 424 Area 3 Landfill Complexes Landfill Cell A3-3 (monument marked by orange cone), looking west (CAU 410 excavation in foreground)

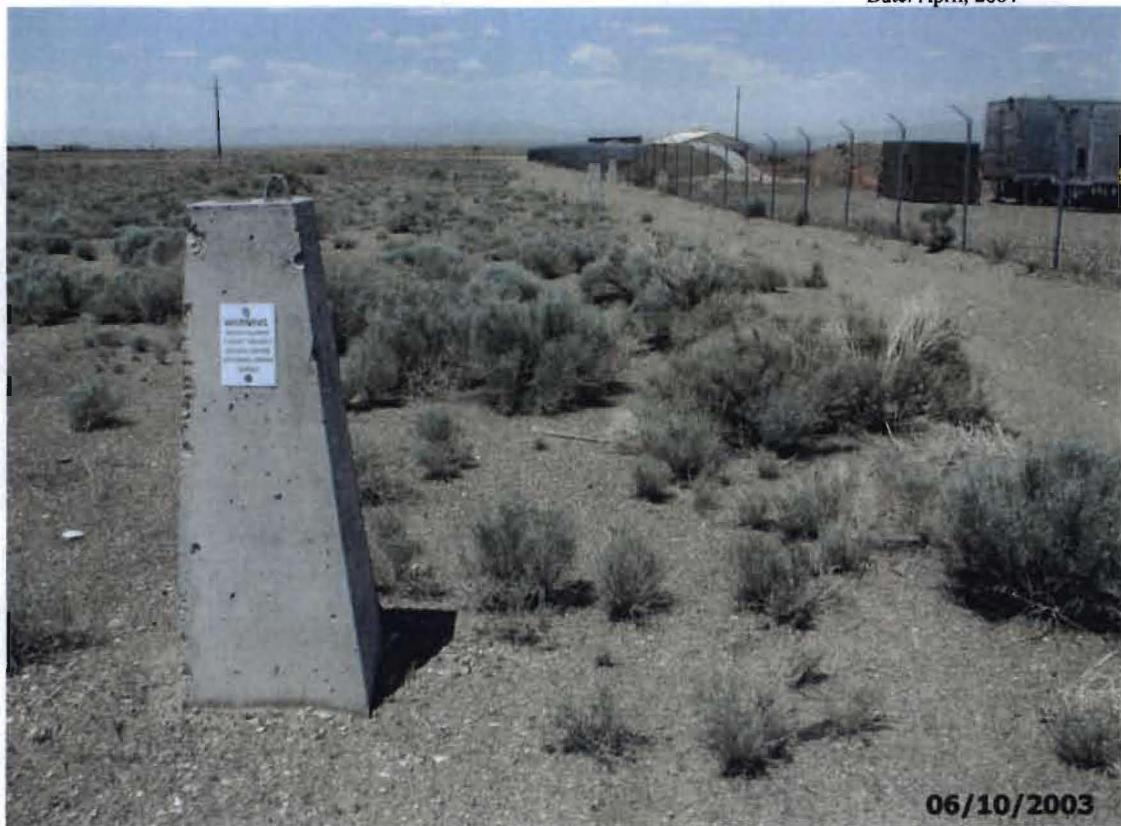
18. CAU 424 Area 3 Landfill Complexes Landfill Cell A3-3 (monument marked by orange cone), looking west (CAU 410 excavation repaired)

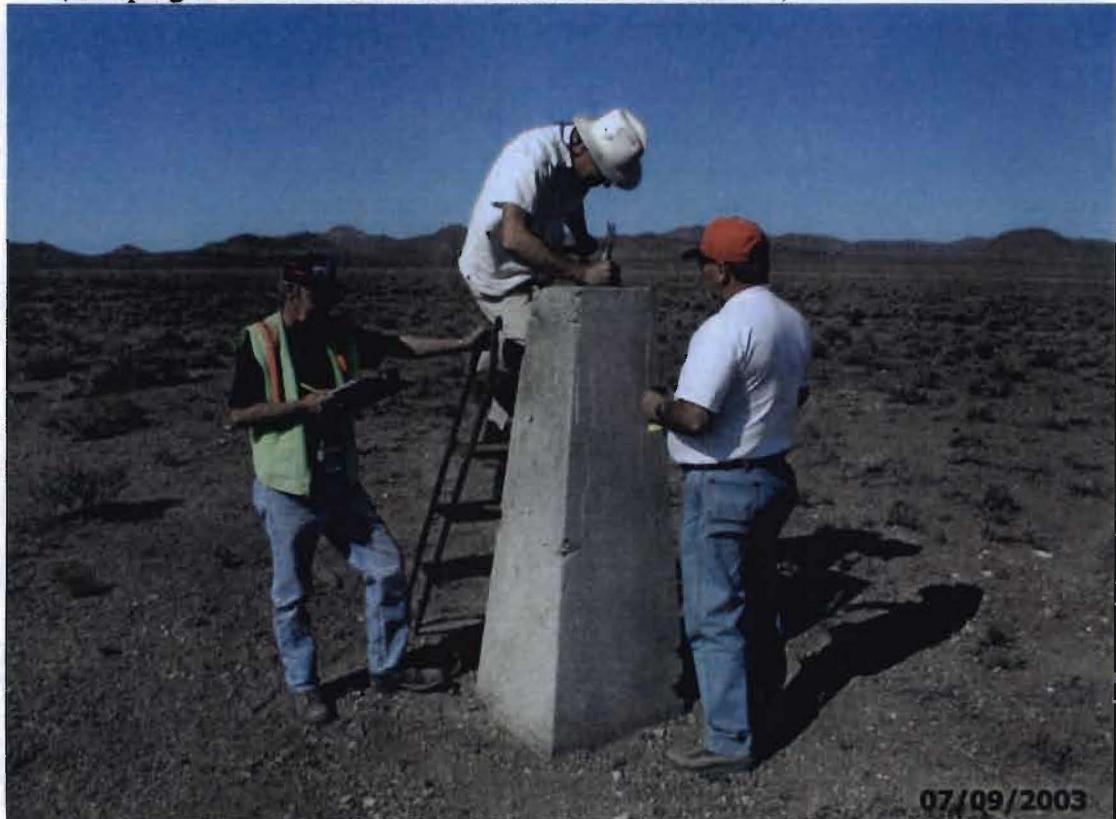
29. CAU 424 Area 3 Landfill Complexes Landfill Cell A3-3, July 2003 repairs
(stamping land-use restriction coordinates on monument)

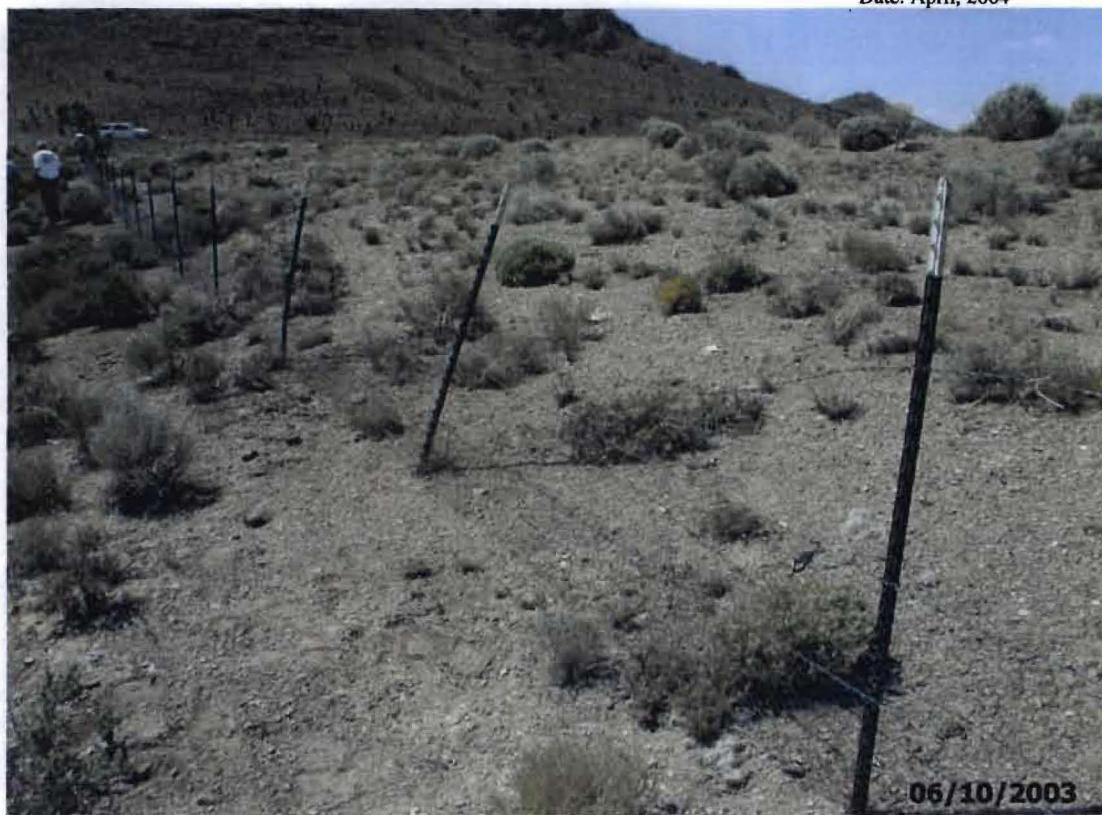
30. CAU 424 Area 3 Landfill Complexes Landfill Cell A3-4, July 2003 repairs
(stamping land-use restriction coordinates on monument)

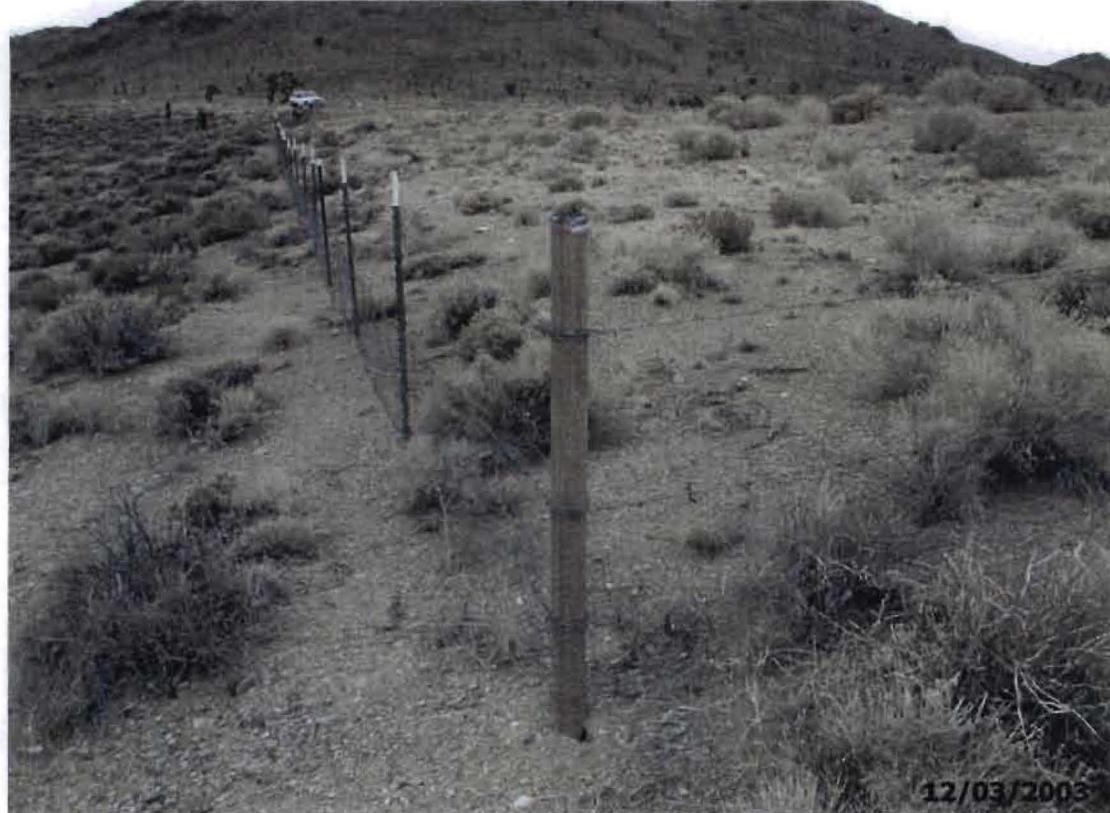
31. CAU 426 Cactus Spring Waste Trenches, looking northwest (damaged fencing)

Small burrows along the fence line were backfilled during the June and December 2003 inspections. On July 16, 2003, the two areas damaged on the south fence line by horses were

repaired. Repairs consisted of straightening several fence posts, replacing one fence post, and reattaching and tensioning fence wires and reattaching a warn sign to the fence post.
