Nevada
Environmental
Restoration
Project

DOE/NV--1274

Post-Closure Inspection Report for the Tonopah Test Range, Nevada

For Calendar Year 2007

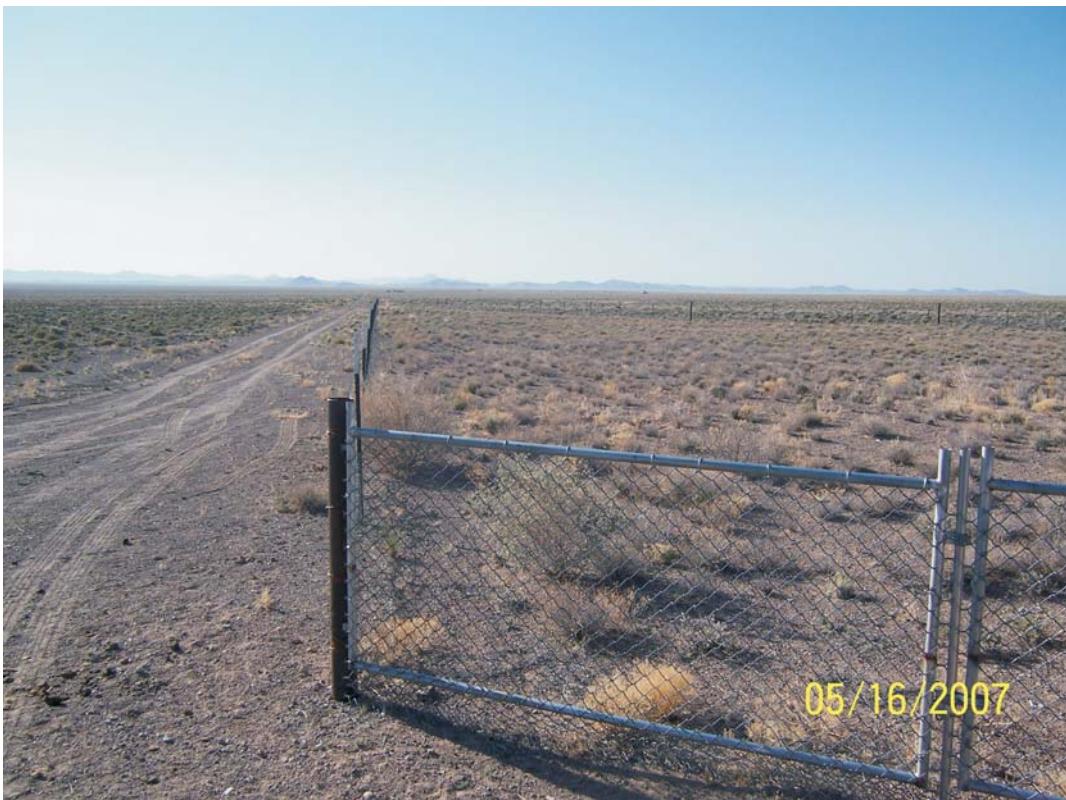
Photograph 1: CAU 400 Bomblet Pit, looking south, 05/16/2007

Bomblet Pit (CAS TA-55-001-TAB2, Ordnance Disposal Pit): The Bomblet Pit is presented in Figure 2 of Attachment A. The annual inspection was conducted on May 15, 2007. The cover vegetation was healthy, well established, and similar to the surrounding area outside the fence. The fence, signs, and cover were in good condition. No issues or concerns were observed.

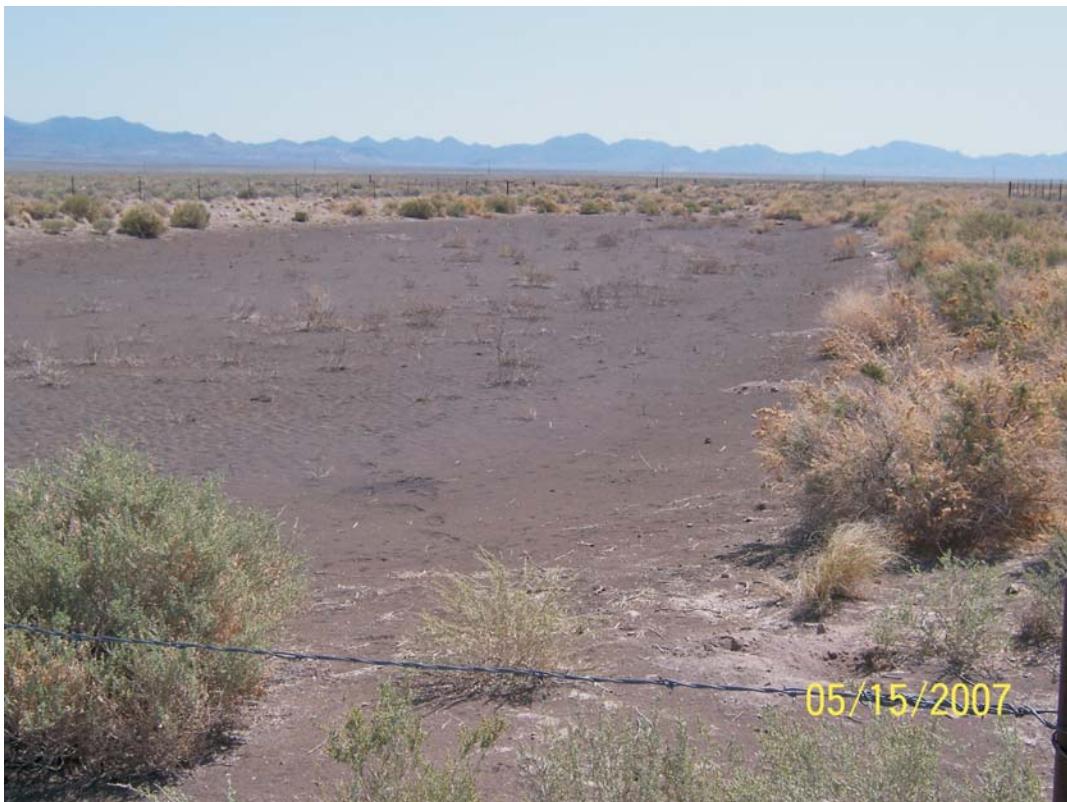
Photograph 3: CAU 400 Five Points Landfill, looking east, 05/15/2007

Five Points Landfill (CAS TA-19-001-05PT, Ordnance Disposal Pit): The Five Points Landfill is presented in Figure 3 of Attachment A. The annual inspection was conducted on May 15, 2007. All signs and fencing were in good condition. The cover vegetation appeared normal, and the vegetation located on the area that was flooded in 2003 and 2006 was showing signs of regrowth. No issues or concerns were observed.

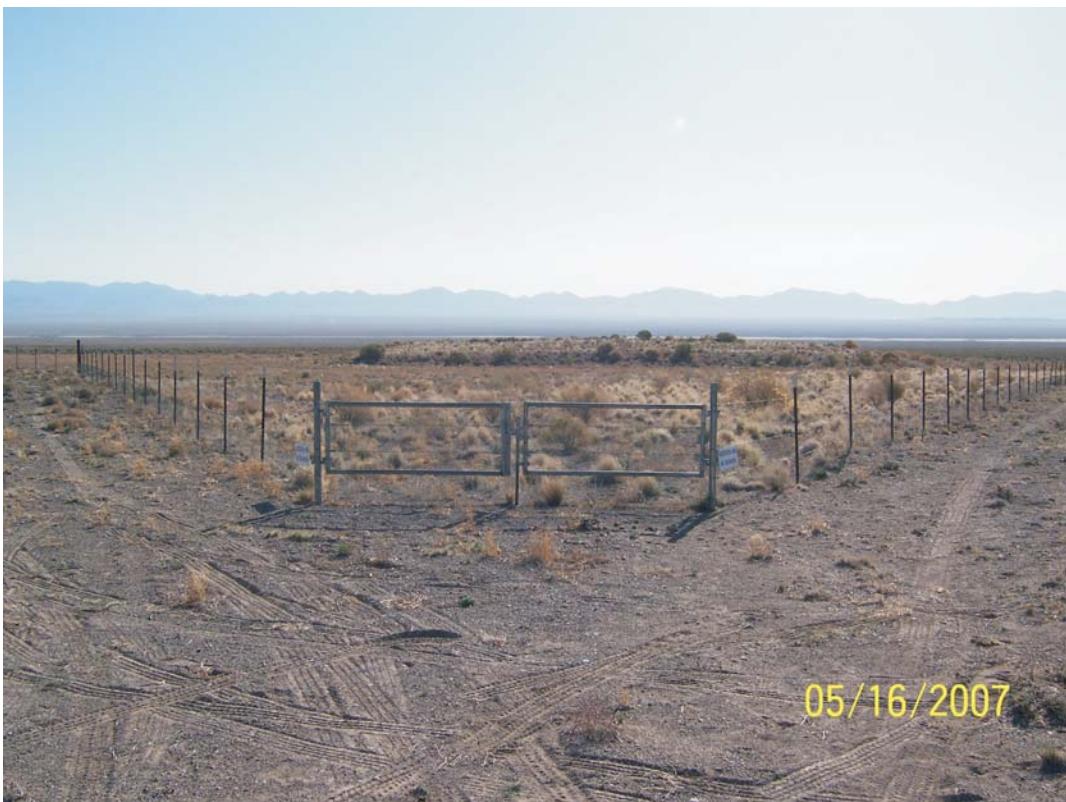
Photograph 5: CAU 404, looking east, 05/16/2007

The annual inspection was conducted on May 15, 2007. This site was in good condition. No damage was noted to the fencing, signs, or cover. The vegetation was healthy and well established. No issues or concerns were observed.

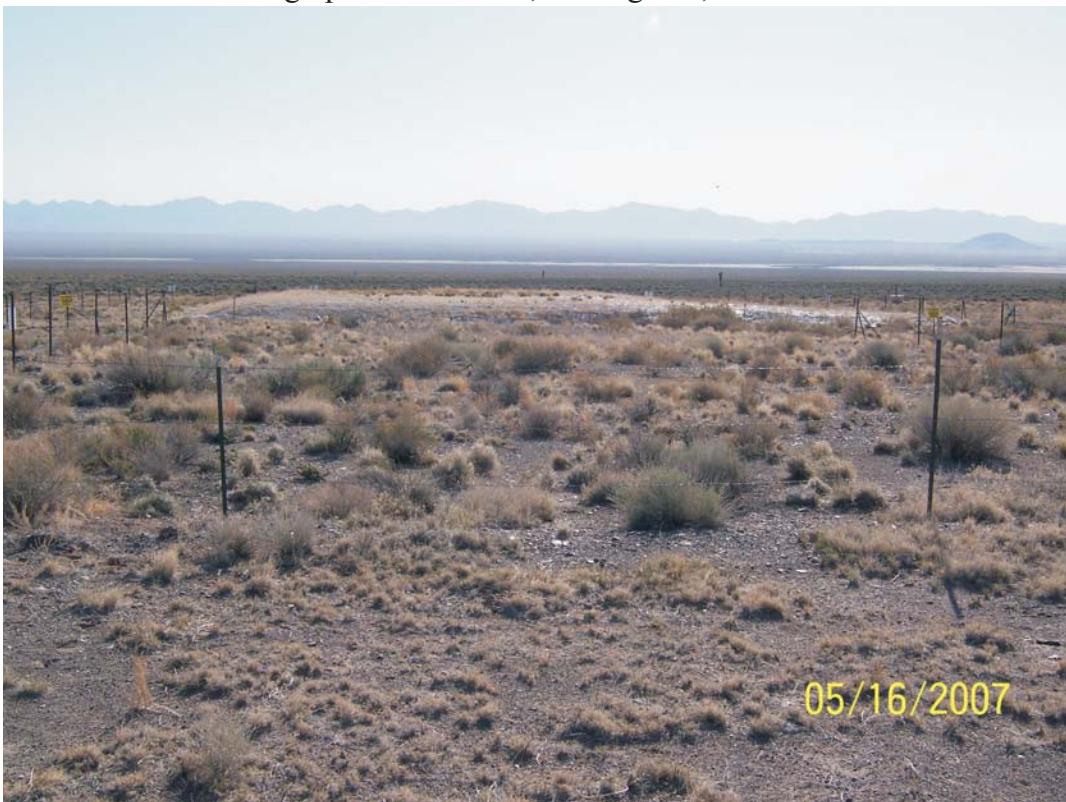
Photograph 6: CAU 407, looking east, 05/16/2007

The annual inspection was conducted on May 15, 2007. The inspection indicated the cover, fence, and warning signs were in good condition. No issues or concerns were observed.

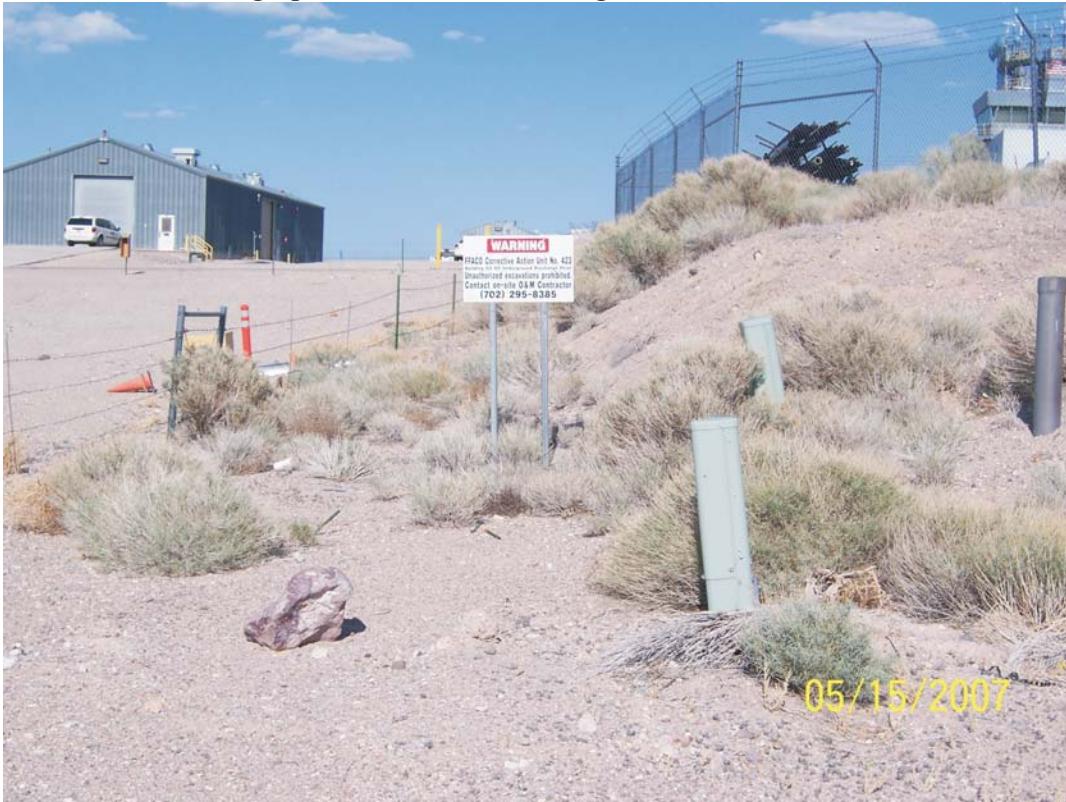
Photograph 8: CAU 423, looking east, 05/15/2007

The annual inspection was conducted on May 15, 2007. The warning sign and at-grade monument were in good condition. No issues or concerns were observed.

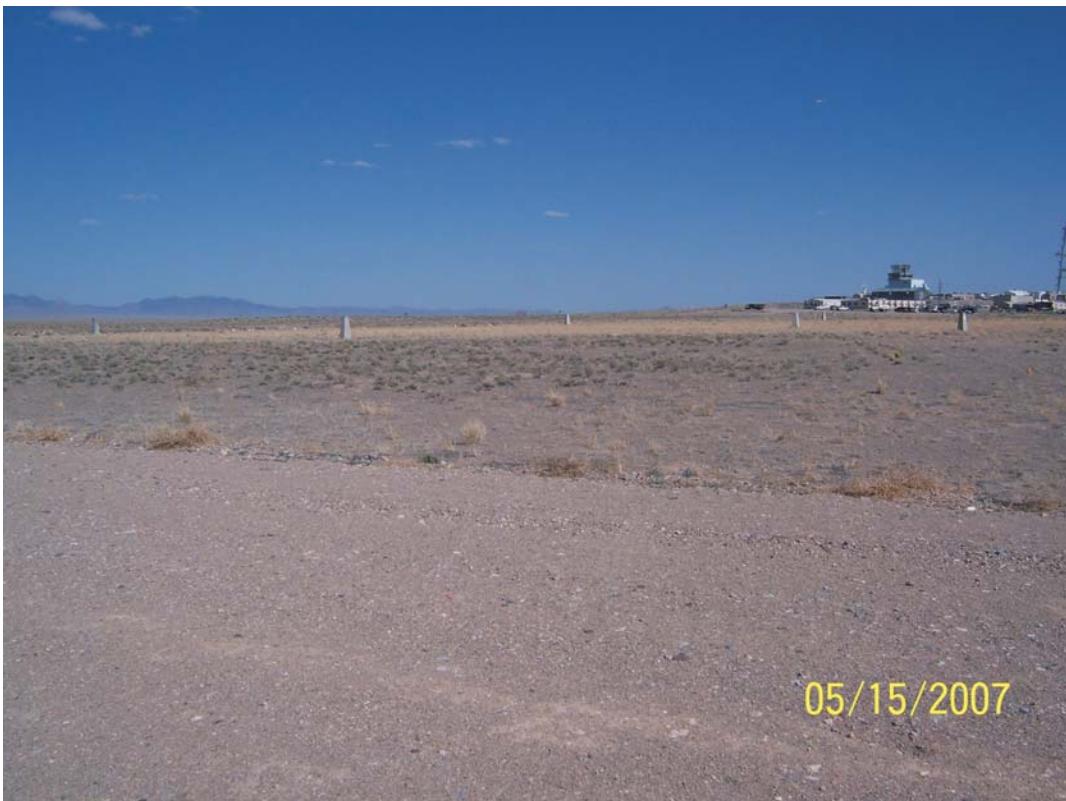
Photograph 9: CAU 424, Landfill Cell A3-1, looking southeast 05/15/2007

Landfill Cell A3-1 (CAS 03-08-001-A301): Landfill Cell A3-1 is located at the north end of CAU 424 and is the largest of the landfill cells. The cover and seven above-grade concrete monuments that demarcate the landfill cell were examined. All signs, survey markers, and monuments were in good condition. Vegetation is established throughout the site, and no cracking, erosion, or subsidence of the cover was noted. No issues or concerns were observed.

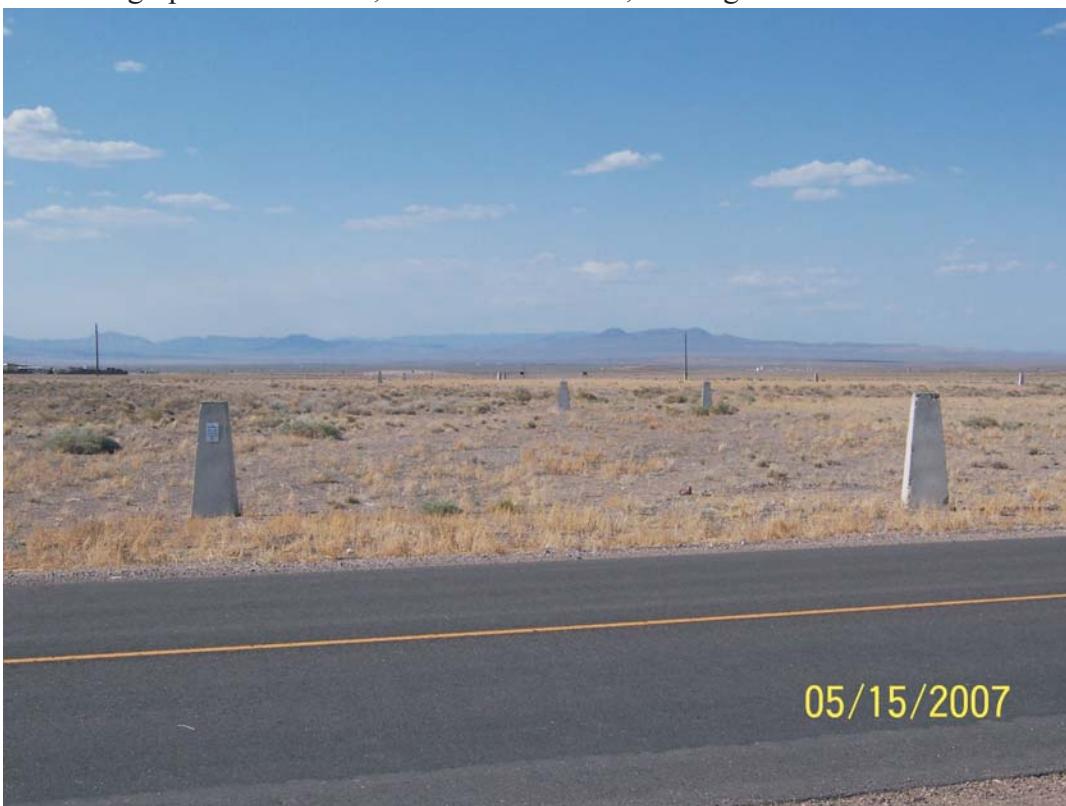
Photograph 10: CAU 424, Landfill Cell A3-2, looking north, 05/15/2007

Landfill Cell A3-2 (CAS 03-08-002-A302): Landfill Cell A3-2 is located due south of Landfill Cell A3-1. The overall condition of the unit was good. All four above-grade monuments and the landfill cover were examined and found to be in good condition. All signs and brass survey markers were legible and intact. No signs of erosion, subsidence, or evidence of unauthorized use were noted. No issues or concerns were observed.

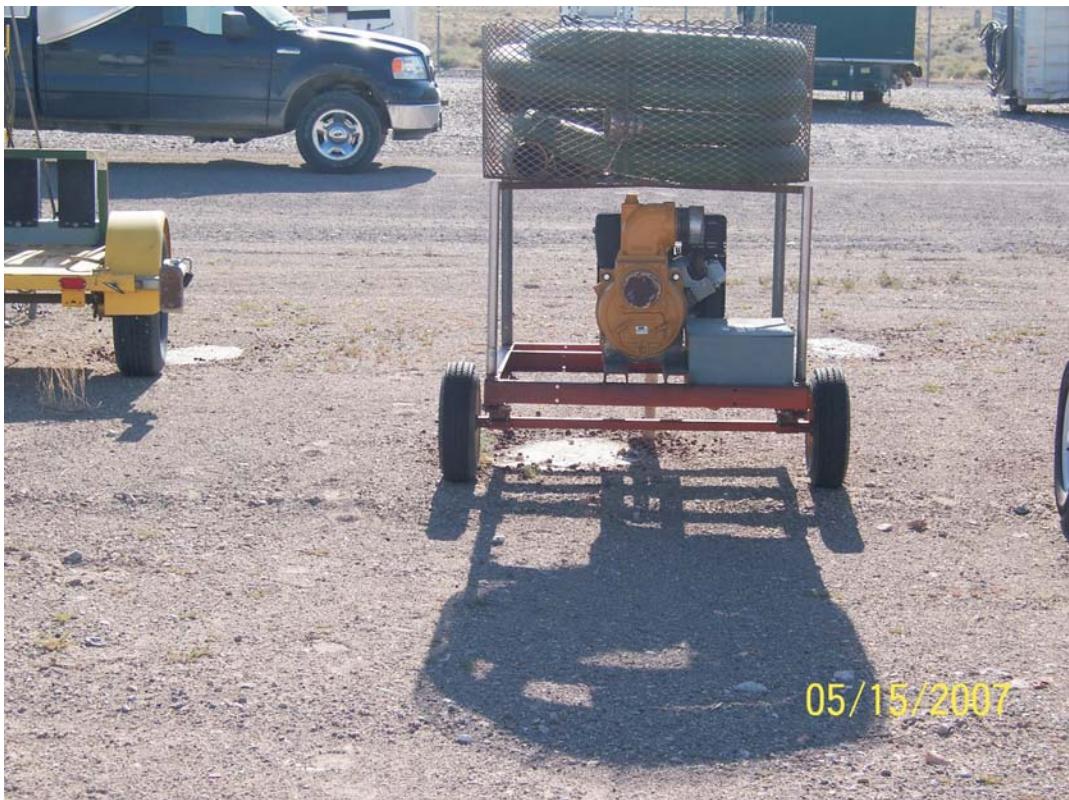
Photograph 11: CAU 424, Landfill Cell A3-3, looking west, 05/15/2007

Landfill Cell A3-3 (CAS 03-08-002-A303): Landfill Cell A3-3 straddles the western fence of the TTR Area 3 Compound, with the portion of the landfill outside the fence marked by three above-grade monuments, and the portion inside the fence marked by three at-grade monuments. The overall condition of the site was good. All six monuments were located and inspected. All monuments, brass survey markers, and warning signs were in good condition. No subsidence, cracking, or erosion was noted. No issues or concerns were observed.

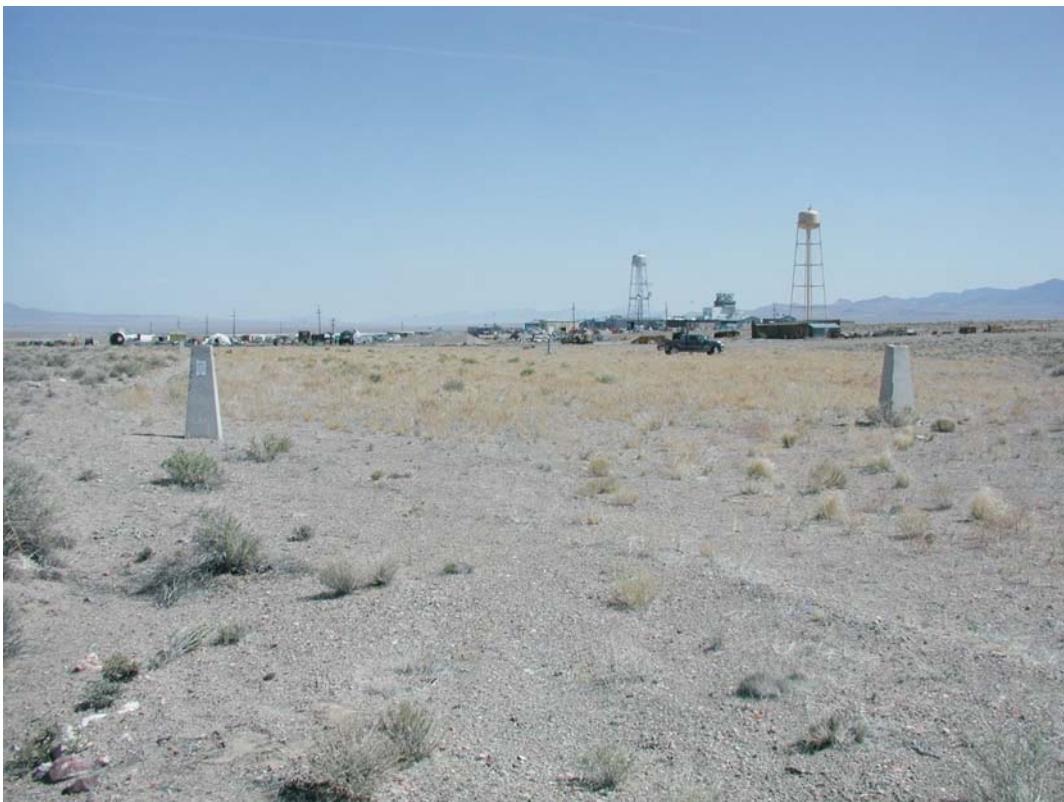
Photograph 13: CAU 424, Landfill Cell A3-4, looking north, 05/16/2007

Landfill Cell A3-4 (CAS 03-08-002-A304): Landfill Cell A3-4 is located south of Dykes Drive at the south end of the CAU. The overall condition of the site was good, and vegetation was established throughout the site. Five above-grade monuments and one at-grade brass survey marker were located and inspected. All monuments, the brass survey marker, and warning signs were in good condition. No issues or concerns were observed.

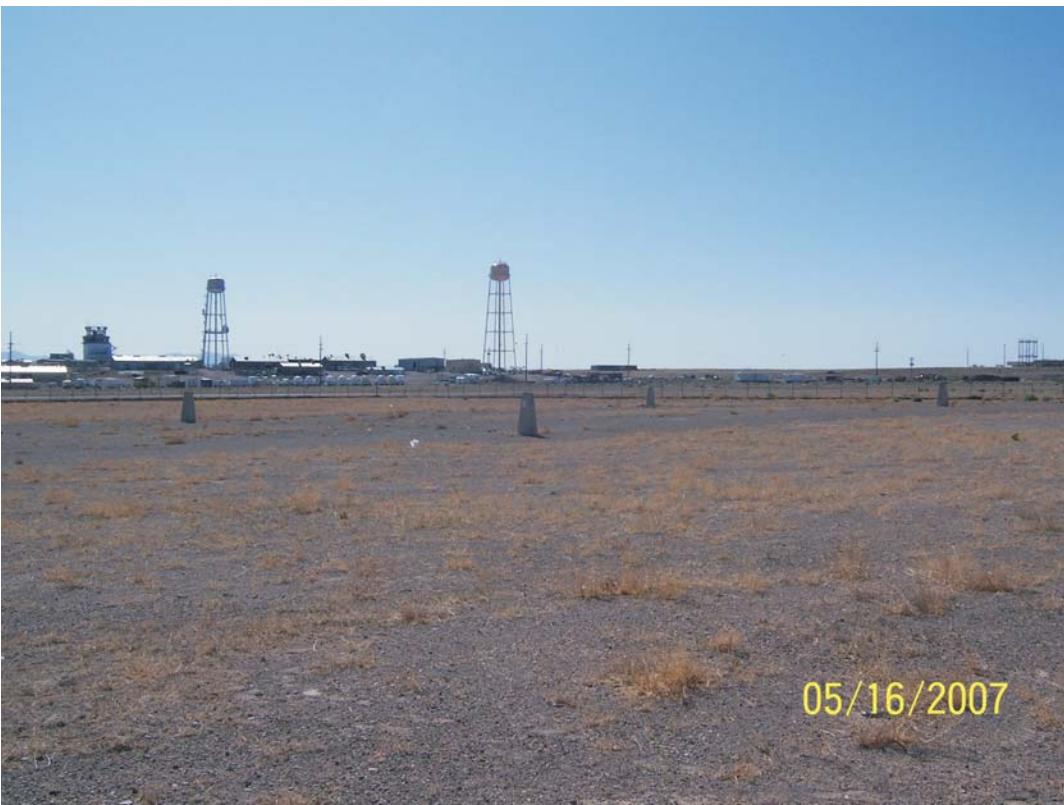
Photograph 14: CAU 424, Landfill Cell A3-5, looking southeast, 05/16/2007

Landfill Cell A3-5 (CAS 03-08-002-A305): Landfill Cell A3-5 is located west of Moody Avenue inside a fenced area in Area 10 south of the Air Force First-Aid Station. All four above-grade monuments and attached warning signs and brass survey markers were located and found to be in good condition. No evidence of subsidence, cracking, or erosion was noted, and sparse vegetation was present. The overall condition of the site was good. No issues or concerns were observed.

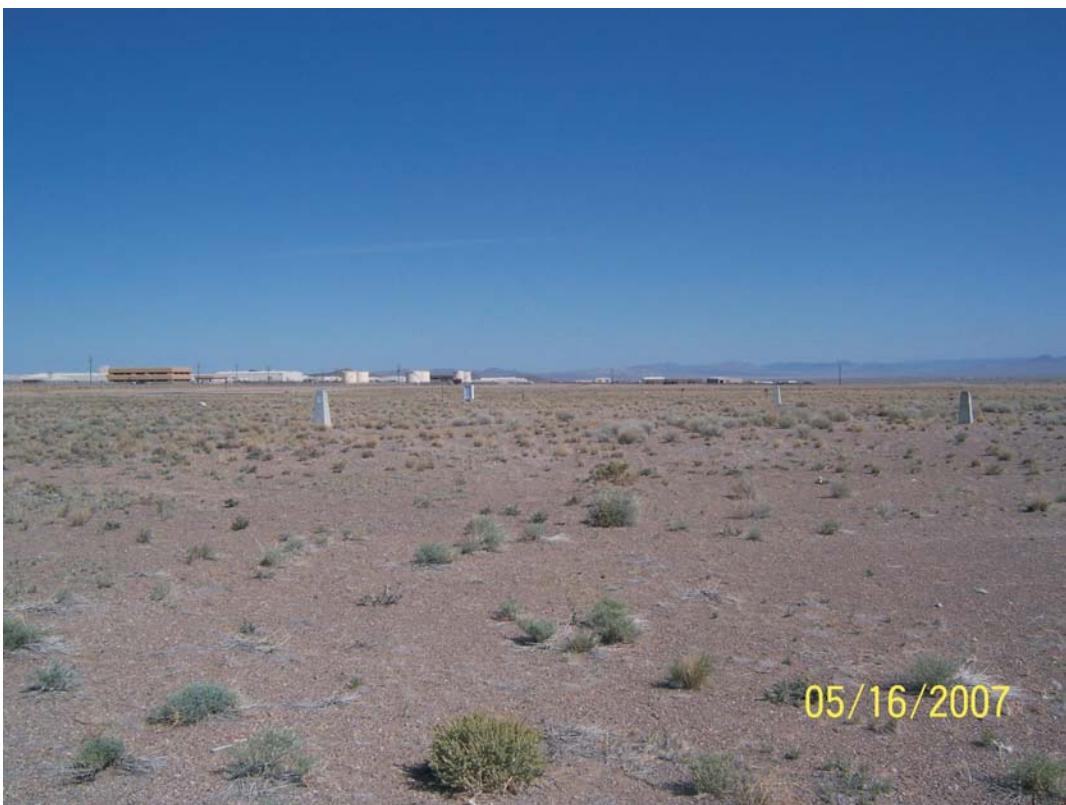
Photograph 15: CAU 424, Landfill Cell A3-6, looking northwest, 05/16/2007

Landfill Cell A3-6 (CAS 03-08-002-A306): Landfill Cell A3-6 is located immediately west and outside of the fence of the TTR Area 3 Compound. All four above-grade monuments and attached warning signs and brass survey markers were located and found to be in good condition. The overall condition of the landfill cover was good. No evidence of subsidence, cracking, or erosion was noted. No issues or concerns were observed.

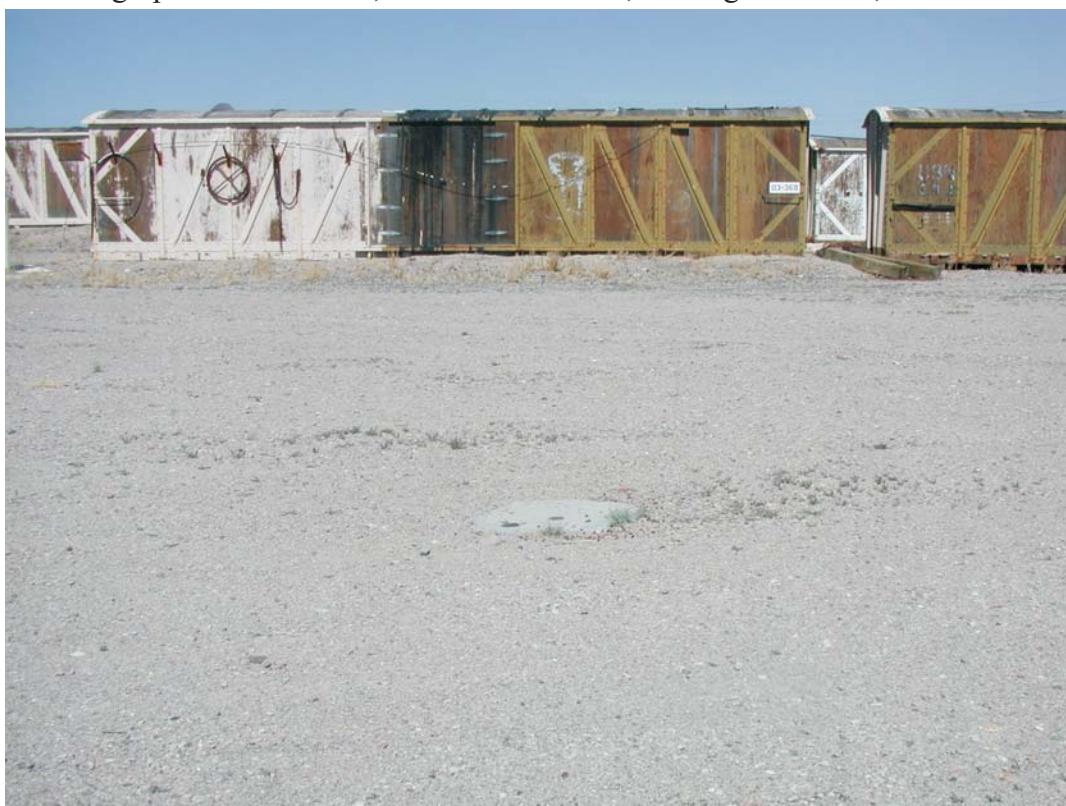
Photograph 16: CAU 424, Landfill Cell A3-8, looking west, 05/16/2007

Landfill Cell A3-8 (CAS 03-08-002-A308): Landfill Cell A3-8 is located southwest of the Area 3 Compound in the boxcar storage yard. Three of the four at-grade brass markers were located and determined to be in good condition. The southwest corner monument was not located due to its location in a posted radioactive materials area and the presence of surface debris. There was no indication that the debris was impacting the condition of the monument. The monument will be examined in future inspections when the surface debris is removed. No erosion, subsidence, or evidence of unauthorized use was noted at the site. The overall condition of the cover was good. No issues or concerns were observed.

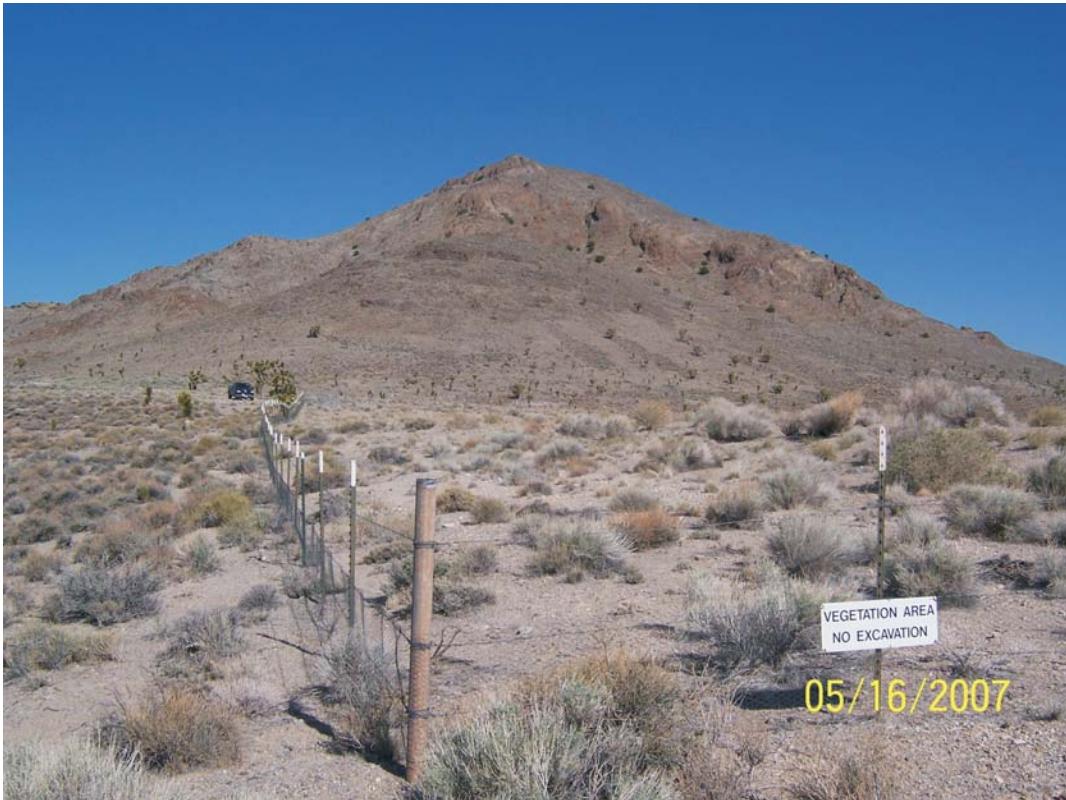
Photograph 17: CAU 426, looking west 05/16/2007

The annual inspection was conducted on May 15, 2007. The fence perimeter was walked, and the site was found to be in good condition. No erosion, subsidence, or evidence of unauthorized use was noted. Vegetation was well established and healthy throughout the site. No issues or concerns were observed.

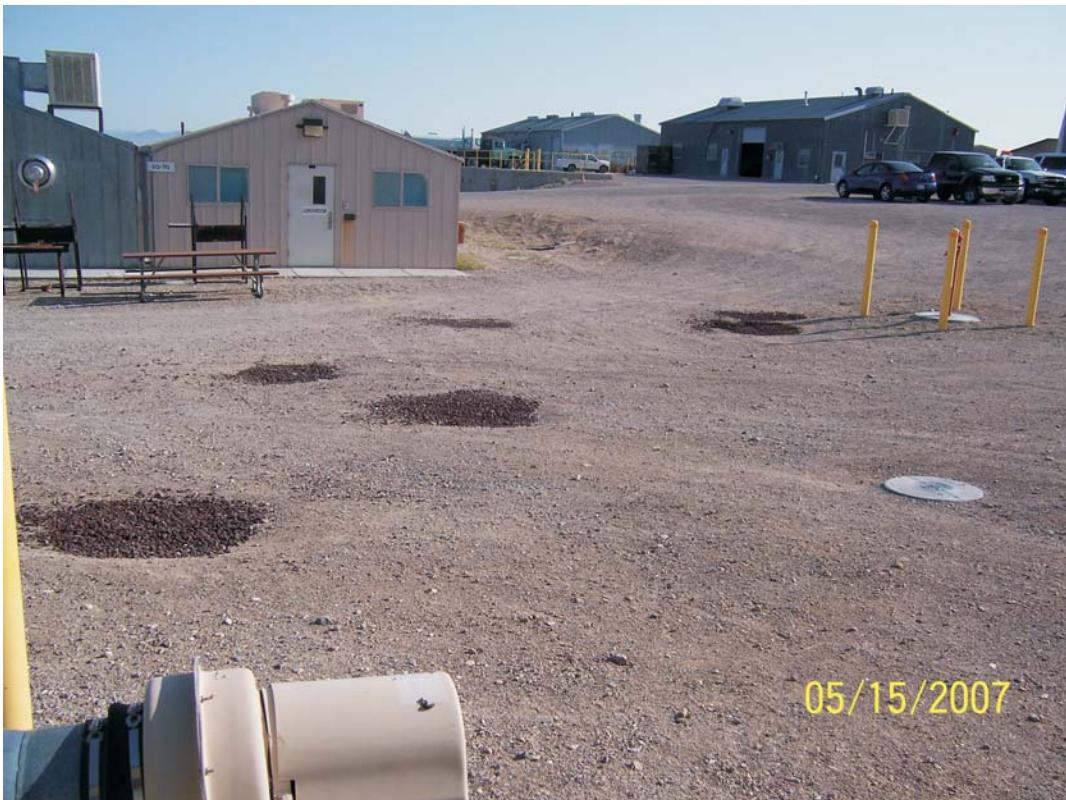
Photograph 18: CAU 427, looking north, 05/15/2007

The annual inspection was conducted on May 15, 2007. All 21 subsurface metal markers, including four markers at Leachfield A, four markers at Leachfield B, four markers at the Abandoned Leachfield, four markers at the Pre-1965 Leachfield, and five markers at Septic Tank 33-5, were located. The five warning signs were intact, in place, and legible. The site was observed to be in good condition, and no maintenance or repairs were recommended. No issues or concerns were observed.

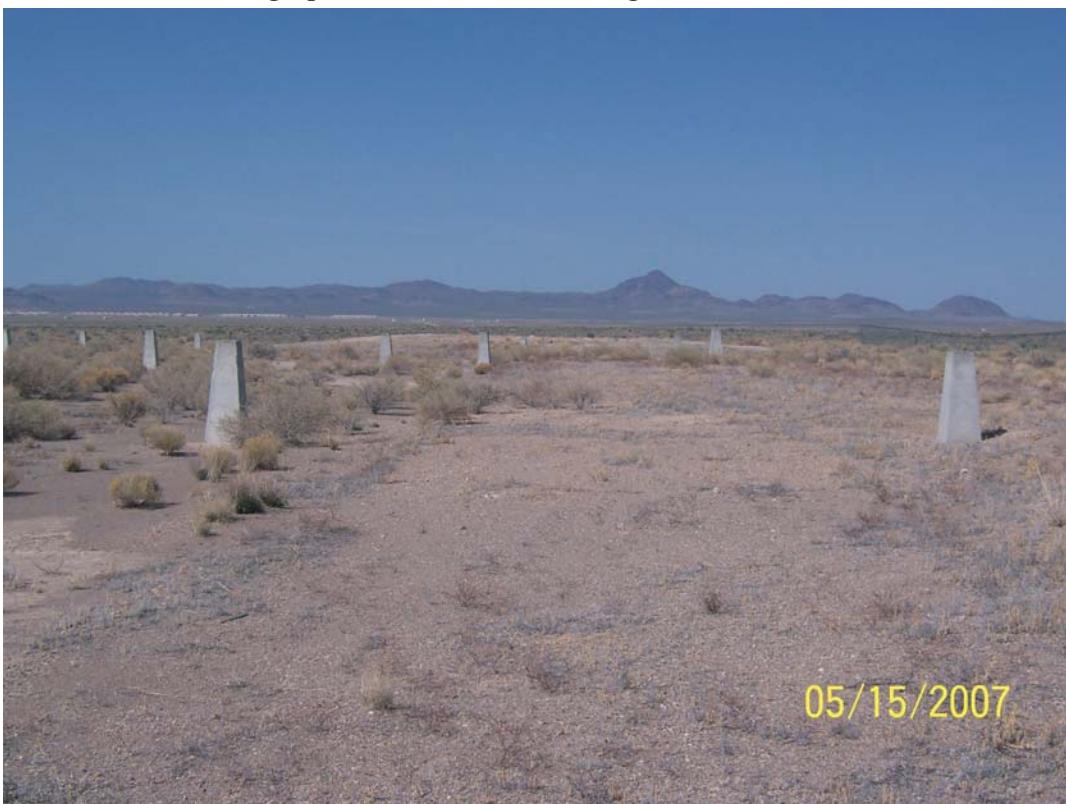
Photograph 20: CAU 453, looking west, 05/15/2007

The annual inspection was conducted on May 15, 2007. The fence, signs, 16 aboveground monuments, and covers were all in excellent condition. There was evidence of animal burrowing at the site that required follow-up action.

Animal burrows observed during the annual inspection were backfilled on August 1, 2007.

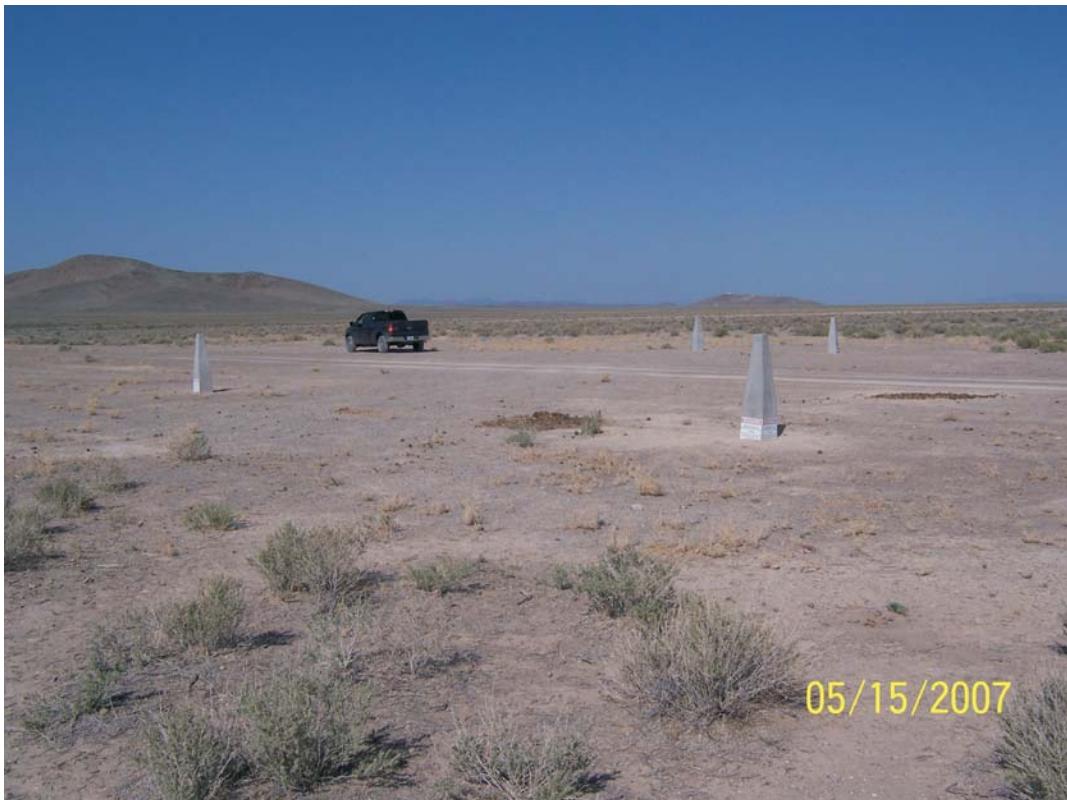
Photograph 21: CAU 487, A-8 anomaly, looking north 05/15/2007

The annual inspection was conducted on May 15, 2007. All warning signs were in place, intact, and legible. No issues or concerns were observed.
