Nevada
Environmental
Restoration
Project

DOE/NV--1315

Post-Closure Inspection Report for the Tonopah Test Range, Nevada

For Calendar Year 2008

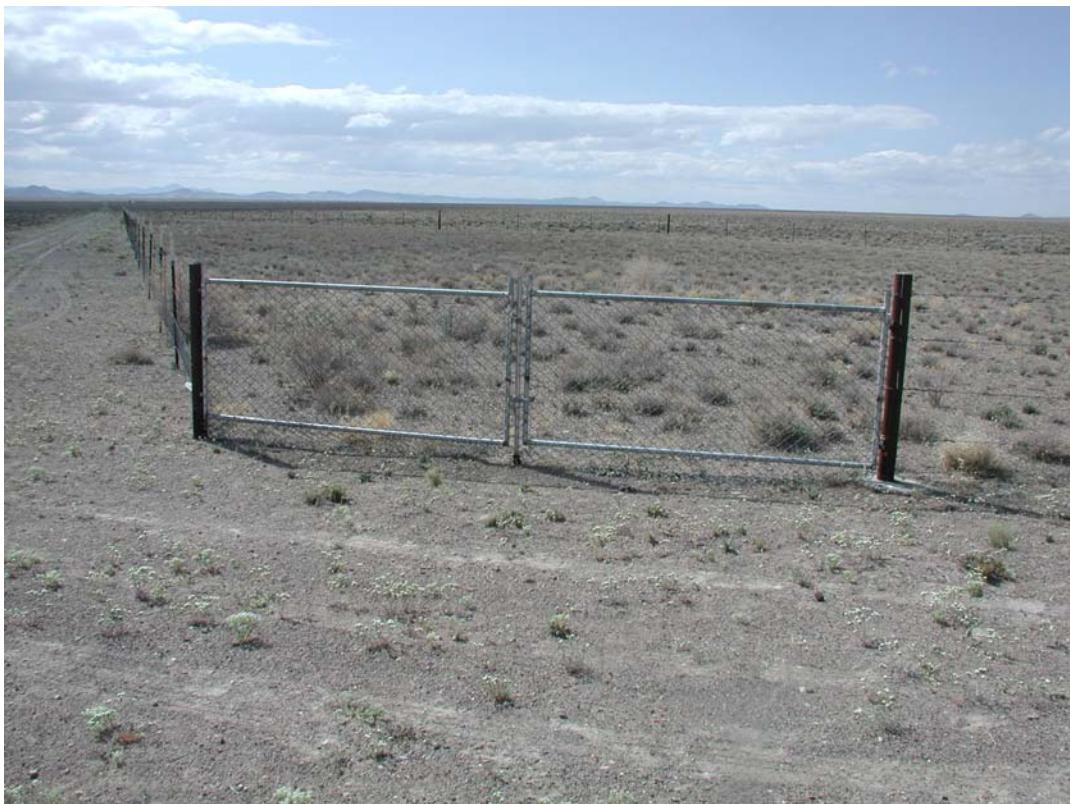
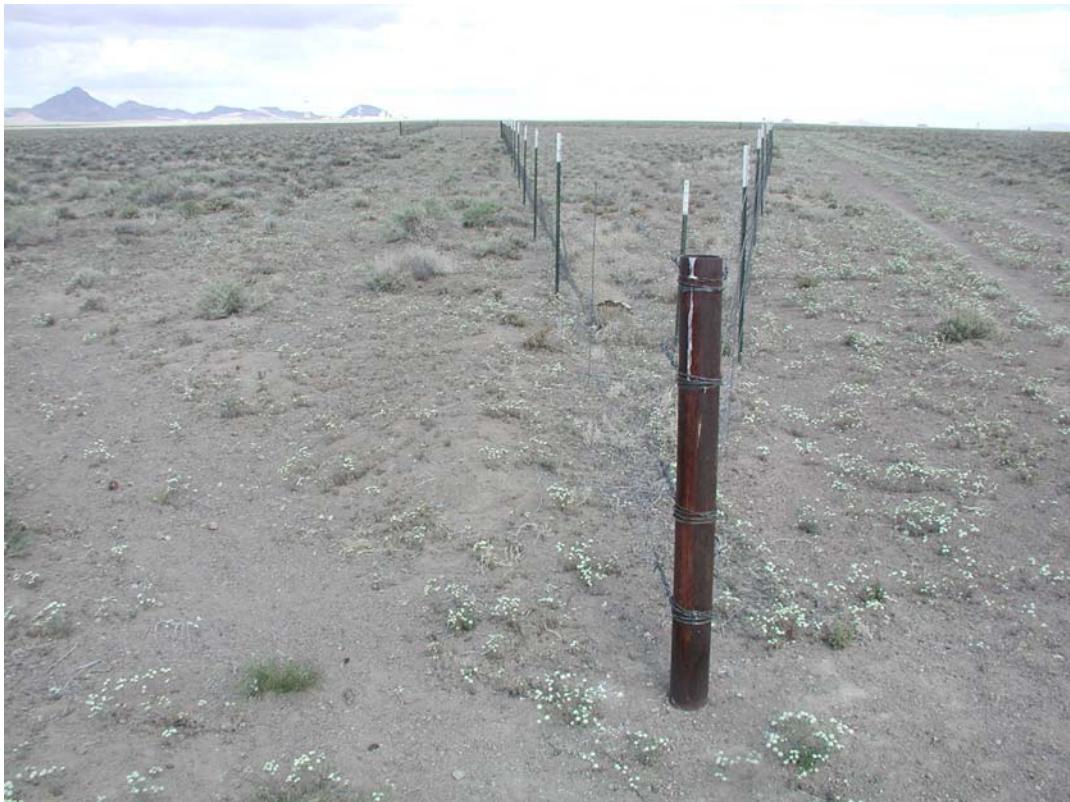
Bomblet Pit (CAS TA-55-001-TAB2, Ordnance Disposal Pit): The Bomblet Pit is presented in Figure 2 of Attachment A. The annual inspection was conducted on May 21, 2008. The fence, signs, and cover were in good condition. As for cover vegetation, the goals of revegetation have been accomplished at the CAU 400 Bomblet Pit site. Native species are established and contribute significantly to overall plant cover and density. Revegetation success standards have been exceeded. No issues or concerns were noted.

Photograph 1: CAU 400 Bomblet Pit, looking south, 05/21/2008

Photograph 2: CAU 400 Bomblet Pit, looking northwest, 05/21/2008

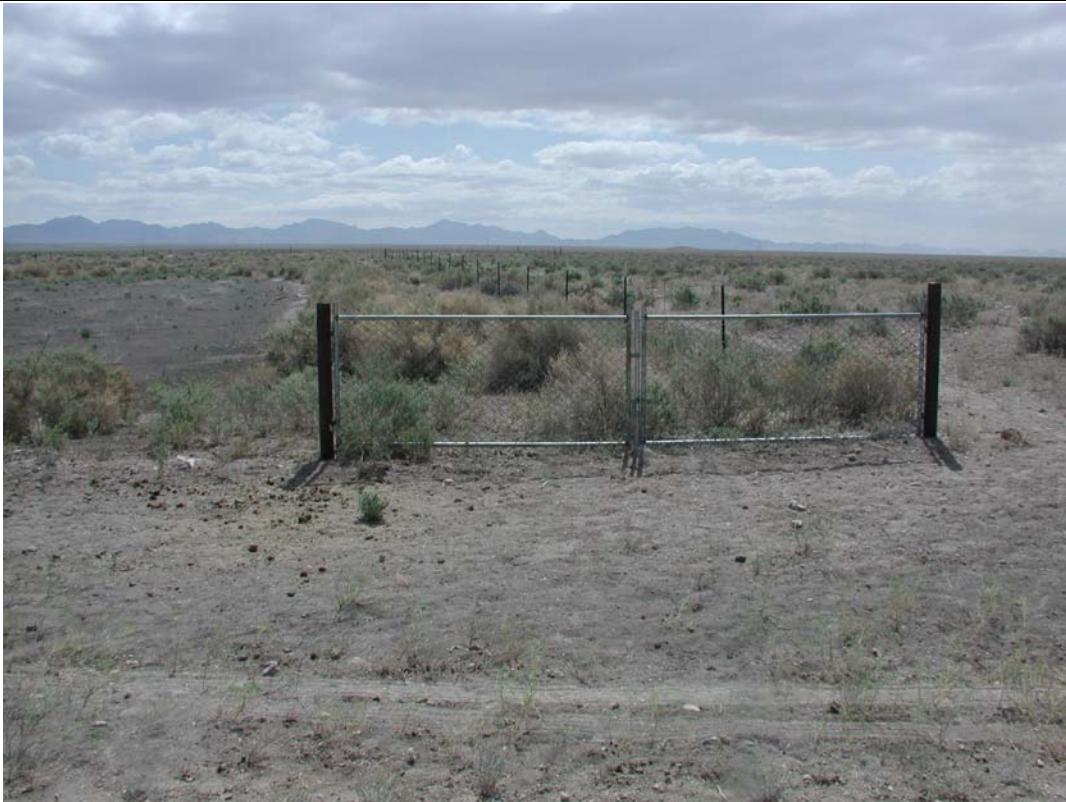
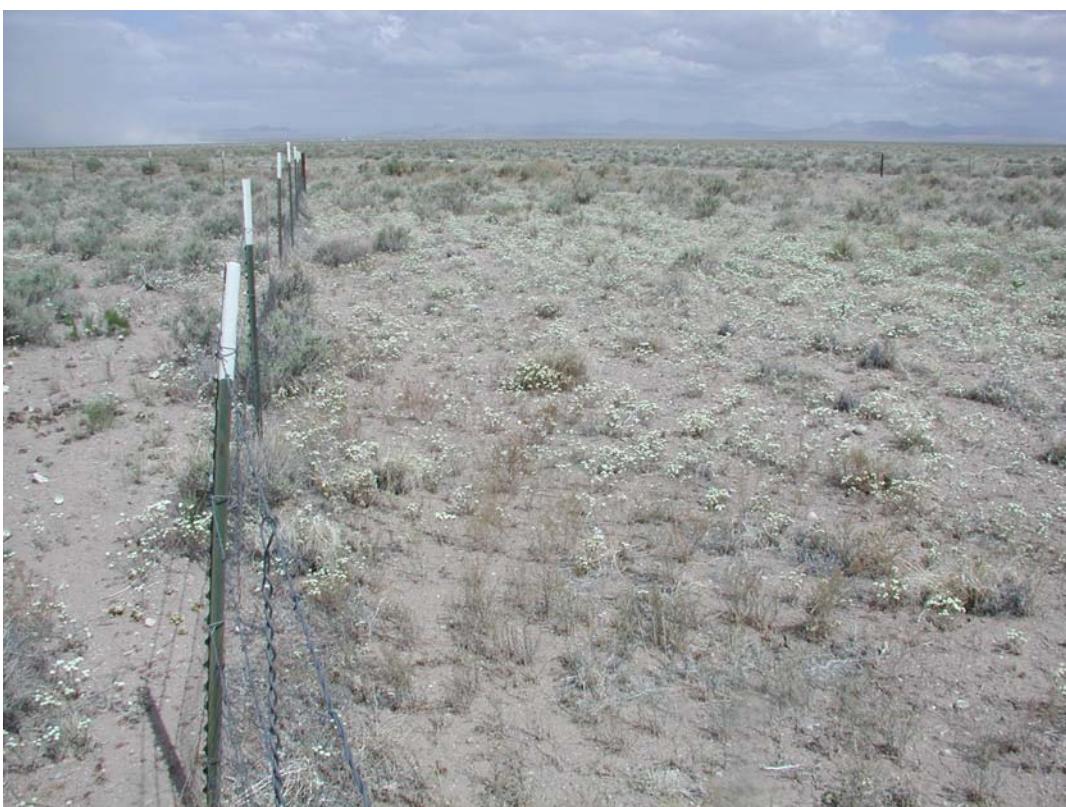
Five Points Landfill (CAS TA-19-001-05PT, Ordnance Disposal Pit): The Five Points Landfill is presented in Figure 3 of Attachment A. The annual inspection was conducted on May 21, 2008. All signs and fencing were in good condition. The cover vegetation appeared normal and healthy in the area that had not previously been flooded, and this area has met the standard for revegetation. The vegetation located on the area that was flooded in 2003 and 2006 does not support a viable native plant community at this time; however, both shrubs and grasses are again establishing in this area. No issues or concerns were noted.

Photograph 3: CAU 400 Five Points Landfill, looking east, 05/21/2008

Photograph 4: CAU 400 Five Points Landfill, looking northwest, 05/21/2008

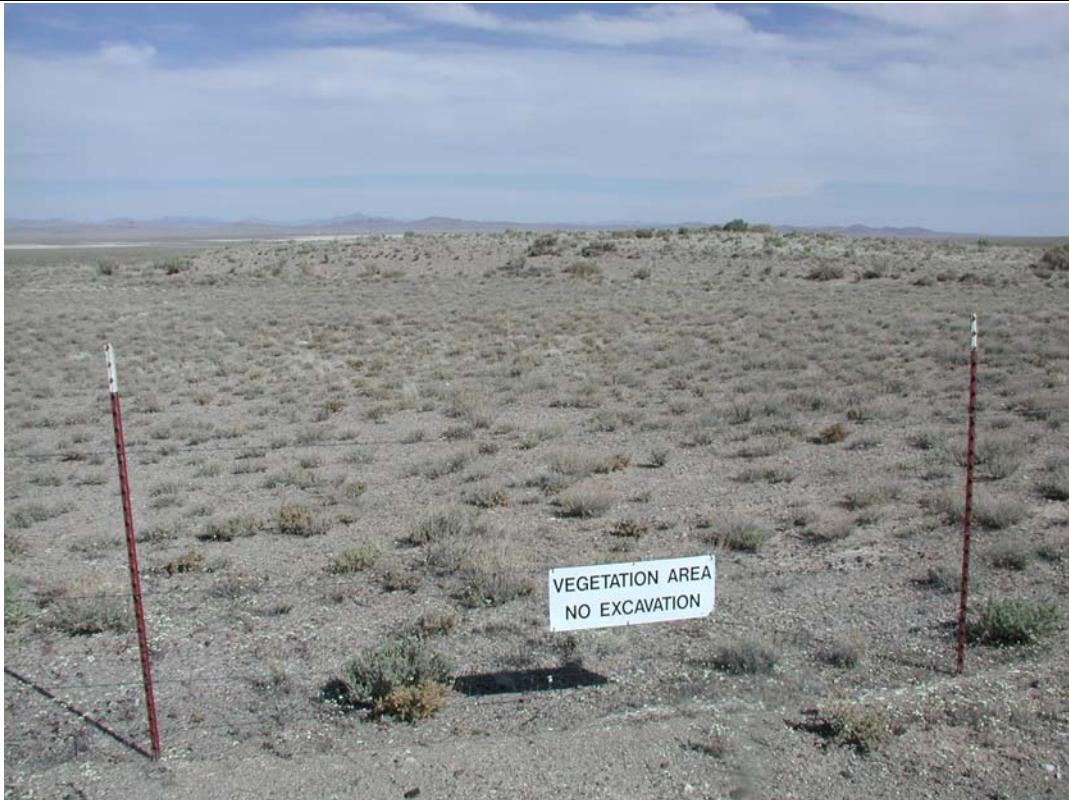
Photograph 5: CAU 404, looking east, 05/20/2008

The annual inspection was conducted on May 20, 2008. This site was in good condition. No damage was noted to the fencing, signs, or cover. Revegetation success standards have been exceeded. The vegetation was healthy and well established. Native species are established and contribute significantly to plant cover and density. Because the density of grasses is greater than in the surrounding areas, removal of the fence could create a grazing issue; if the fence is removed, then vegetation monitoring should continue. No issues or concerns were noted.

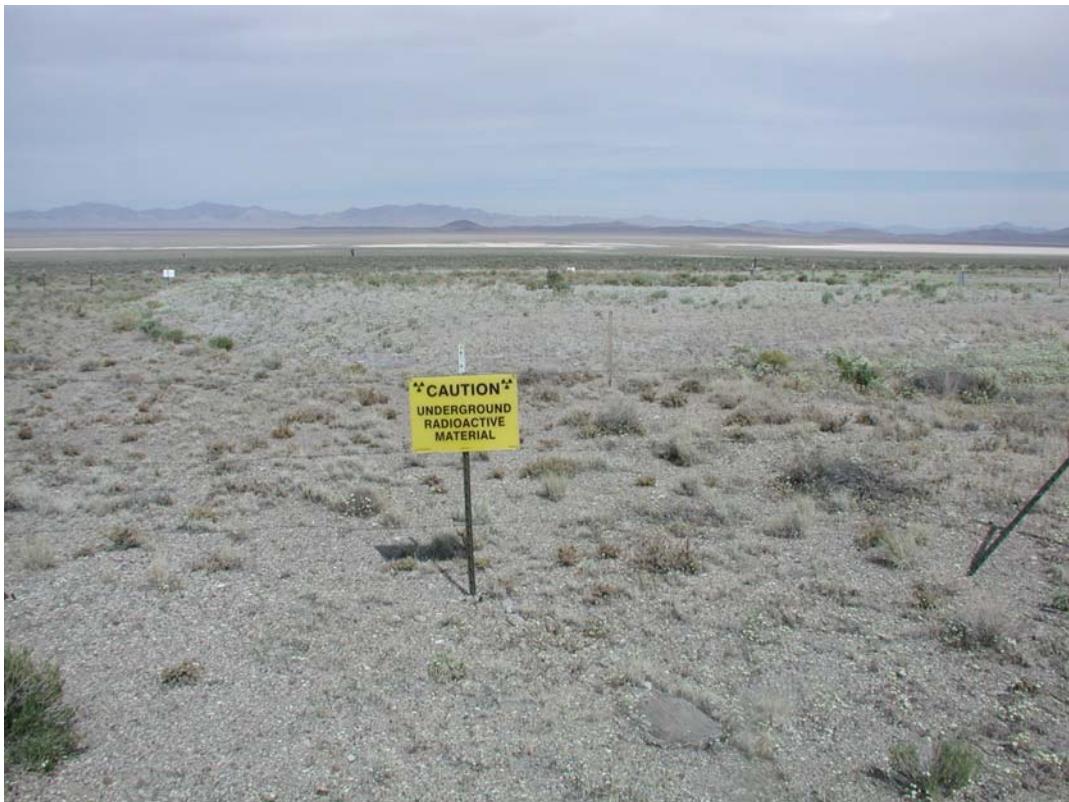
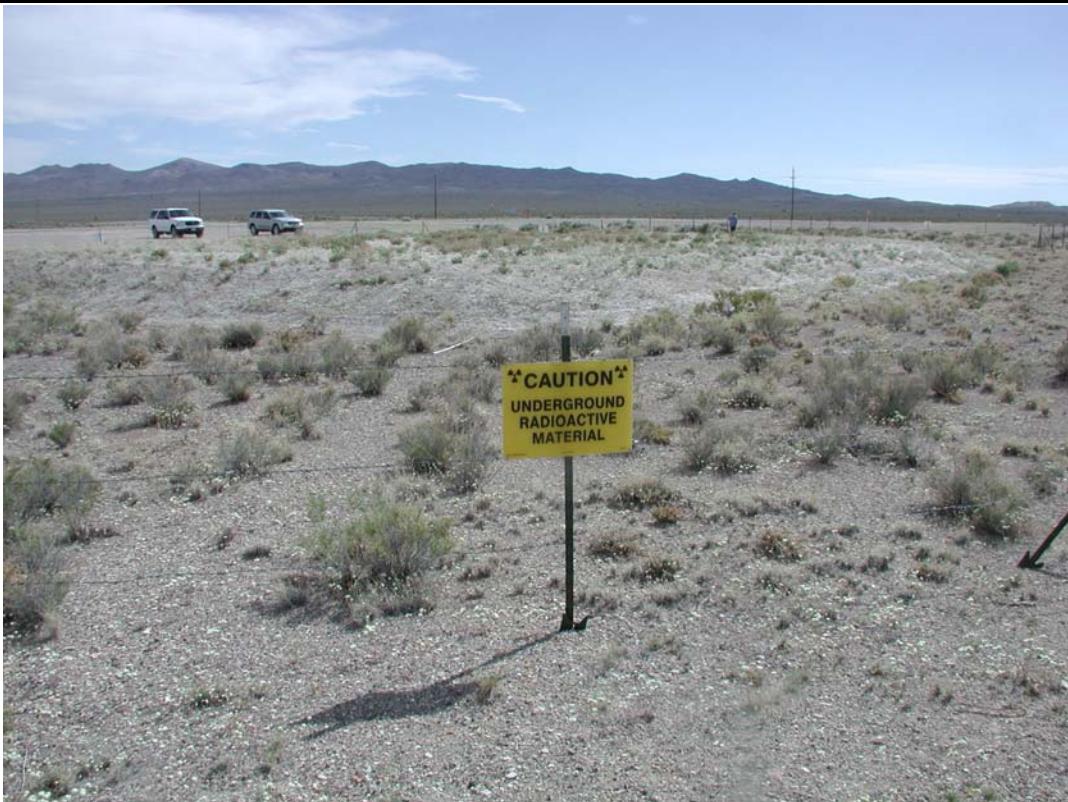
The annual inspection was conducted on May 20, 2008. The fence was erect and stable, but some of the strands of barbed wire were loose and were recommended to be tightened as a best management practice. All warning signs were in good condition. The cover was in good condition with the exception of some small animal burrows on the side slope of the waste unit cover. These were determined to not be significant and do not require remedial action at this time. Vegetation is becoming established on the cover. Plant density on the site is higher than on the reference area, even after substantial declines in plant density over the last four years. There is no evidence that water moving off the cover is creating erosion gullies.

Photograph 6: CAU 407, looking east, 05/20/2008

Photograph 7: CAU 407, looking southwest, 05/20/2008

Loose barbed wire on the south and northwest corner fence was tightened on July 10, 2008.

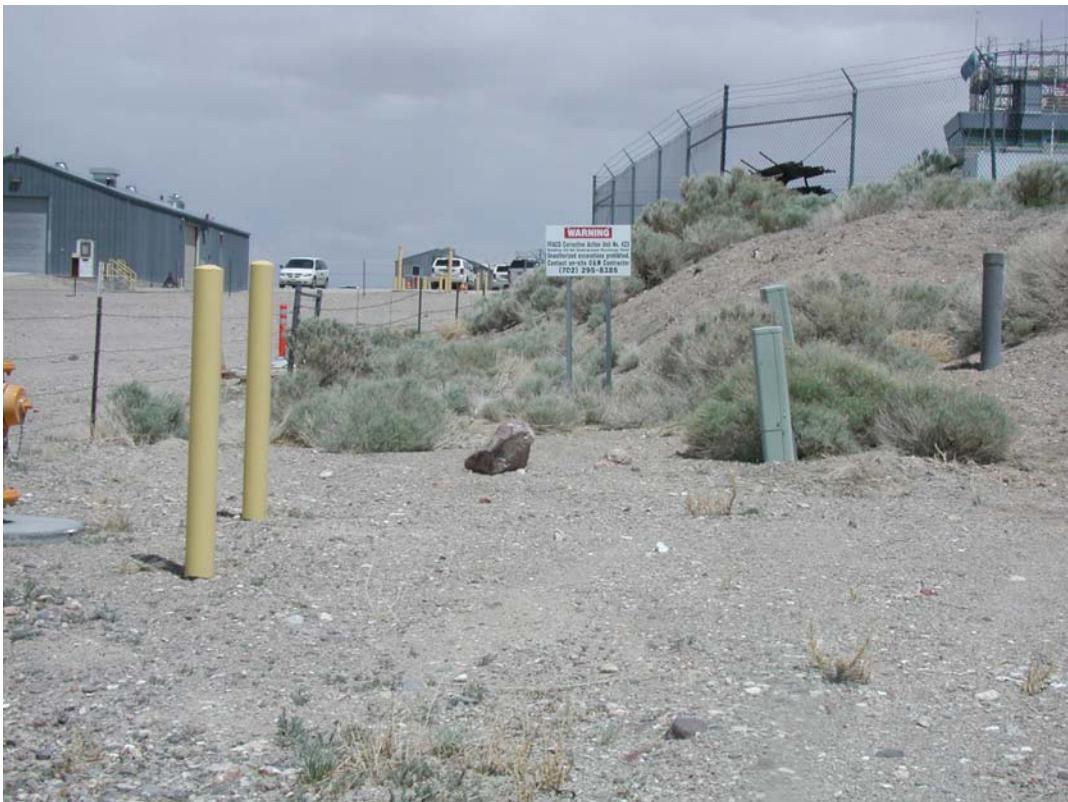
Photograph 8: CAU 423, looking east, 05/21/2008

The annual inspection was conducted on May 21, 2008. The warning sign and at-grade marker were in good condition. No issues or concerns were noted.

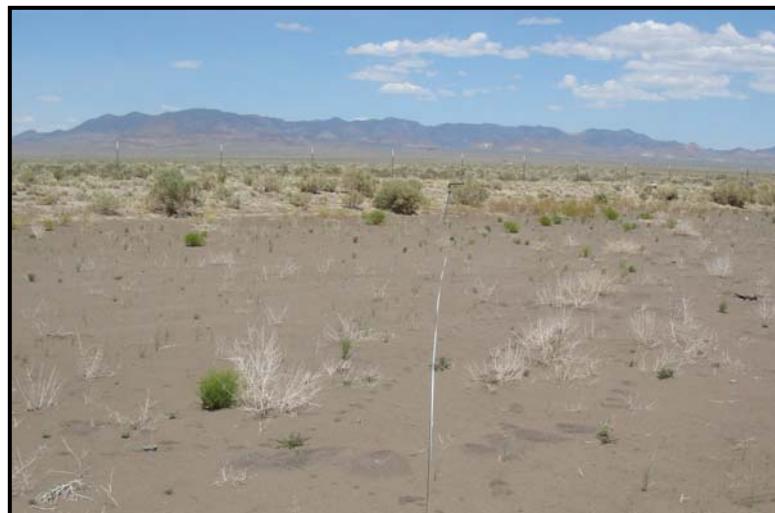
**Figure 3. Flooded bottom area at the
 CAU 400 Five Points Landfill**

The check dams upstream were in place in 2008; however, their effectiveness against a flash flood is unknown. In 2008, there were no signs of heavy water movement through the channel that traverses the site. There was a layer of silts/sands in the bottom areas suggesting some overland erosion, but deep gullies did not appear to be forming. The southeastern section of the site represents the “uplands” on the site, and soil in this area appeared stable.

The area that has been flooded, which is approximately 40 to 50 percent of the area, does not support a viable native plant community at this point. The first years following the remedial revegetation efforts in 2004, many native shrubs and grasses reappeared, only to be lost to flooding and the associated deposition of sediment in 2006 and 2007. This area will continue to be susceptible to flooding and sedimentation without major recontouring at the site. Removal of the perimeter fence and allowing unrestricted access to the site may result in a “dust bowl” condition in the flooded areas. The soils in the flooded area were mostly clays and finer textured soils that, when impacted by something such as an animal’s hooves, may create a fine dust. Under these conditions, native perennial plants do not establish and the area becomes a dust bowl. Animals may also be drawn to this site because of the abundant shrub growth around the periphery of the flooded area (Figure 3).

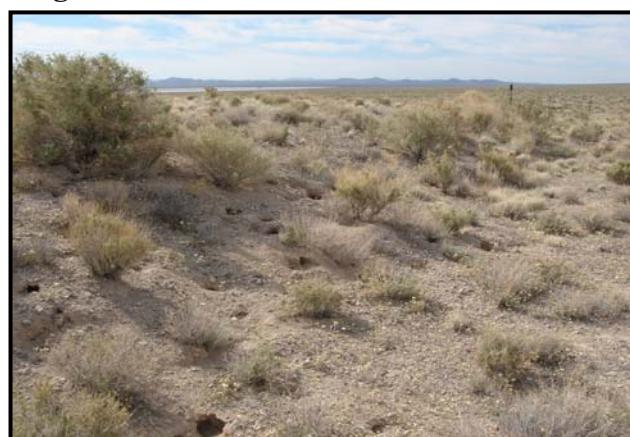
There were no signs of heavy use of plants by browsing animals, such as small mammals. The fence surrounding the area has protected it from large grazing animals, such as horses and antelope. The slopes of the cover were the most heavily used portion of the site by wildlife. Small mammals have constructed numerous burrows on the slopes of the cover (Figure 7).

Figure 7. Small mammal burrows along west facing slope of cover

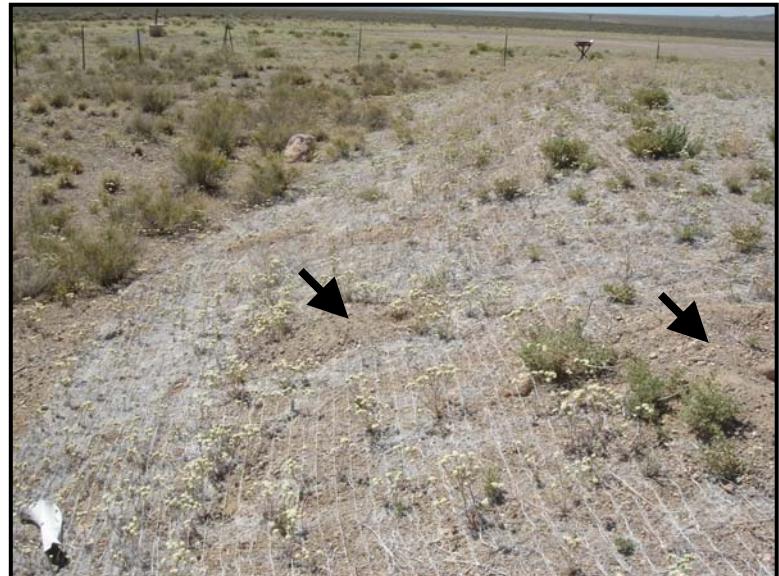
After the site was reseeded, an erosion blanket was used instead of using straw mulch and crimping it. After 4 years, there was still evidence of the erosion blanket (Figure 9). The soil on the cover appeared stable and compacted.

Figure 9. Small mammal burrows on west facing slope of cover at CAU 407. Arrows indicate where cover fill material has been moved to surface.

There was no evidence that water moving off the cover was creating erosion gullies. Some burrowing was evident along the edges of the cover; however, the volume and characteristics of the excavated soil suggested the burrows were shallow. The young shrubs and grasses that were found on the cover were protected from large grazing animals by the perimeter fence. It is recommended that this fence remain in place until plants have a chance to become better established.
