DOE/NV--1391

# Post-Closure Inspection Report for the Tonopah Test Range, Nevada

## For Calendar Year 2009

U.S. Department of Energy  
National Nuclear Security Administration  
Nevada Site Office

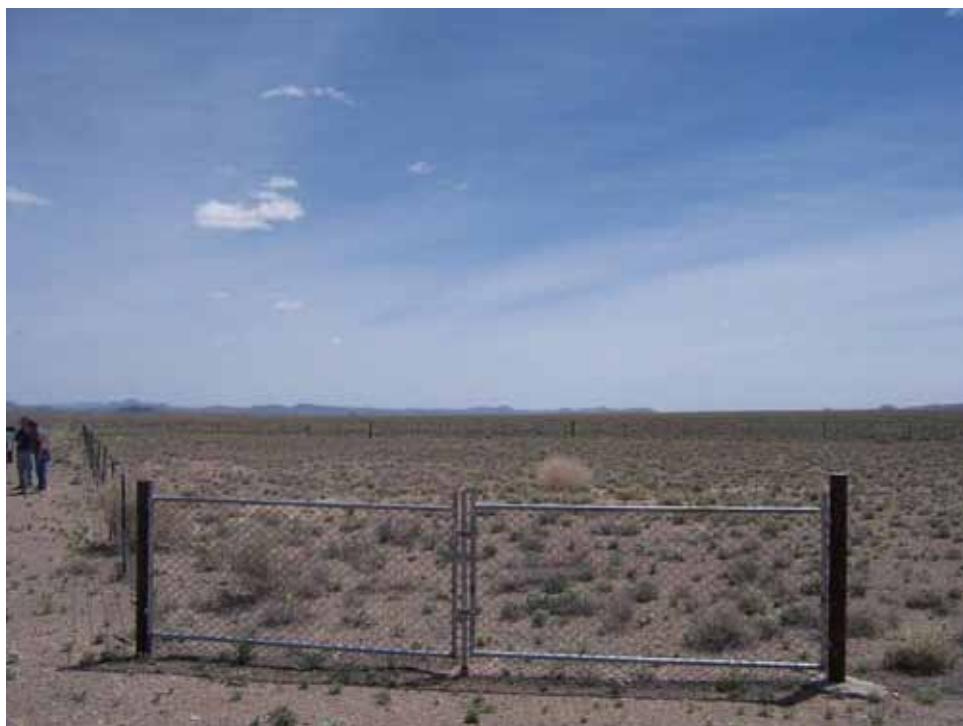
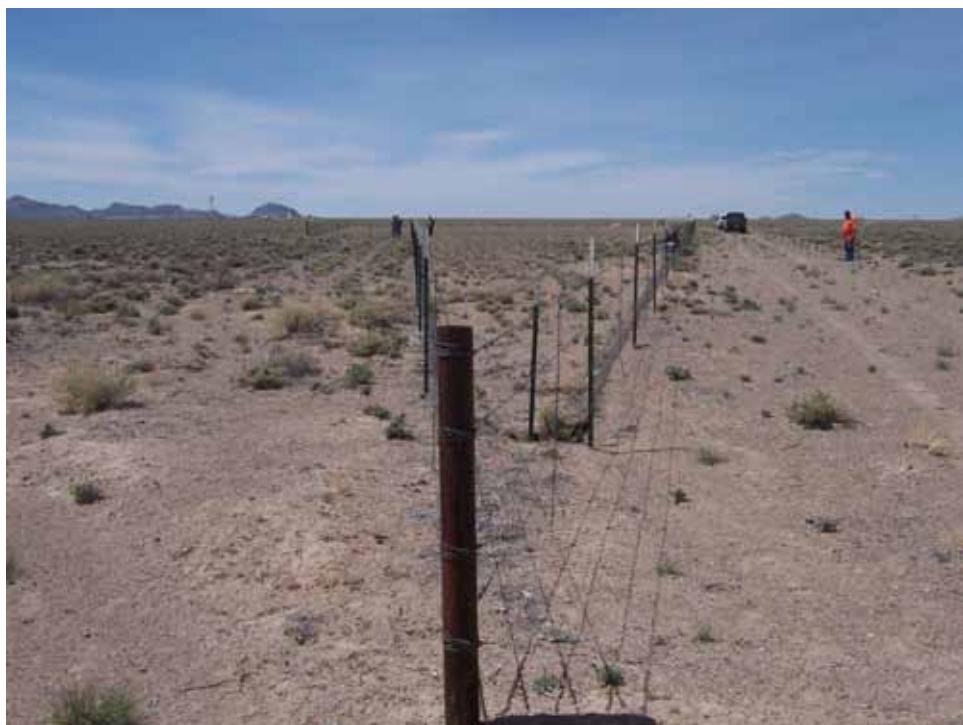
Bomblet Pit (CAS TA-55-001-TAB2, Ordnance Disposal Pit): The Bomblet Pit is shown in Figure 2 of Attachment A. The annual inspection was conducted on May 5, 2009. The fence, signs, cover, and vegetation were in good condition. Small animal burrows were noted that were recommended to be backfilled as a best management practice. No other issues or concerns were noted.

Photograph 1: CAU 400 Bomblet Pit, looking south, 05/05/2009

Photograph 2: CAU 400 Bomblet Pit, looking northwest, 05/05/2009

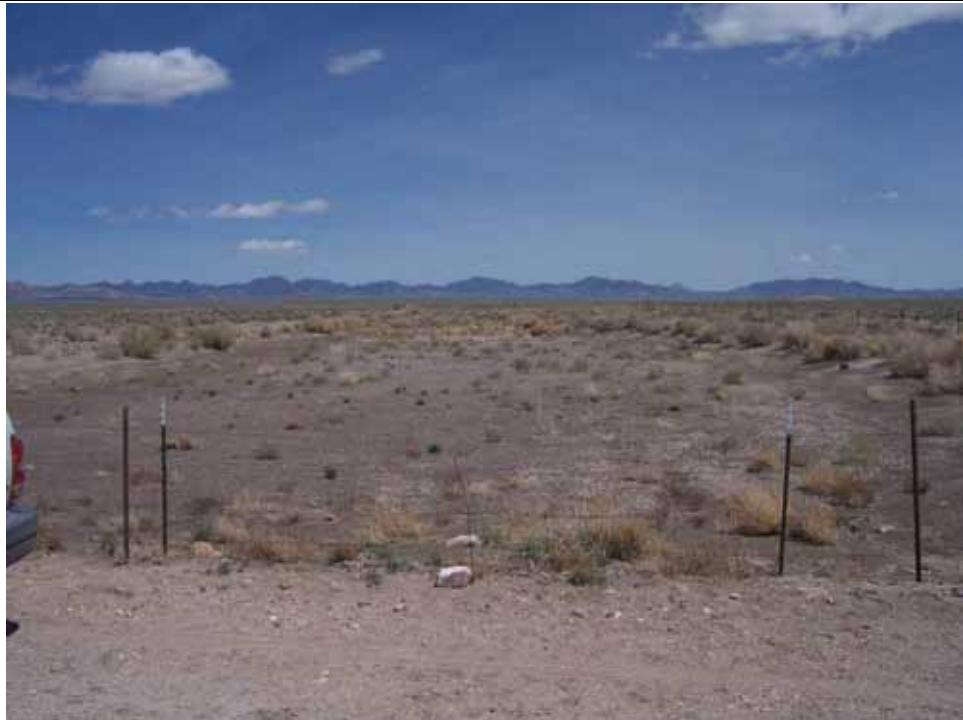
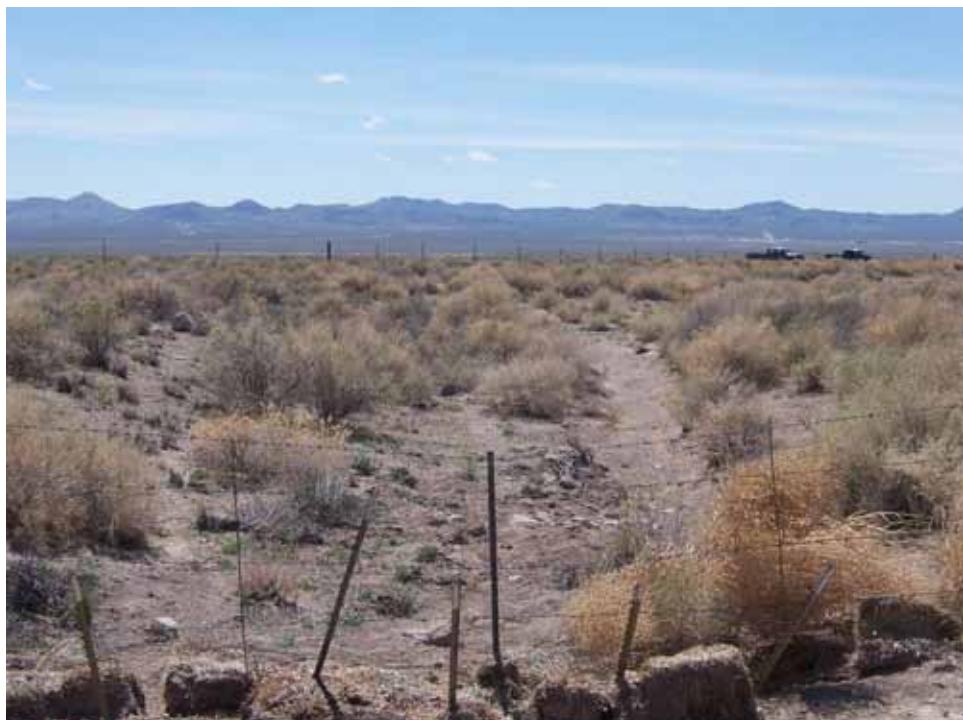
Five Points Landfill (CAS TA-19-001-05PT, Ordnance Disposal Pit): The Five Points Landfill is shown in Figure 3 of Attachment A. The annual inspection was conducted on May 5, 2009. Signs and fencing were in good condition, and the vegetation appeared to be healthy. Small animal burrows were noted that were recommended to be backfilled as a best management practice. No other issues or concerns were noted.

Photograph 3: CAU 400 Five Points Landfill, looking east, 05/05/2009

Photograph 4: CAU 400 Five Points Landfill, looking west, 05/05/2009

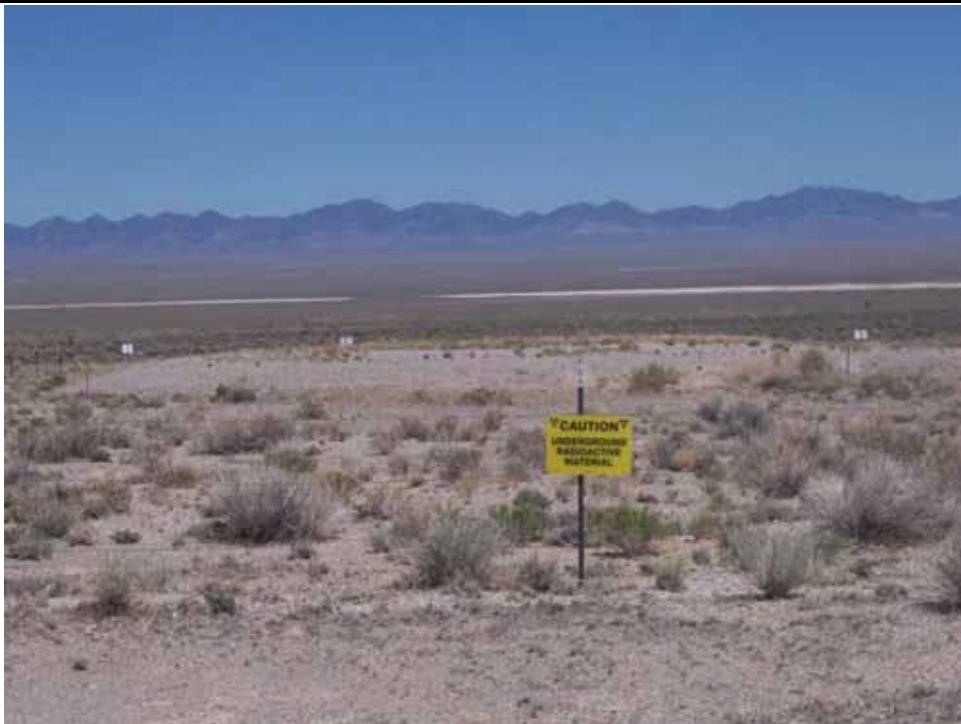
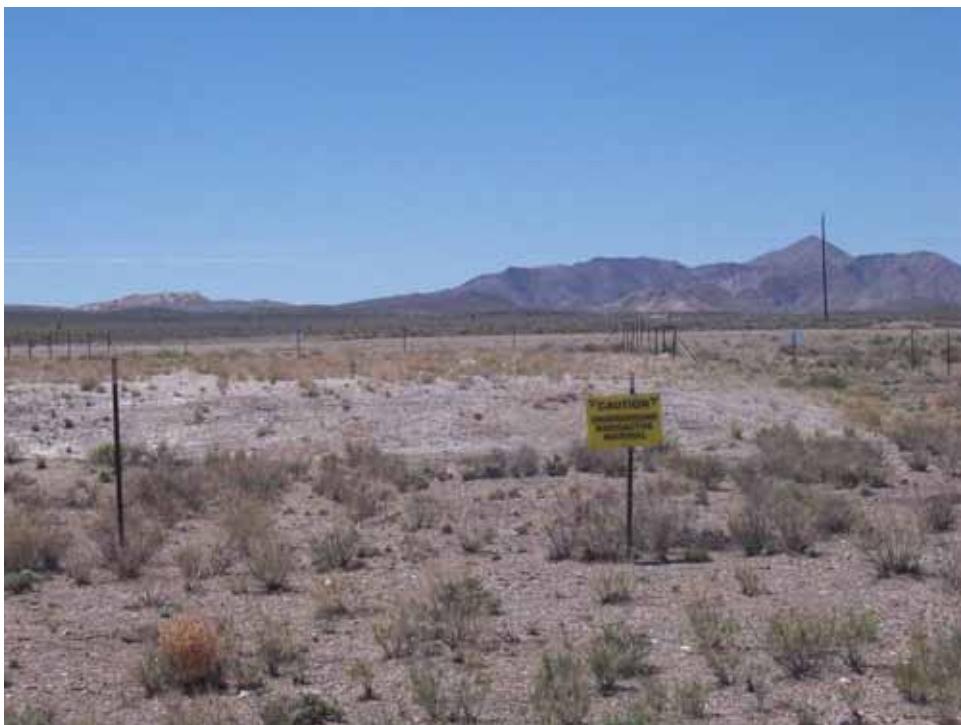
The annual inspection was conducted on May 5, 2009. Signs, fencing, and cover were in good condition, and maintenance and repairs were not recommended. Vegetation is becoming established on the cover. No issues or concerns were noted.

Photograph 5: CAU 407, looking east, 05/06/2009

Photograph 6: CAU 407, looking west, 05/06/2009

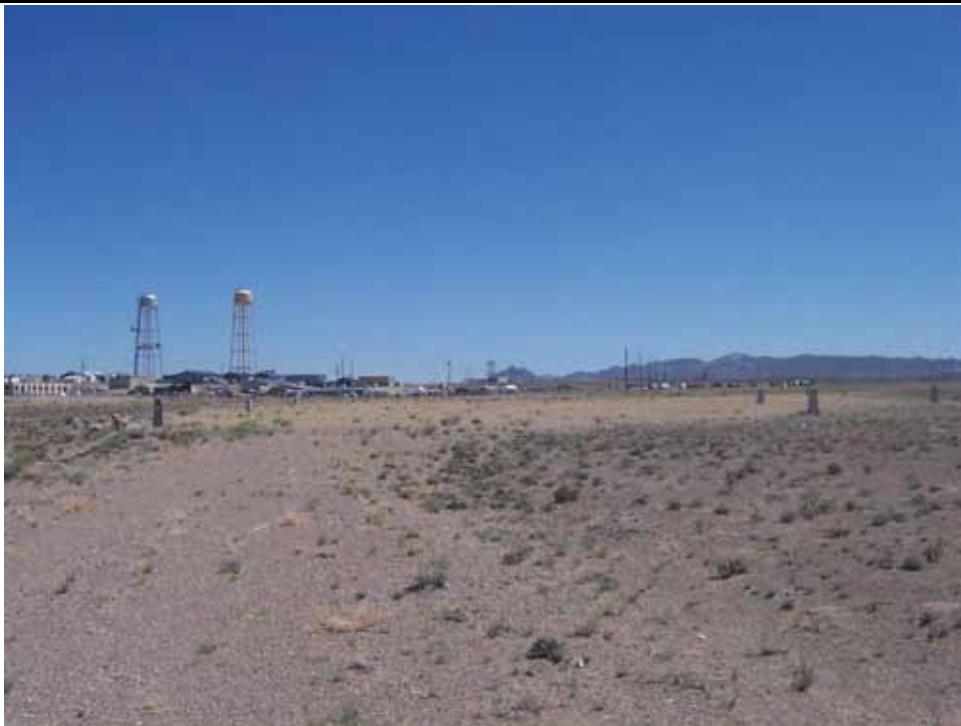
Photograph 7: CAU 424, Landfill Cell A3-1, looking southeast, 05/06/2009

Landfill Cell A3-1 (CAS 03-08-001-A301): All signs, survey markers, and monuments were in good condition. Vegetation is established throughout the site, and no cracking, erosion, or subsidence of the cover was noted. No issues or concerns were noted.

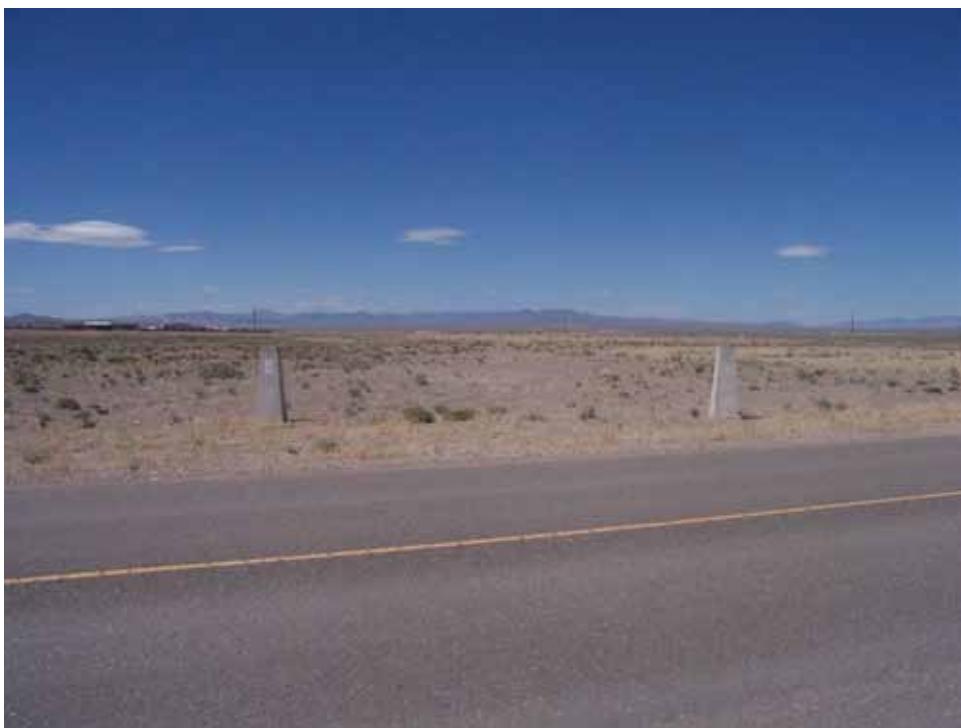
Photograph 8: CAU 424, Landfill Cell A3-2, looking north, 05/06/2009

Landfill Cell A3-2 (CAS 03-08-002-A302): The concrete monuments and landfill cover were in good condition. All signs and brass survey markers were legible and intact. No signs of erosion, subsidence, or evidence of unauthorized use were noted. No issues or concerns were noted.

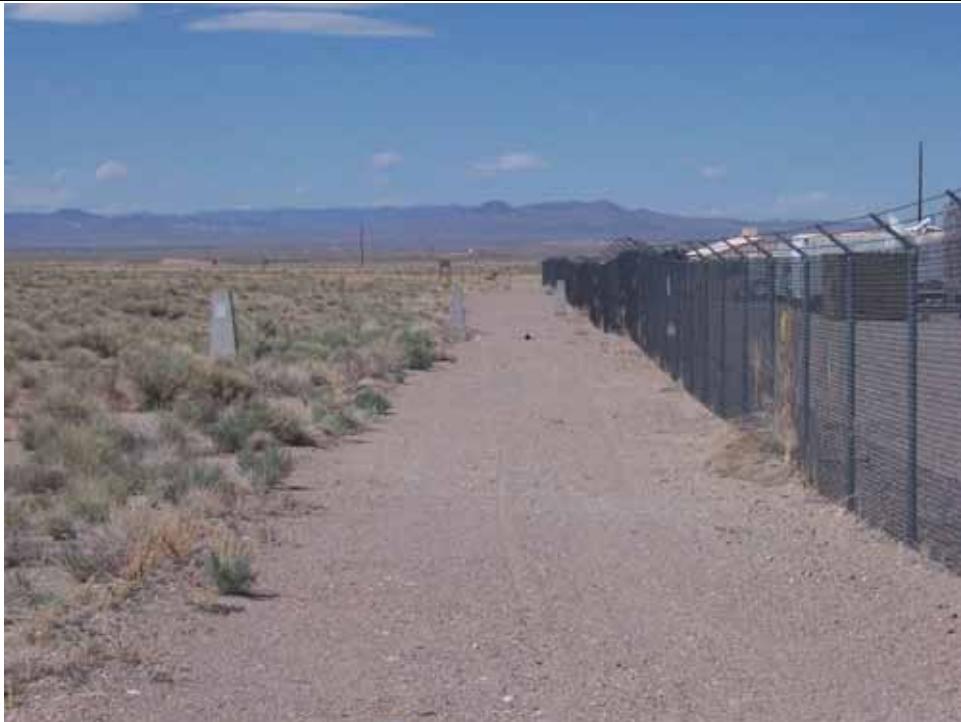
Photograph 9: CAU 424, Landfill Cell A3-3, looking northwest, 05/06/2009

Landfill Cell A3-3 (CAS 03-08-002-A303): All monuments, brass survey markers, and warning signs were in good condition. No subsidence, cracking, or erosion was noted. No issues or concerns were noted.

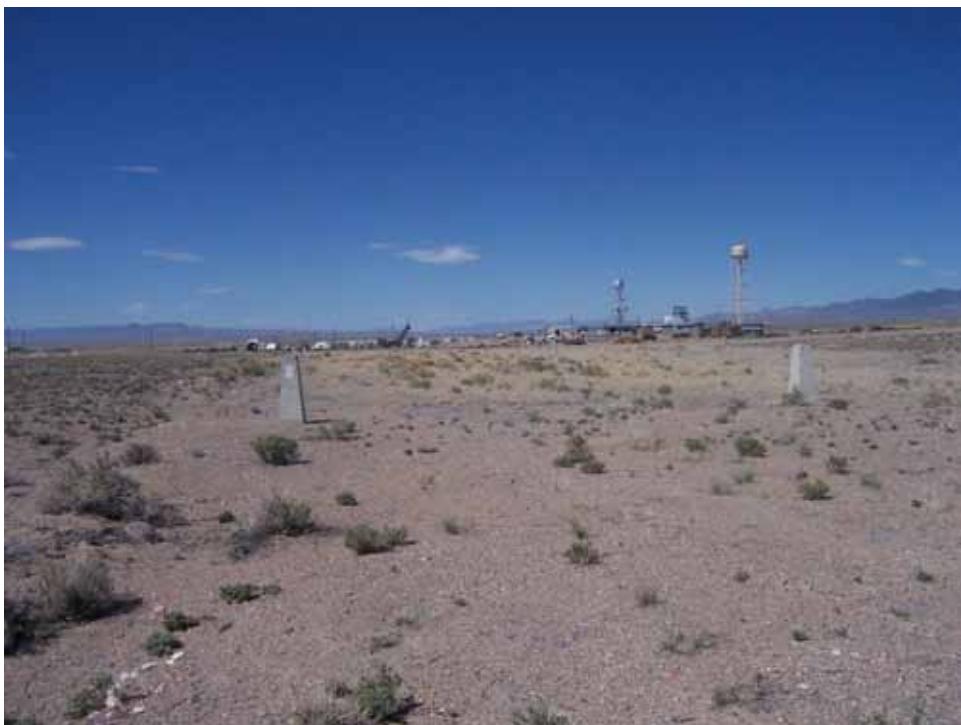
Photograph 10: CAU 424, Landfill Cell A3-4, looking north, 05/06/2009

Landfill Cell A3-4 (CAS 03-08-002-A304): The overall condition of the site was good, and vegetation was established throughout the site. All monuments, the brass survey marker, and warning signs were in good condition. No issues or concerns were noted.

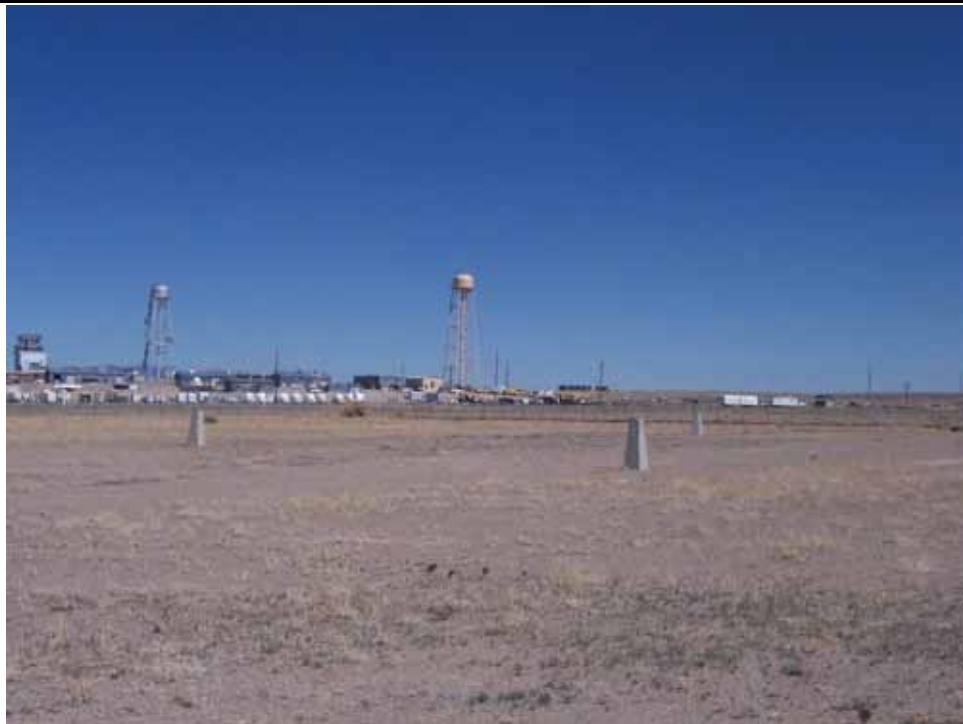
Photograph 11: CAU 424, Landfill Cell A3-5, looking southeast, 05/06/2009

Landfill Cell A3-5 (CAS 03-08-002-A305): All monuments and attached warning signs and brass survey markers were in good condition. No evidence of subsidence, cracking, or erosion was noted, and sparse vegetation was present. No issues or concerns were noted.

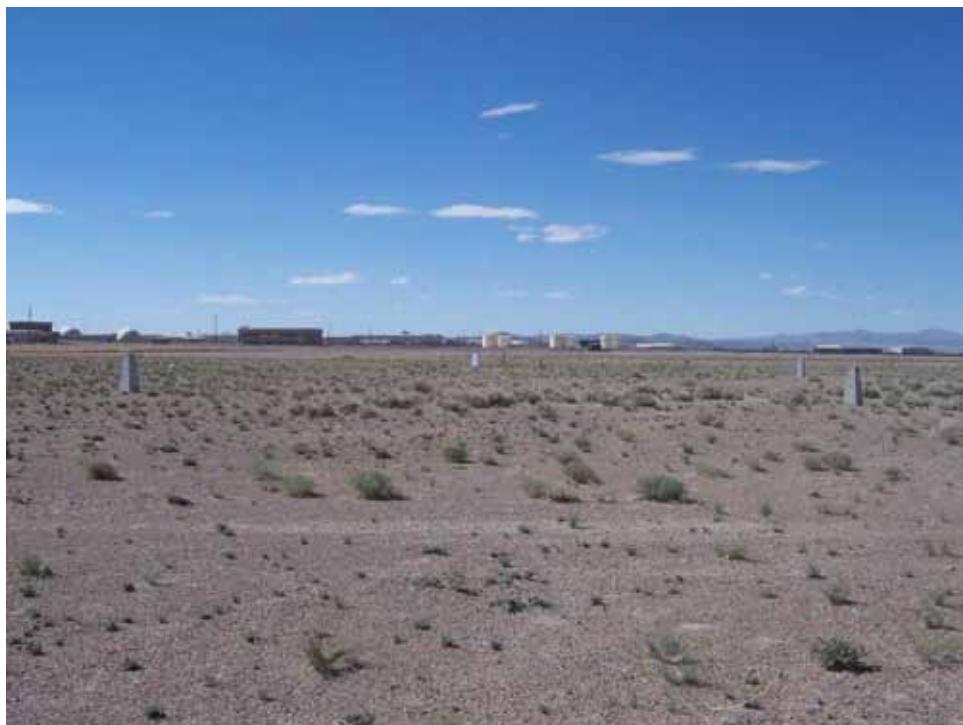
Photograph 12: CAU 424, Landfill Cell A3-6, looking south, 05/06/2009

Landfill Cell A3-6 (CAS 03-08-002-A306): All monuments and attached warning signs and brass survey markers were in good condition. No evidence of subsidence, cracking, or erosion was noted. No issues or concerns were noted.

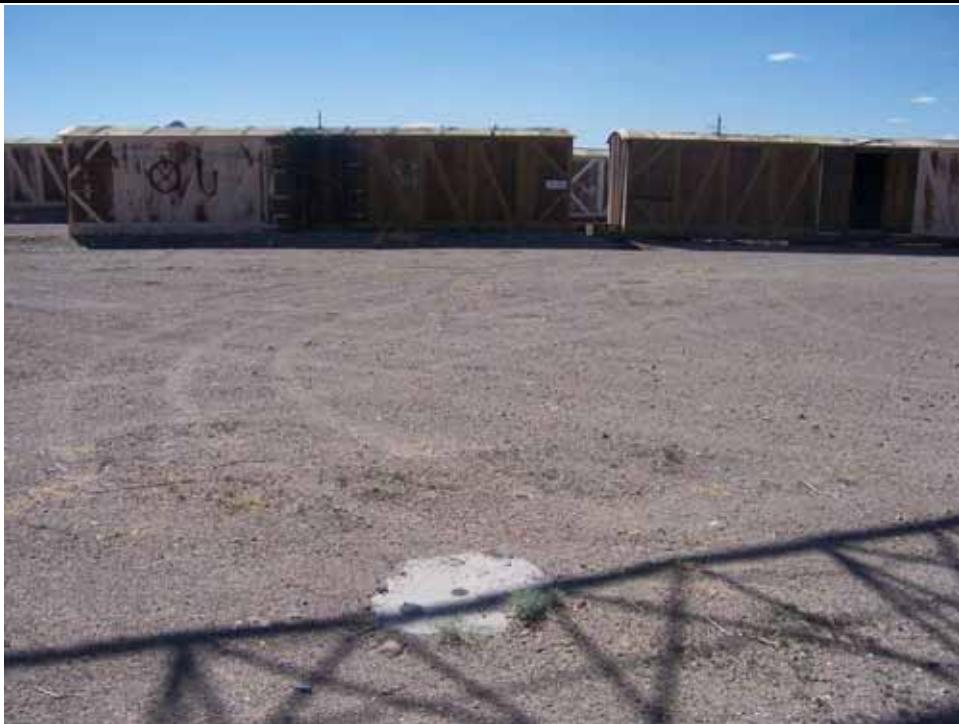
Photograph 13: CAU 424, Landfill Cell A3-8, looking west, 05/06/2009

Landfill Cell A3-8 (CAS 03-08-002-A308): Brass markers were in good condition. No erosion, subsidence, or evidence of unauthorized use was noted. No issues or concerns were noted.

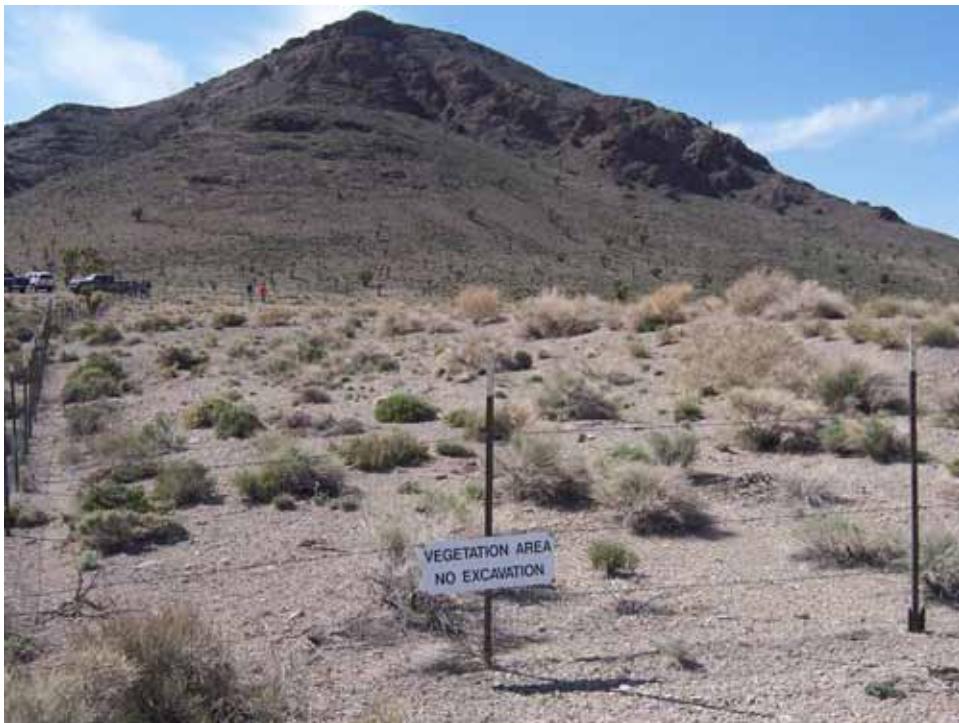
Photograph 14: CAU 426, looking west, 05/05/2009

The annual inspection was conducted on May 5, 2009. The signs and fencing were in good condition. No erosion, subsidence, or evidence of unauthorized use was noted. Vegetation was well established and healthy throughout the site. No issues or concerns were noted.

The site was observed to be in good condition. Site inspections should continue as scheduled. Revegetation standards were achieved again in 2009, and discontinuation of vegetation monitoring is recommended.

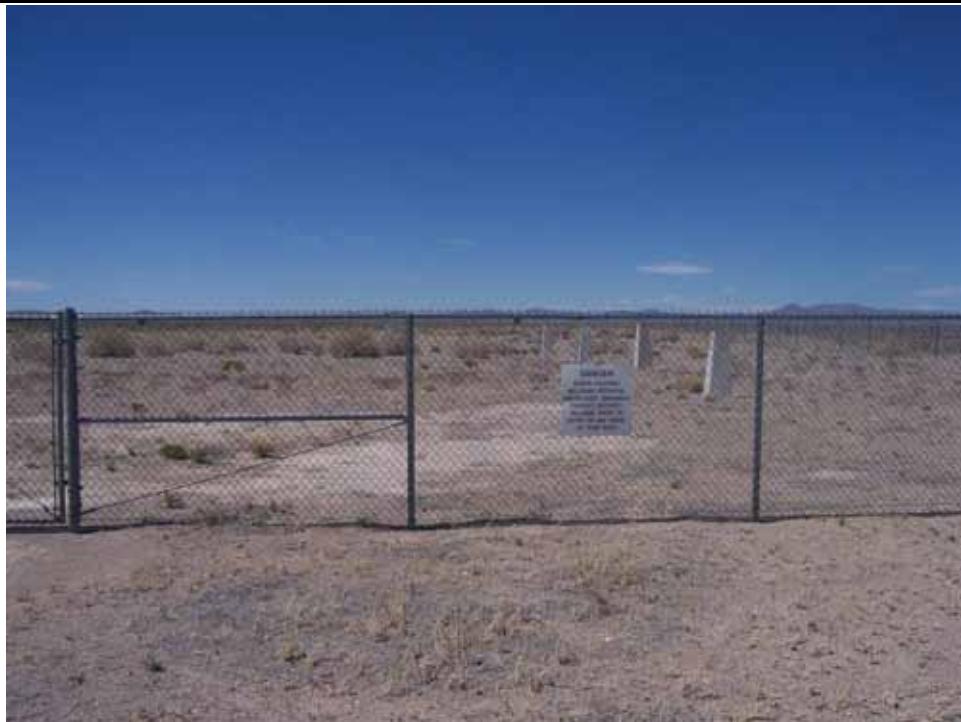
Photograph 15: CAU 453, looking northwest, 05/06/2009

The annual inspection was conducted on May 6, 2009. The fence, signs, and monuments were in excellent condition. There was evidence of animal burrowing and a large depression that required follow-up action.

Animal burrows observed during the annual inspection were backfilled, and the depression was restored to grade on June 25, 2009.

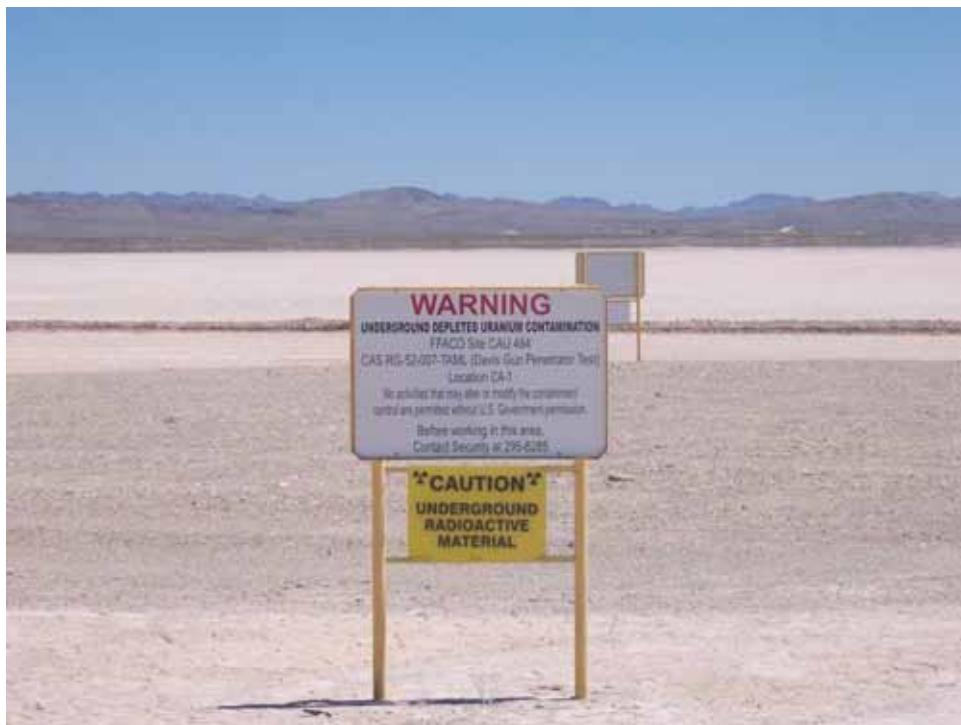
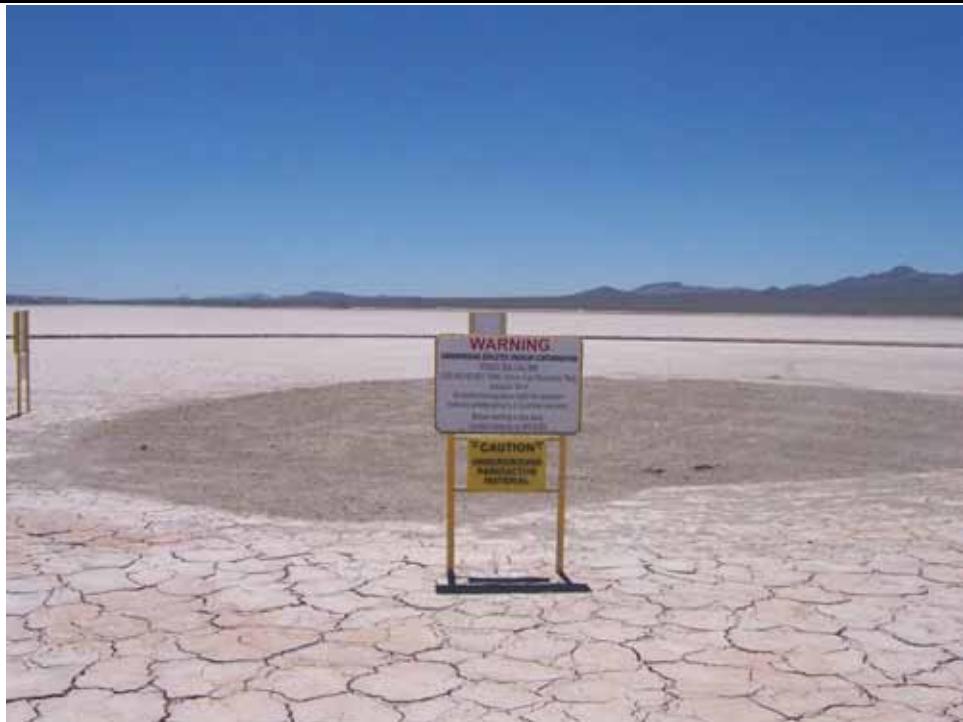
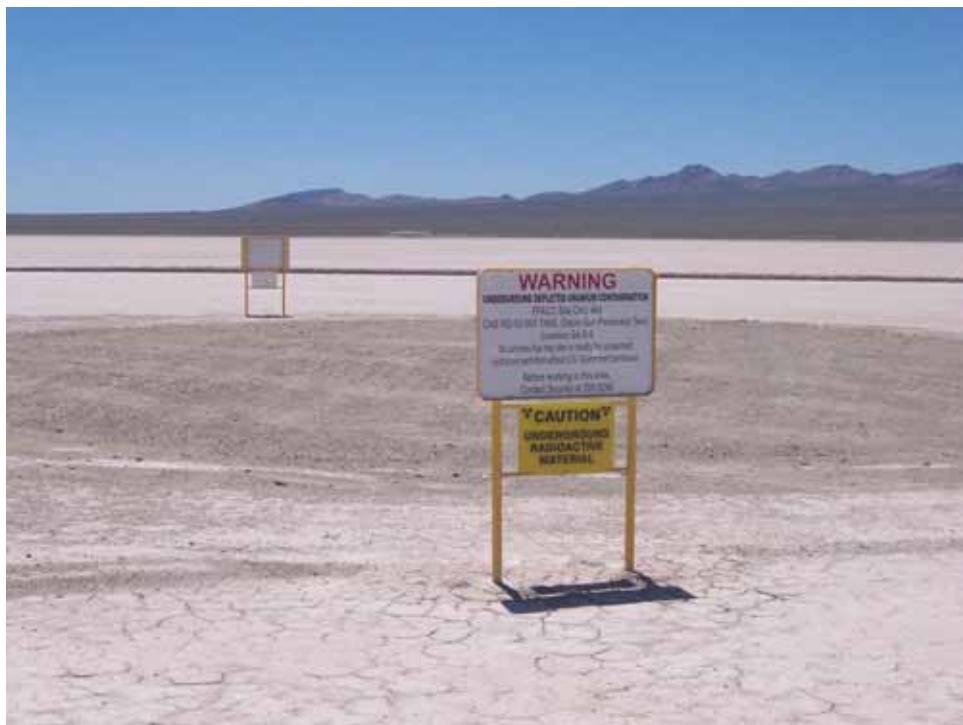
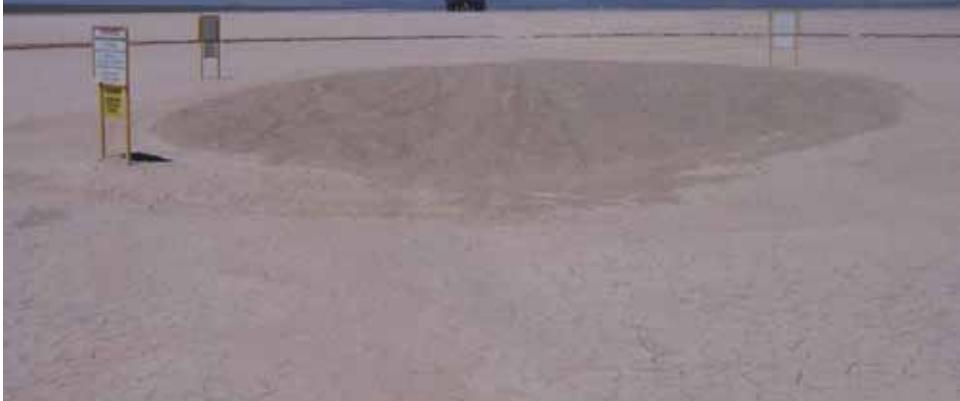
The annual inspection was conducted on May 6, 2009. Signs and covers were in good condition. No issues or concerns were noted.

Photograph 16: CAU 484, CA1 anomaly, looking east, 05/06/2009

Photograph 17: CAU 484, SA4 anomaly, looking southwest, 05/06/2009

Photograph 18: CAU 484, SA5-9 anomaly, looking west, 05/06/2009

Photograph 19: CAU 484, SA12-15 anomaly, looking north, 05/06/2009

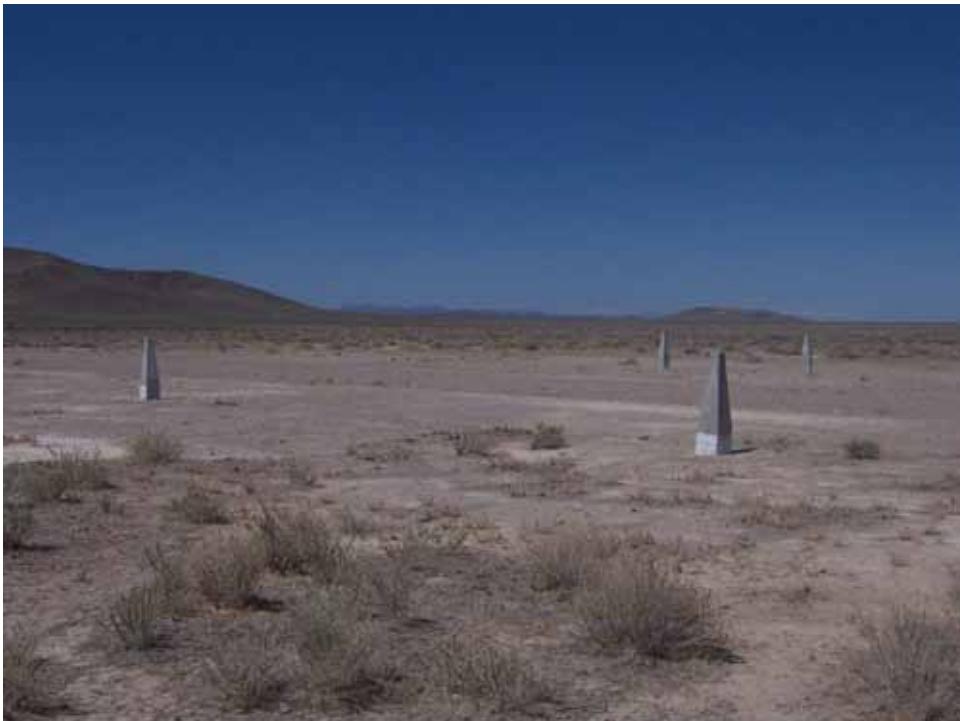
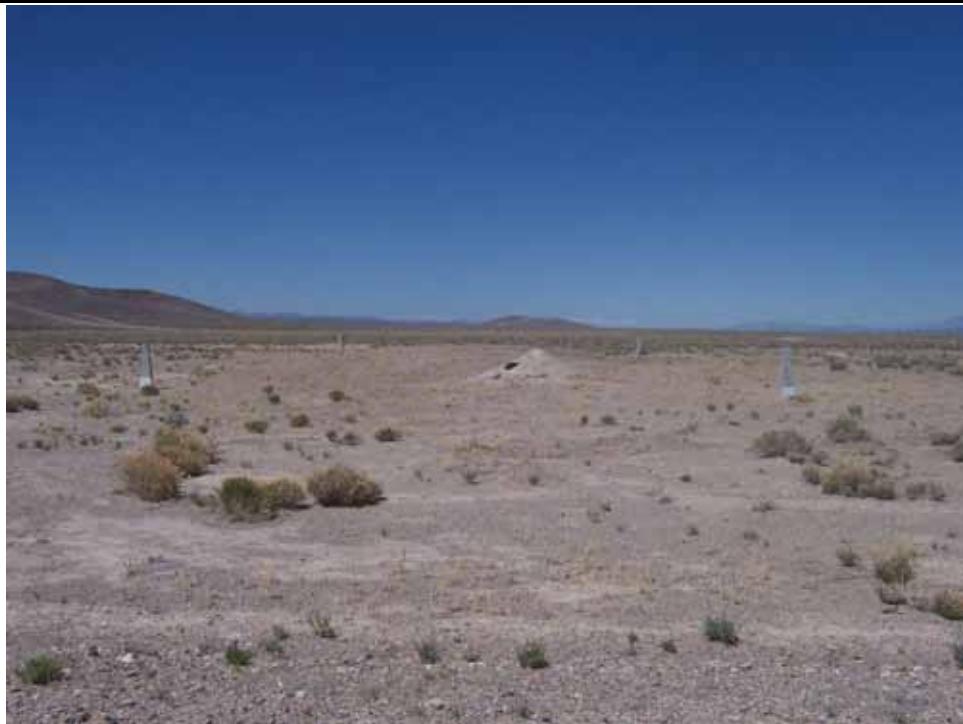
The annual inspection was conducted on May 6, 2009. All warning signs were in place, intact, and legible, and the monuments were in good condition. No issues or concerns were noted.

Photograph 20: CAU 487, A-8 anomaly, looking north, 05/06/2009

Photograph 21: CAU 487, A-17 anomaly, looking west, 05/06/2009
