File No. TX-53, 3-2
T-16806, T-16807
Project No. 13-838-00

Re: Static Tests of Half-Scale TX-53 Crush Nose

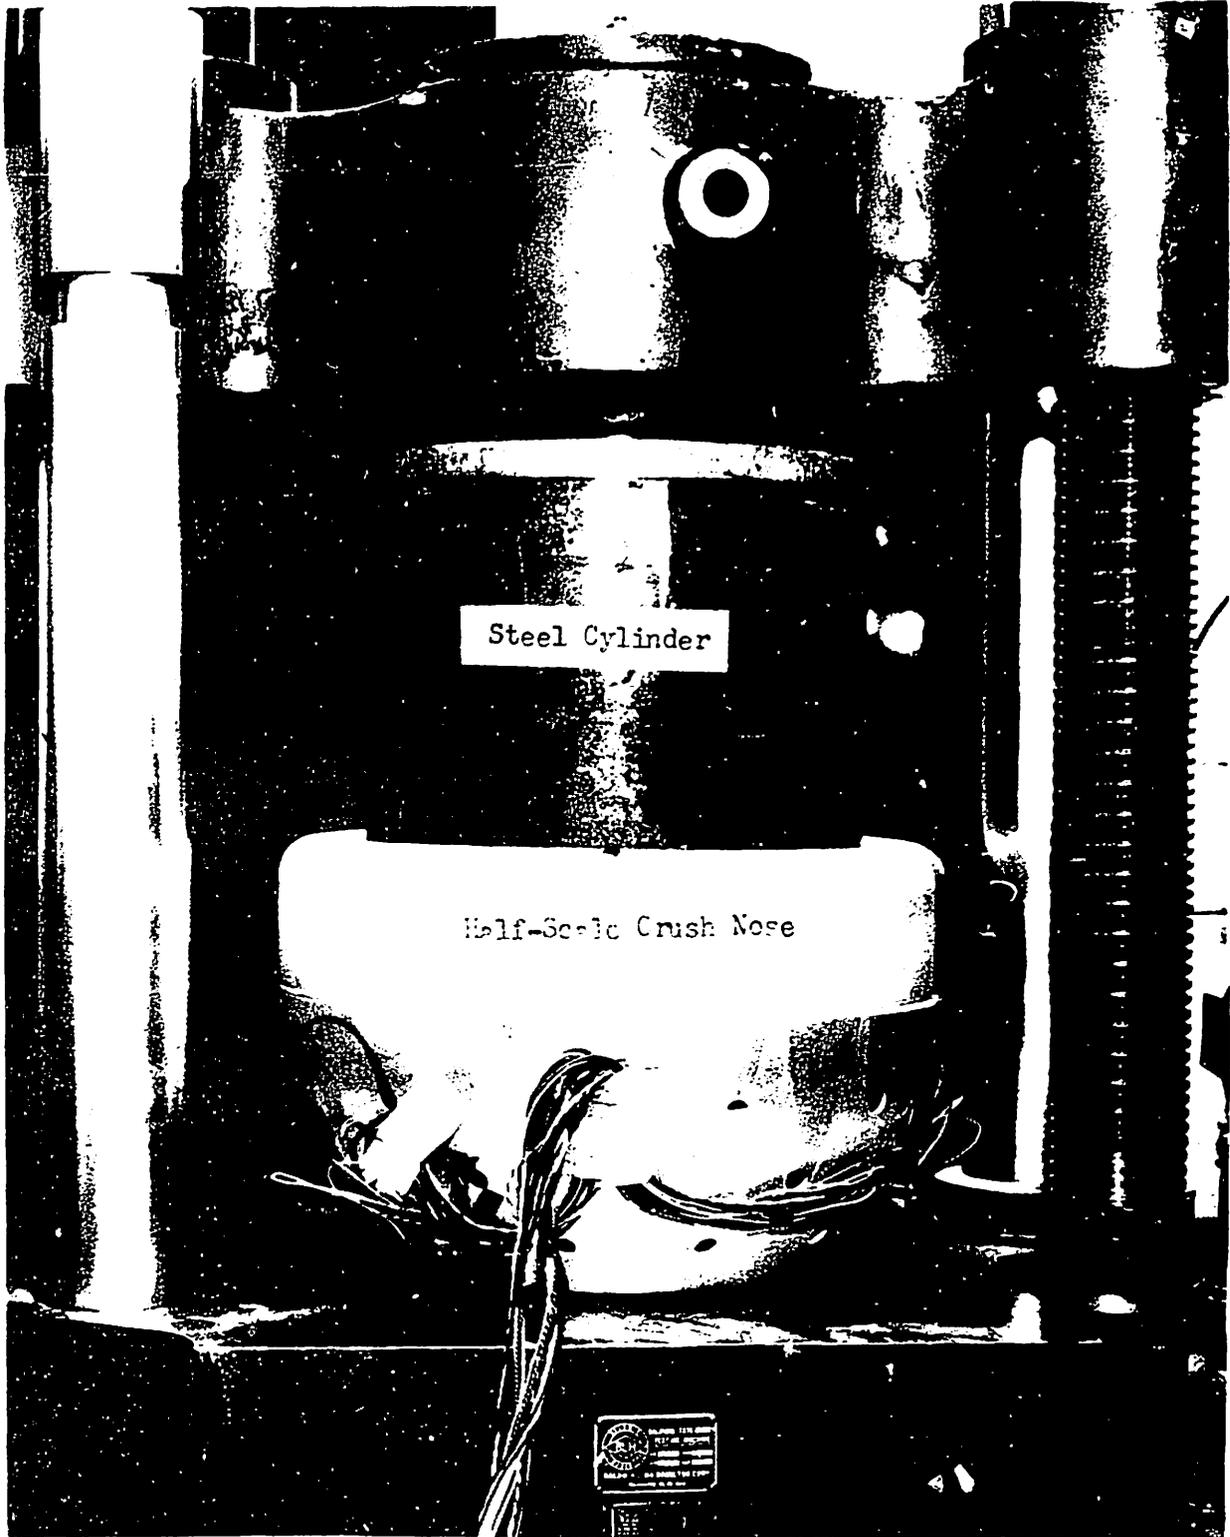
The first test unit, fabricated of 6061-T6 aluminum, was coated with No. 1006 Stresscoat and assembled into the test machine as shown in Fig. 1. Load was applied to the aft end of the nose section by an aluminum plate and steel cylinder. Three rectangular rosette strain gages were also mounted on the unit, two of which are shown in Fig. 2.

FIG. 1 SETUP FOR STATIC TESTS OF HALF-SCALE TX-88 CRUSH NOSE.

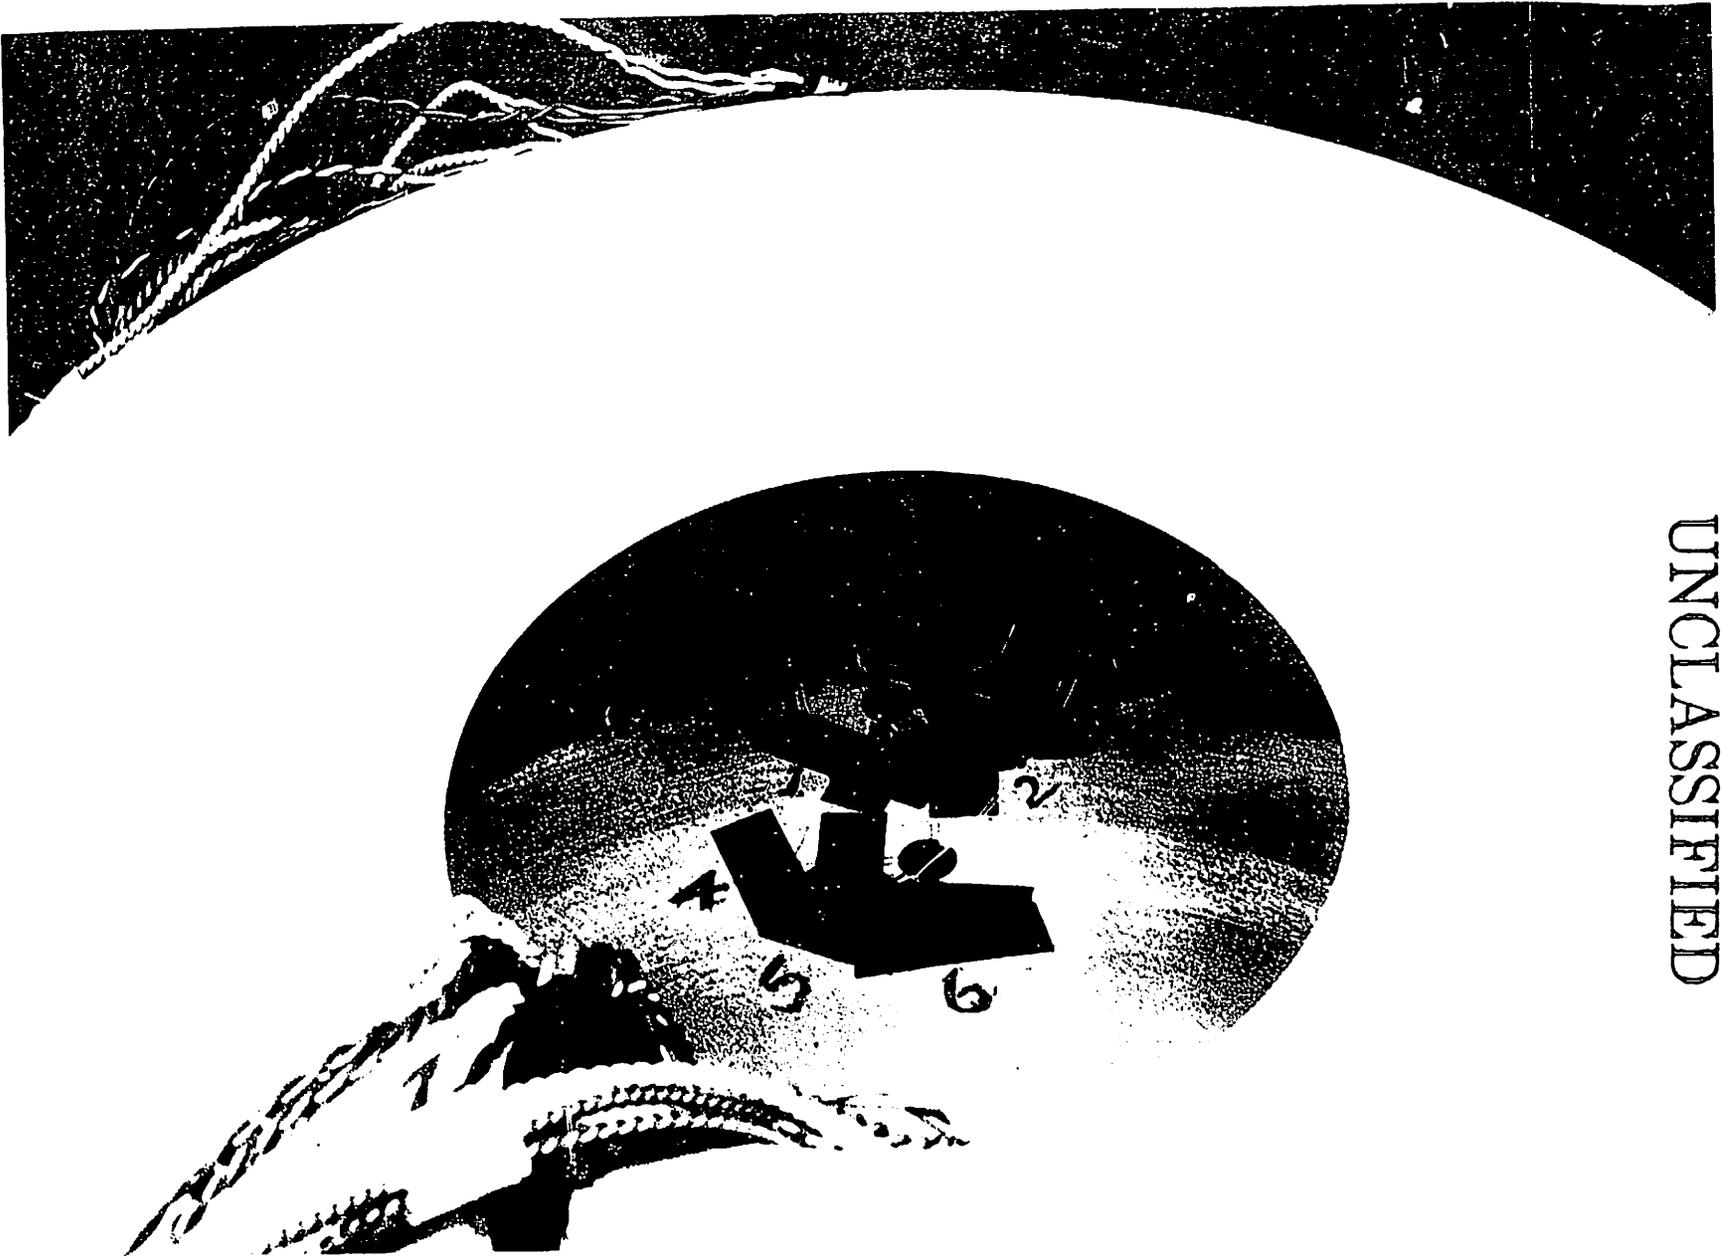
Testing of the second nose section, also made of 6061-T6 aluminum, was essentially the same as the first, except no Stresscoat was used, and additional strain gages were mounted. Locations of strain gages are shown in Figures 3 and 4. Gages No. 19 thru 30, not shown, were mounted diametrically opposite gages No. 7 thru 18, and in the same arrangement.

FIG. 3 LOCATIONS OF STRAIN GAGES ON THE INSIDE OF THE SECOND TEST UNIT - STATIC TESTS OF HALF-SCALE TX-53 CRUSH ROSE.

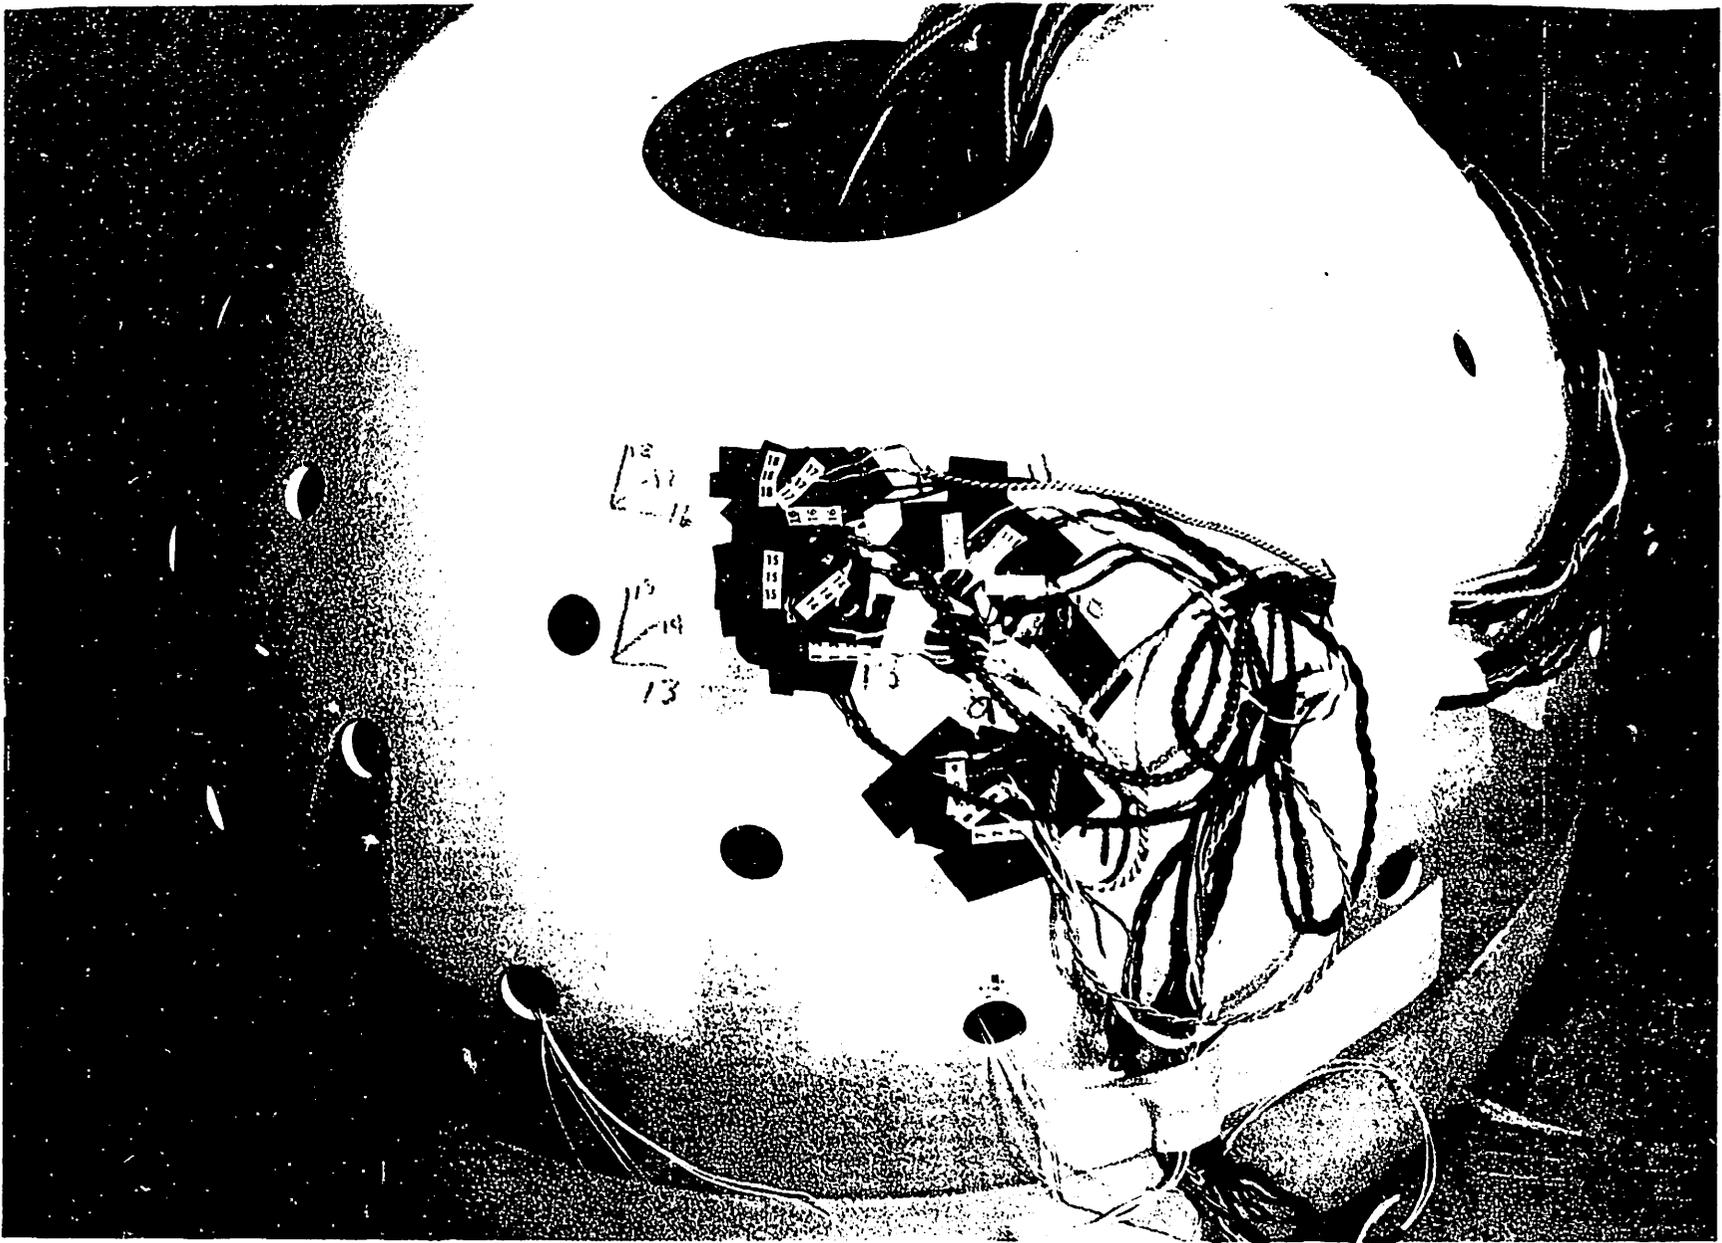
Strain readings from the test on the second unit are given in Table II and principal stresses in Table III. The highest stress determined at 45,000 pounds load was 14,850 psi tension at strain gage location Nos. 16, 17, and 18 (Fig. 4). Failure occurred at 46,500 pounds and was similar to the failure of the first unit, except that tearing of the metal was not as extensive.

FIG. 4 LOCATIONS OF STRAIN GAGES ON THE SECOND TEST UNIT - STATIC TEST OF HALF-SCALE TX-53 CRUSH NOSE.

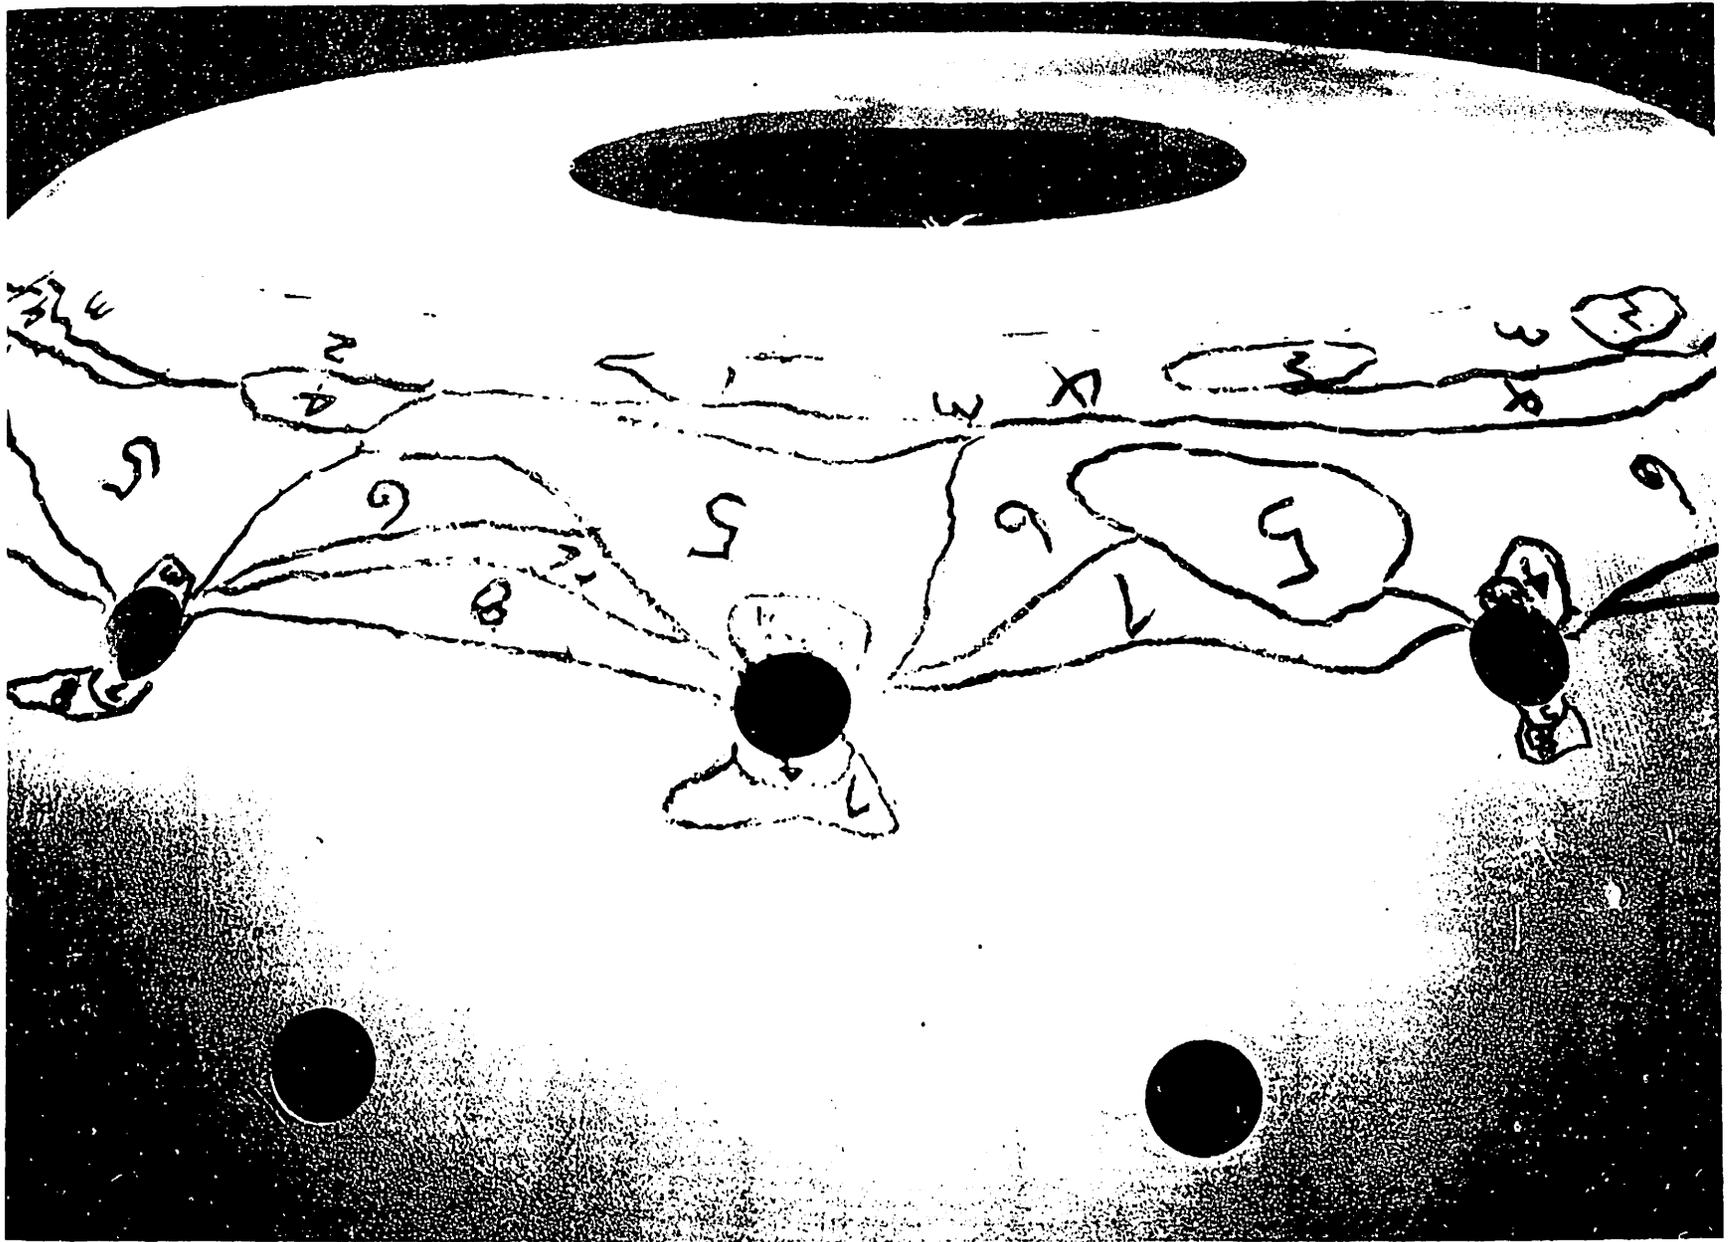
Results of the Stresscoat test on the first unit are given in Table I. Crack patterns formed are shown in Figures 5 and 6. These crack patterns indicated the highest tensile stresses in the Stresscoated portion of the unit occurred in the region of the forward row of holes.

FIG. 5 STRESSCOAT CRACK PATTERNS ON FIRST TEST UNIT - STATIC TEST AT 1000 LBS - 1-10-53
 TX-53 CRUSH NOSE.

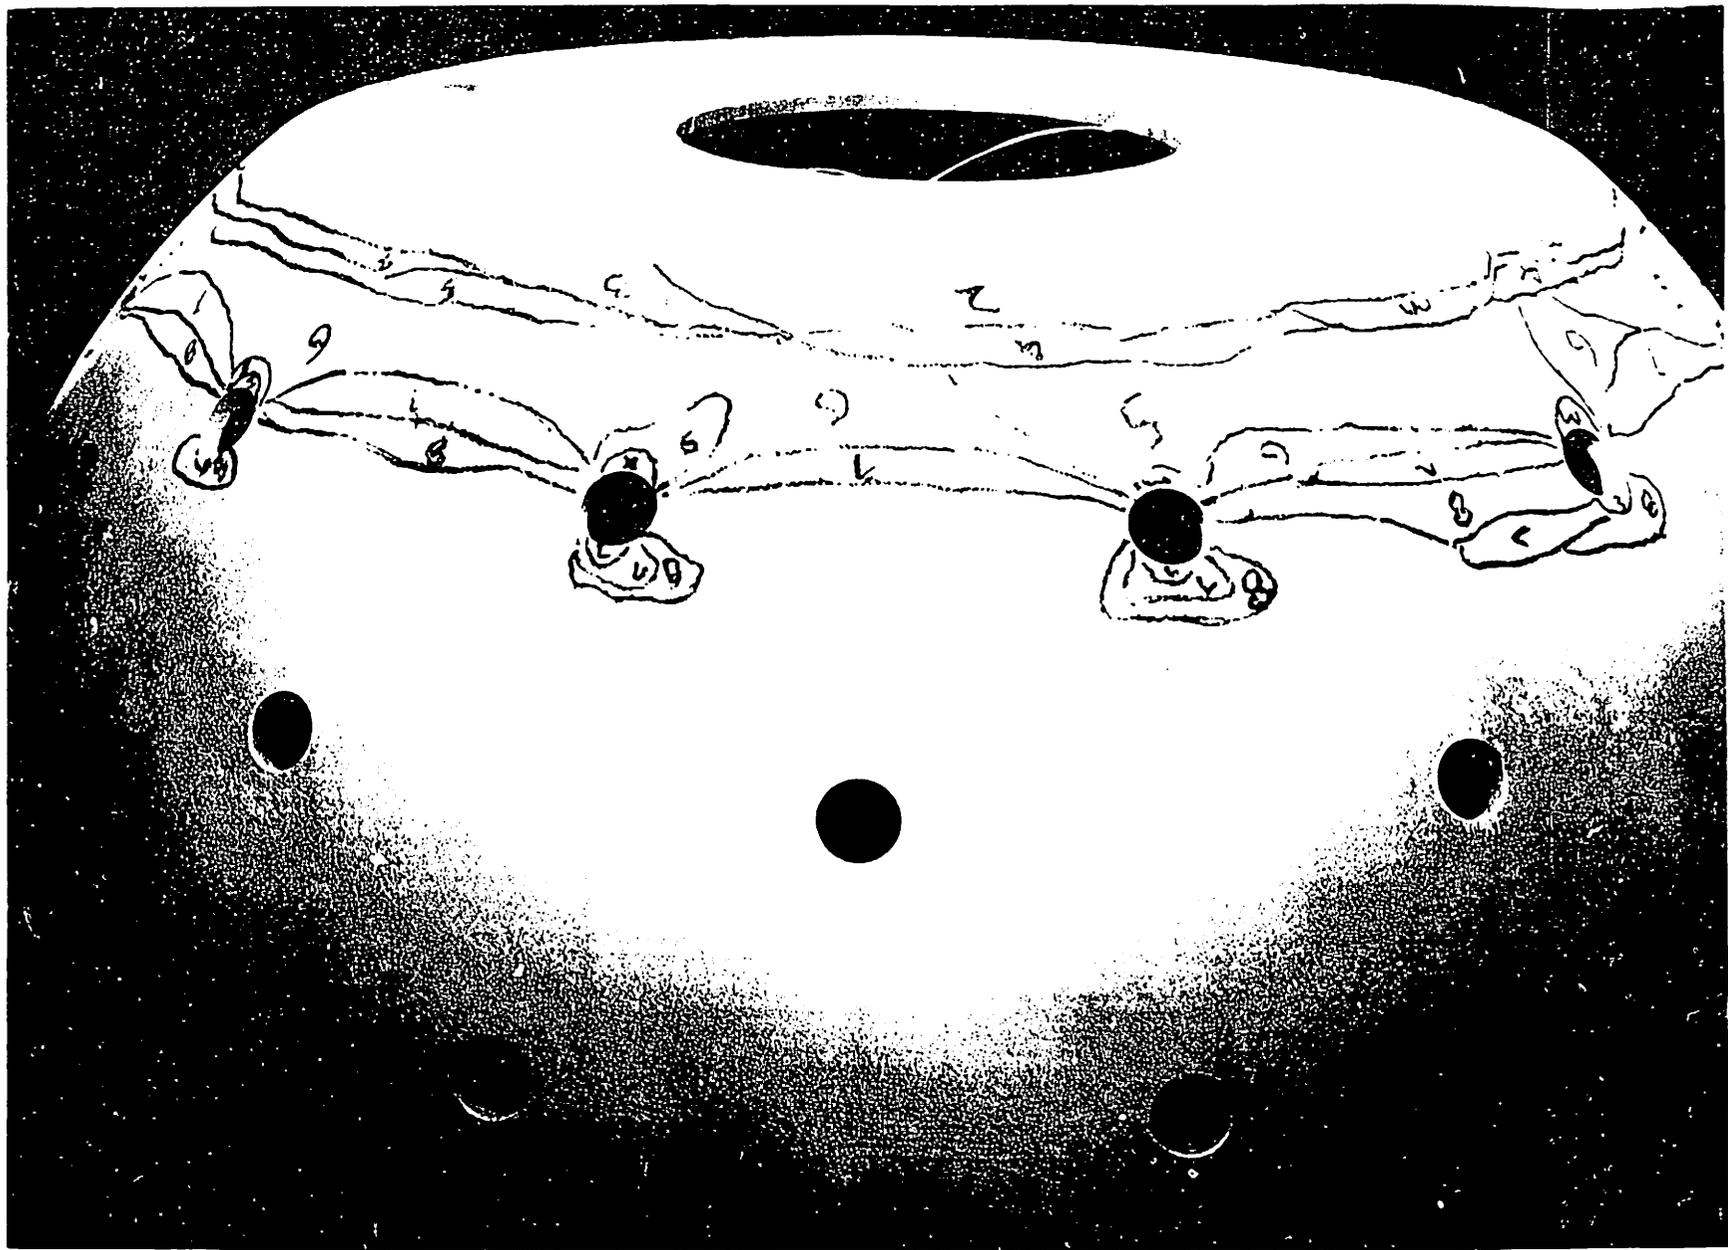
FIG. 6 STRESS COAT CRACK PATTERNS ON FIRST TEST UNIT - DATED PHOTO OF HALB-32AL. 1-19-53
TX-53 CRUSH NOSE.

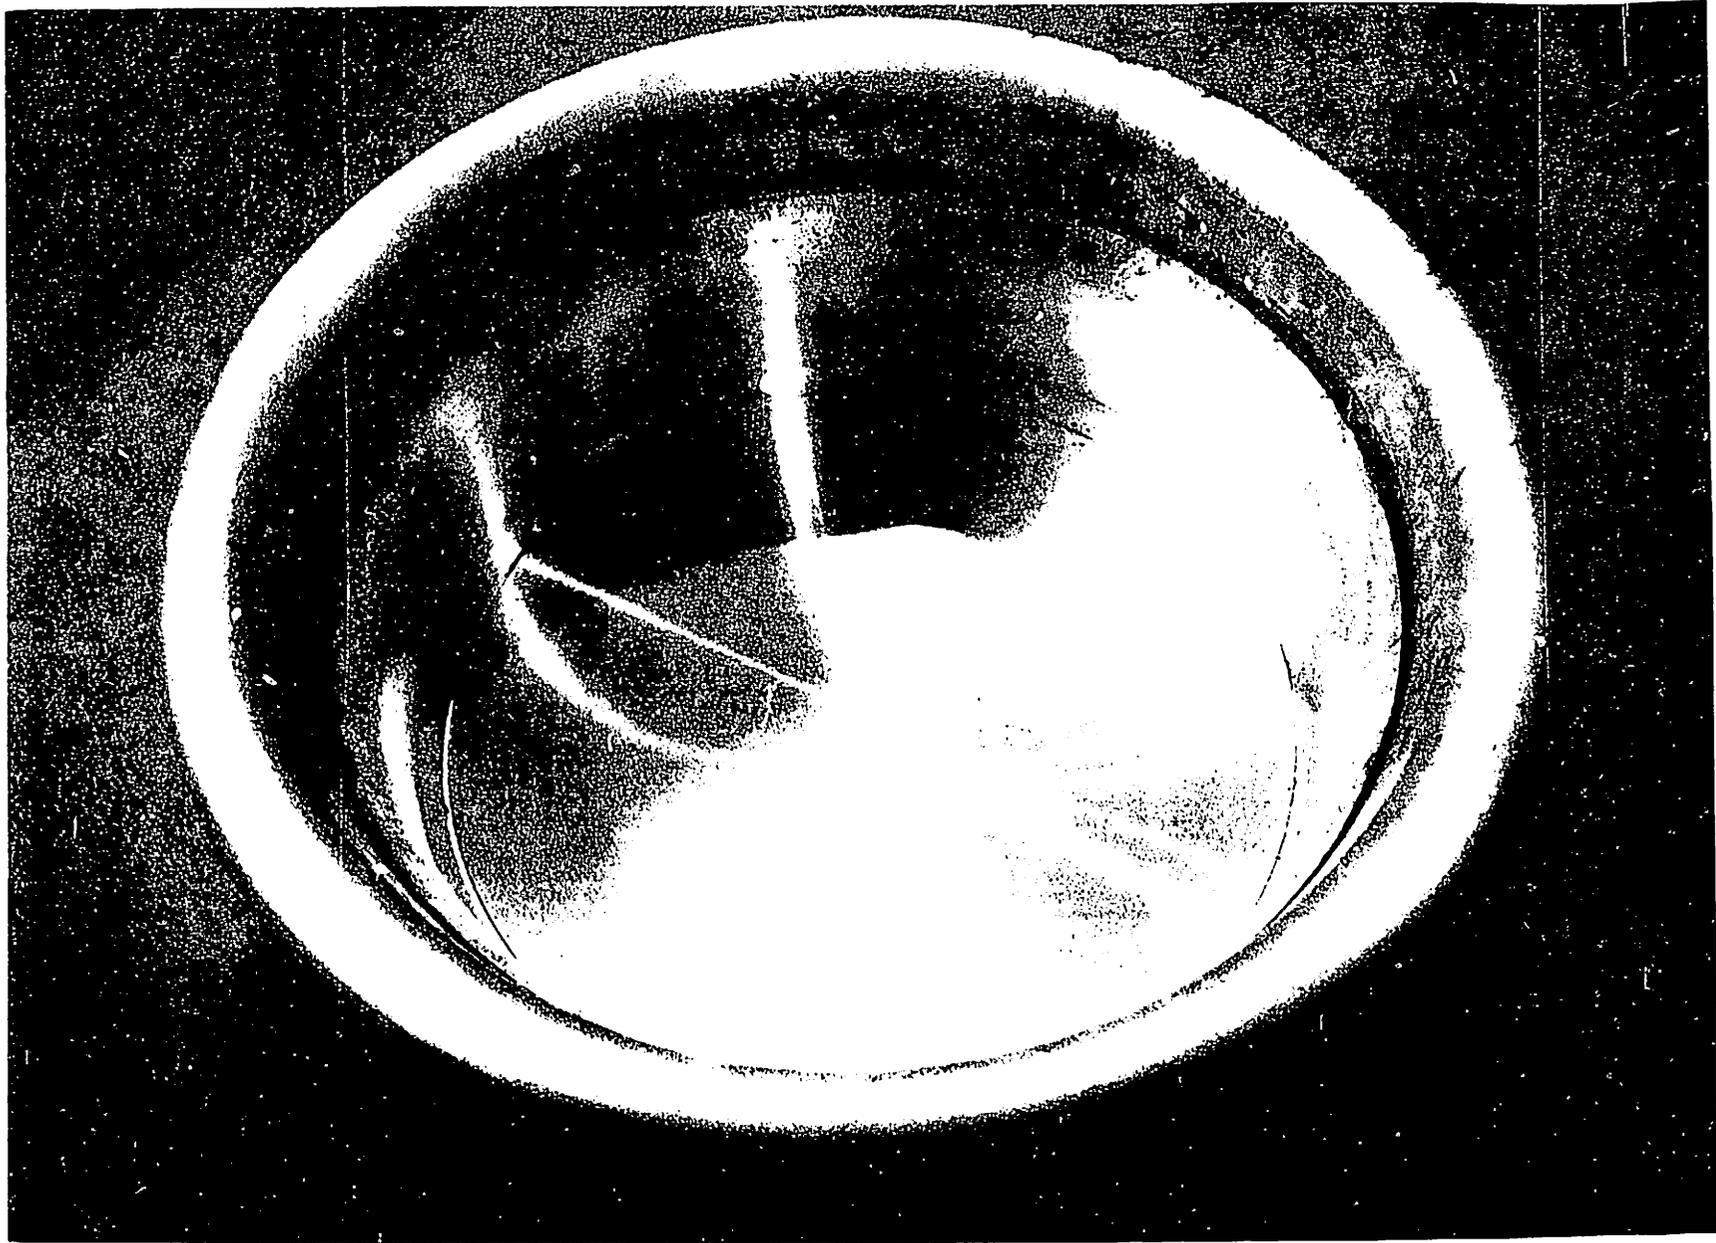
Failure of the third unit occurred at 77,000 pounds, and consisted of rolling only with no tearing of the metal. Figures 8 and 9 show the nose section after collapse.

FIG. 8 THIRD TEST UNIT AFTER FAILURE - STATIC TESTS OF HALF-SCALE TX-33 CRUSH ROSE.

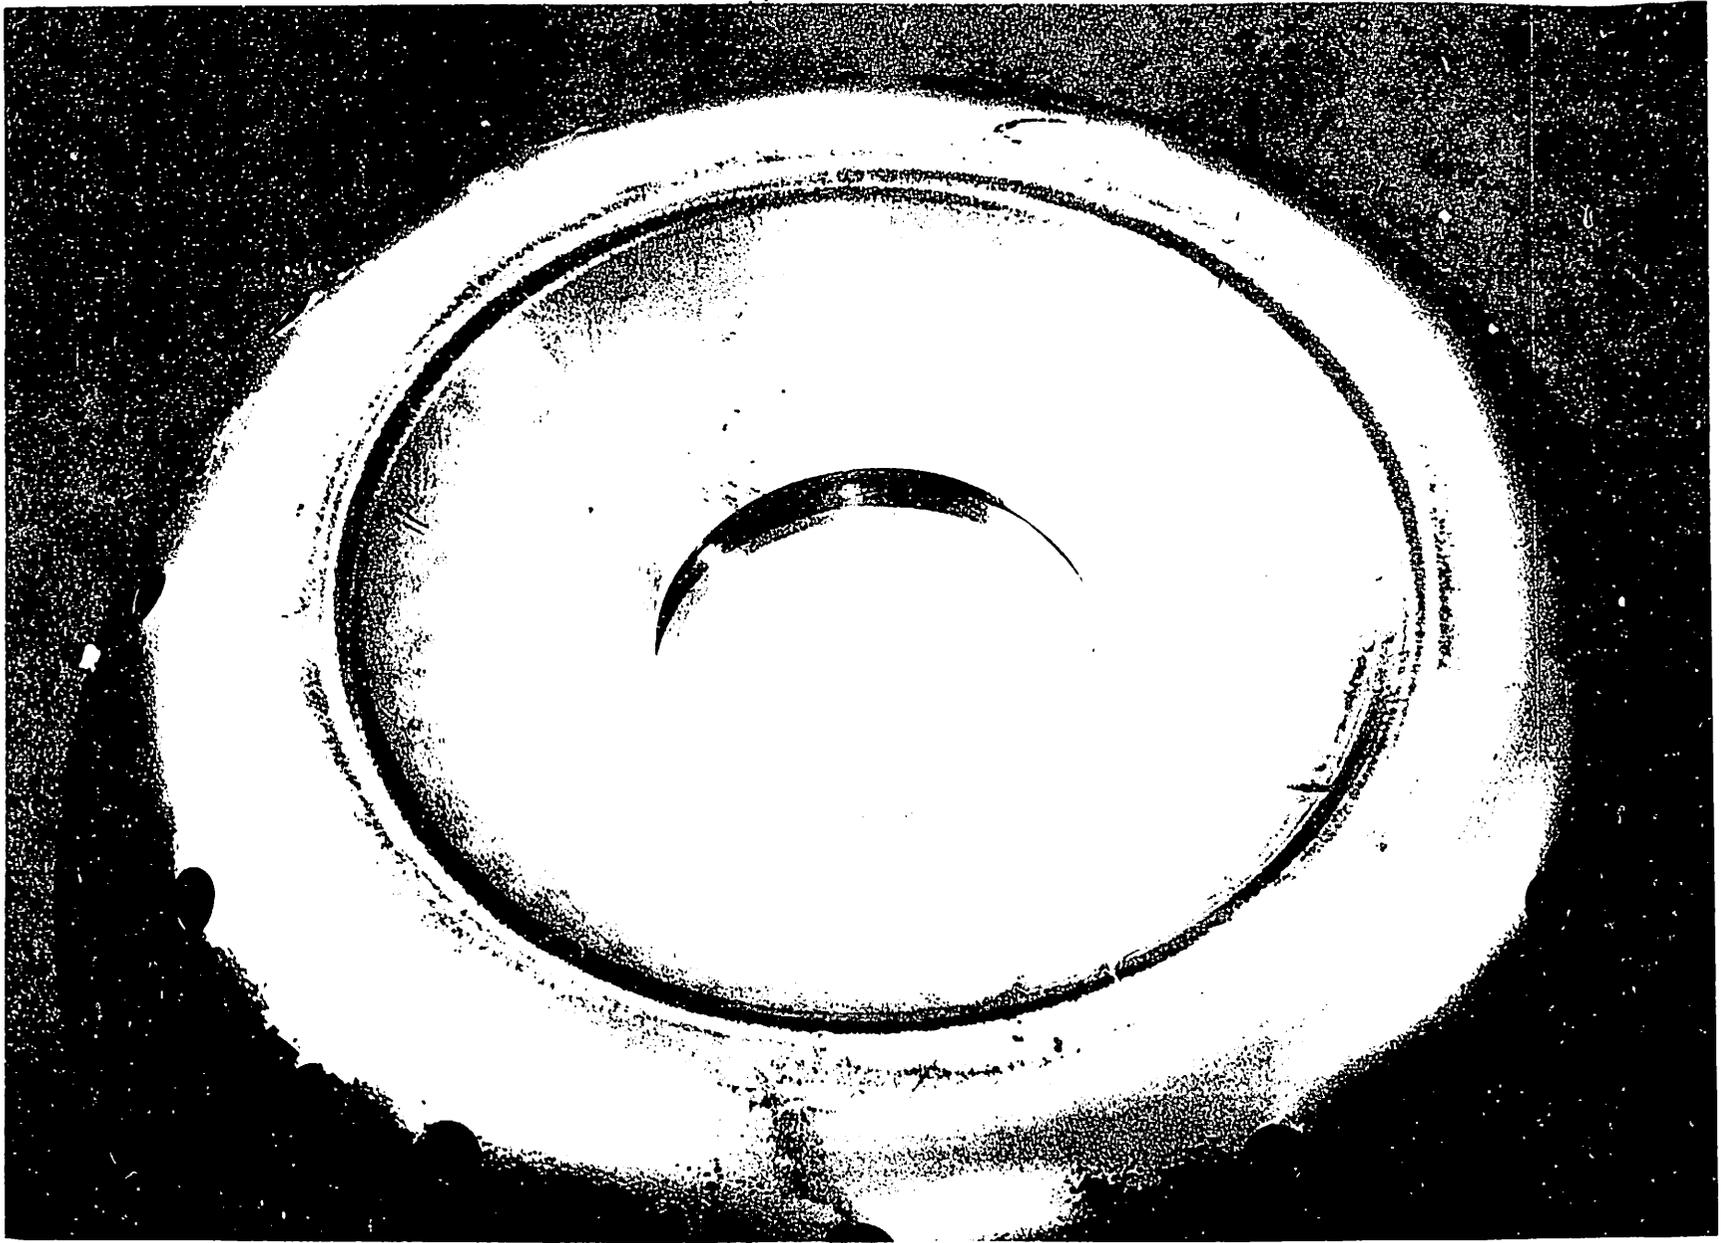
FIG. 9 THIRD TEST UNIT AFTER FAILURE - STATIC TESTS OF HALF-SCALE TX-53 CROSS ROSE.
