SAND2013-0733

# INSTALLATION OF FIVE NEW HYDROGEOLOGIC GROUNDWATER MONITORING WELLS

This Phase I Environmental Baseline Survey (EBS) provides the findings of a survey and assessment for installation of 5 new Sandia National Laboratories (SNL) hydrogeologic groundwater monitoring wells to be located on Kirtland Air Force Base (KAFB), New Mexico. The purpose of this document is to provide information regarding baseline environmental conditions of the proposed sites. This document was prepared in accordance with U.S. Air Force (USAF) policy, as defined by Air Force Instruction (AFI) 32-7066, *Environmental Baseline Surveys in Real Estate Transactions* (1994), as supplemented by the Headquarters Air Force Materiel Command memorandum *HQ AFMC Supplemental Guidance for the Environmental Impact Analysis Process and Environmental Baseline Surveys*, dated 11 April 2011. To ensure that all site conditions are addressed, the American Society for Testing and Materials (ASTM) Standard E1527-05, 2005, "Practice for Environmental Site Assessments: Phase I Site Assessments"; E1528-06, 2006, "Standard Practice for Limited Environmental Due Diligence: Transaction Screen Process"; and ASTM Standard

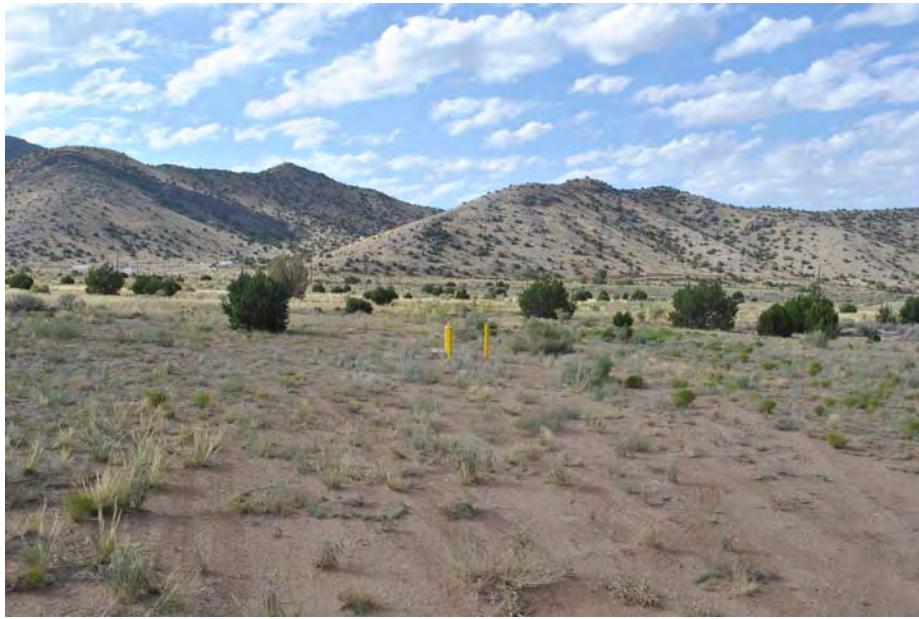
Photograph D-1. Site A looking south toward well CCBA-MW1.

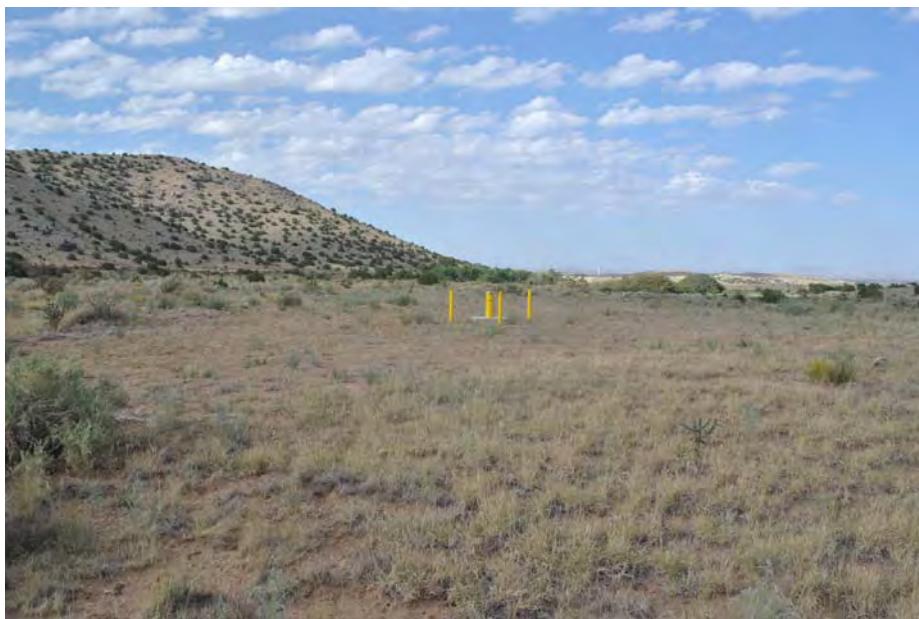
Photograph D-2. Site A looking southwest toward well CCBA-MW2.

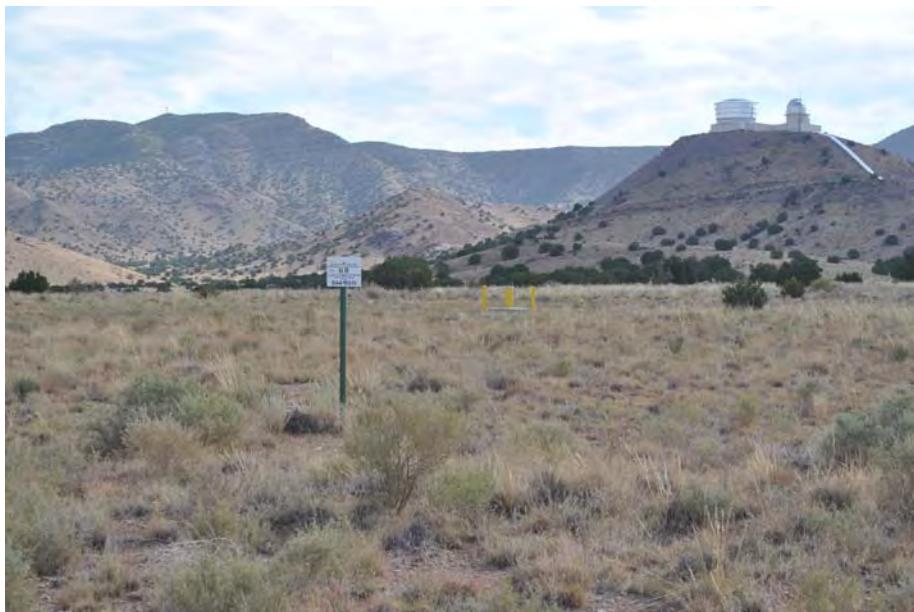
Photograph D-3. Site B looking east toward well OBS-MW3.

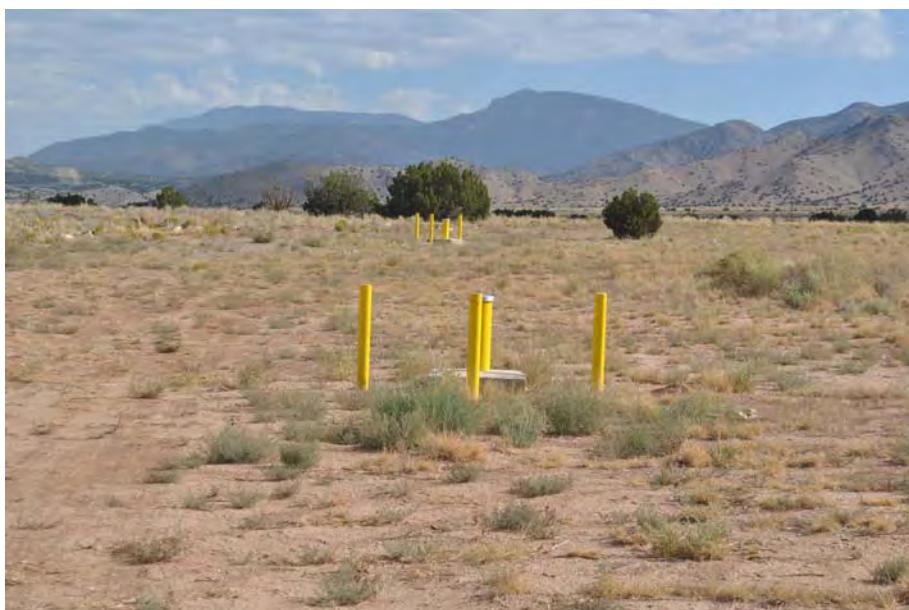
Photograph D-4. Site B looking northeast toward wells OBS-MW1 and 2.
