In-situ Observations and Measurements of Thread Failure in Thin Walled Aluminum Alloy Joints

Bonnie R. Antoun¹
Gerald W. Wellman²
J. Franklin Dempsey²
Spencer Grange²
Kevin Connelly¹
Helena Jin¹
John S. Korellis¹

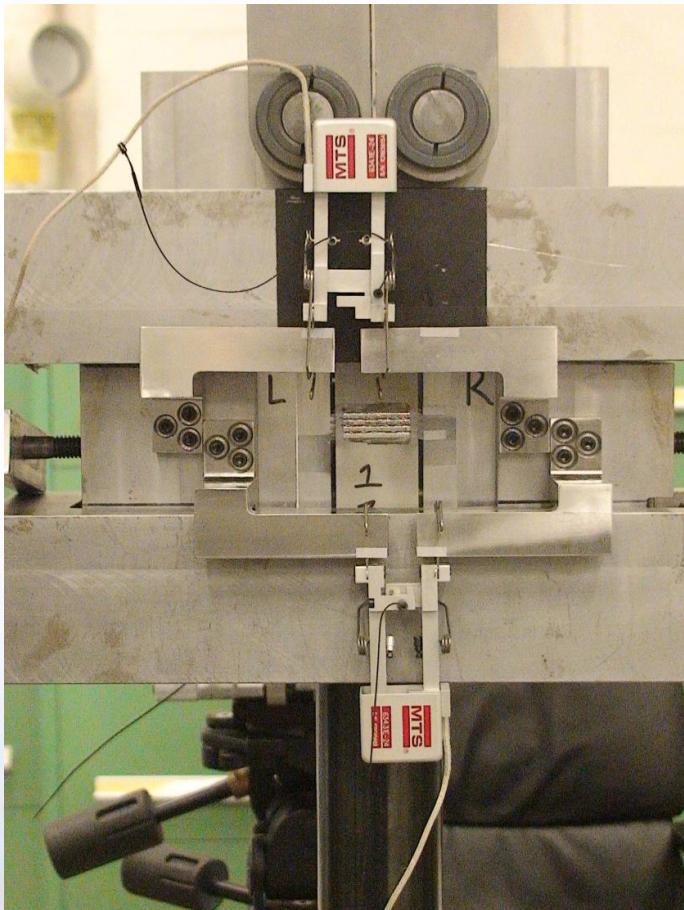
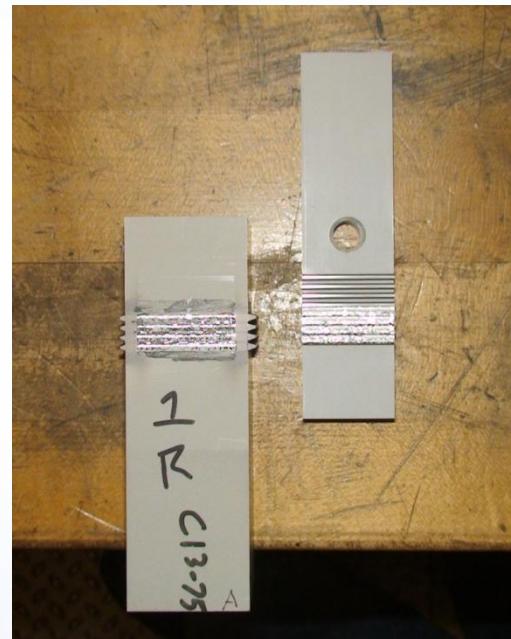
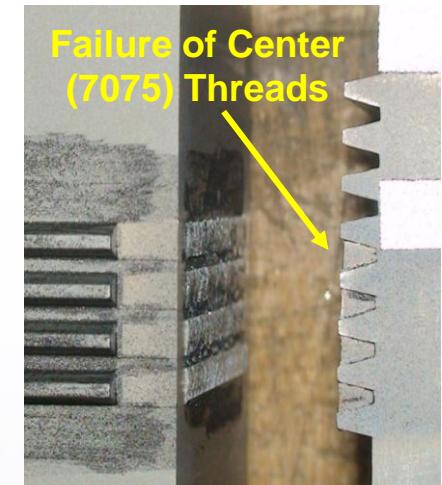
TEST #5 7050-T74 side threads, 7075-T7351 center threads

- Thread failure by shear mechanism.
- 7075 (center threads) failed due to lower strength relative to 7050 alloy

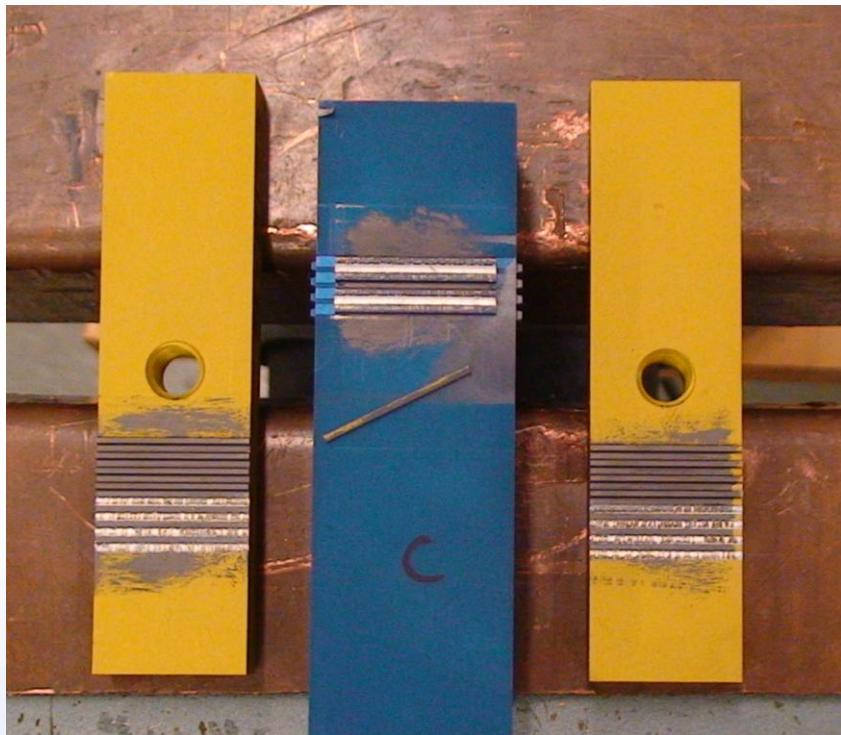
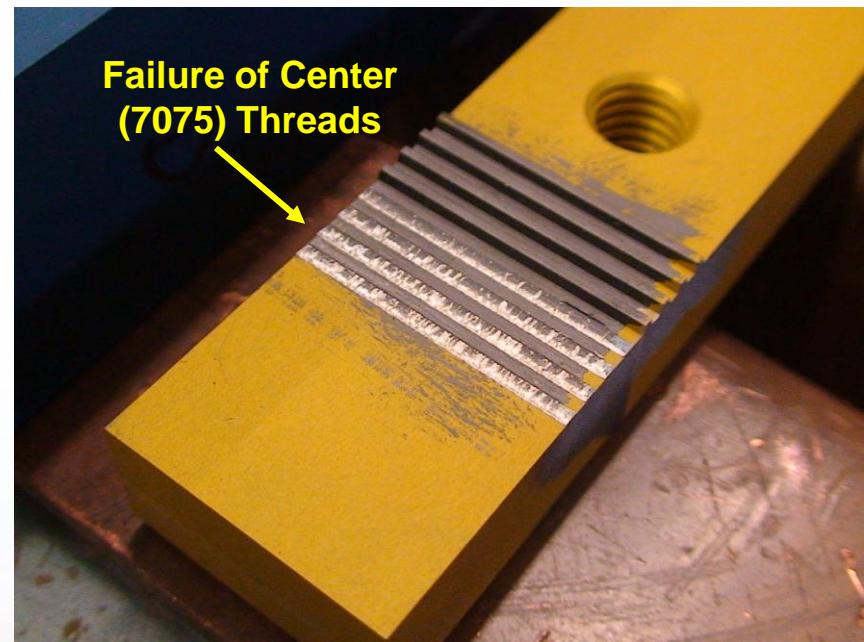
TEST #9A 7075-T7351 side threads, 7050-T74 center threads

- Thread failure by shear mechanism.
- 7075 (side threads) failed due to lower strength relative to 7050 alloy (center threads)
