Title: Associate Directorate Environmental Management Infrastructure Plan for
Area G and Area L Domes

Associate Directorate Environmental Management Infrastructure Plan for Area G and Area L Domes

13 September 2017

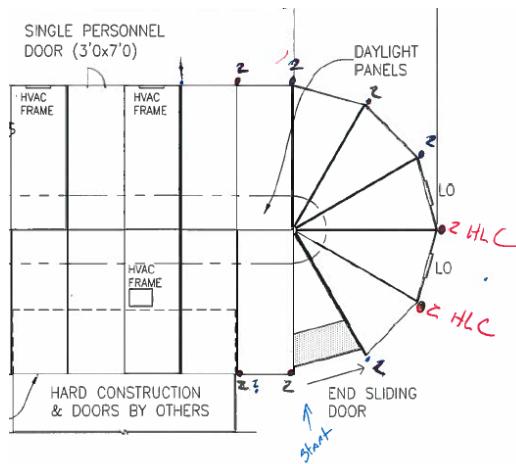
Dome 33 bolt location.

Dome 33 has 6 Hilti bolts. The hold down capacity has been identified as marginal as a result of the engineering study. It is recommended that the bolts be replaced because the bolts do not meet current LANL building standards. Two of the 6 bolts are mounted on a supporting wall and are not part of the anchoring system and thus not a concern of engineering. The remaining 4 bolts are located on the east side of the dome, see below diagram note 2 HLC -HX and anchor 2 metal plates.

The two plates will be replaced by cutting off the existing bolts and fabricating 2 new anchoring plates. The new anchoring plates will then be anchored with Hilti M12 HSL (laboratory standard) and are included in the cost.

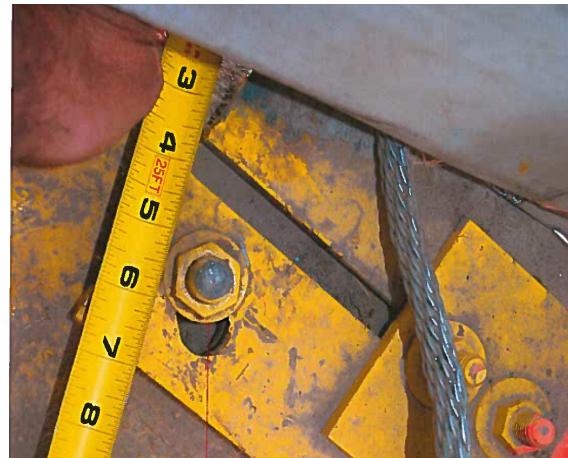
Bolt requiring replacement.

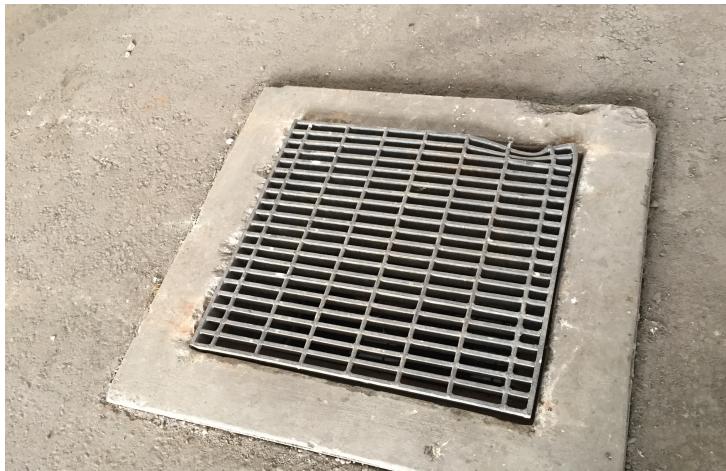
Dome 224 sump access.
