North Slope of Alaska ARM Facilities
Monthly Status Update
Sandia National Labs

November 2016

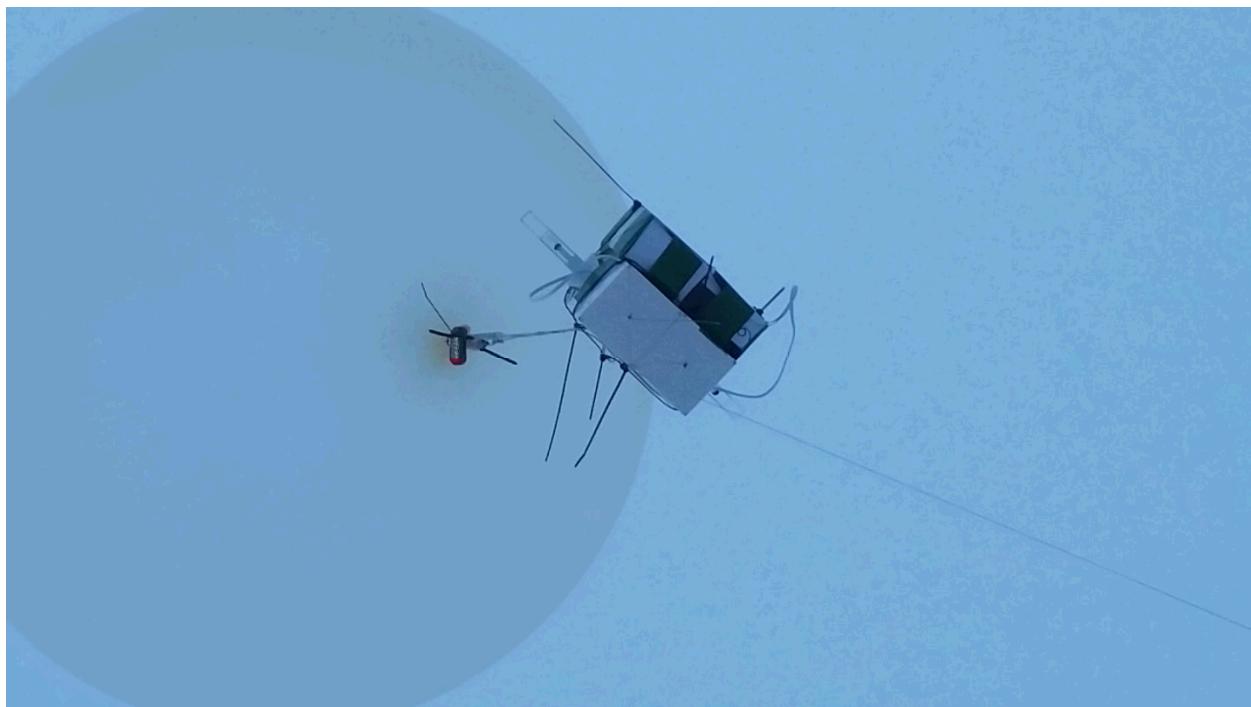
Cloud base was about 100 m, cloud top was 500 m, and there was heavy icing. Flights were conducted with the autoreeler and a sonde balloon filled to the standard 1,600L. There was too much drag created by flying two iMet sondes and SLWCs back to back with the 1,600L balloon. Flights could not maintain 200m AGL.

Figure 1: Original side-by-side configuration with 1,600L balloon was unsuccessful

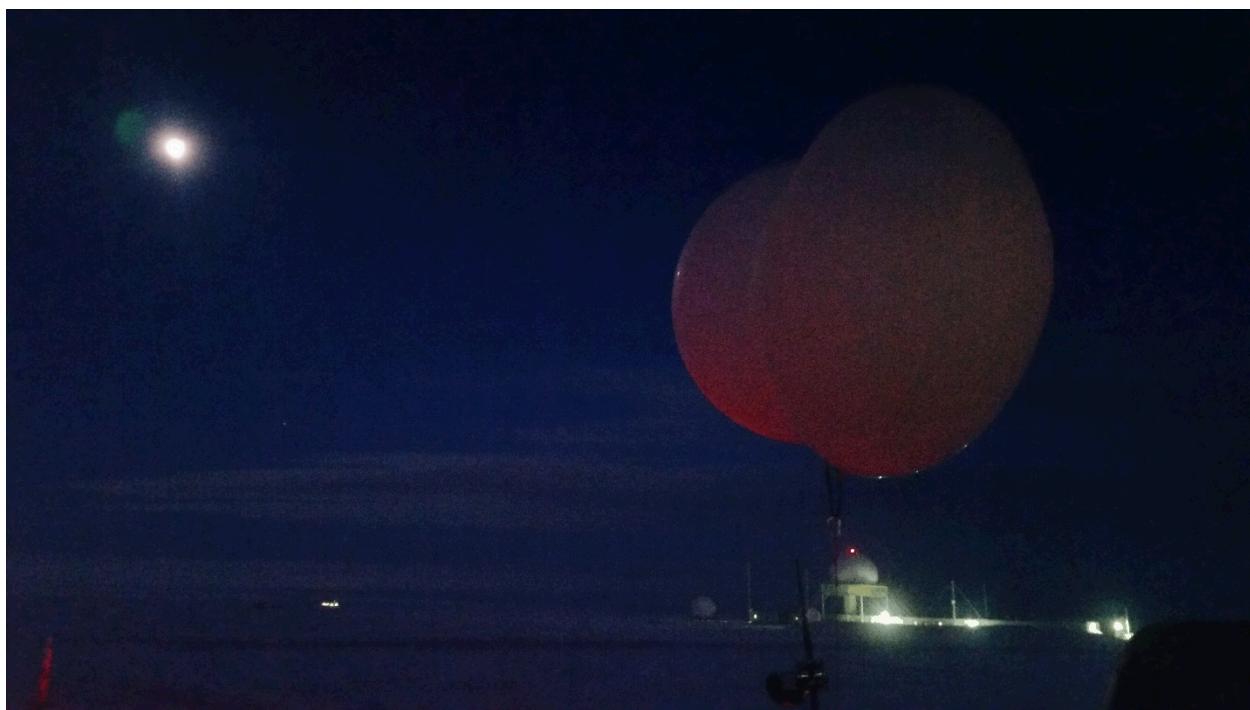
The autoreeler struggled on the way in, two balloons together created a lot of surface area and drag.

Figure 4: 2,215L and 1,600L sonde balloons prepared for flight on 11/17/16

Overall the autoreeler proved to be a cost-effective and low-risk method of obtaining TBS data from lightweight, inexpensive sensors. To improve the autoreeler motor strength we would like to replace the 12 V motor with a 24 V and increase the braid (line) strength to 250 lb in 2017. The cost for this would be \$525.

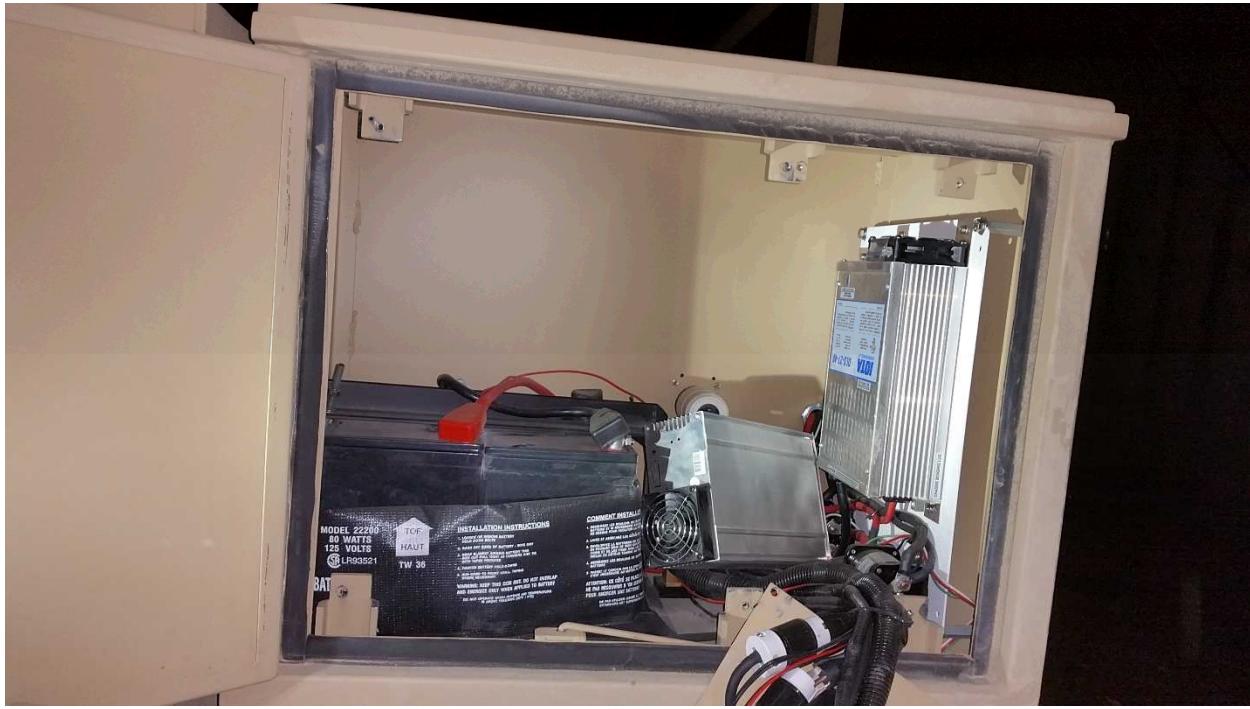
The winch motor on the aerostat trailer failed on the last day of flights in October. The motor was shipped to Albuquerque and it was revealed that all of the windings were burnt and it would be more cost-effective to purchase a new motor than to repair it. We believed that the windings had burned due to insufficient current output from the battery bank on the winch trailer.

When in Oliktok we investigated the batteries and determined that the welds on one of the battery charger mounts had broken and as a result the charger had unplugged and was not charging one of the batteries. Both batteries also tested poorly on a load tester

and were charged and removed to warm storage for the winter. The trailer was taken to CH2MHill in Deadhorse for repair and there it was found that the welds on the second battery charger were also about to fail. Both chargers were remounted.

Figure 5: Broken charger behind panel on aerostat trailer
