## Materials compatibility in Dish-Stirling Solar Generators using Cu-Si-Mg eutectic for latent heat storage

A.M. Kruizenga, E.A. Withey, C.E. Andraka, and P.J. Gibbs

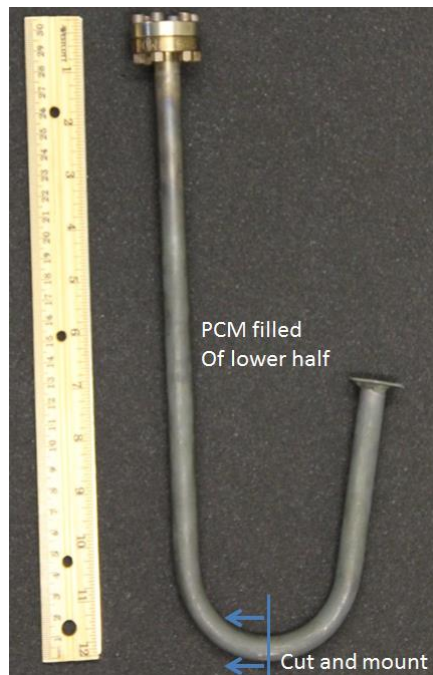
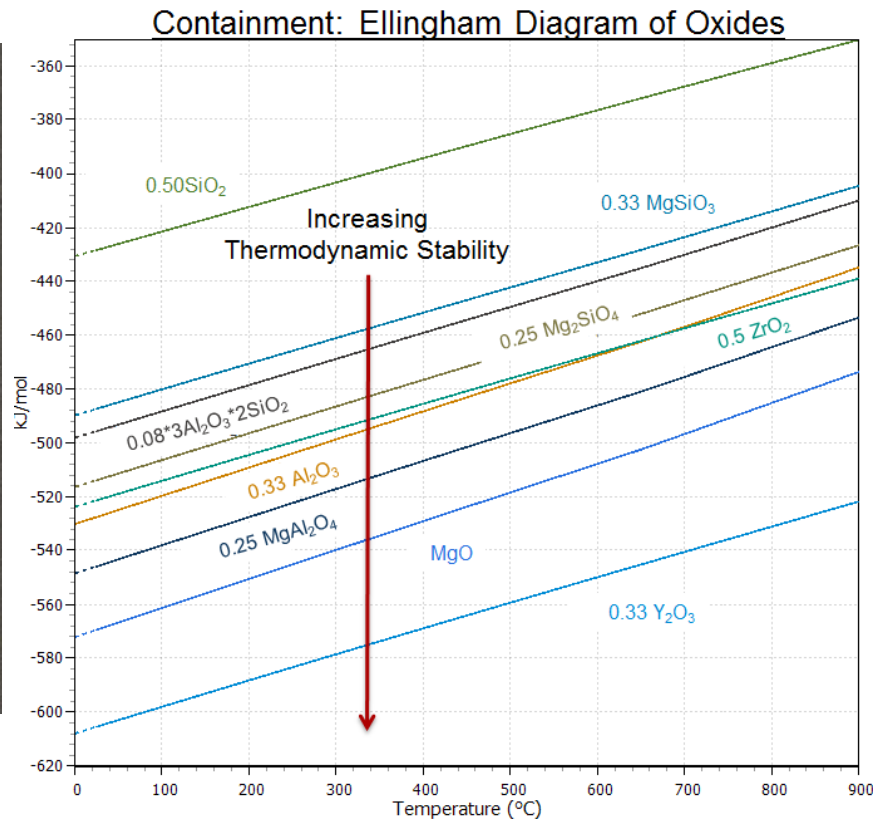
- Alloying is rapid
- Nickel dissolved into solution
- 30% wall thickness lost in 6.5 days

Need to choose materials based on lowest energy of formation to prevent material degradation.

Tests using best available thermodynamically compatible materials were pursued.

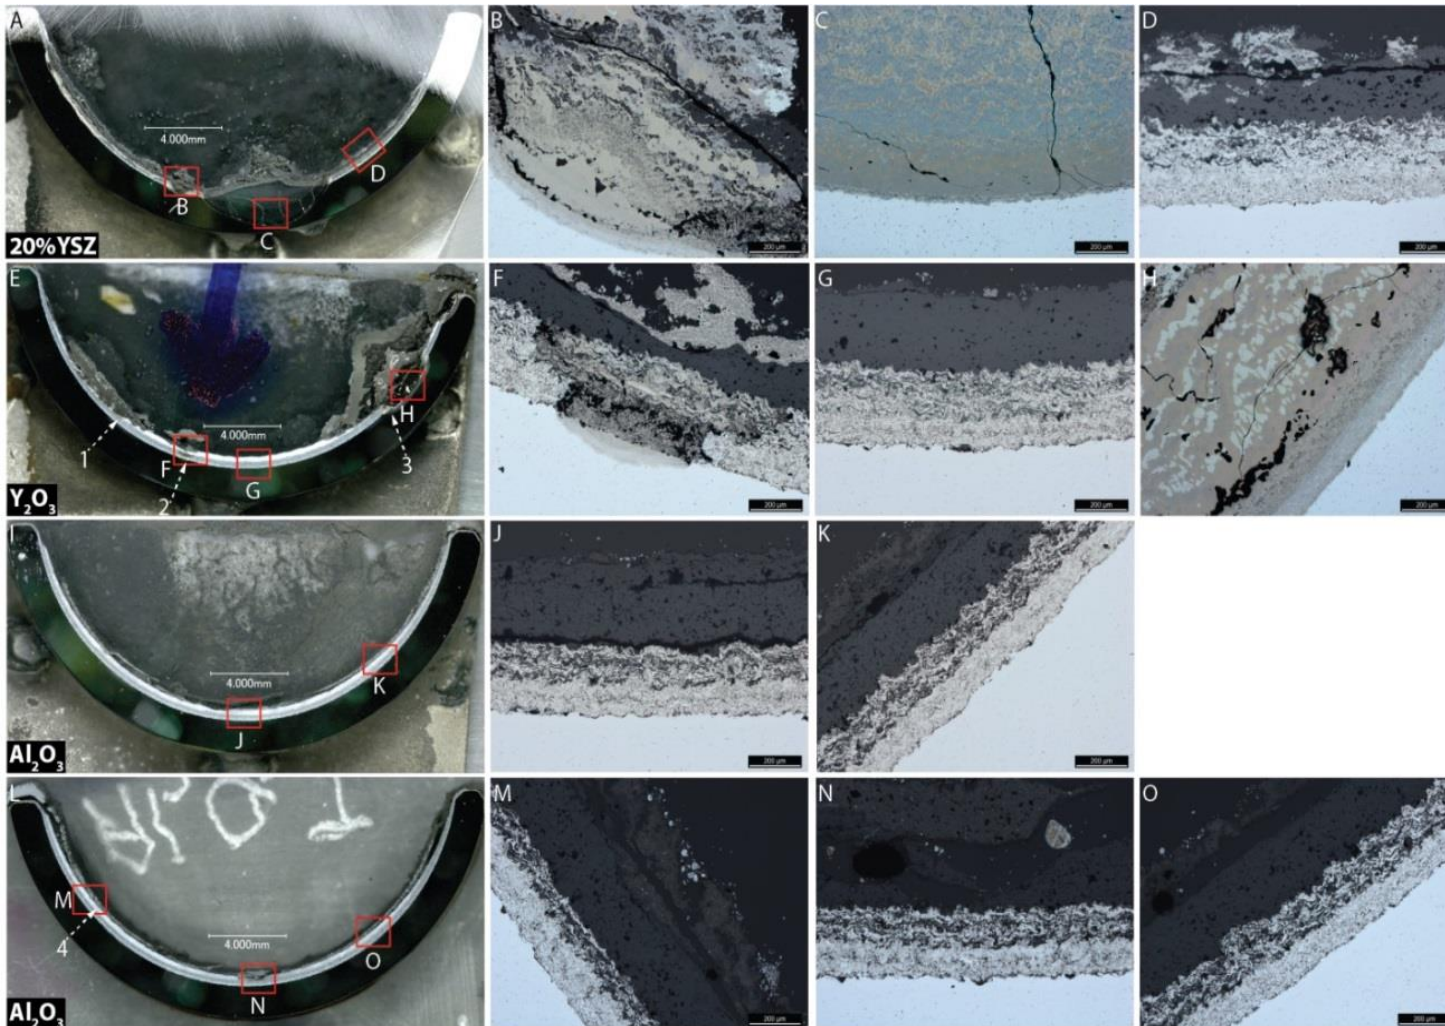
# 820°C, 500 hour results

20% YSZ analysis:

Large Failures in 20%  
YSZ coating

Y<sub>2</sub>O<sub>3</sub> analysis:

Varying failure sizes  
were over the Y<sub>2</sub>O<sub>3</sub>

Al<sub>2</sub>O<sub>3</sub> analysis:

No failures in Al<sub>2</sub>O<sub>3</sub> after  
investigating several  
locations

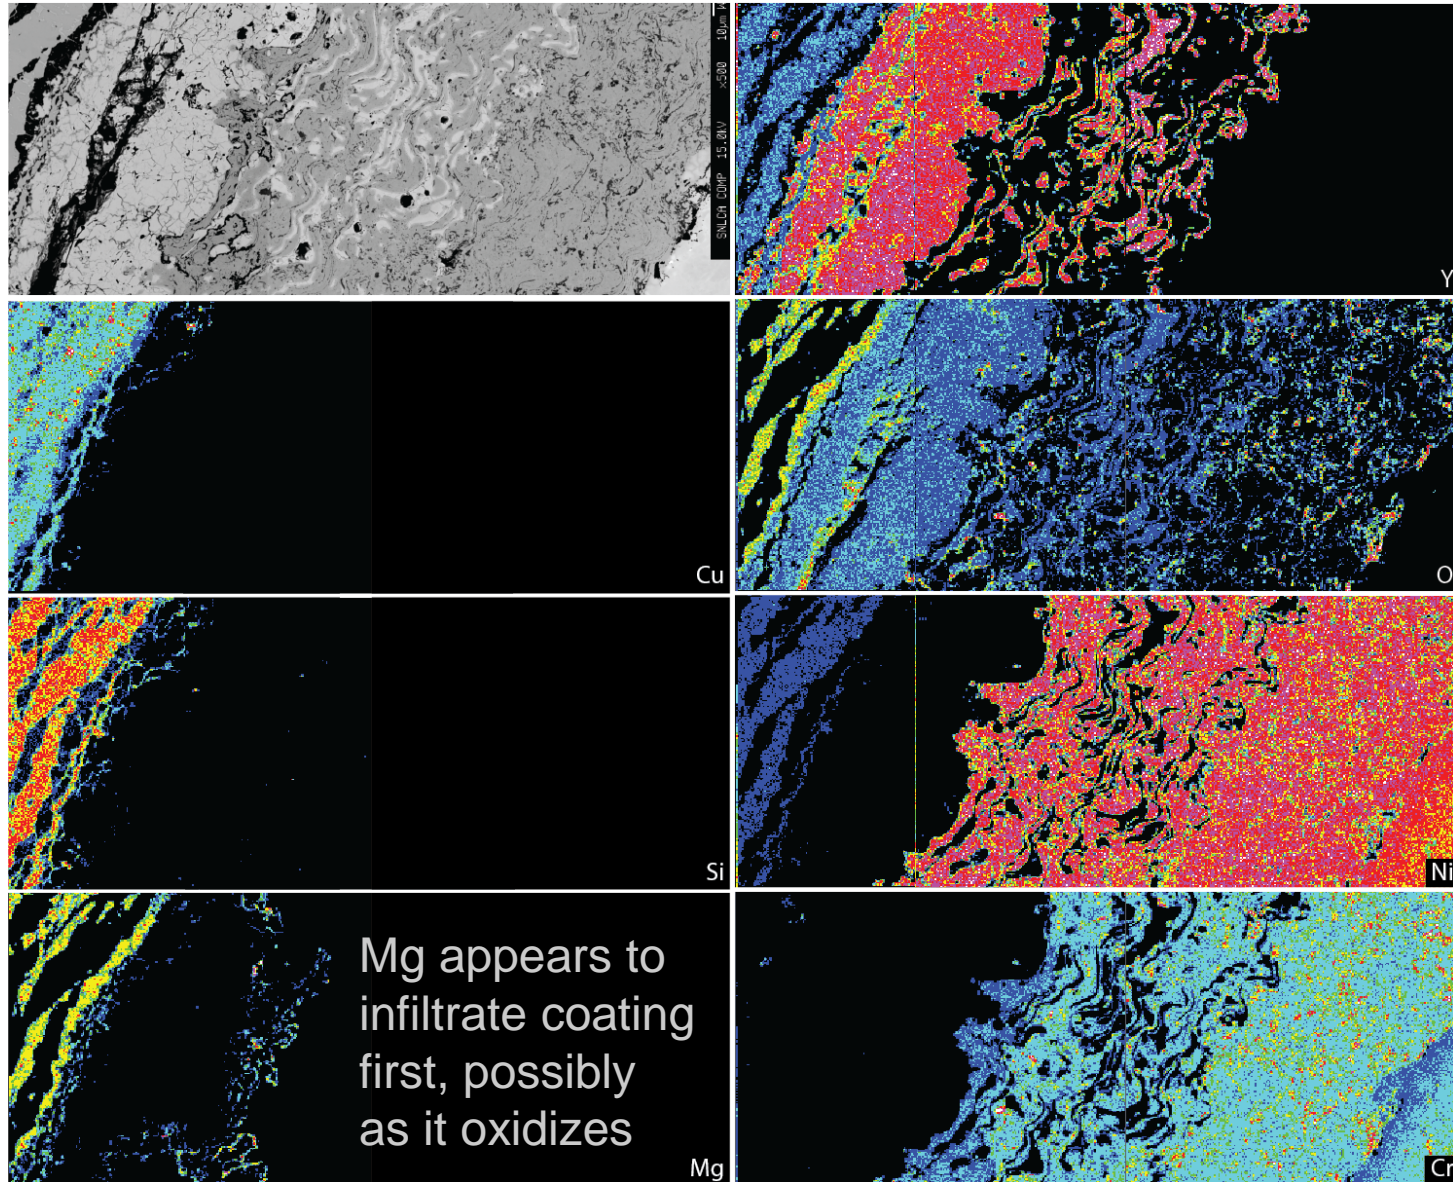
# Y<sub>2</sub>O<sub>3</sub> Area 1: Beginning of interaction

**Tentative Conclusion:**  
Mg infiltrates Y<sub>2</sub>O<sub>3</sub> as it oxidizes and leaves easy pathway for Si infiltration

- $Y_2O_3 + 3Mg \rightarrow 3MgO + 2Y$  will result in equilibrium amount of MgO since low driving force in either direction
- Conversion of Y<sub>2</sub>O<sub>3</sub> to MgO results in open porosity for Si easily infiltrate and attack Haynes 230

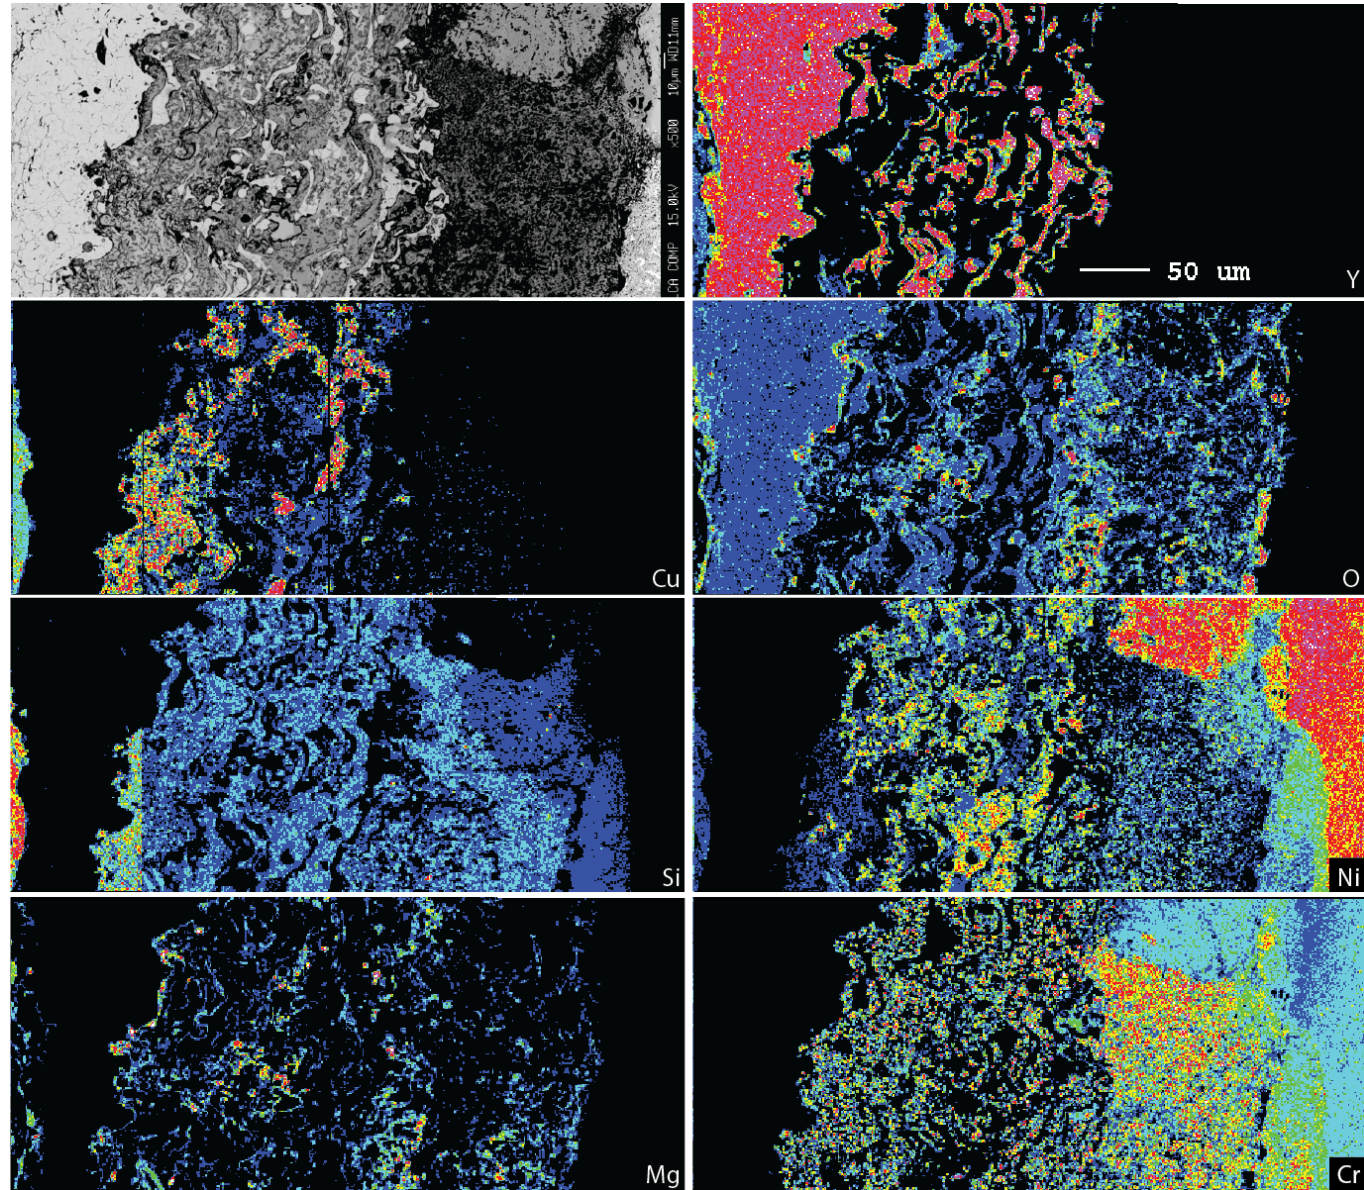
# Y<sub>2</sub>O<sub>3</sub> Area 2: Early Diffusion Layer

In areas of further attack, Si more invasive than Mg

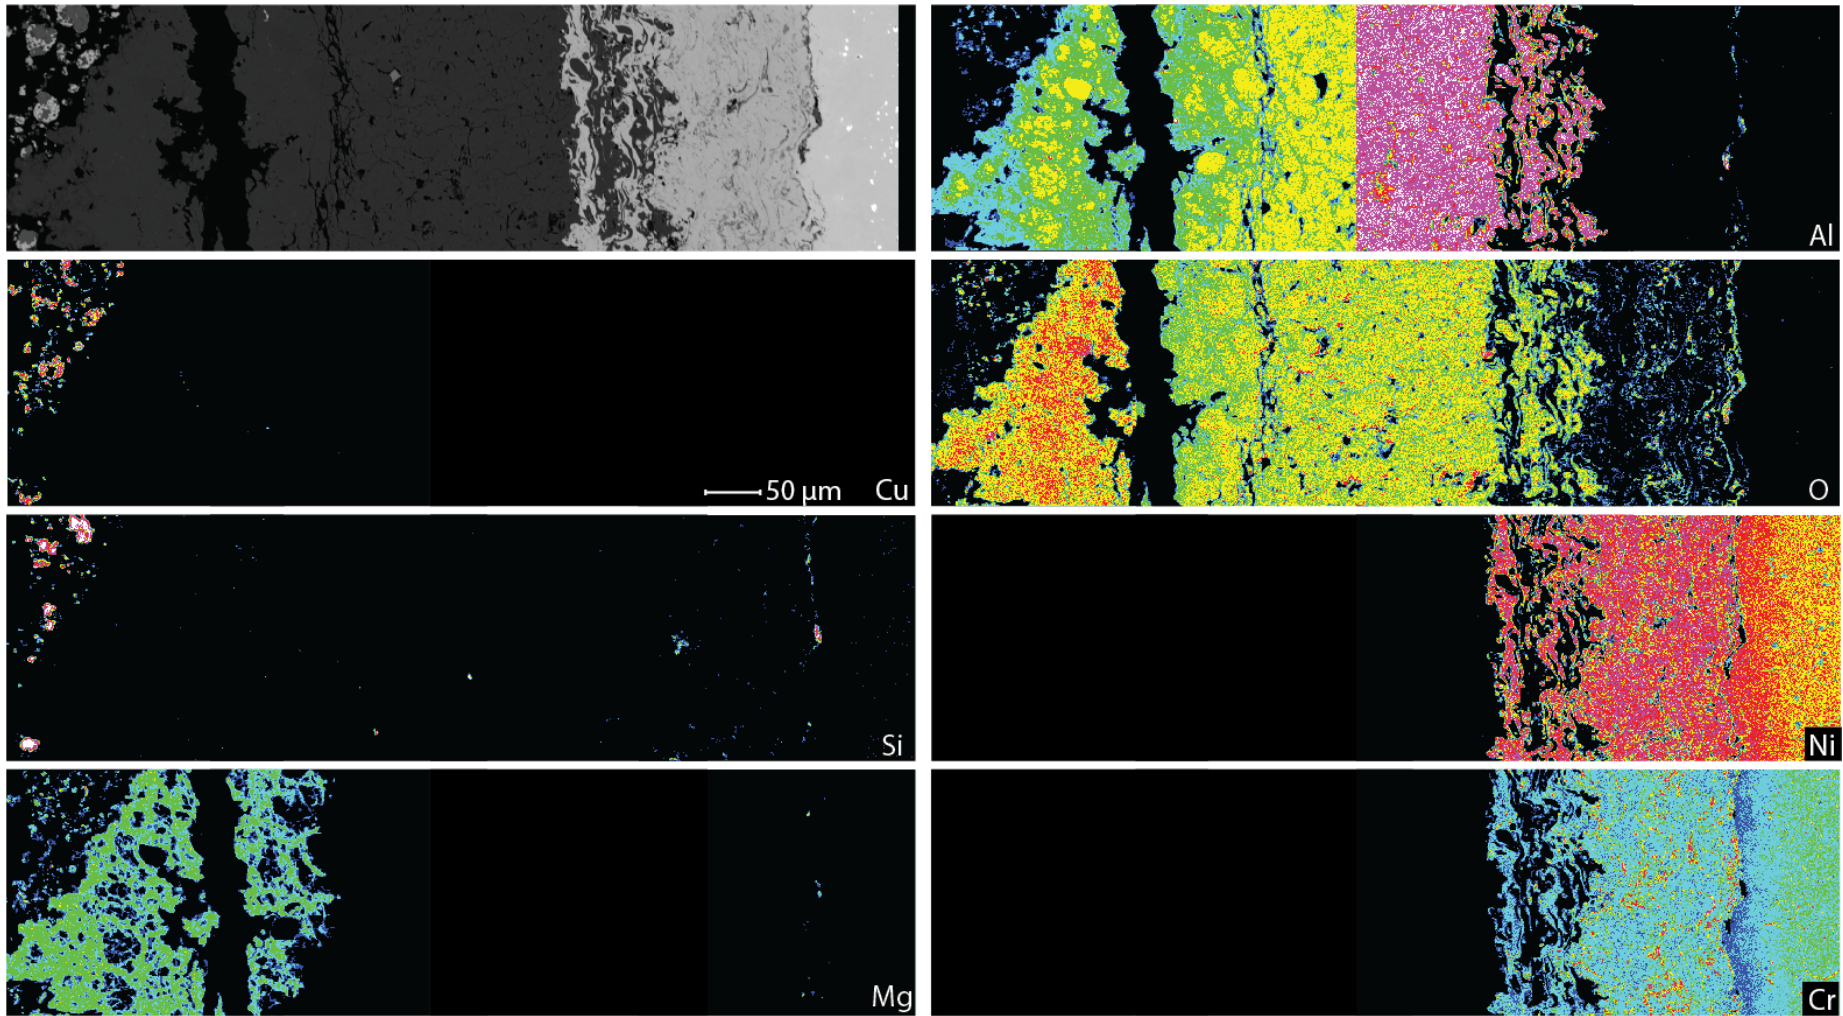
# Surface Film on $\text{Al}_2\text{O}_3$ Coating

Mg reacts with  $\text{Al}_2\text{O}_3$  to form compound oxide, most likely  $\text{MgAl}_2\text{O}_4$   
 $\text{MgAl}_2\text{O}_4$  likely behaves as a kinetic barrier that slows elemental diffusion

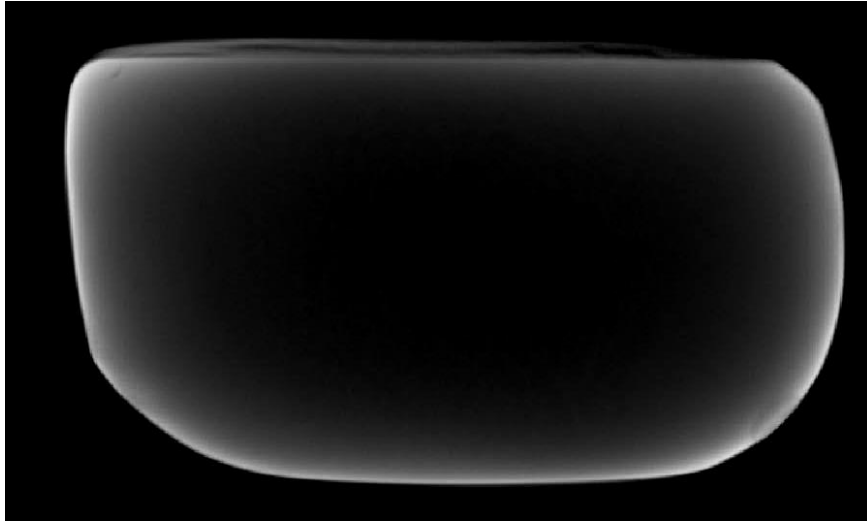
Alumina Scan

Some areas of interest were observed on the alumina

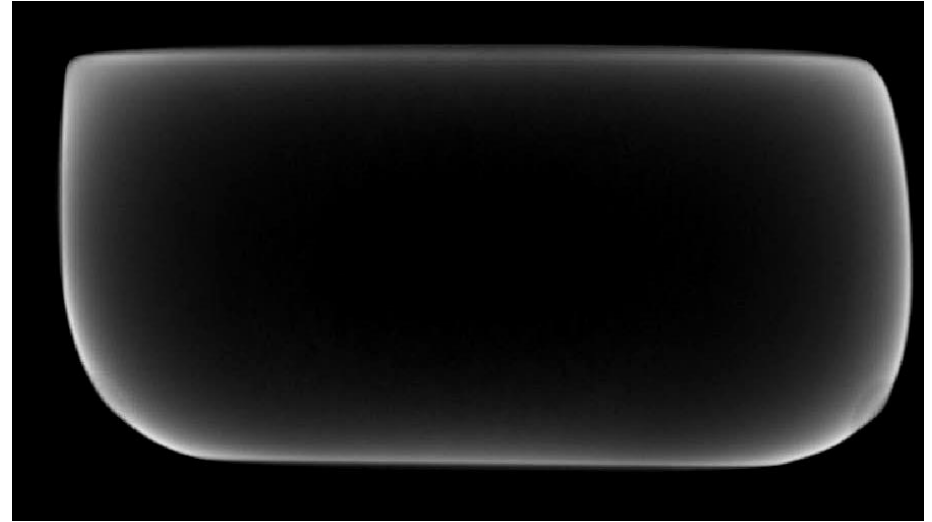
Spinel Scan

No obvious defects were observed on spinel samples

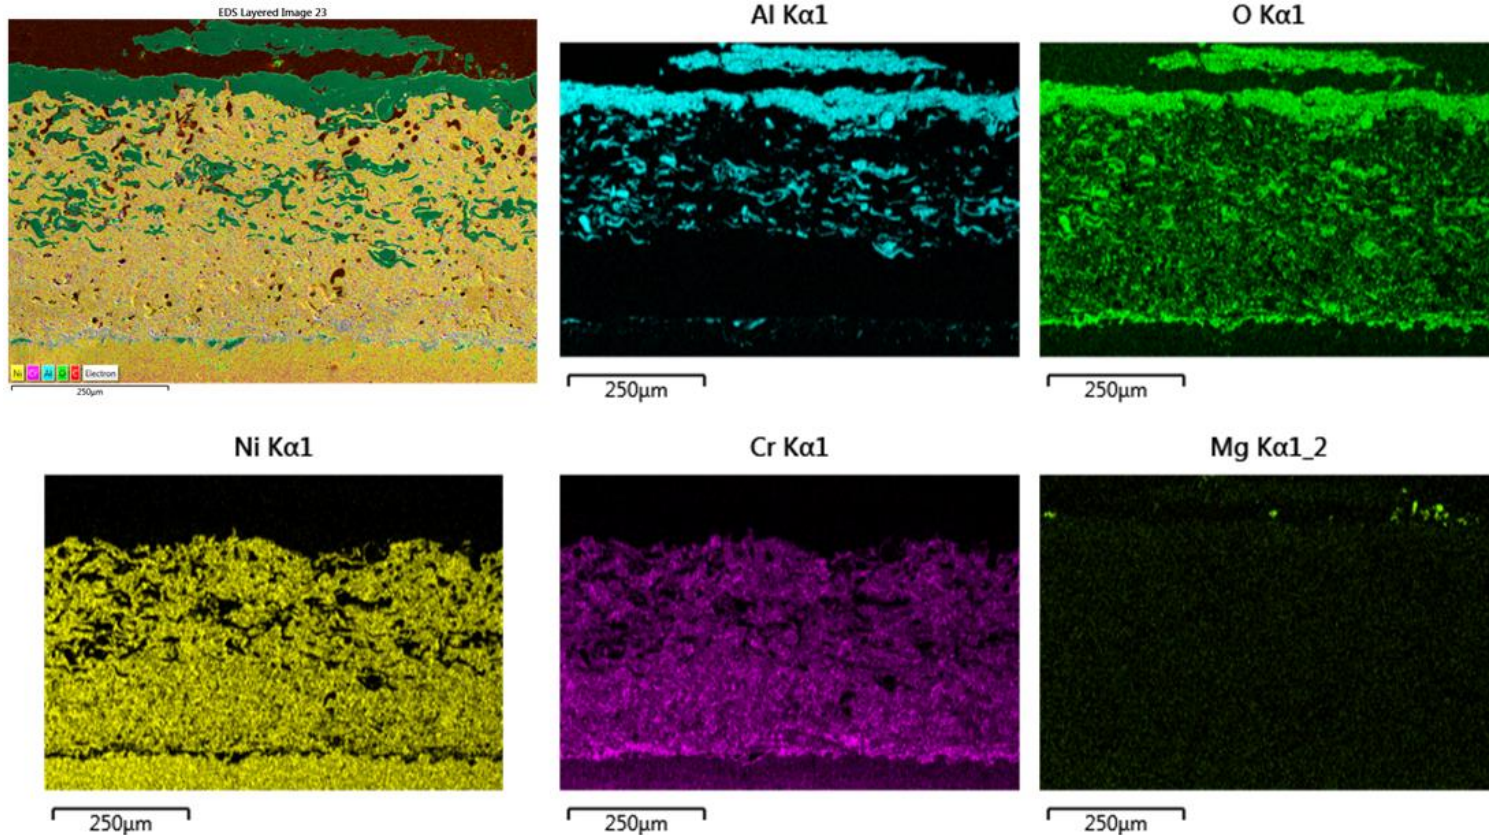
# Alumina microscopy

- Pure alumina outer layer were found to be relatively thin
- Low Mg content indicates no PCM contact, therefore thin initial coating
- Transition layer of Ni/Cr was found to have oxygen present (likely chrome oxide)

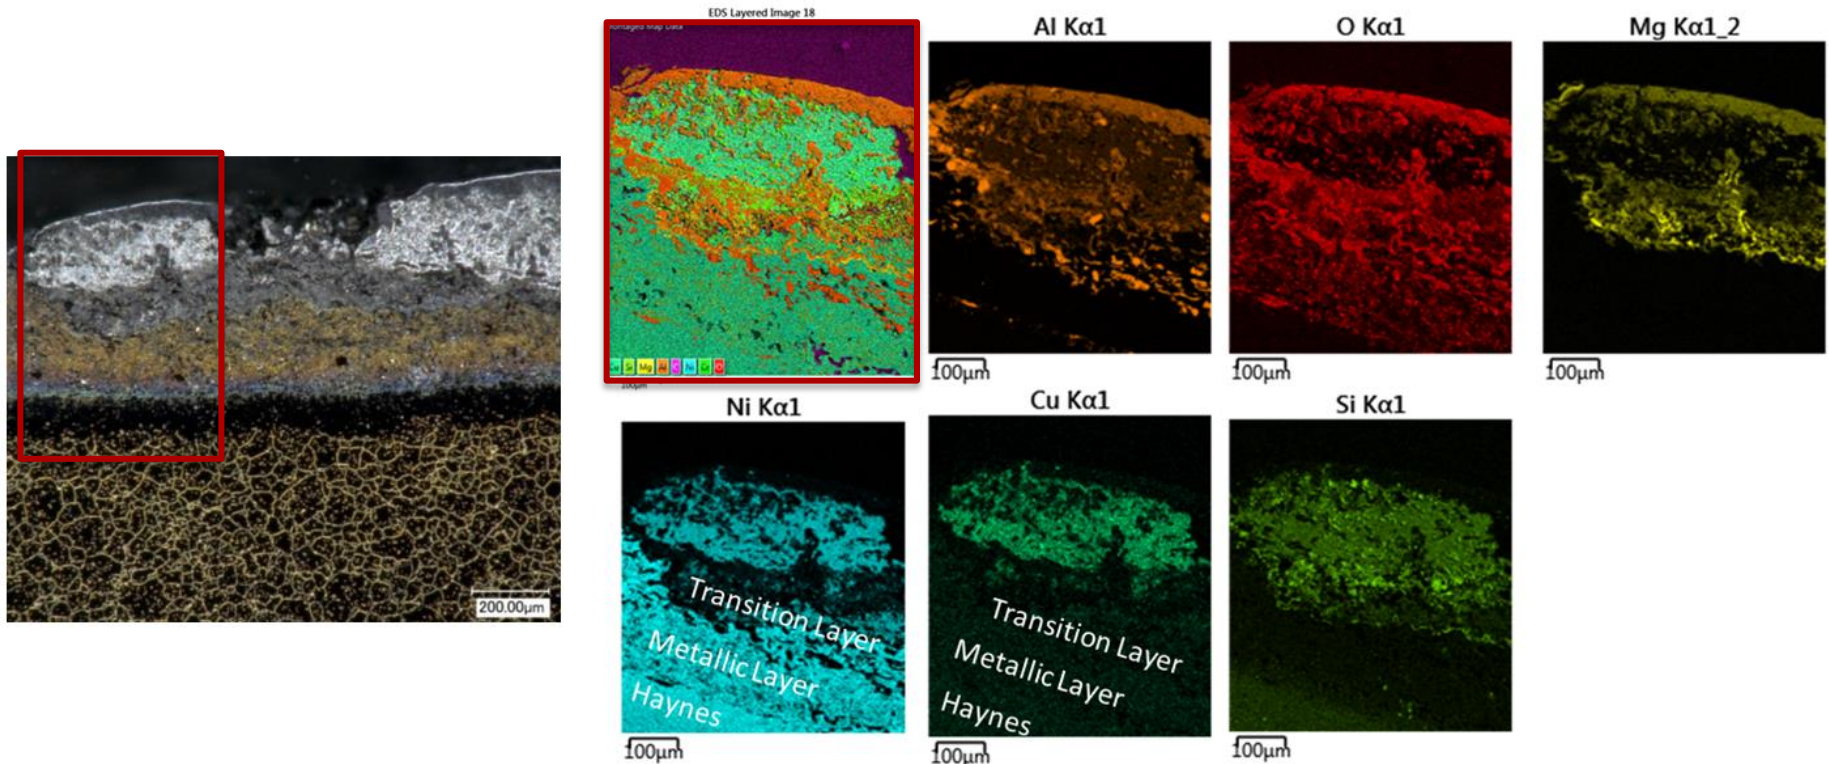
# Localized Attack Observed

## Local attack:

- PCM penetration of the alumina resulted in interaction with the transition layer:
  - Mg reaction with alumina – likely forming spinel
  - Cu/Si reaction with Ni (as observed in previous studies)
- Unclear if attack resulted from an initially thin region or acute chemical attack
