**Environmental Baseline Survey**

July 2017

# **Environmental Baseline Survey for Installation of Five New Hydrogeologic Groundwater Monitoring Wells**

Prepared by  
Sandia National Laboratories  
Albuquerque, New Mexico 87185 and Livermore, California 94550

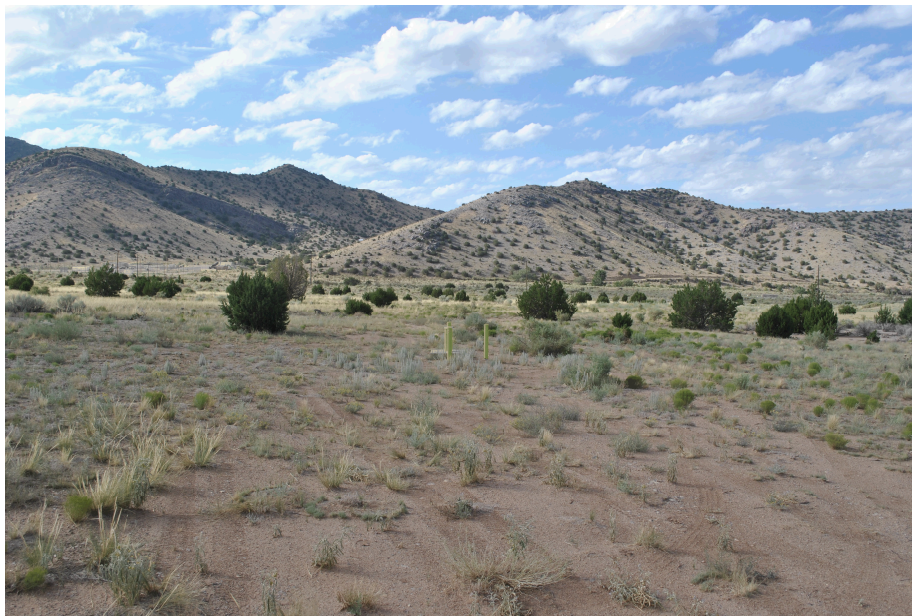
Photograph D-1. Site A looking south toward well CCBA-MW1.

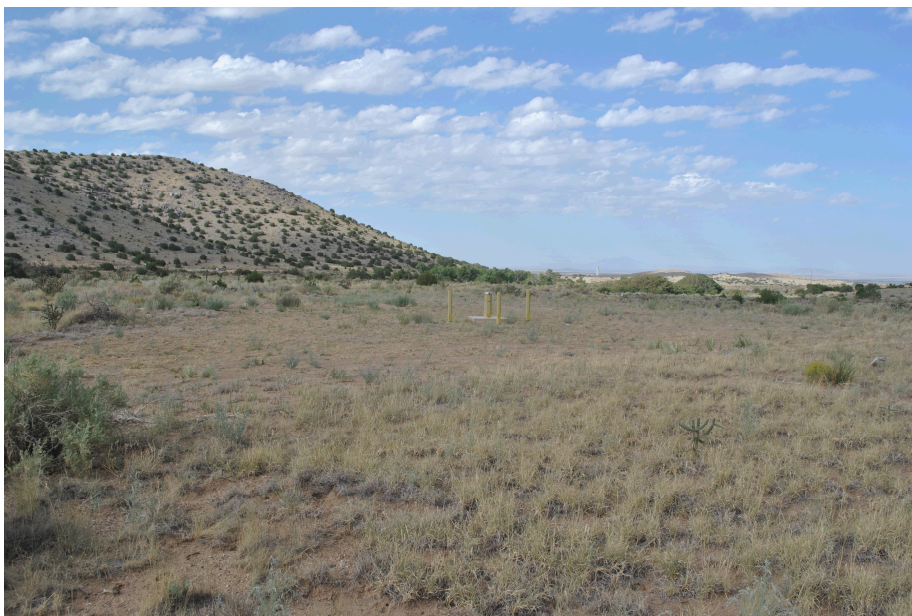
Photograph D-2. Site A looking southwest toward well CCBA-MW2.

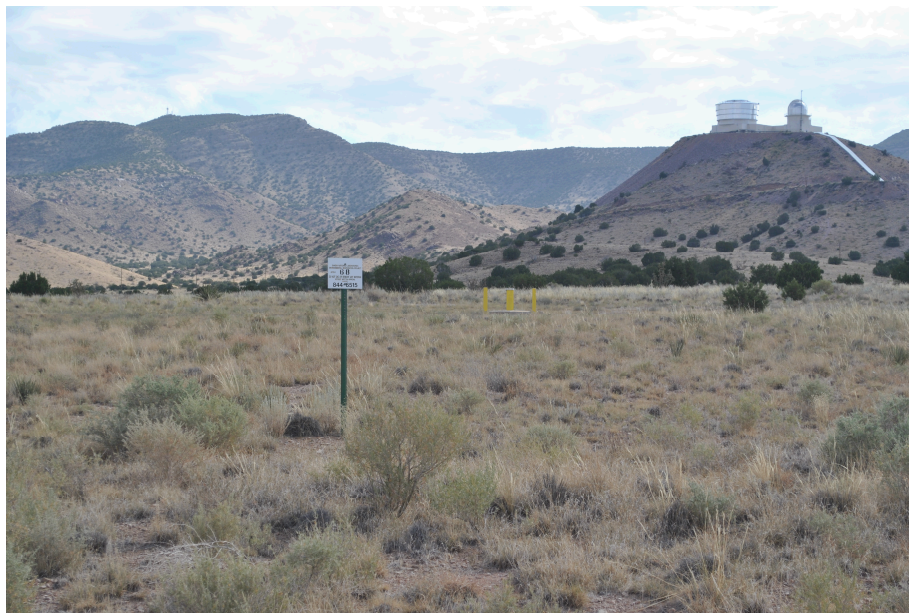
Photograph D-3. Site B looking east toward well OBS-MW3.

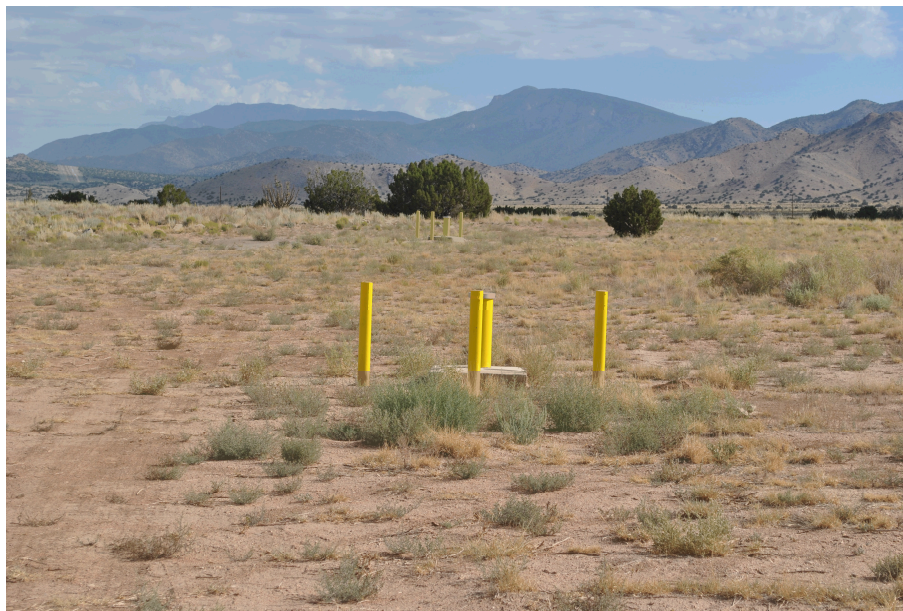
Photograph D-4. Site B looking northeast toward wells OBS-MW1 and 2.
