GaN MISFET Trench Edge Calibrations

Caleb E Glaser – NSME PhD Student

Goal of work : Determine cause of trench edge curvature and prevention

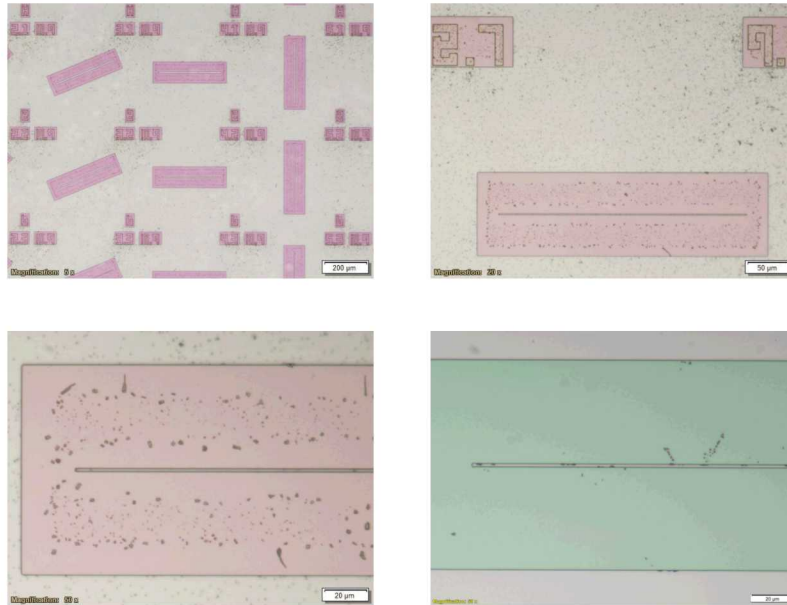
Step 9
GaICP GaN NPN Etch

Difference in color on devices is due to varying SiN thickness.

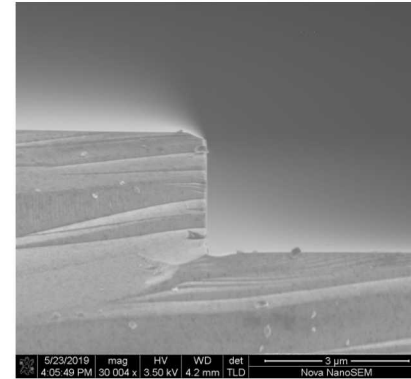
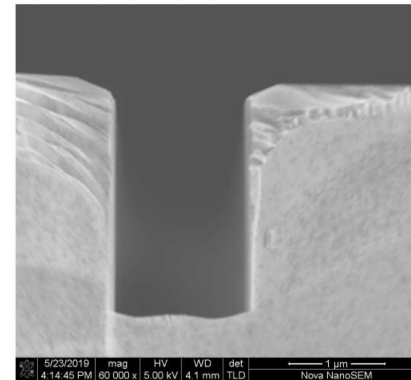
RIE+GaICP+10 min AZ 400K

Cause of curved edge → AZ 400K developer

Increased time in solution → Increased edge curve

- Increase thickness of N layer and reduce AZ 400K time
 - Reduces impact of curve and distance etched into P layer
 - Maintain removal of etch damage
- Crystallographically oriented alignment marks
 - Etch alignment marks to exposed plane for alignment of subsequent mask layers
 - Can be very difficult to reach maintain adequate alignment

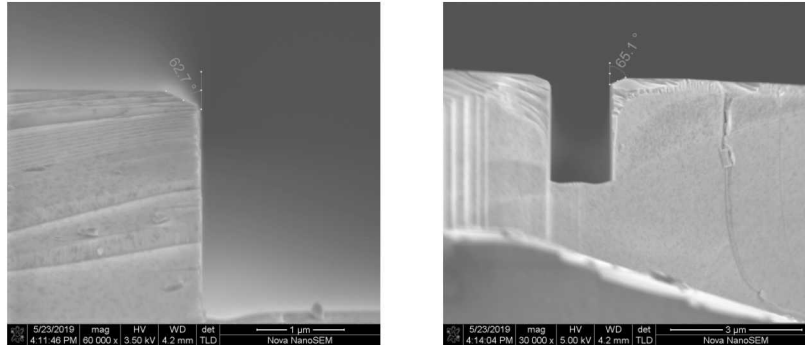
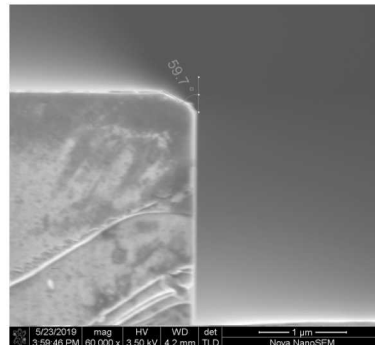
10 min AZ 400K

Mean angle $\approx 63^\circ$

Angle of trench edge remains constant with increasing AZ 400K treatment time

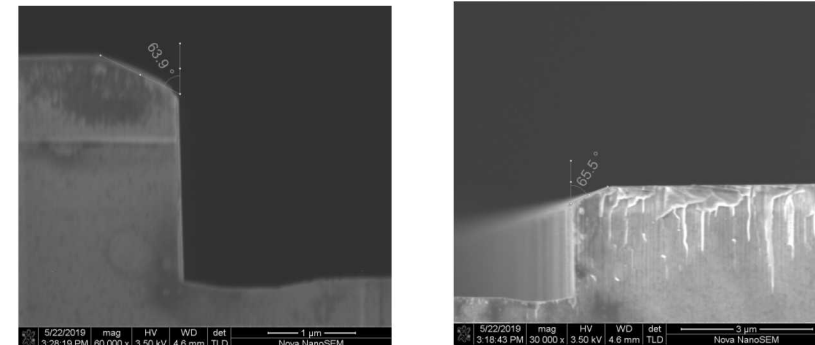
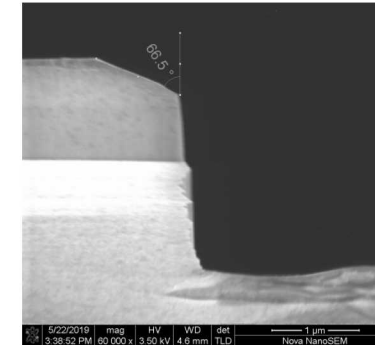
60 min AZ 400K

Mean angle $\approx 65^\circ$

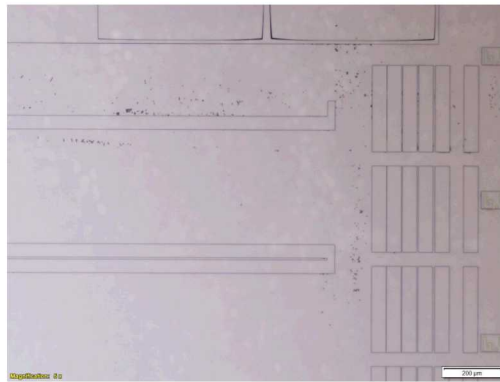
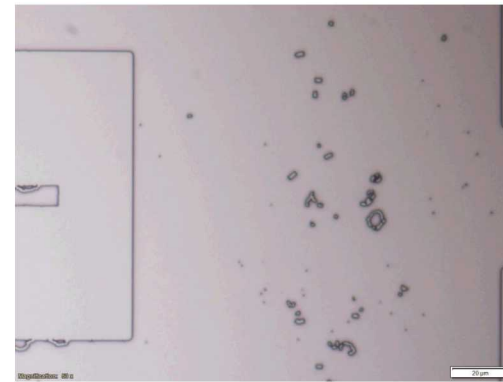
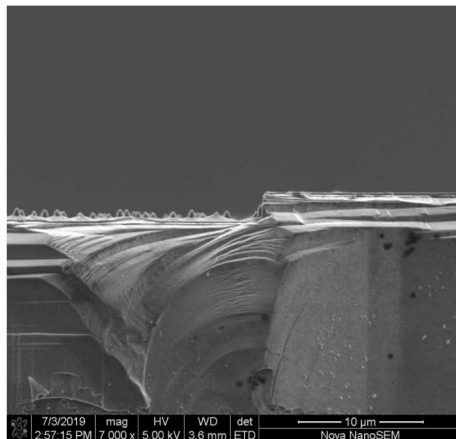
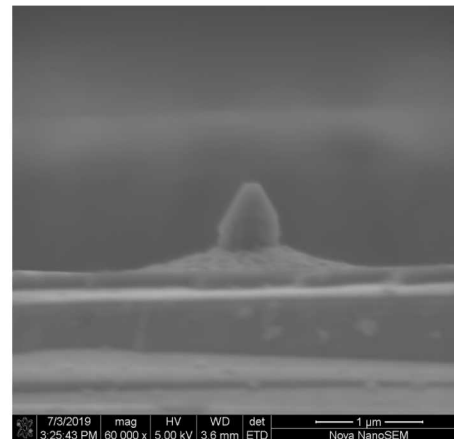
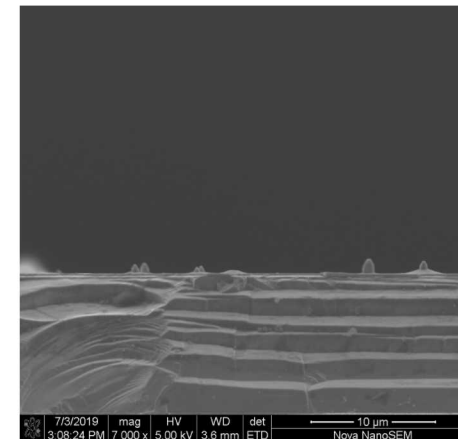
- Pyramidal/cone-shaped contaminants found along trenches after HF SiN removal
- Contamination uniform across wafer, but increased near devices parallel to wafer flat

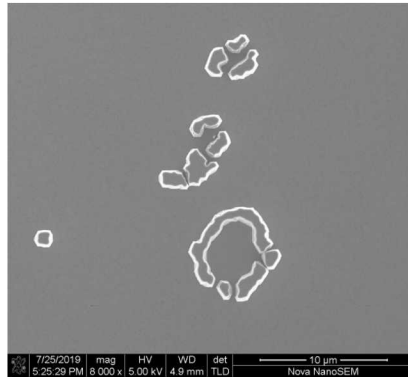
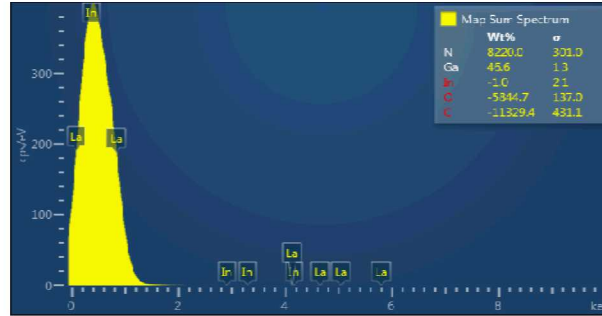
- EDX data inconclusive
 - Contamination appears to be organic
- Various cleaning methods used to reduce contamination
