Case Studies: Nuclear Accidents and Government Response

Case Studies:

Radiological Accidents and Government Response

- **Goiânia**
 - Goiânia, Brazil (1985)
- **Harborview Hospital**
 - Seattle, WA USA (2019)

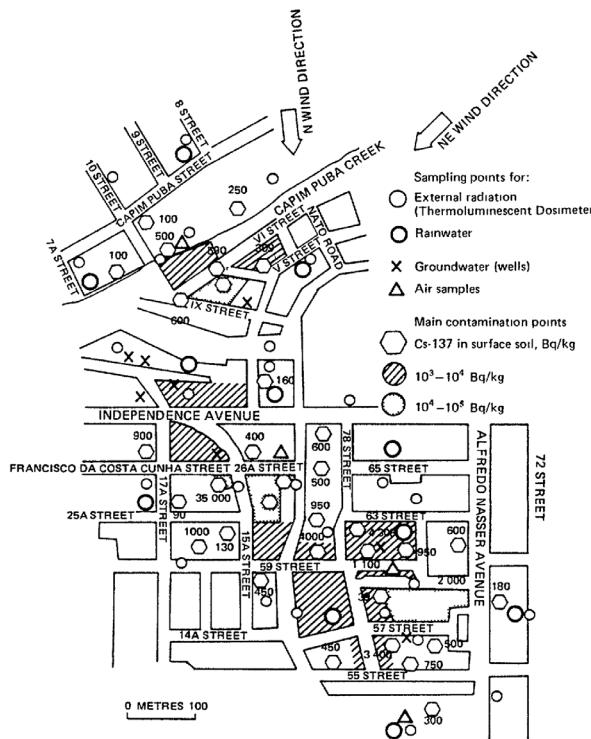
FIG. 16. Plan of the Aeroporto section of Goiânia showing the locations of the principal sites of contamination and the sampling points.

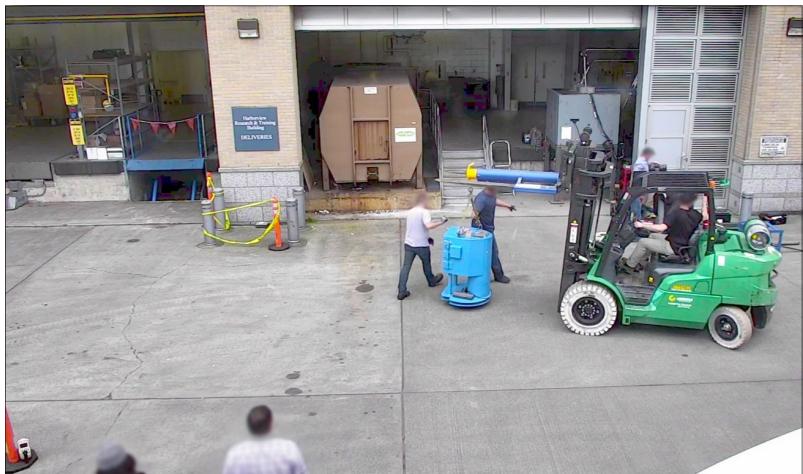
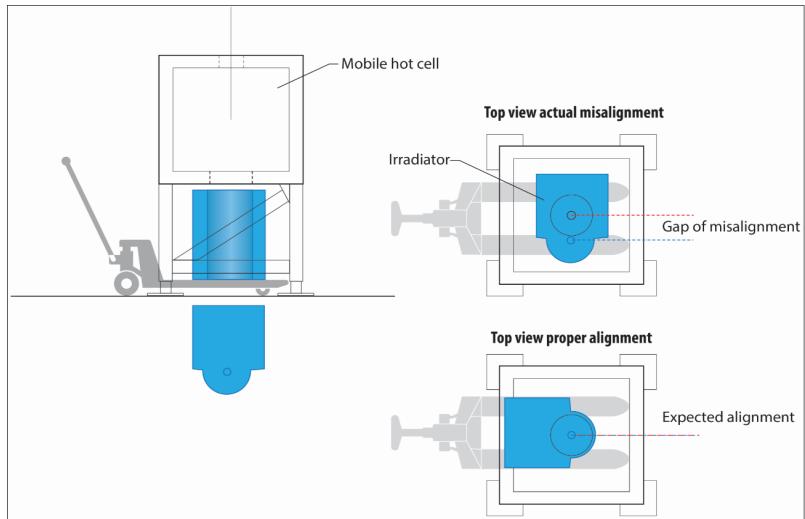
Harborview Pre-Event Chronology (May 2, 2019):

- (1600) Irradiator moved from the storage location to loading dock using a forklift, engine hoist, and pallet jack
- (1715) Recover team attempted to mate the irradiator to the bottom of the modular hot cell. They determined:

- Lifting rod was too long to bring the source assembly into the hotcell in a single unit
 - Remnants of the IDD safety system prevented mating the irradiator to the hotcell, requiring the removal of the shielding donut from inside the hotcell

- Loading bay door was partially closed to limit light leakage to cameras in MHC
- (1825) Multiple cuts were made by hand to the lifting rod to allow the source to be moved into the hotcell.

- (1845) The source was lifted from the irradiator into the MHC. This resulted in higher-than-expected doses (400 mR/hr at 1 m from bottom of MHC). Team added additional shielding and posted area as a radiation area.

- Team elected to continue operations even though ambient dose rates were 10X higher than expected from pre-job planning.

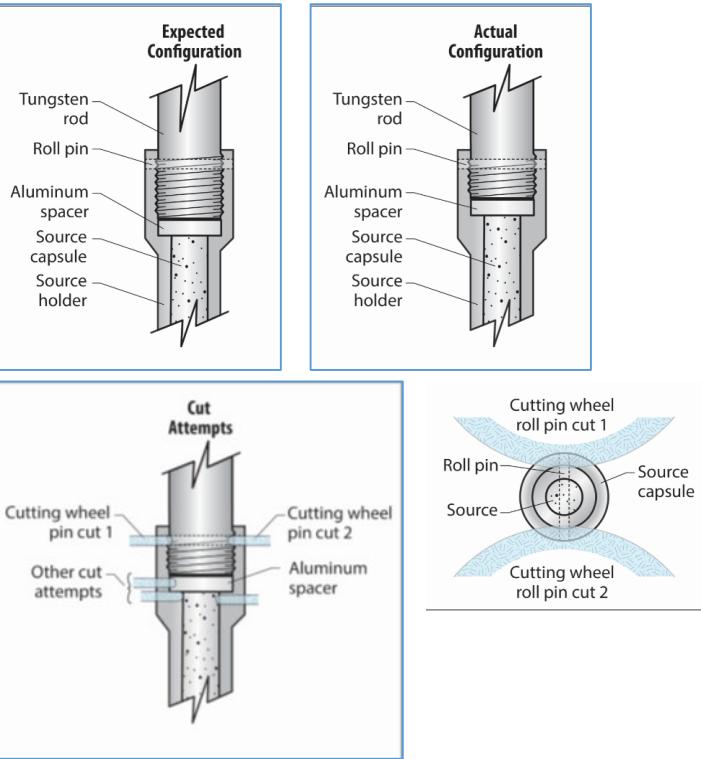
- (1931) Team began a series of cuts on the assembly to allow source capsule to be unscrewed
- (2005) Team was still not able to unscrew source capsule. They believed threads were oxidized, and began performing circumferential cuts to free source.
- (2015) White spots can be noted in the HRT security feed. This was not available to the workers in the room.
- (2127) Assembly moved to transfer location prior to end of shift after 27 separate cuts. Movement observed between source and source tube
- (2129) Team notified UW radiation control officer of a potential breach of the source. RCO turned on the contamination meter in the room and confirmed breach with a large area wipe that “pegged” the meter at over 500 kcpm.

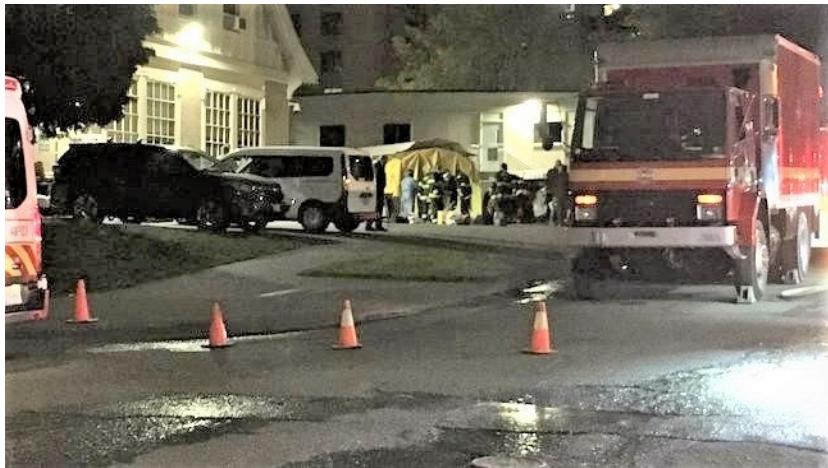
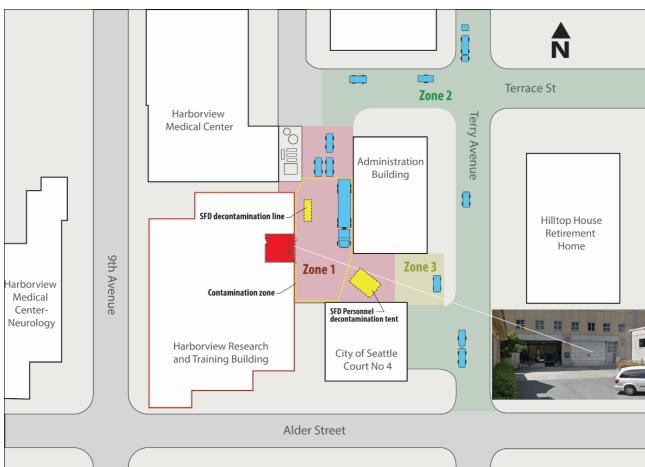
- (2134) The roll-up door to the loading bay was closed to prevent further release through doorway.
- (2146) Large area surveys of the area were performed, confirming significant release. A box of Nitrile gloves was found in the loading dock. This is the first PPE used by the team.
- (2225) Seattle Emergency Response notified of accident. Hazmat team dispatched.
- (2230) Primary building ventilation shut down. Secondary ventilation, including exhaust systems, left operational.
- (2328) Damaged source transferred into shipping cask for storage and eventual removal.
- (2230) HAZMAT team arrives and begins set up to contain incident. DECON support requested, and a decon tent set up by 2359

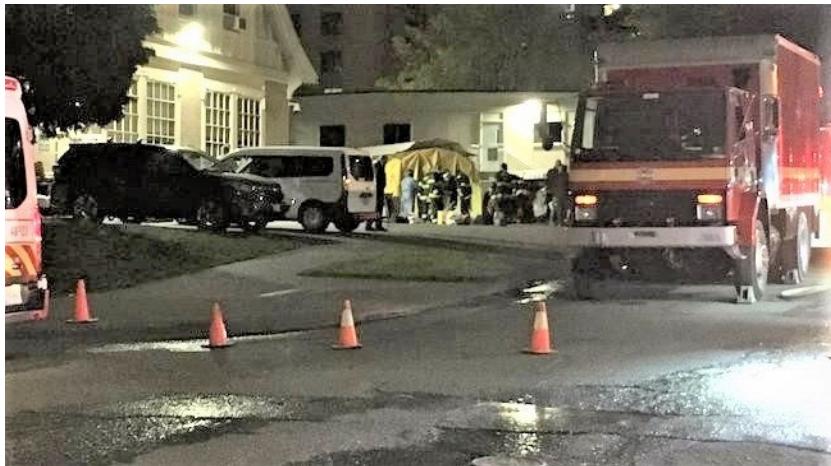
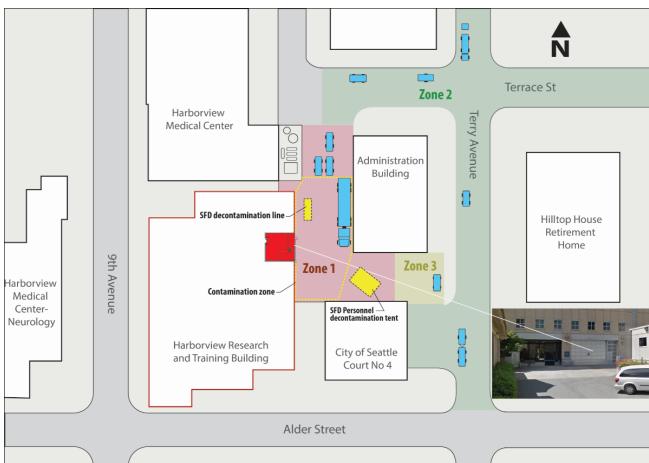
- (May 3) Federal Radiological Assistance Program team dispatched to Seattle to support event
- Surveyed interior of building to determine habitability and extent of contamination
- RAP team discovered contamination on the coils of multiple refrigerator and freezer units in the building on multiple floors.
- Identified multiple exhaust systems still operating from fume hoods, biological storage cabinets, and equipment rooms
- Identified contamination from elevator shafts on multiple floors.
- Located and isolated multiple spots of contamination on the pavement outside the loading dock roll-up door.
