**SANDIA REPORT**

SAND2021-11327

# HEAF Cable Fragility Testing at the Solar Furnace at the NSTTF

Austin M. Glover, Chris LaFleur, Jeff Engerer

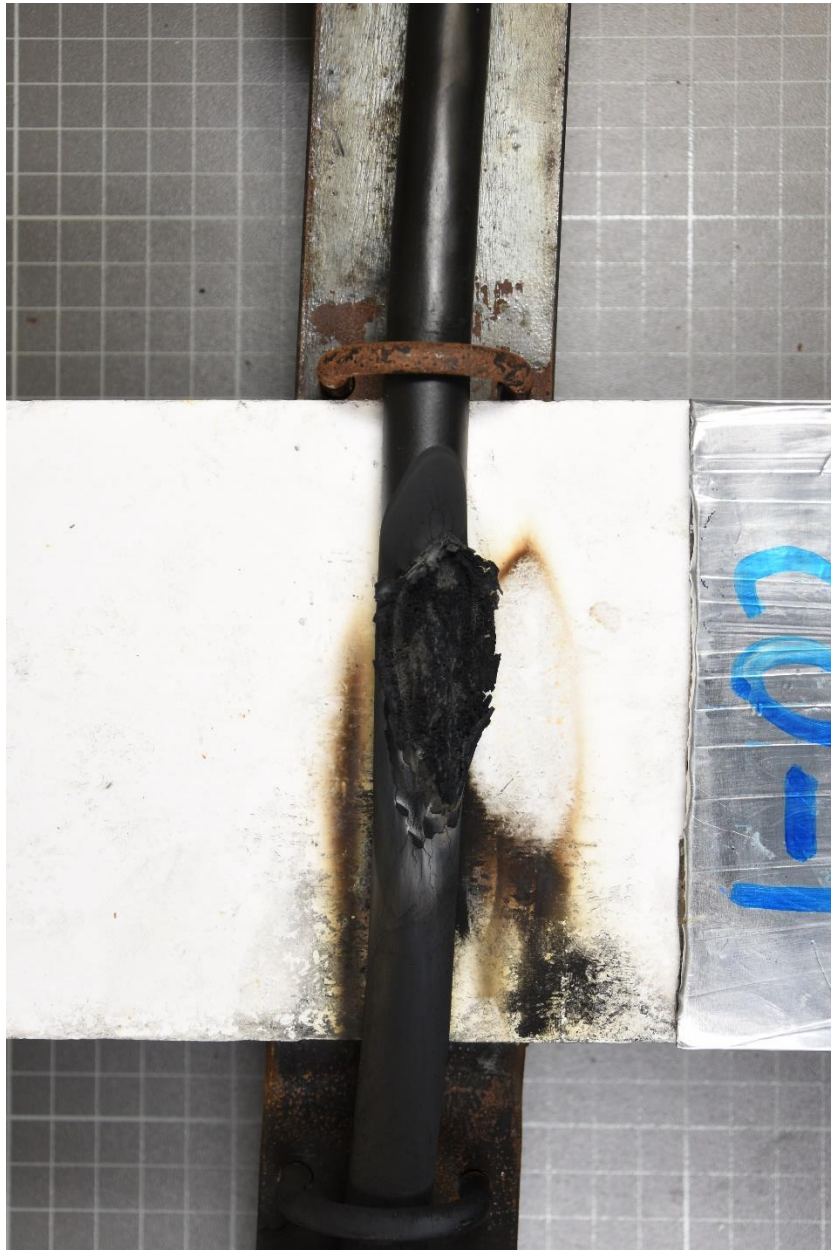
**Figure 3-4: Test 1-02 Post-test Photo**

Figure 3-4 shows the target cable after the exposure profile. As shown, surface damage to the jacket is present. However, the insulated wires were not exposed during this test.

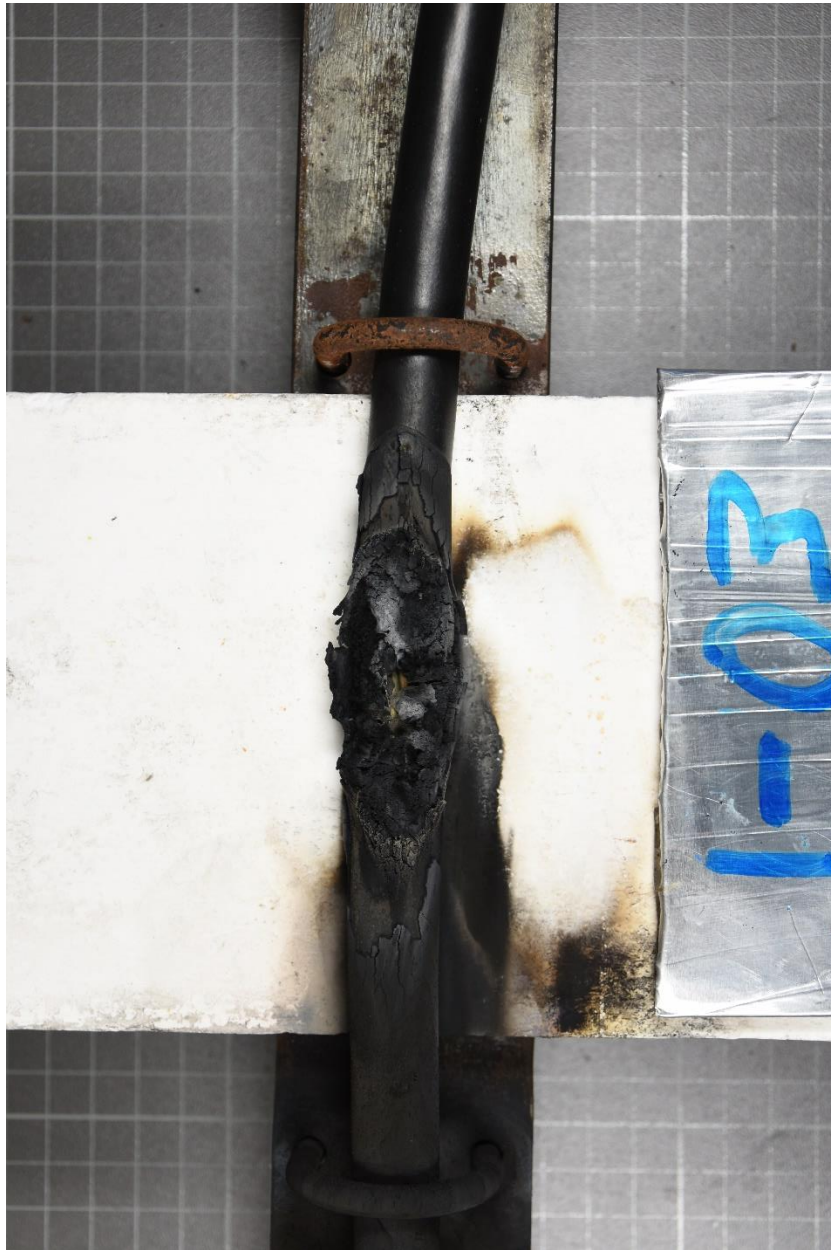
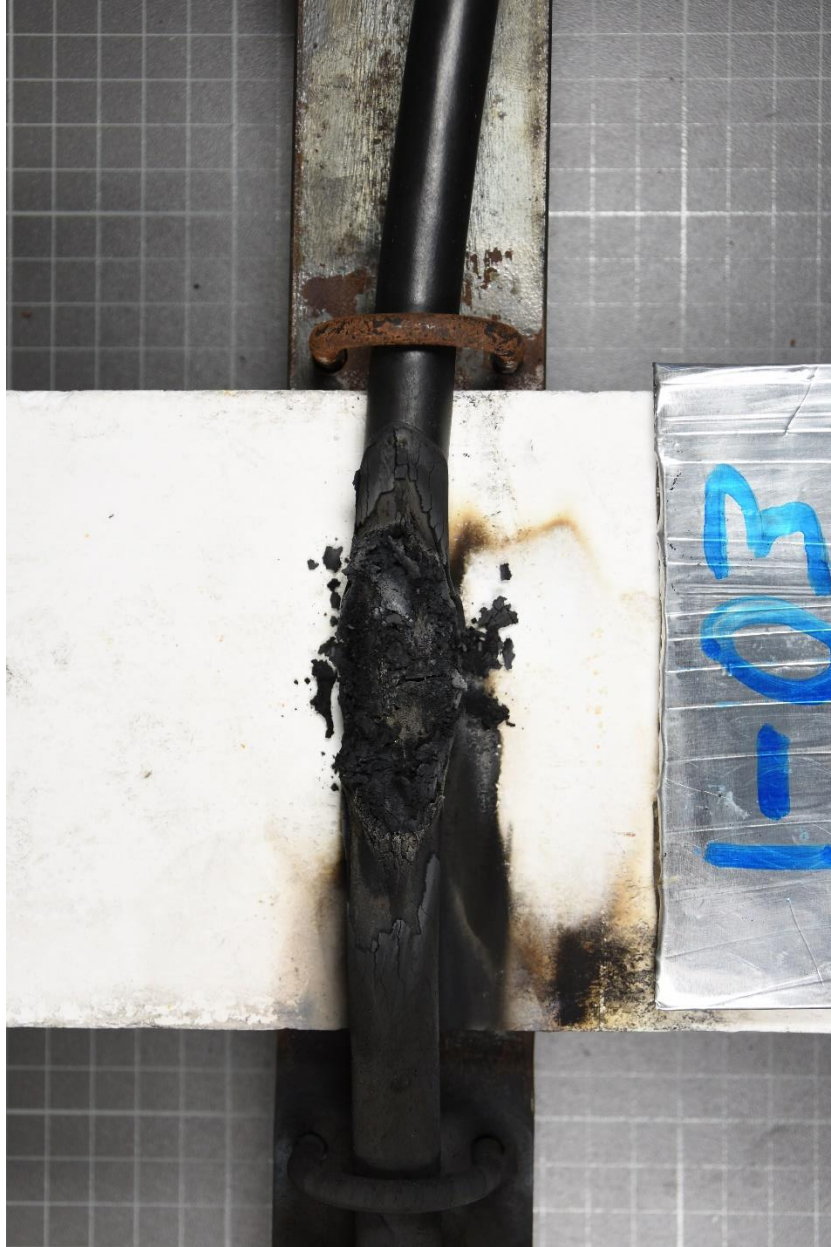
Figure 3-9 and Figure 3-10 show the target cable after the exposure profile. As shown, the insulated wires under the jacket were exposed during this test.

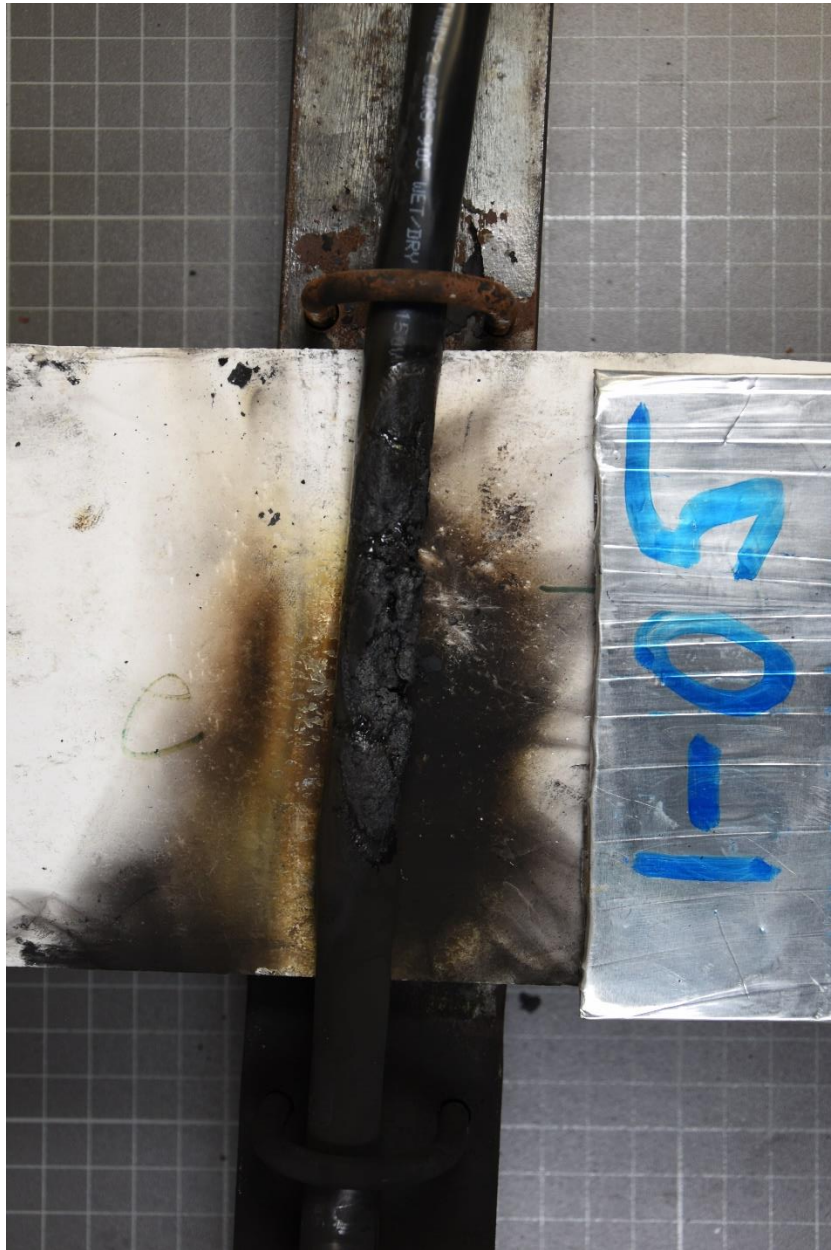
Figure 3-15: Test 1-05 Post-test Photo

Figure 3-15 shows the target cable after the exposure profile. As shown, surface damage to the jacket is present. However, the insulated wires were not exposed during this test.

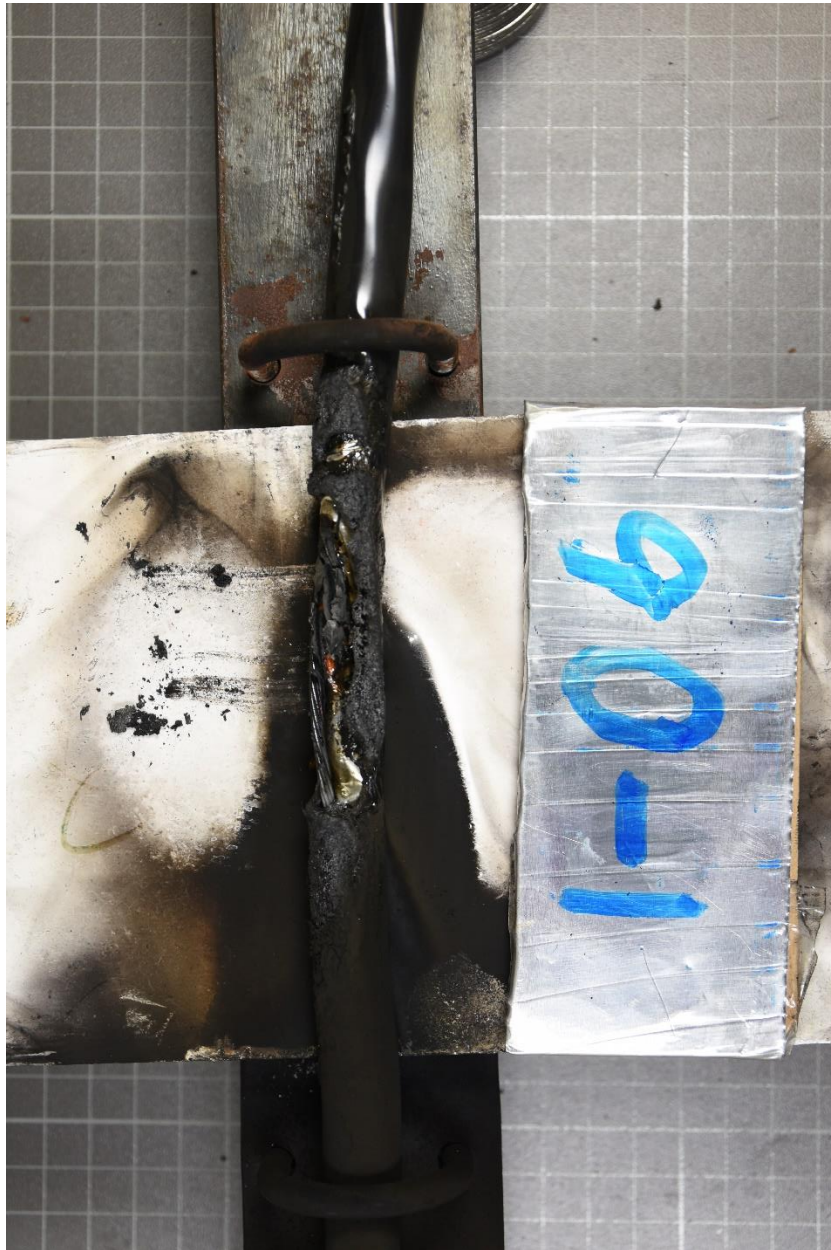
Figure 3-20: Test 1-06 Post-test Photo

Figure 3-20 shows the target cable after the exposure profile. As shown, the insulated wires under the jacket were exposed during this test. Also, there is damage to the insulation, exposing bare wire.

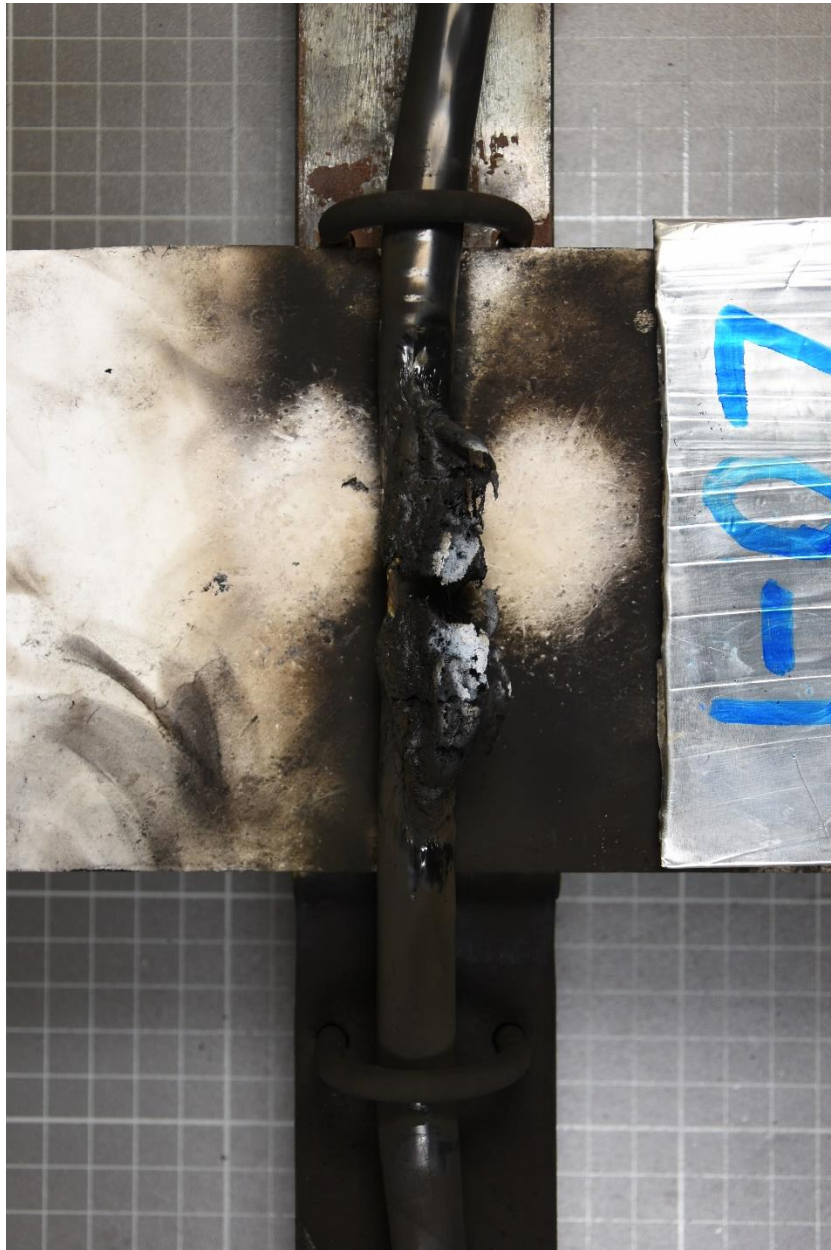
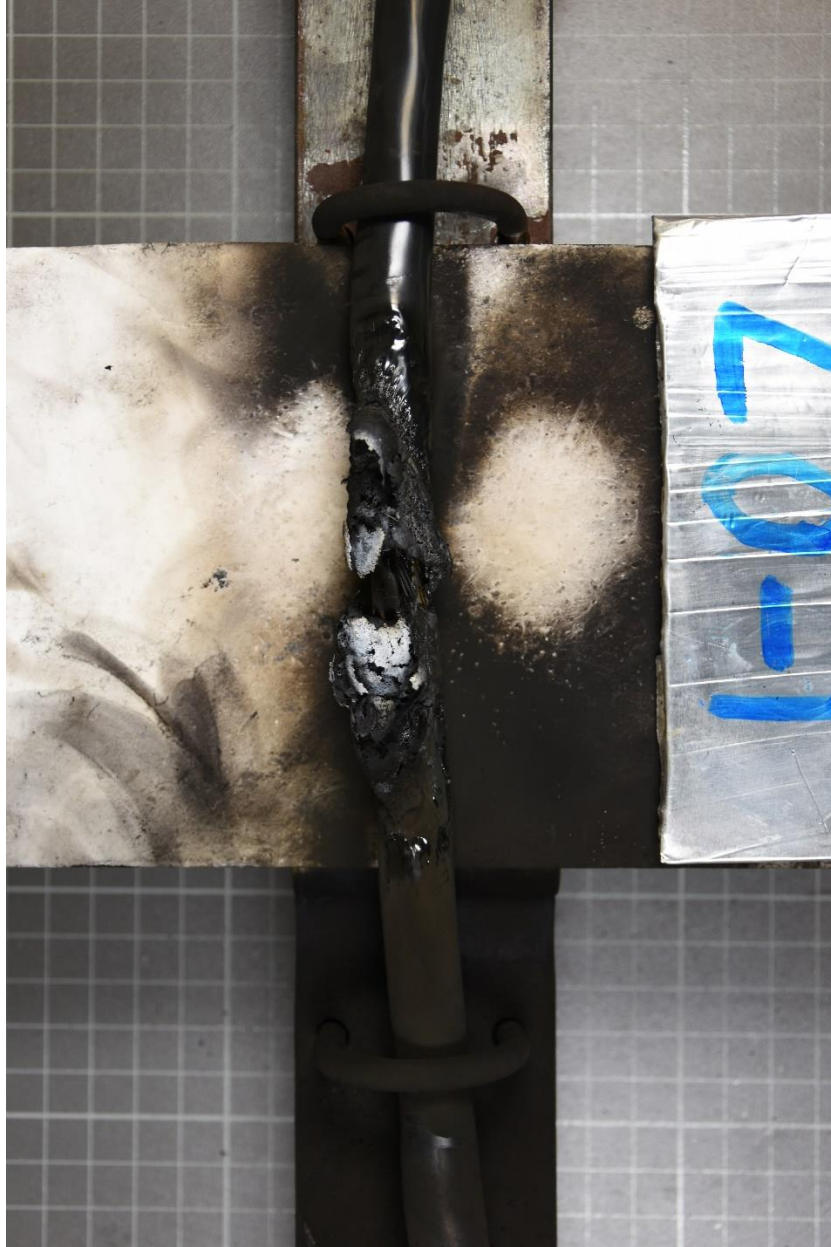
Figure 3-25 Figure 3-26 show the target cable after the exposure profile. As shown, the insulated wires under the jacket were exposed during this test.

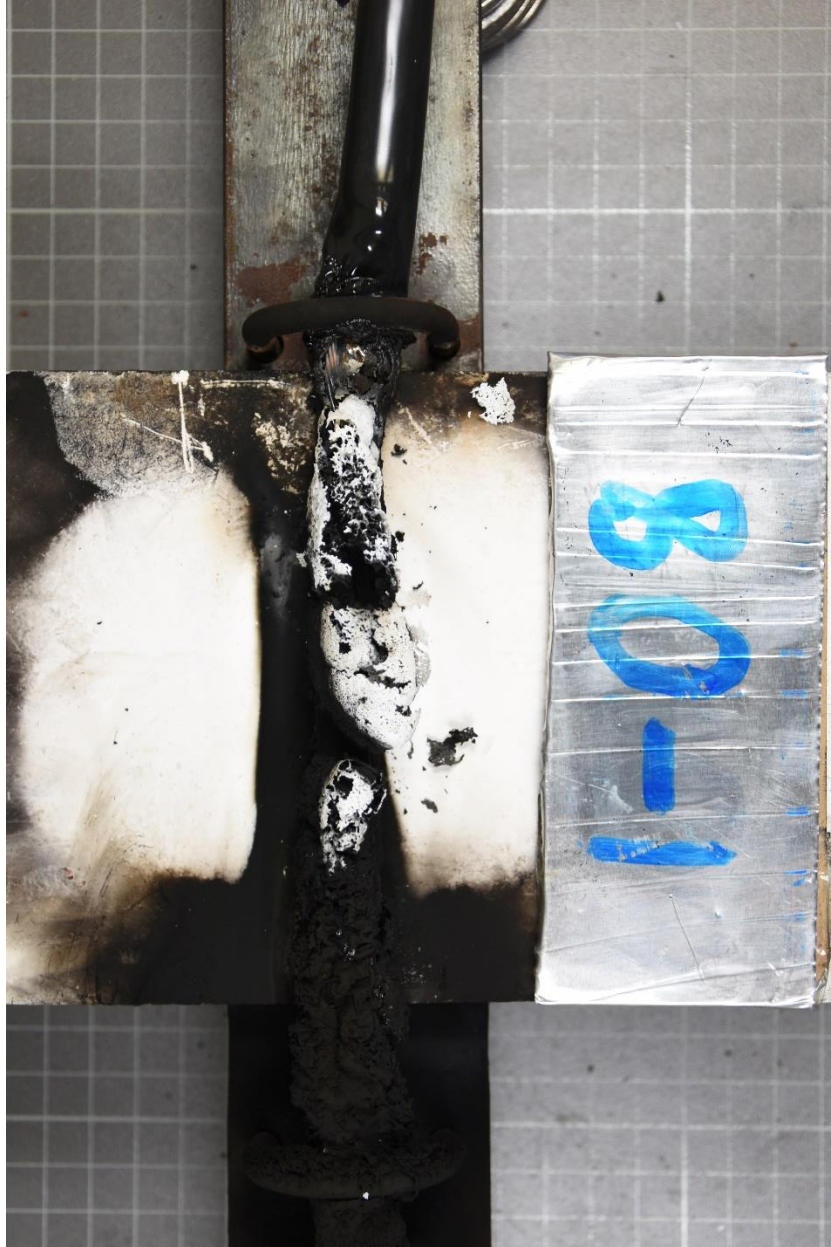
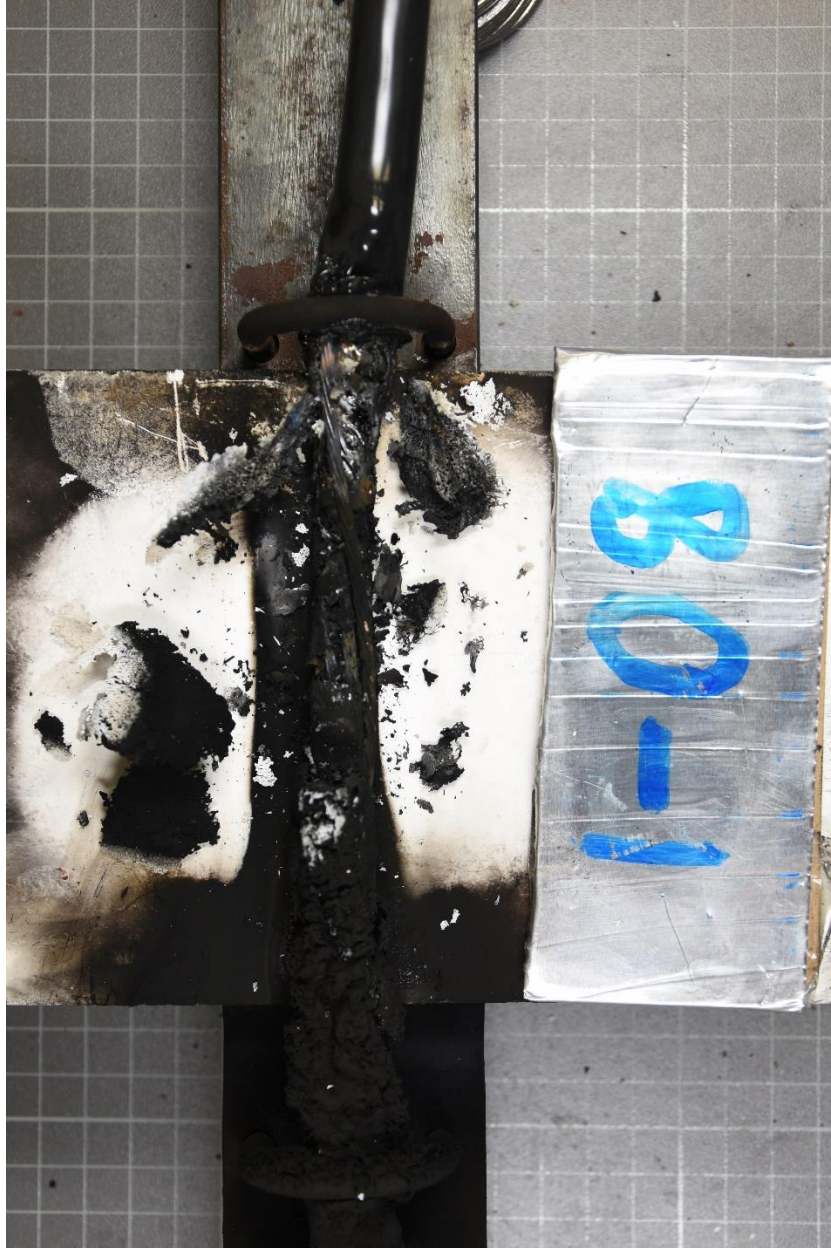
Figure 3-31 and Figure 3-32 show the target cable after the exposure profile. As shown, the insulated wires under the jacket were exposed during this test. Also, there is damage to the insulation, exposing bare wire.

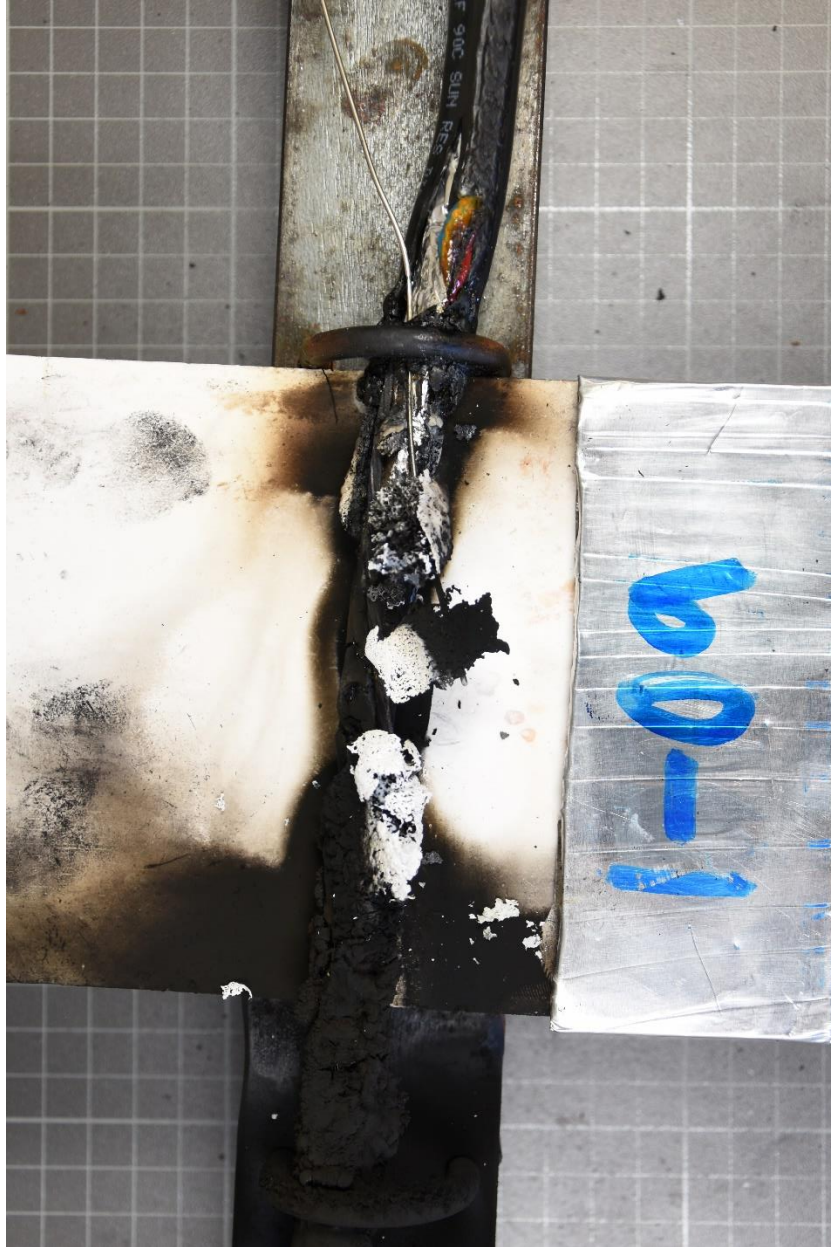
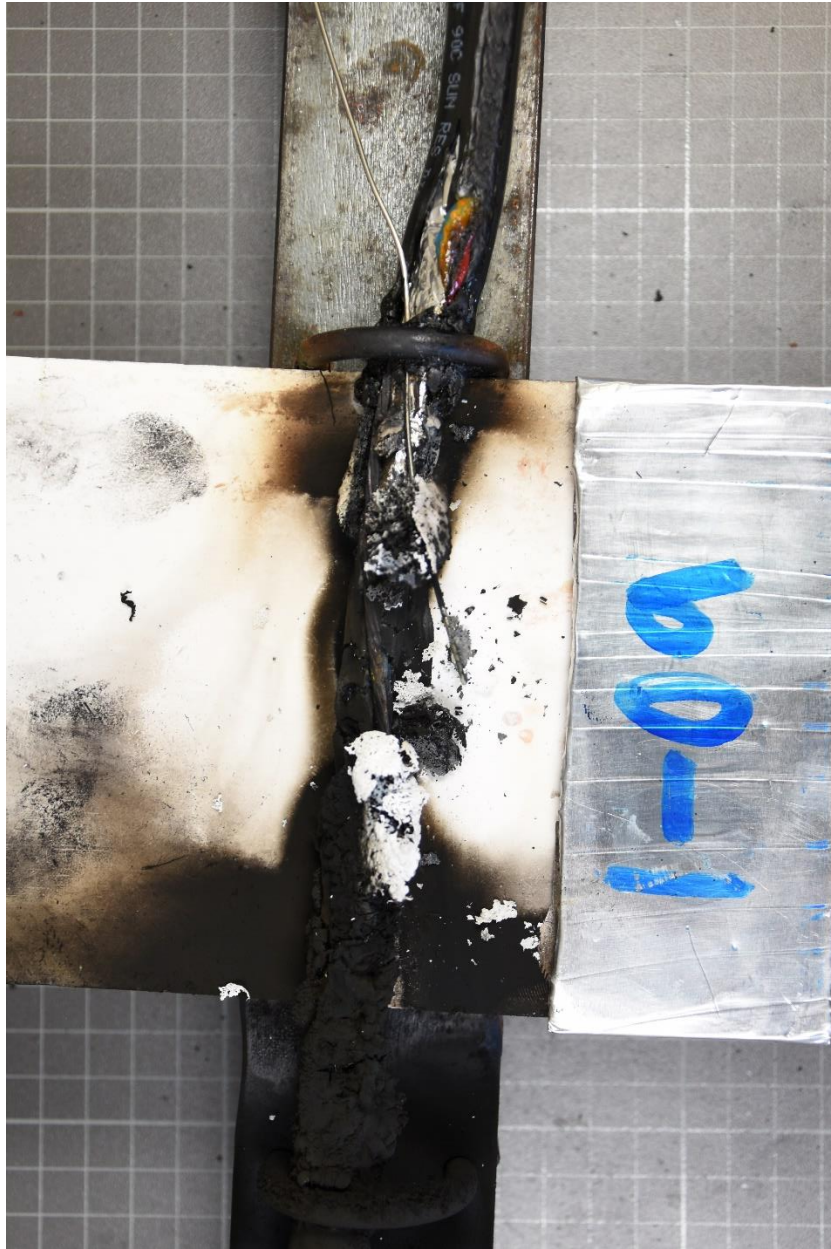
Figure 3-36 and Figure 3-37 show the target cable after the exposure profile. As shown, the insulated wires under the jacket were exposed during this test. Also, it appears that there is damage to the insulation, exposing bare wire.

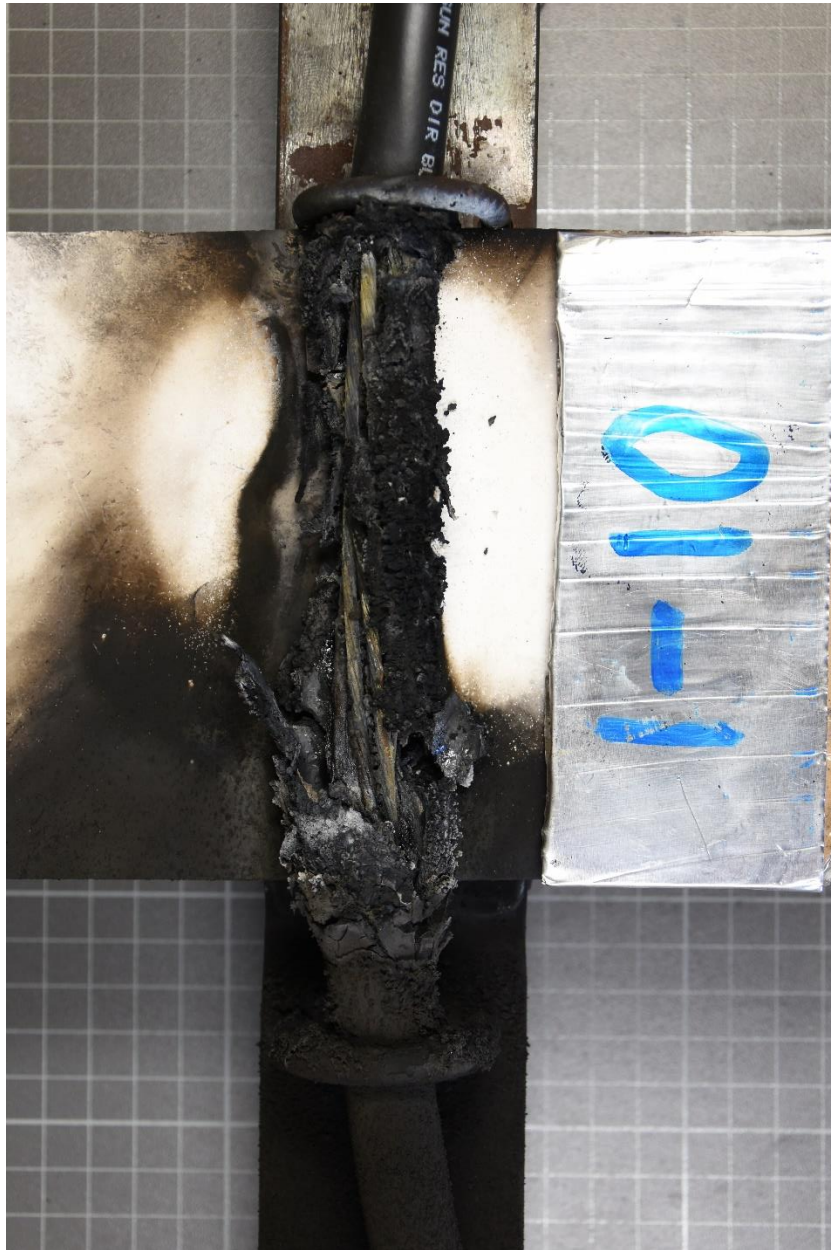
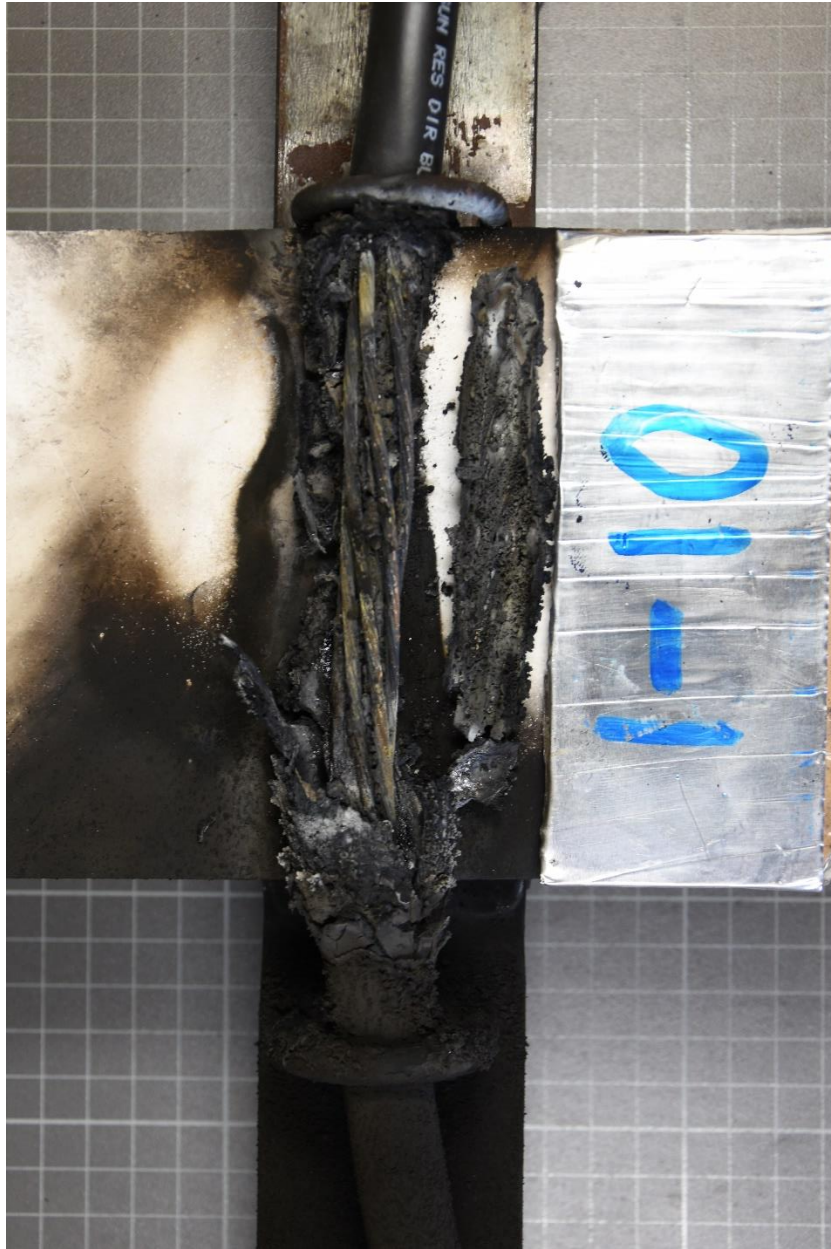
Figure 3-41 and Figure 3-42 show the target cable after the exposure profile. As shown, the jacket and insulation are completely ablated.

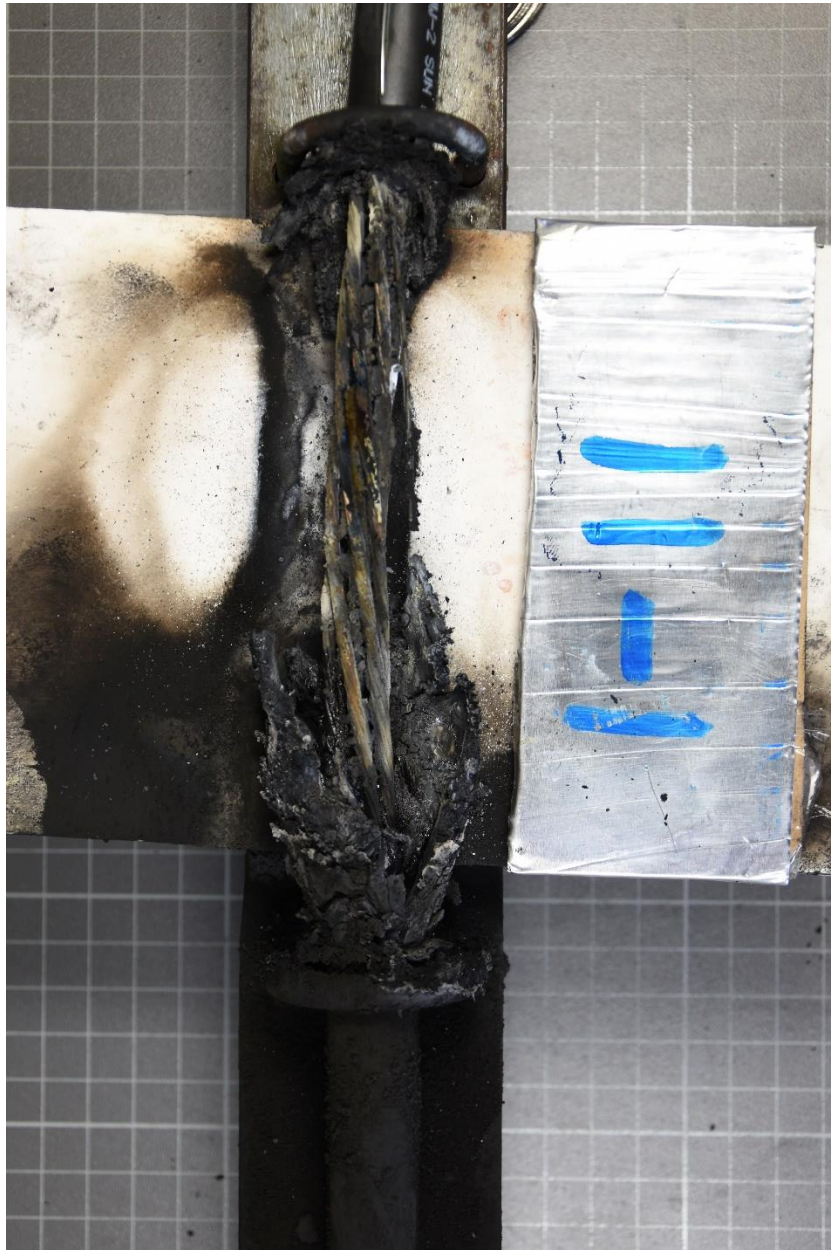
**Figure 3-46: Test 1-11 Post-test Photo**

Figure 3-46 shows the target cable after the exposure profile. As shown, the jacket and insulation are completely ablated.

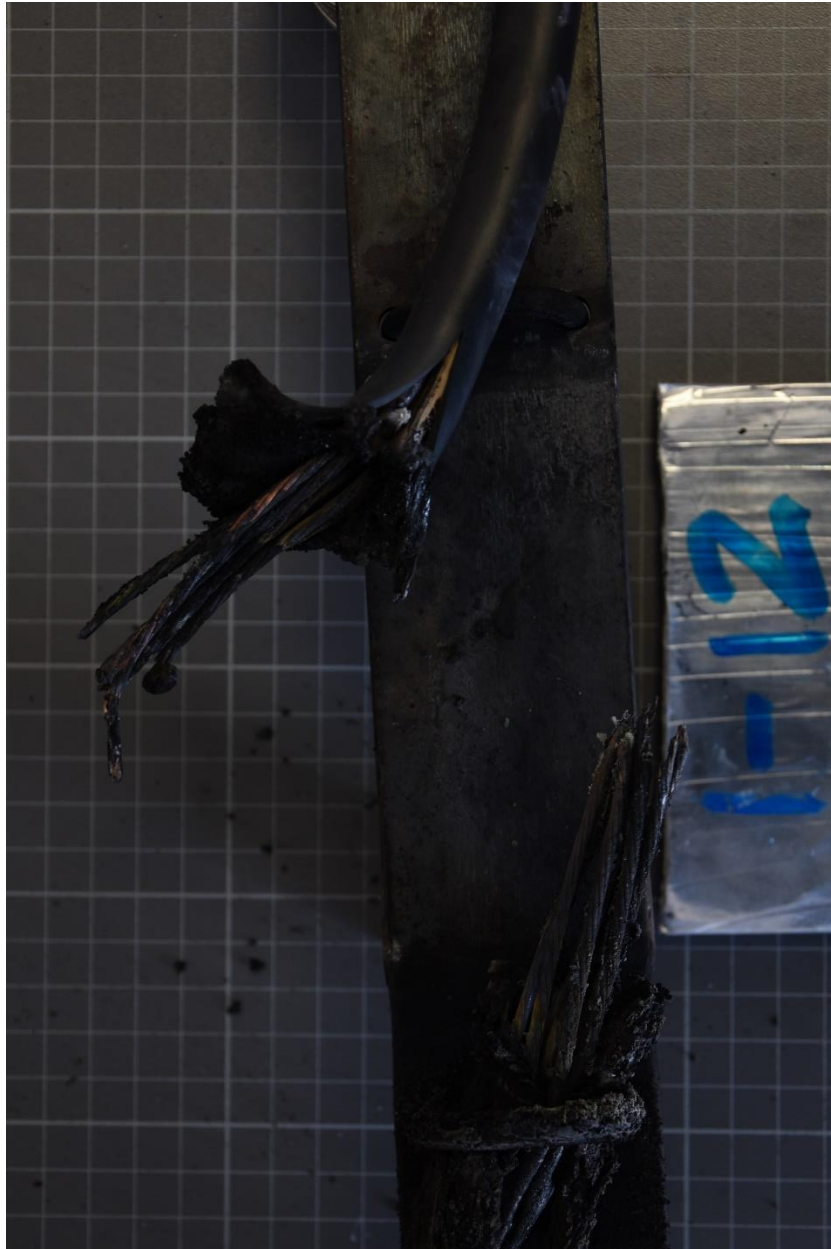
**Figure 3-50: Test 1-12 Post-test Photo**

Figure 3-50 shows the target cable after the exposure profile. As shown, the jacket and insulation are completely ablated, and the inner wires were separated. The cables were severed during the test exposure. Note, the exposure for this photo is dark because the background light was not turned on.

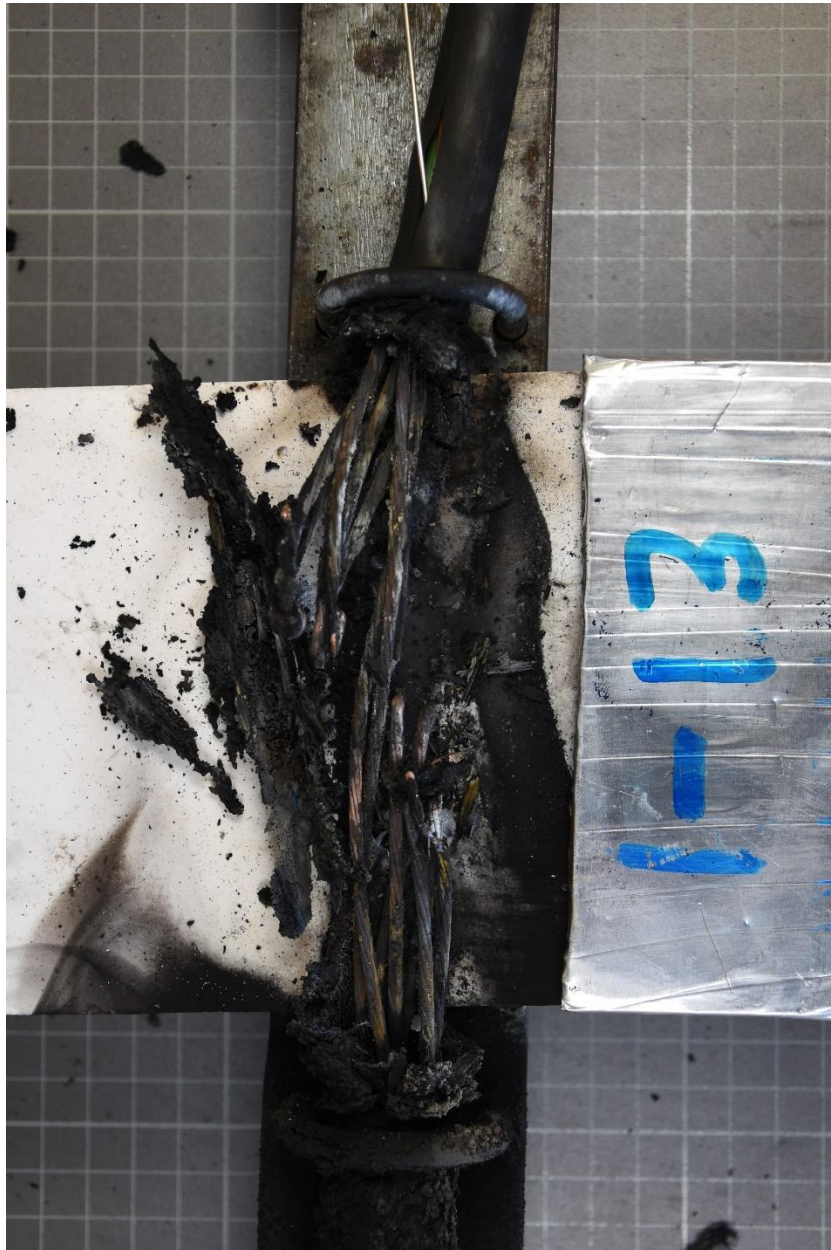
Figure 3-54: Test 1-13 Post-test Photo

Figure 3-54 shows the target cable after the exposure profile. As shown, the jacket and insulation are completely ablated, and the inner wires were separated.

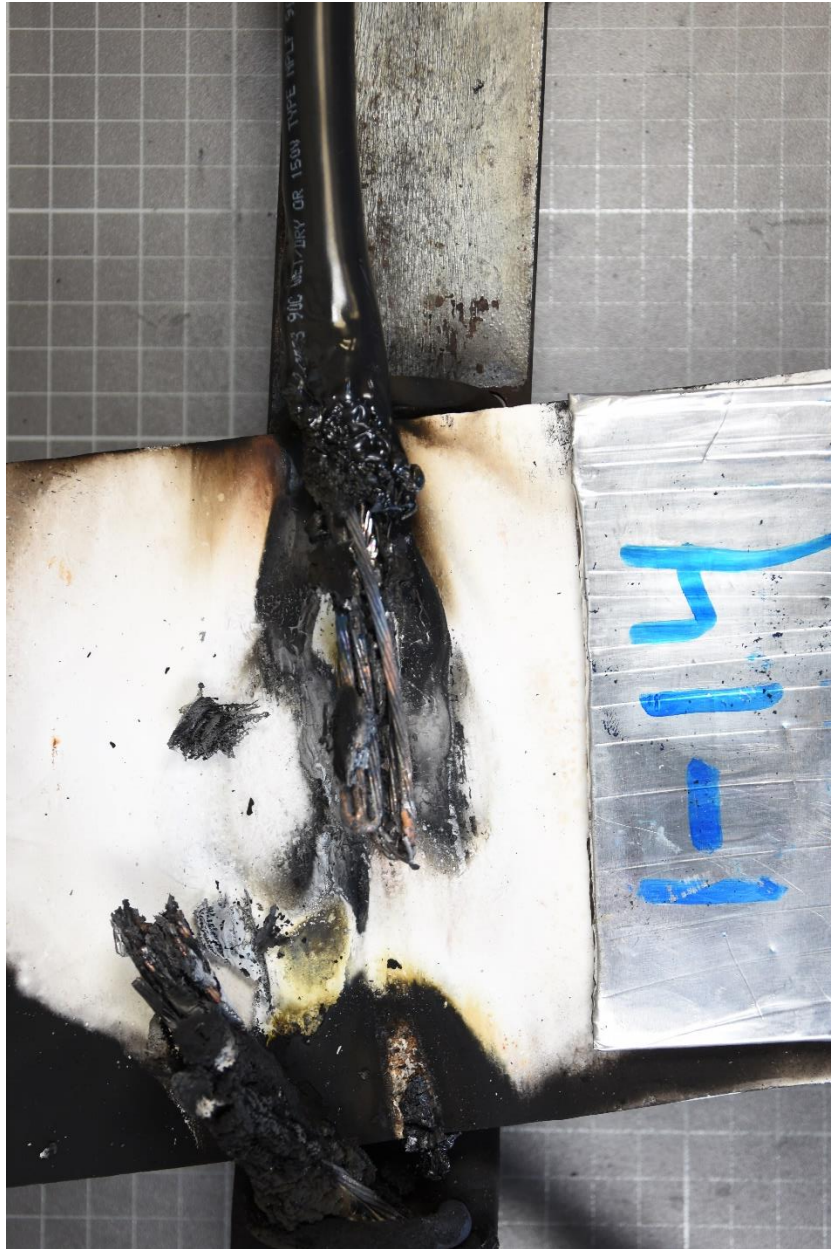
**Figure 3-58: Test 1-14 Post-test Photo**

Figure 3-58 shows the target cable after the exposure profile. As shown, the jacket and insulation are completely ablated, and the inner wires were separated. The cables were severed during the test exposure.

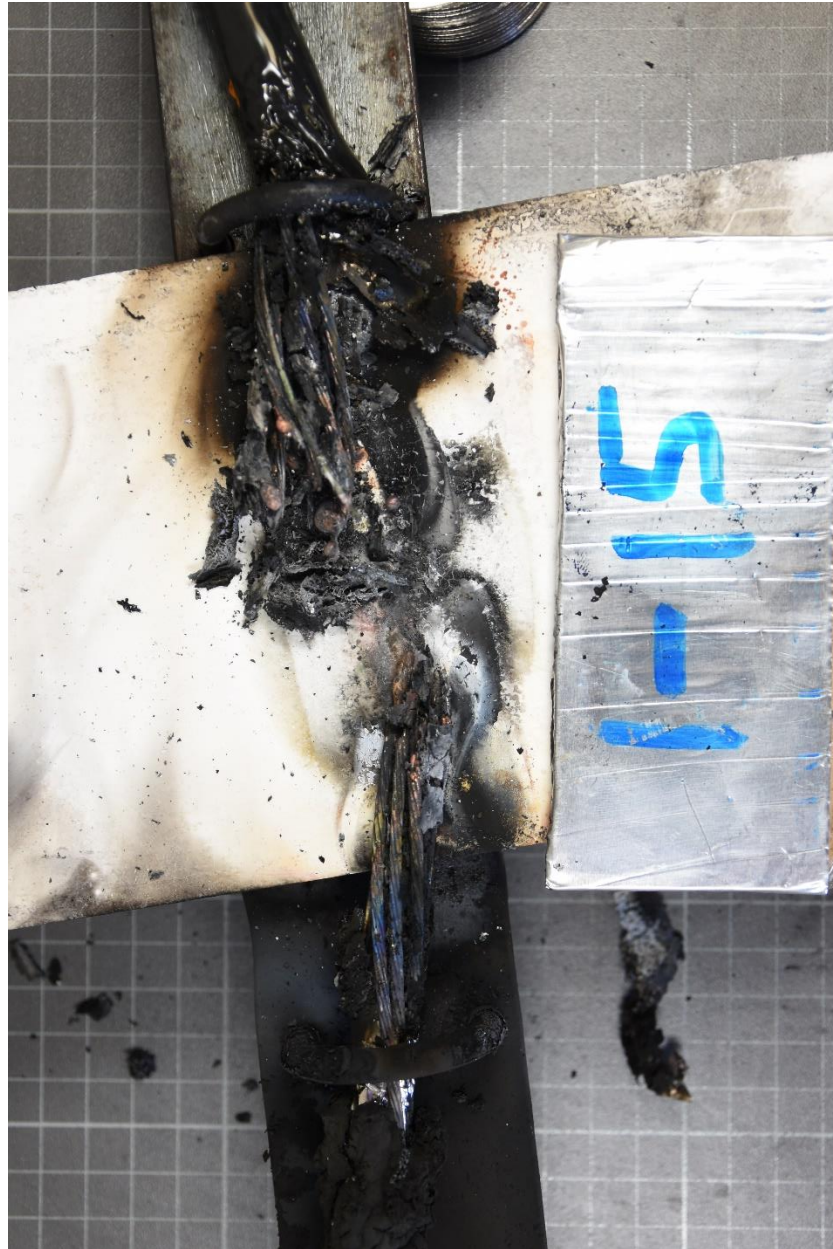
Figure 3-62: Test 1-15 Post-test Photo

Figure 3-62 shows the target cable after the exposure profile. As shown, the jacket and insulation are completely ablated, and the inner wires were separated. The cables were severed during the test exposure.

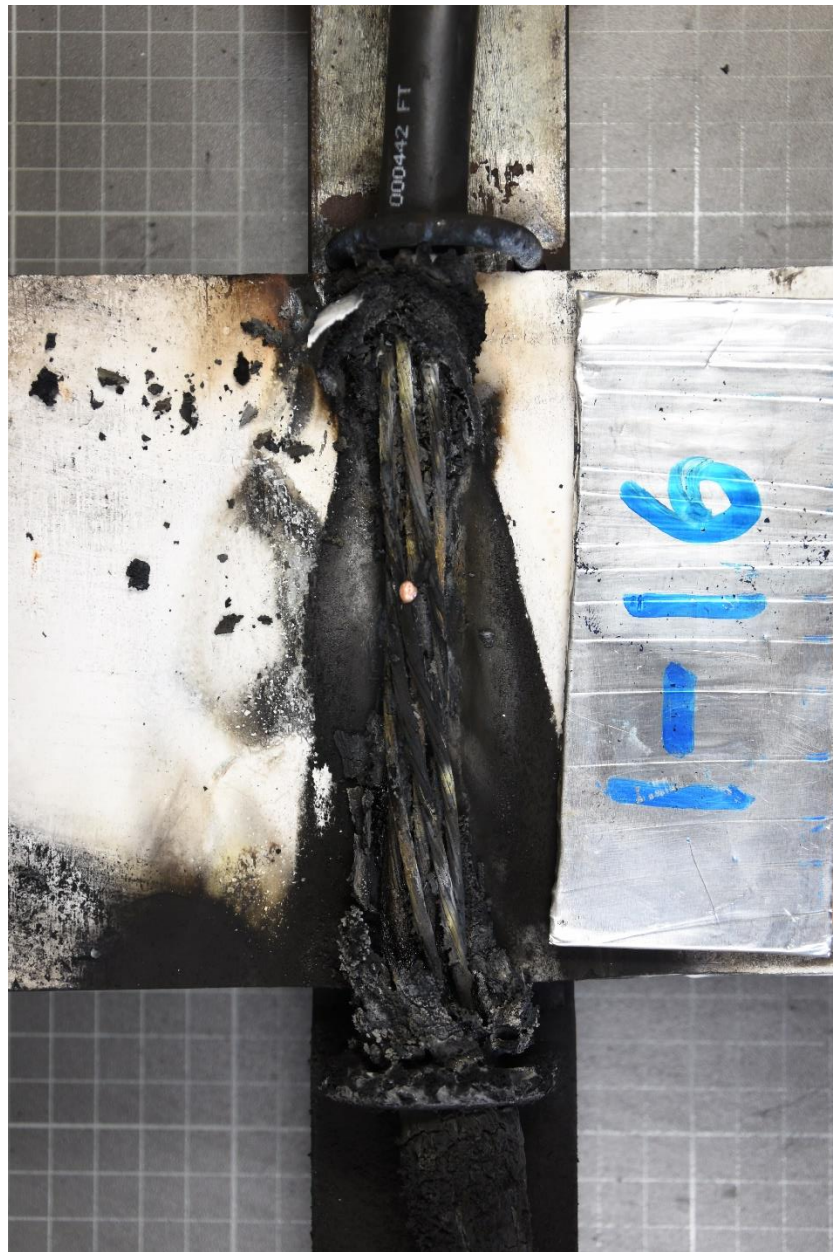
Figure 3-66: Test 1-16 Post-test Photo

Figure 3-66 shows the target cable after the exposure profile. As shown, the jacket and insulation are completely ablated.

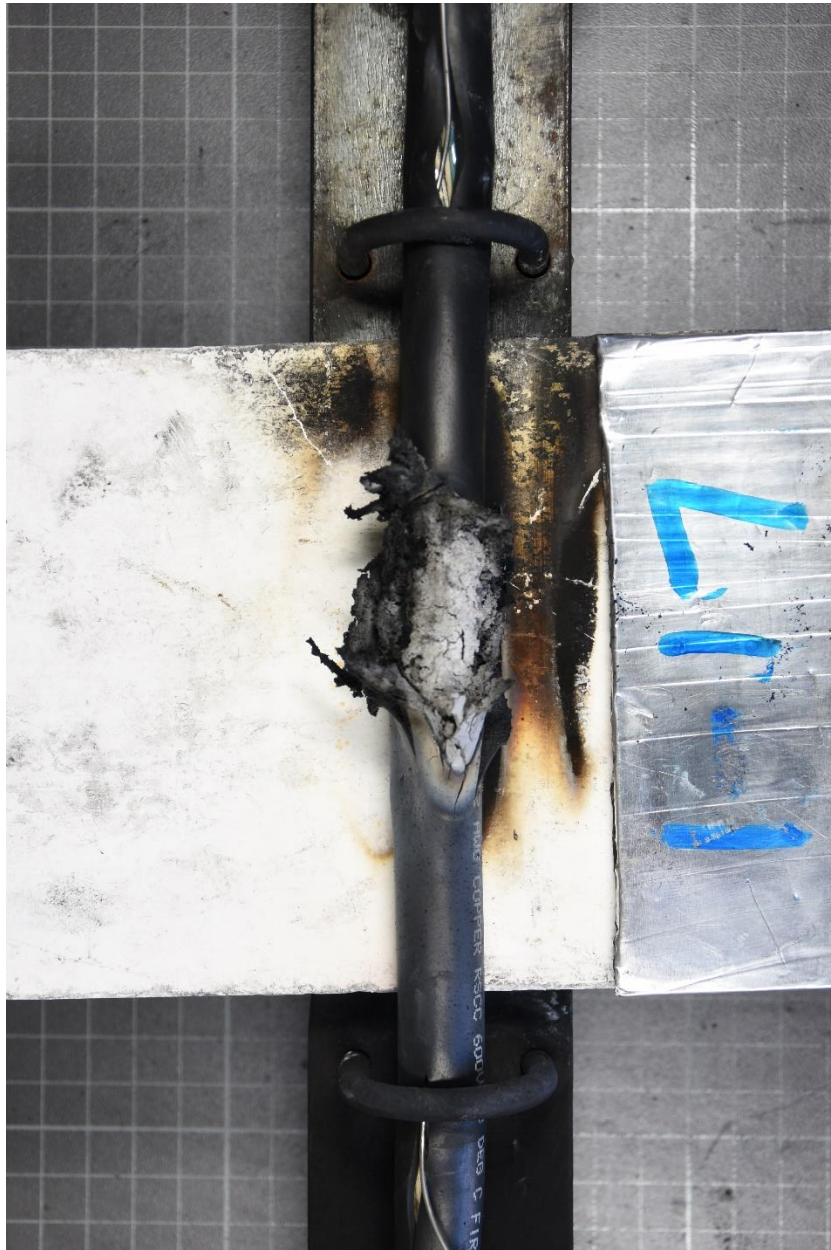
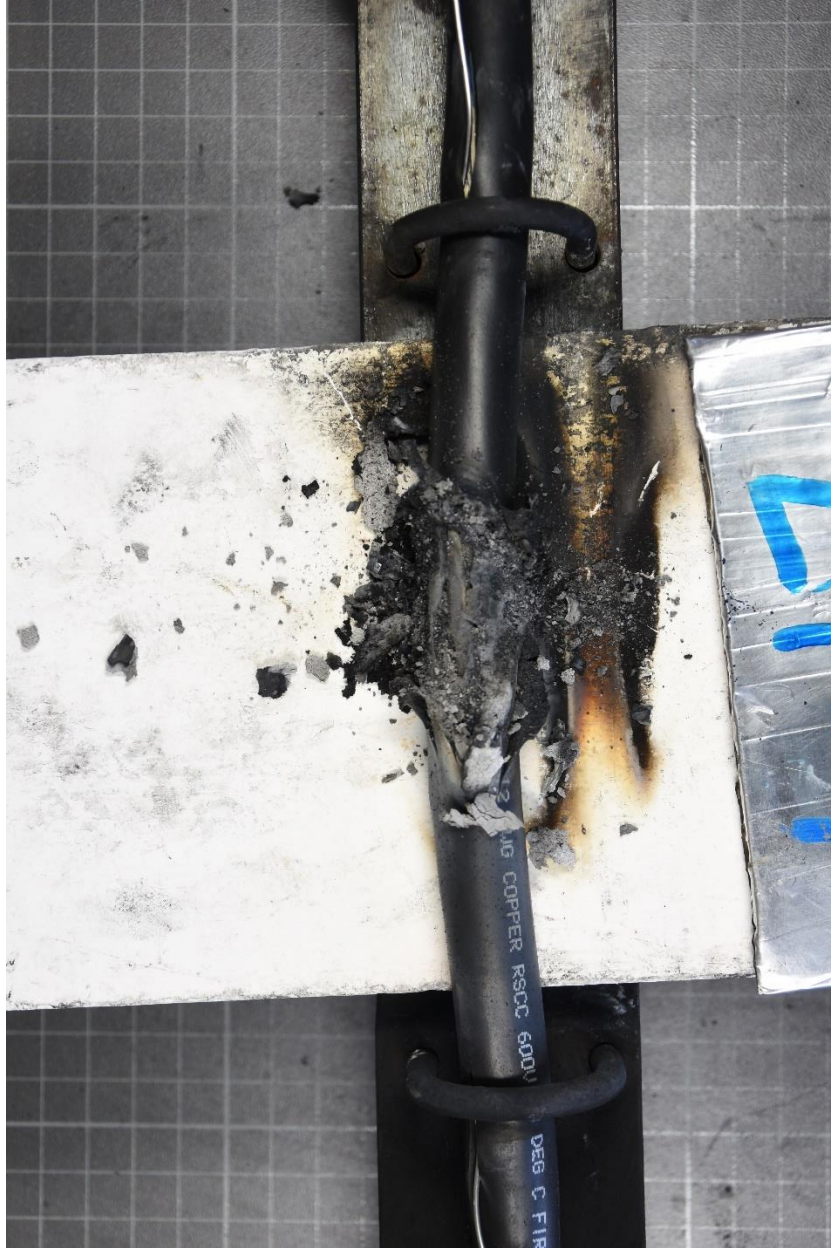
Figure 3-70 and Figure 3-71 show the target cable after the exposure profile. As shown, the insulated wires under the jacket were exposed during this test.
