**SANDIA REPORT**

SAND2021-11327

# HEAF Cable Fragility Testing at the Solar Furnace at the NSTTF

Austin M. Glover, Chris LaFleur, Jeff Engerer

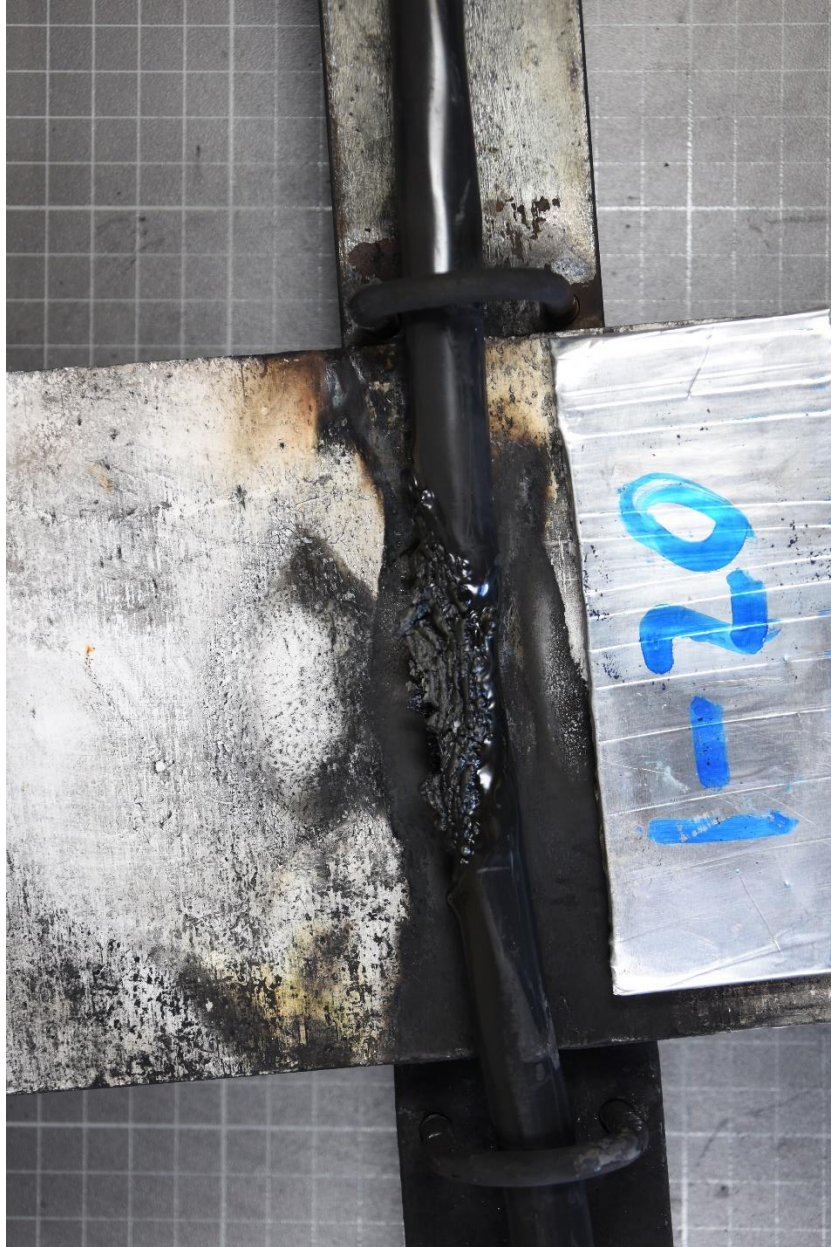
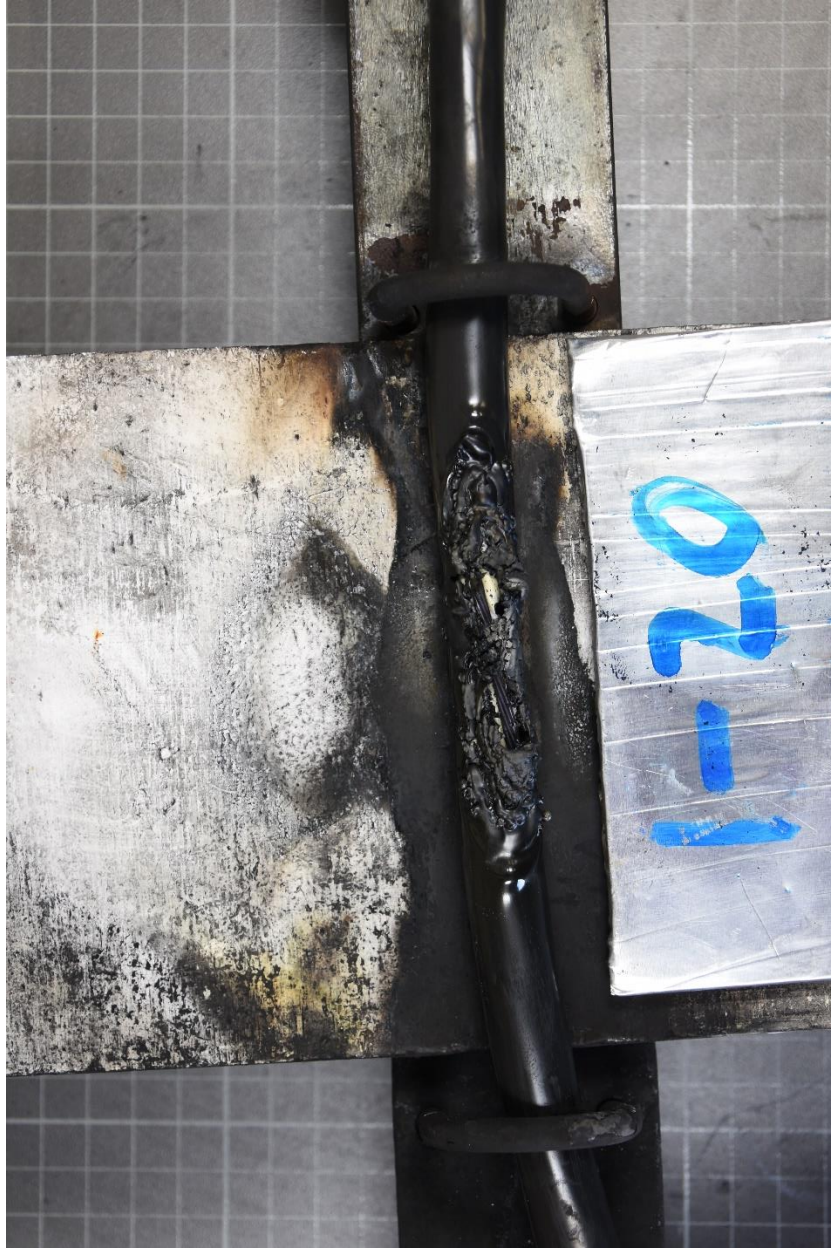
Figure 3-75, Figure 3-76, and Figure 3-77 show the target cable after the exposure profile. As shown, the insulated wires under the jacket were exposed during this test. Note that the photos for this test were mislabeled as Test 1-20.

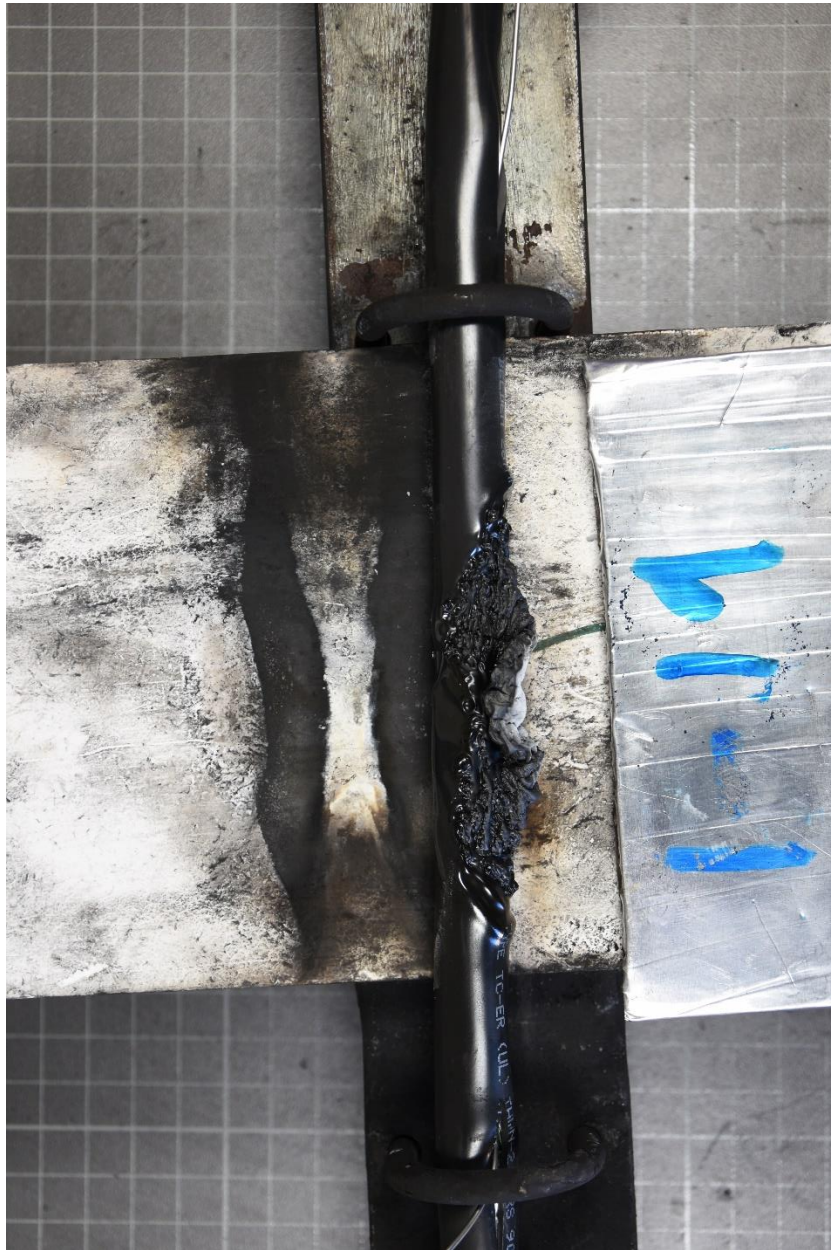
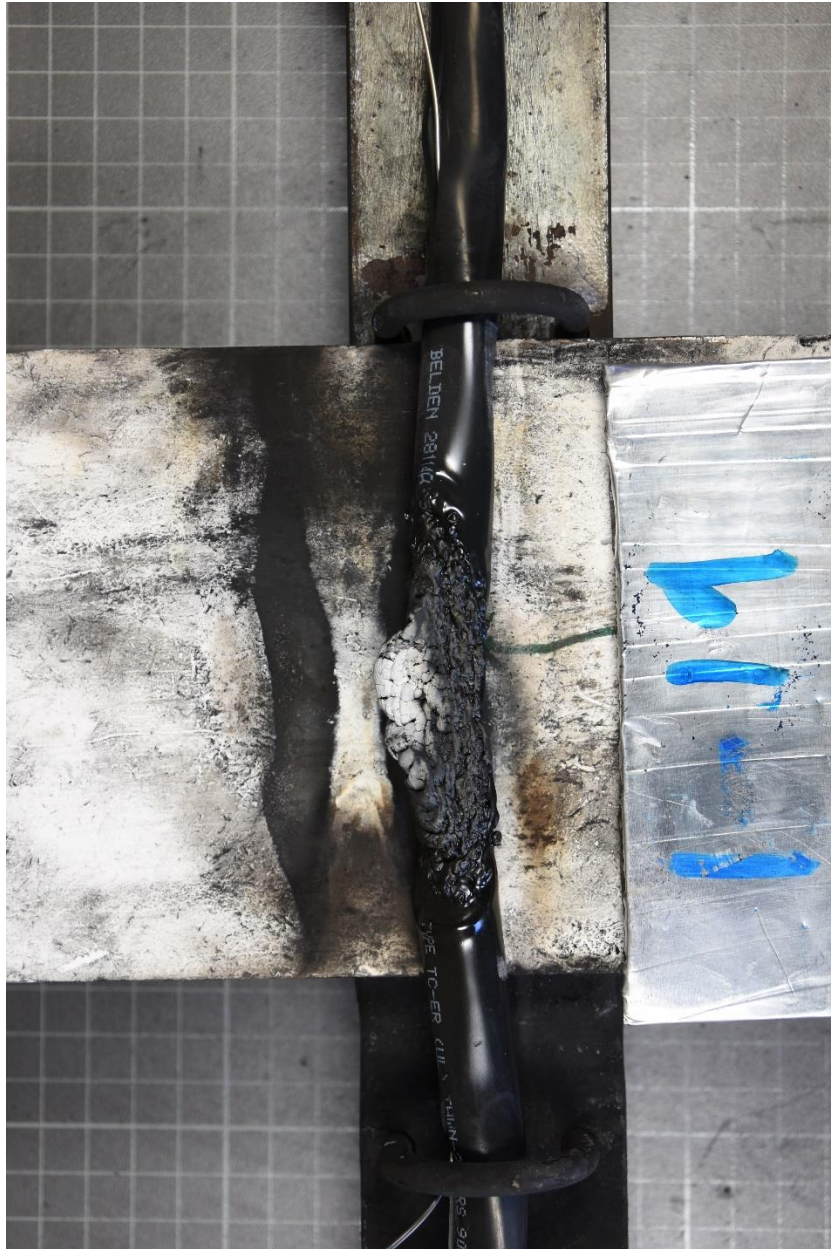
Figure 3-81 and Figure 3-82 show the target cable after the exposure profile. As shown, surface damage to the jacket is present. However, the insulated wires were not exposed during this test.

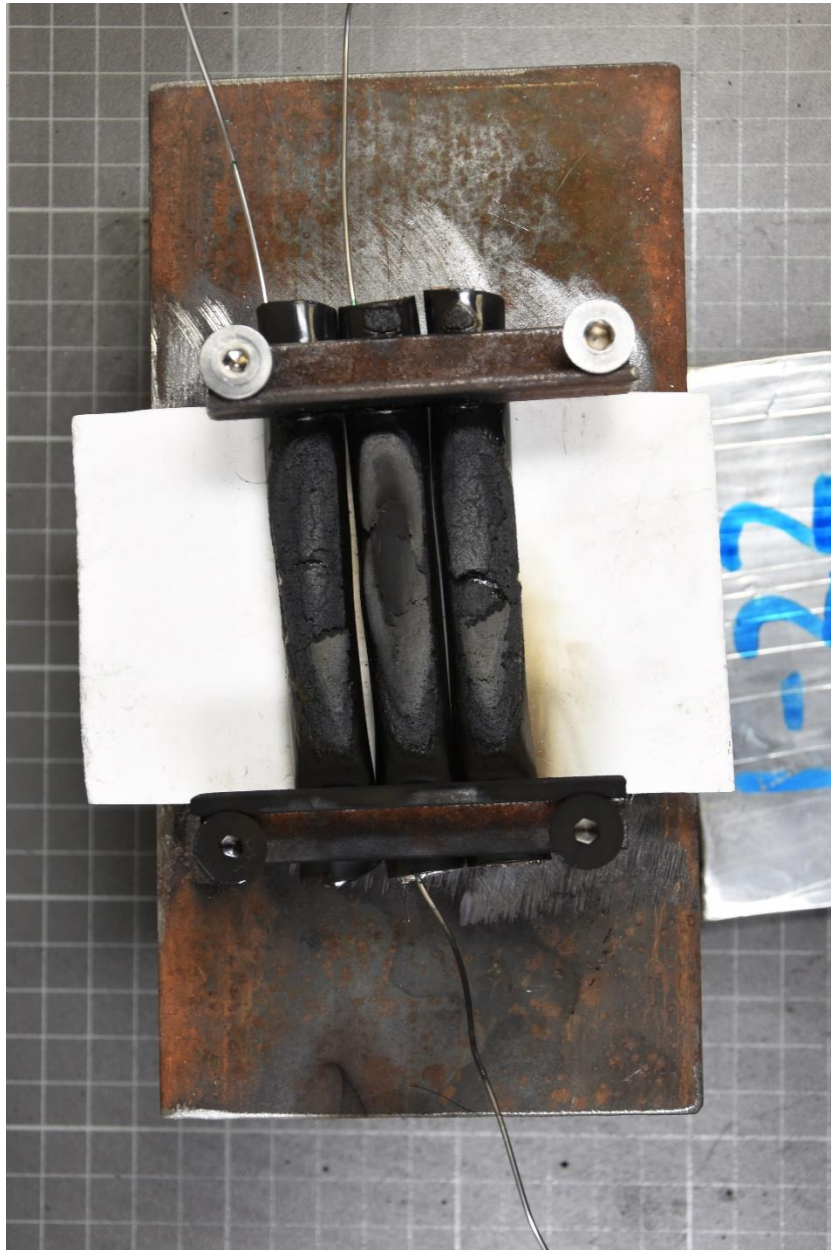
Figure 3-96: Test 1-22 Post-test Photo (1)

Figure 3-96 and Figure 3-97 show the target cable after the exposure profile. As shown, surface damage to the jacket is present. However, the insulated wires were not exposed during this test.

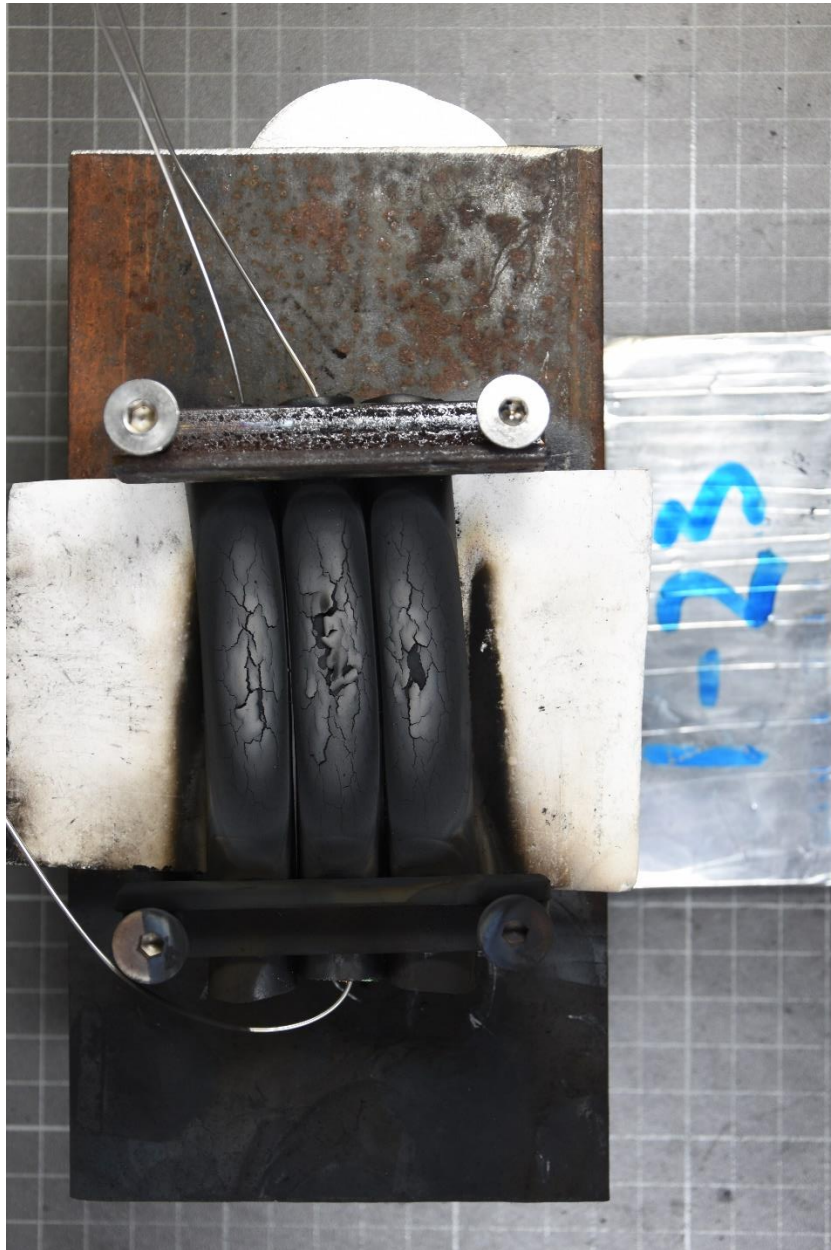
Figure 3-102: Test 1-23 Post-test Photo (1)

Figure 3-102 and Figure 3-103 show the target cable after the exposure profile. As shown, surface damage to the jacket is present. However, the insulated wires were not exposed during this test.

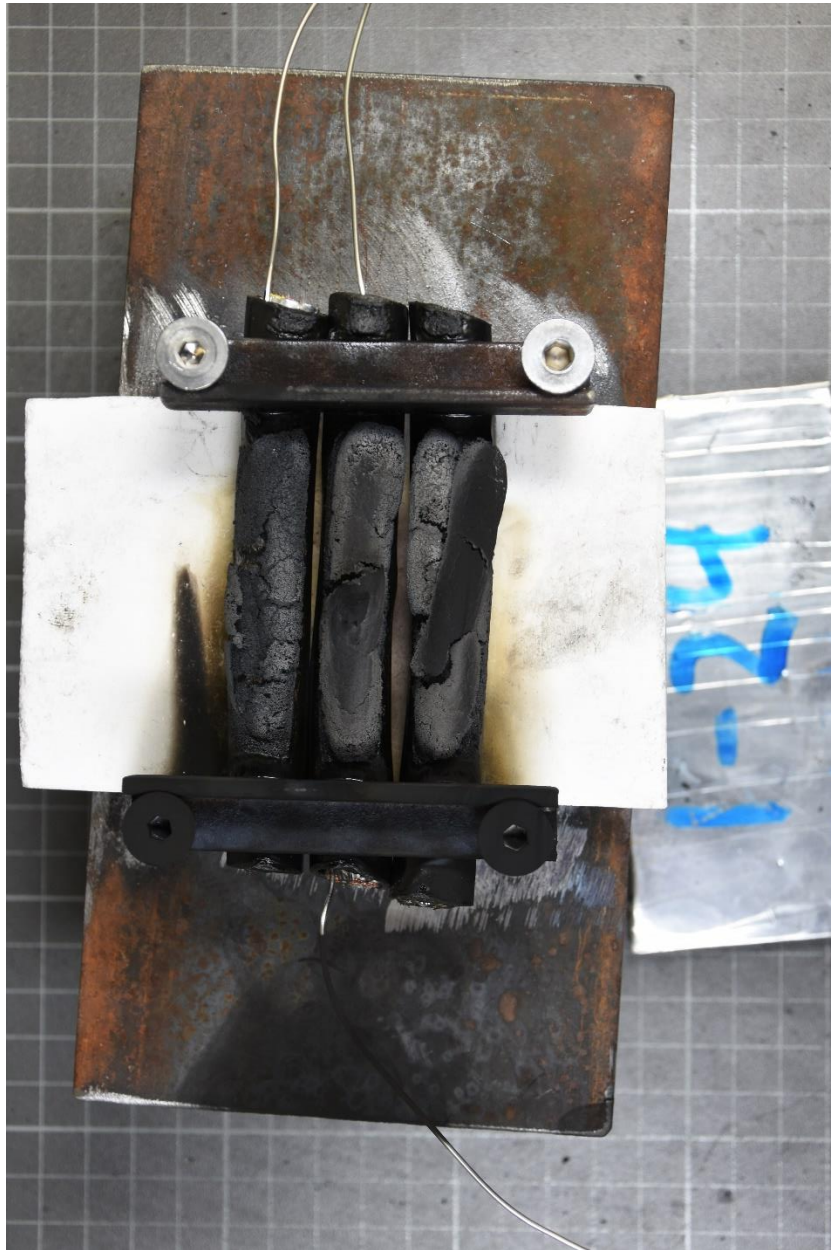
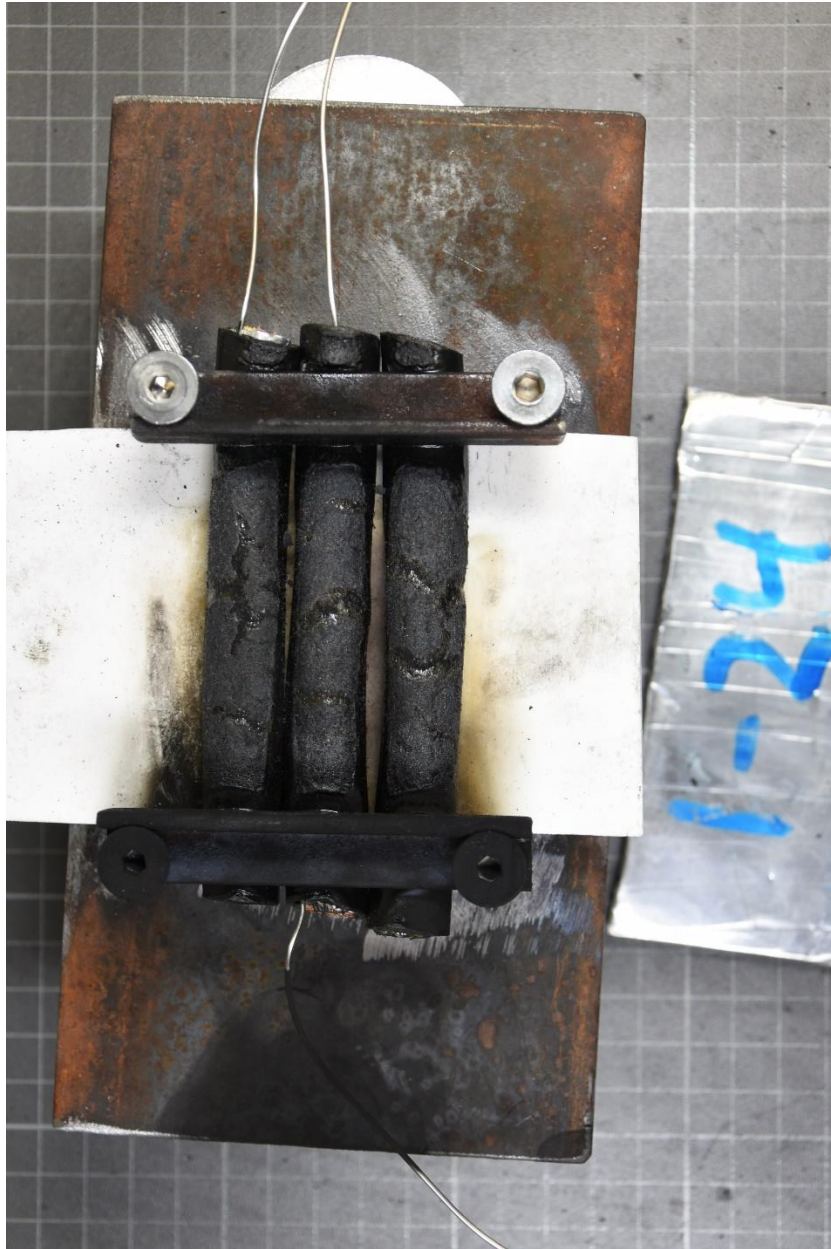
Figure 3-108 and Figure 3-109 show the target cable after the exposure profile. As shown, surface damage to the jacket is present. However, the insulated wires were not exposed during this test.

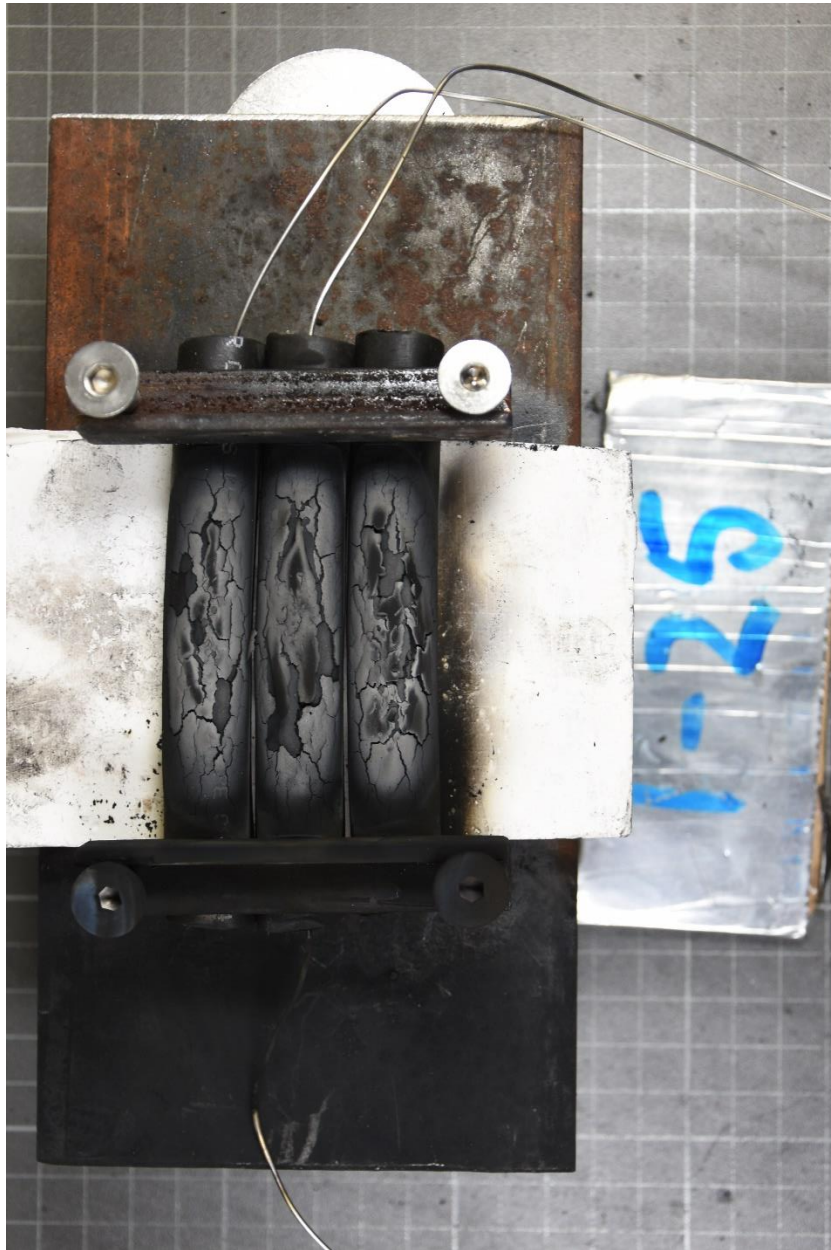
Figure 3-114: Test 1-25 Post-test Photo (1)

Figure 3-114 and Figure 3-115 show the target cable after the exposure profile. As shown, surface damage to the jacket is present. However, the insulated wires were not exposed during this test.

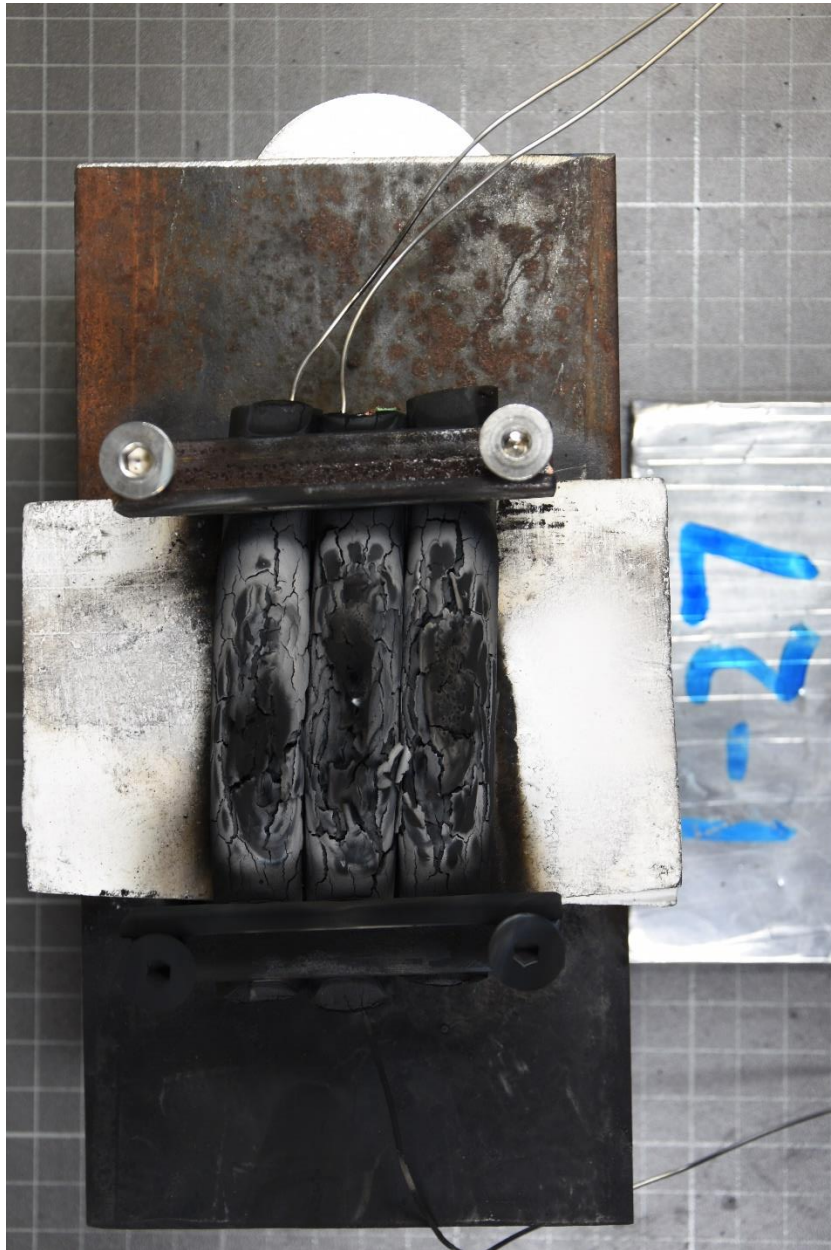
Figure 3-126: Test 1-27 Post-test Photo (1)

Figure 3-126 and Figure 3-127 show the target cable after the exposure profile. As shown, surface damage to the jacket is present. However, the insulated wires were not exposed during this test.
