Thermal Hydraulic Static Operation of a Chloride Molten Salt Shut-Off Valve

¹Sandia National Laboratories, Org. 8923 & ²Gosco Valves

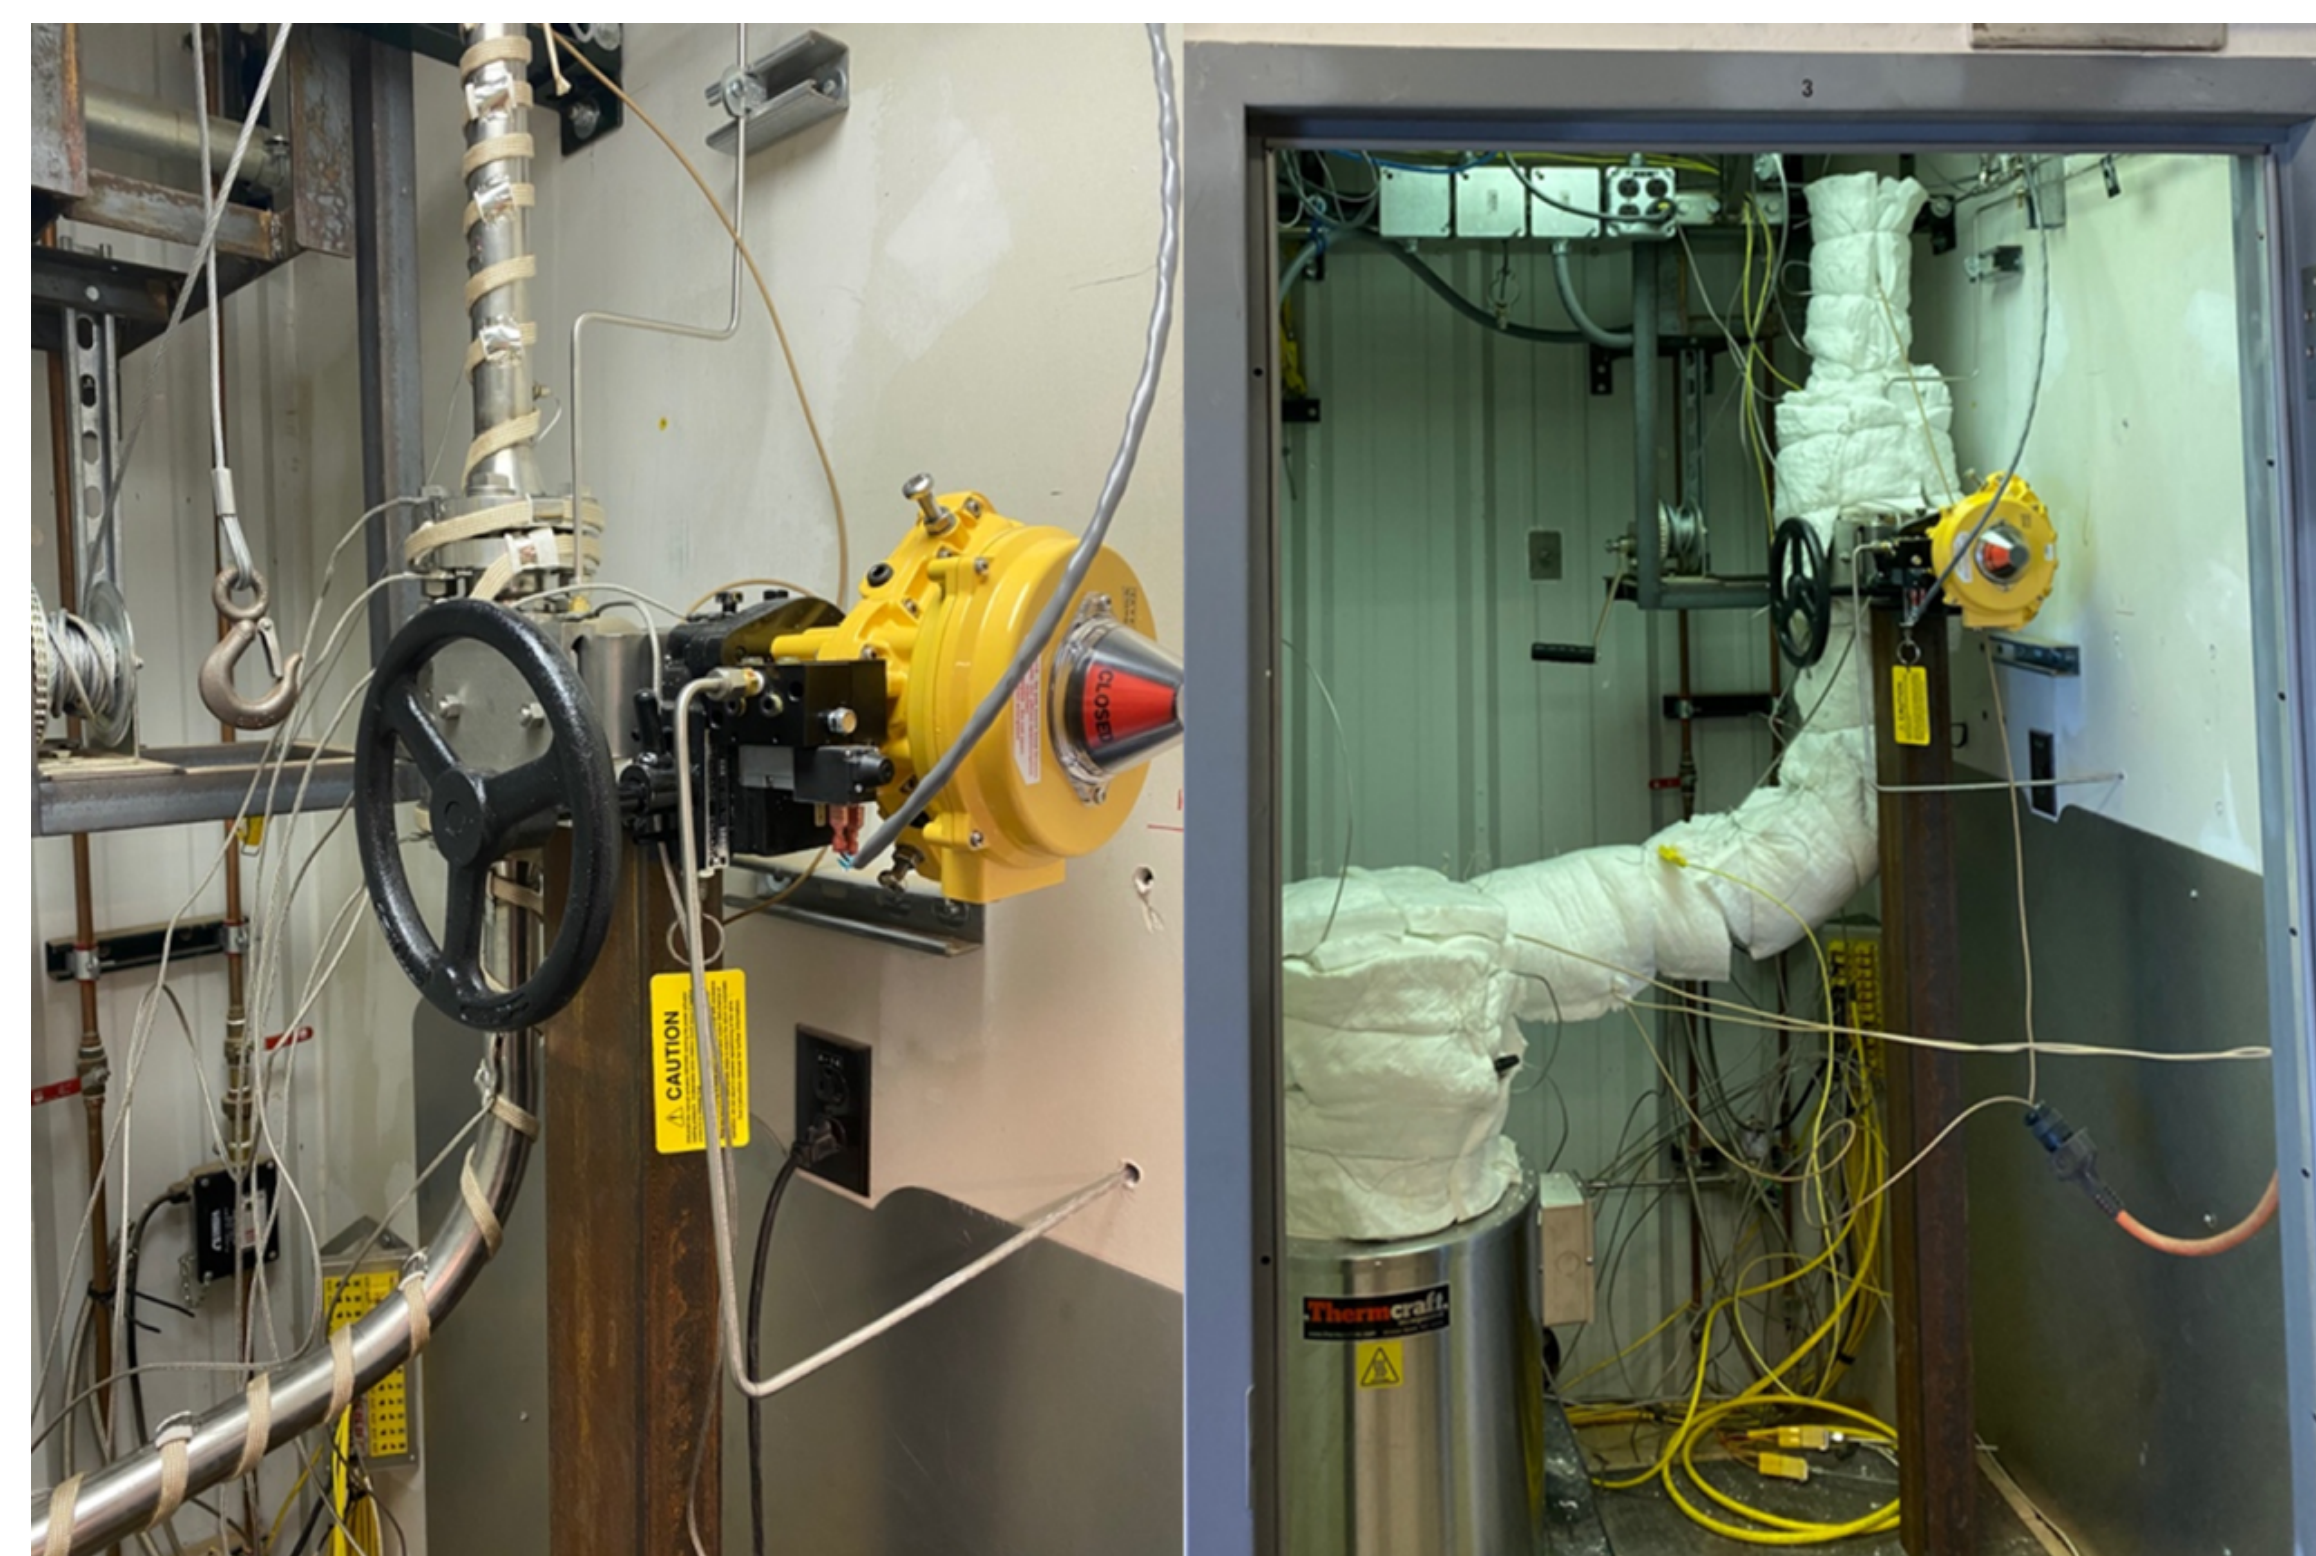
Figure 1. Gosco Valve Set-Up Exposed (left) and Insulated (right)

- Salt was initially heated in reservoir to 550°C, challenges were encountered heating the Gosco valve
- After several hours of heating, 8.9lbs of salt was pushed via pressure into the valve body at 500 °C
- The valve was actuated 10 times successfully, actuation was not smooth and salt levels were not maintained in the piping system
- Test was subsequently shut down after potential system failures were noted

- A standard API 598 test was conducted on the valve and yielded no change from pre-salt exposure
- A 720psig shell test was conducted with no leakage
- A seal test on the valve actuator showed significant leakage
- The Inconel 625 flanges and piping system did not fail or leak
- The Flexitalic gaskets appeared to be in good condition after testing and did not show signs of failure

- Testing did not reach 500°C so conclusions about >700 °C functionality cannot be made
- Valve components were not wetted for extended periods of time so corrosion analysis cannot be adequately performed
- At 500°C all proposed methods of valve cost reduction were successful. The boronized nickel valve did not show signs of damage and survived post-exposure testing
- Flanged connections with Flexitalic gaskets did not fail or leak
- All complications and failures can be attributed to failure of the Kinetrol actuator
- New actuators with longer brackets and viton seals are desired for retesting
