Experimental Testing of a 1MW sCO₂ Turbocompressor

Logan Rapp
Sandia National Laboratories
sCO₂ Symposium
February 2022

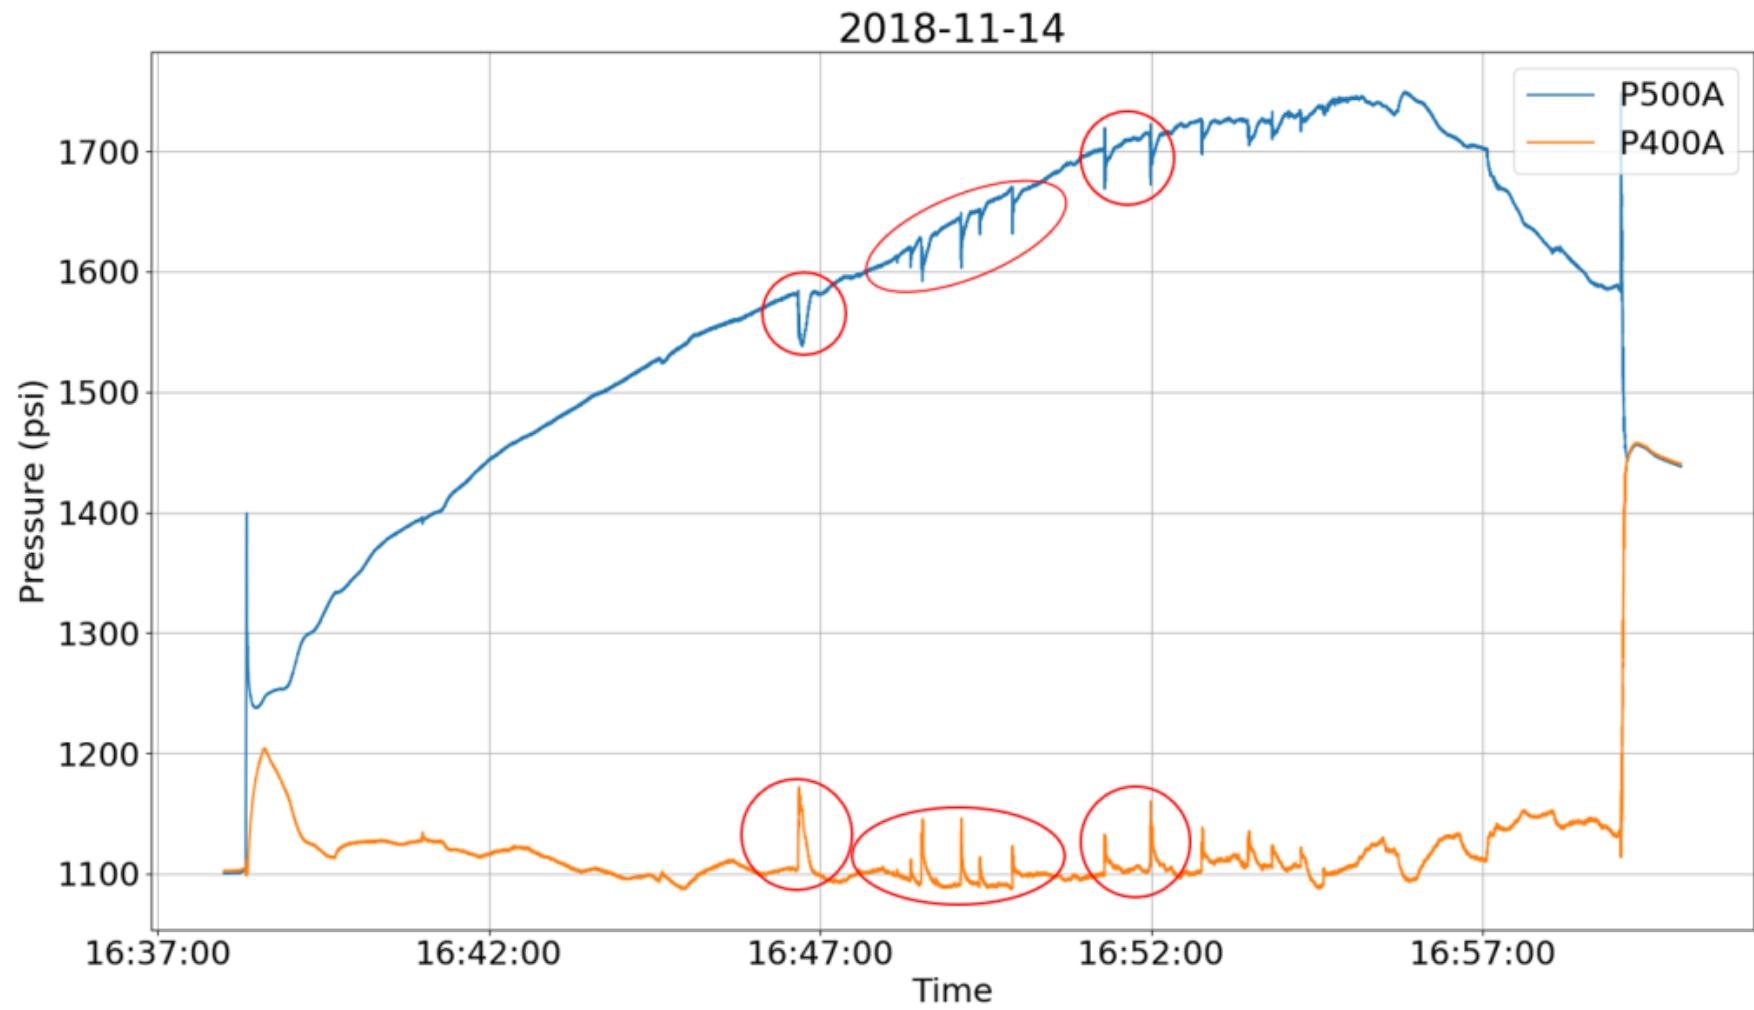
In Tests #1-3, both the thrust bearing and the radial bearings experienced rubs/failures

Spikes in pressure indicate thrust bearing rubs

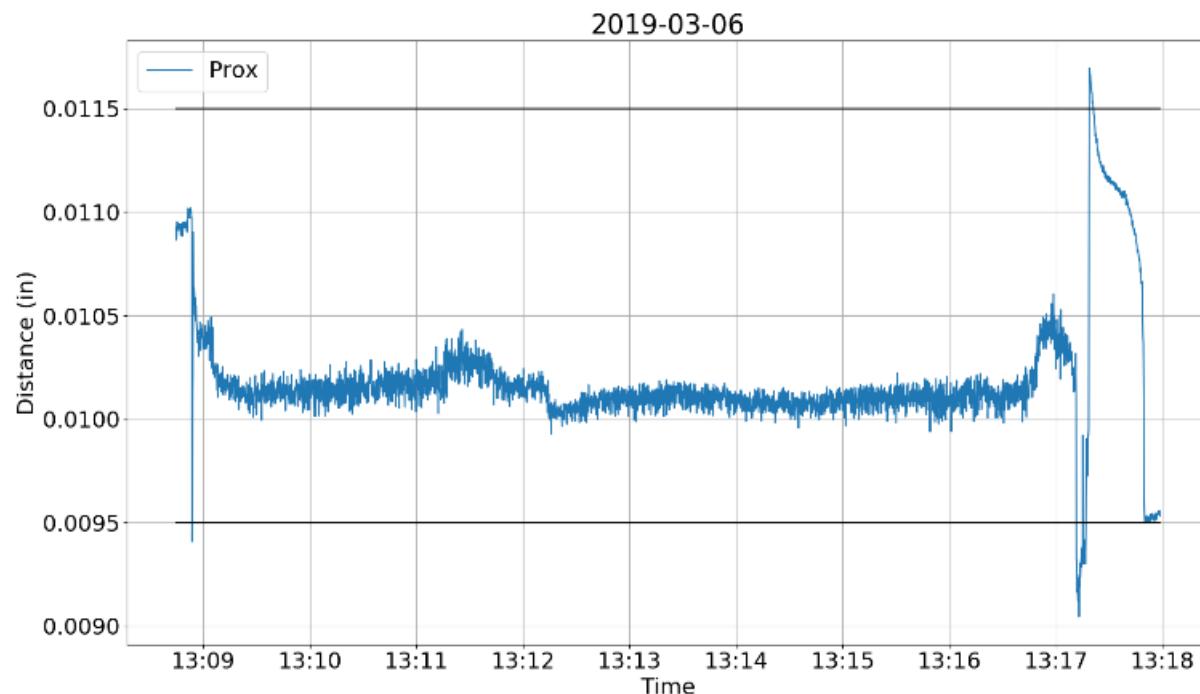
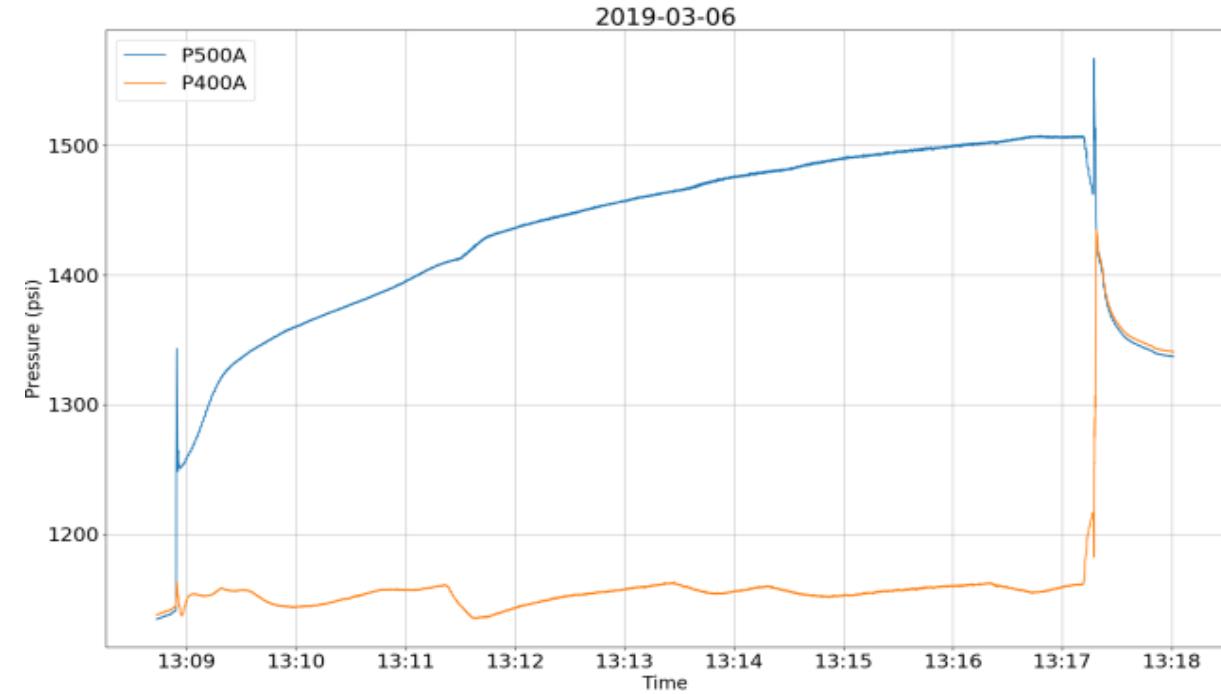
Thrust bearing issue resolved

By adjusting Valve F and the TCV the force on the rotor was balanced.

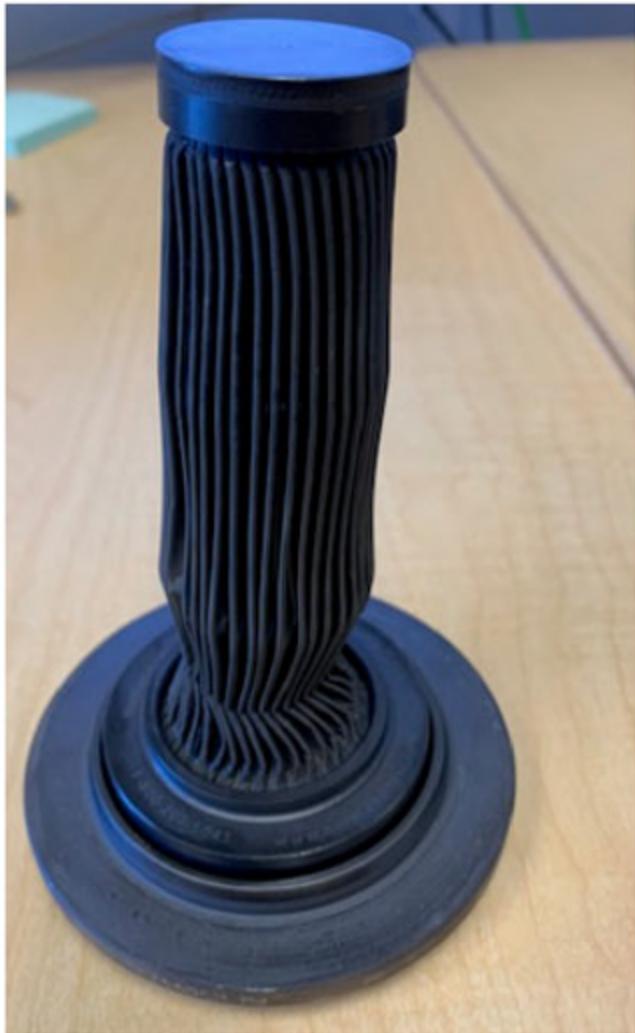
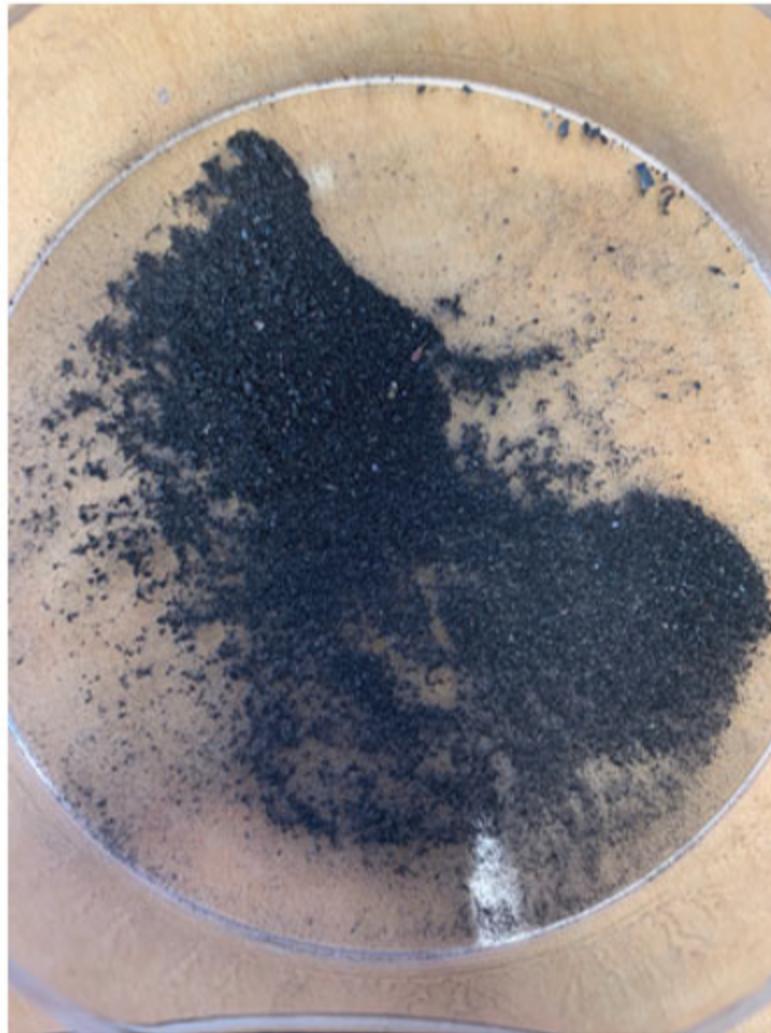
Filter Collapse

~2/3rds Common Stainless Steel, ~1/3rd Aluminum and Silicon, small percentages of Ca, Cu, Na, K, Ti.

- Indicates material is likely coming from stainless steel piping or recuperators
- Aluminum and silicon source unknown
- Accumulation of material has been significantly less than previously
- Perhaps bearing failures were causing accumulation?

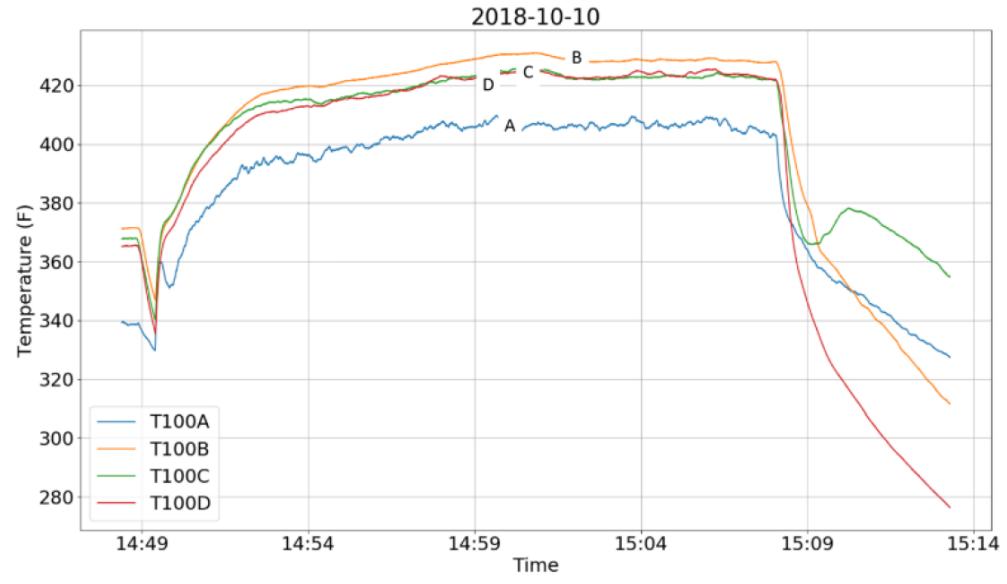
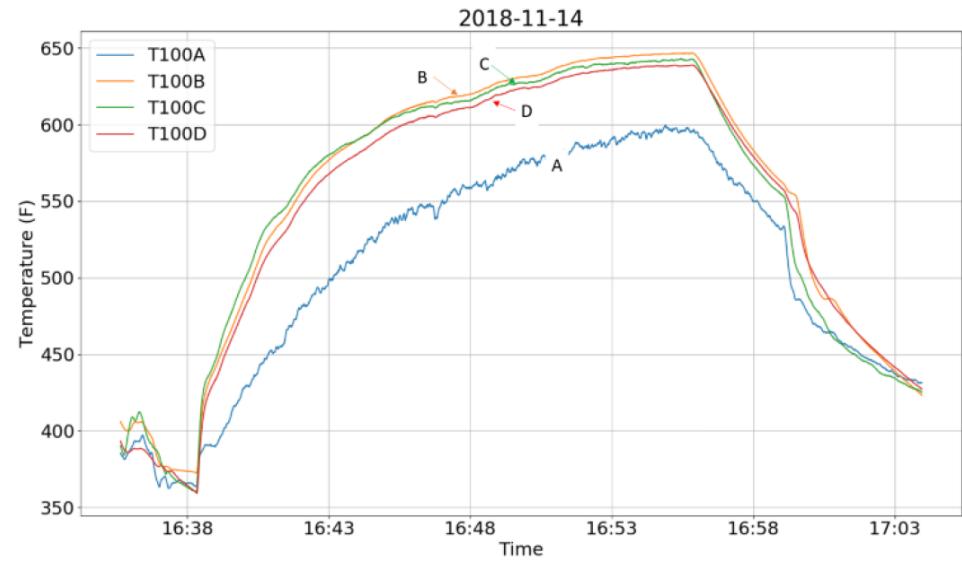
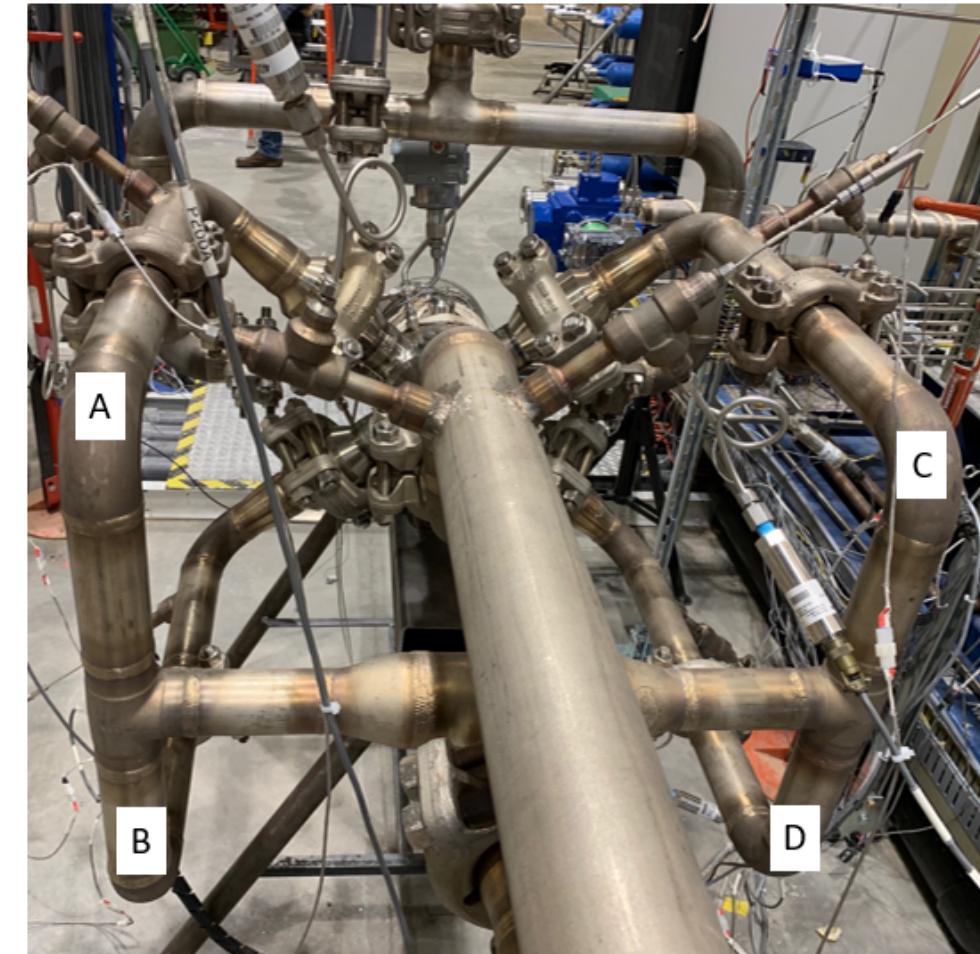
Turbine Inlets

Leg “A” was consistently lower temperature than the other 3
