Printed Wiring Assemblies (PWA) and Counterfeit Detection using Non-Destructive X-ray CT Analysis

Sandia National Labs/Computer Science R&D

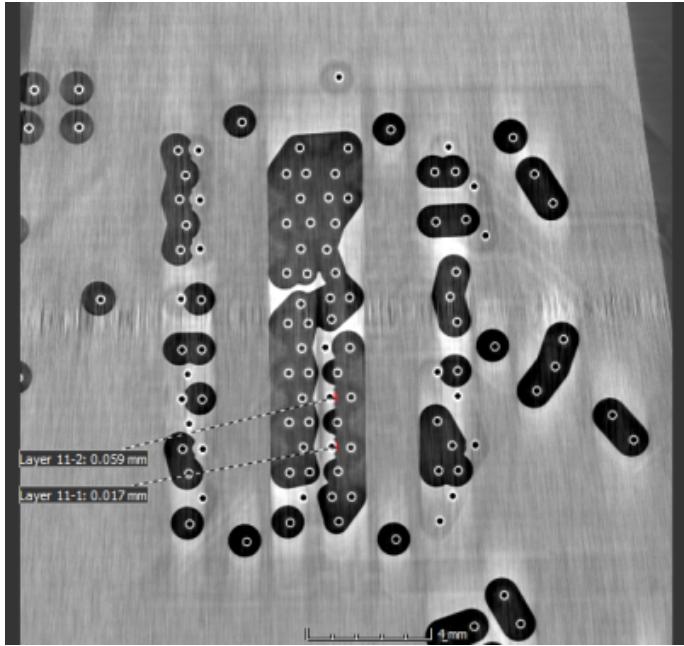
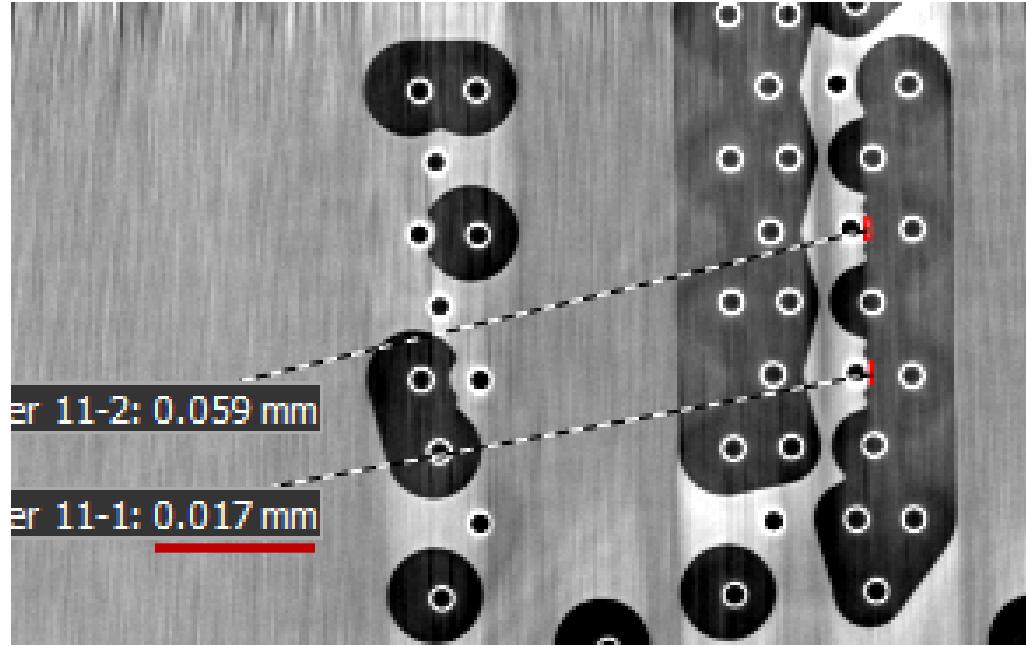
Issue location identified – less than 25 micron.

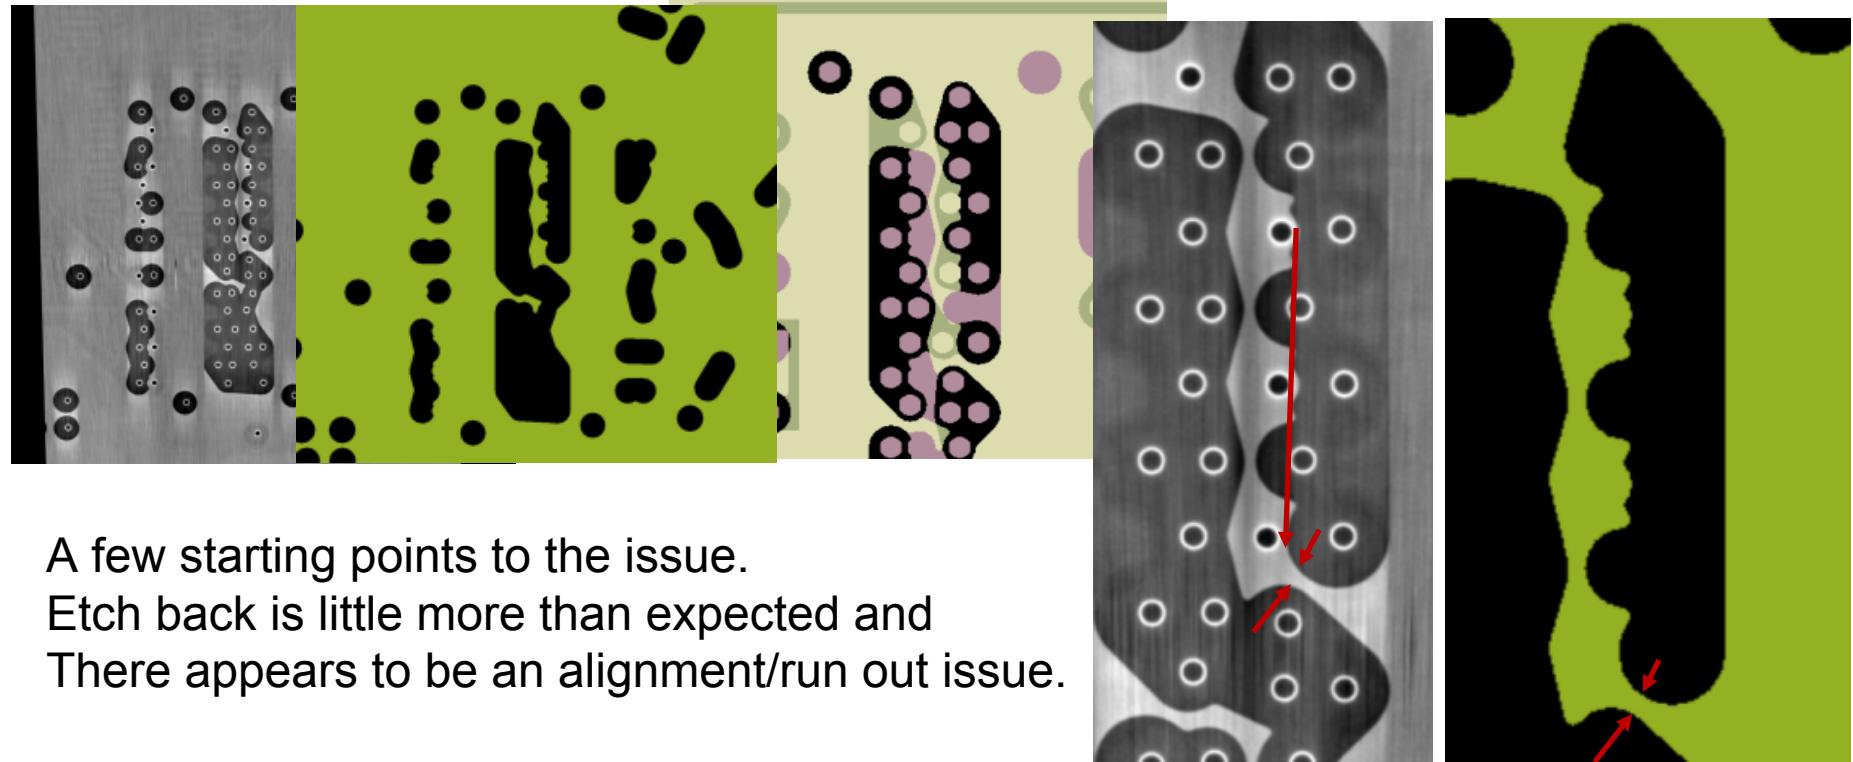
A few starting points to the issue.
Etch back is little more than expected and
There appears to be an alignment/run out issue.

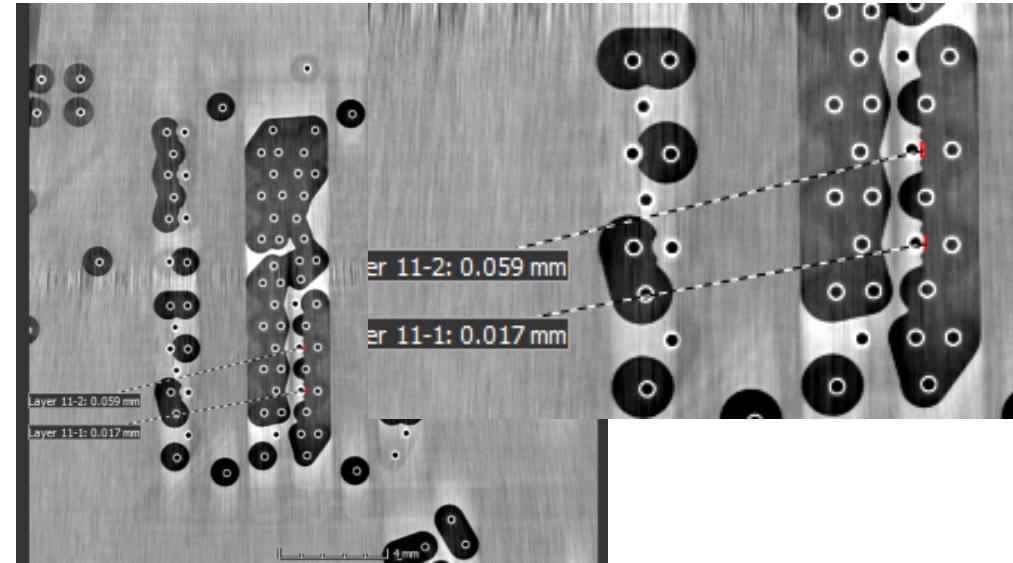
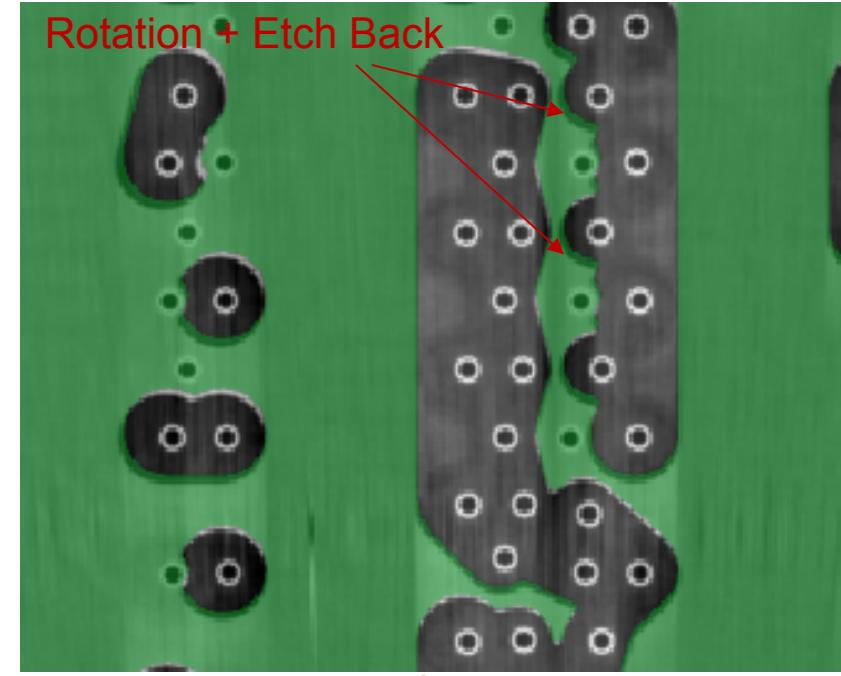
Overlay of X-ray to Gerber

Whether alignment or assembly issue,
we can start to deduce the production error.

From the rough estimate of translation – 0.5 degree rotation or greater in rotation error.
With an approximate 0.001" to 0.003" (inch) shift to the left.

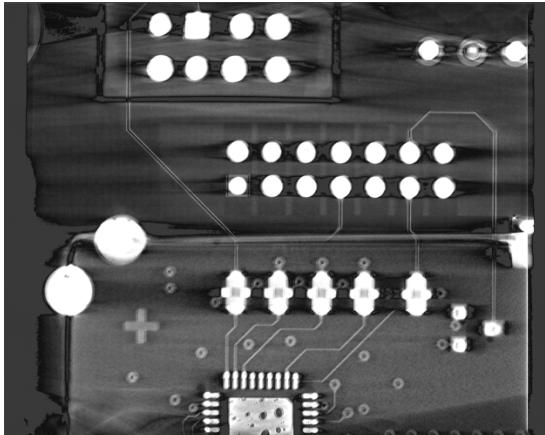
- Populated Boards pose challenges due to high Z-materials absorbing and scattering of X-rays.
 - Ghosting/Bleed Through/Smearing are few technical terms used to describe this challenge.
 - Issues come from assumption made by the Felder Kamp (FDK)

Example of artifacts present in traditional CT reconstructions
